# **BS.3998 (2010) TREE CONDITION SURVEY**

**Trust Management Ltd**

**Bellway Nutwood**

**December 2022**

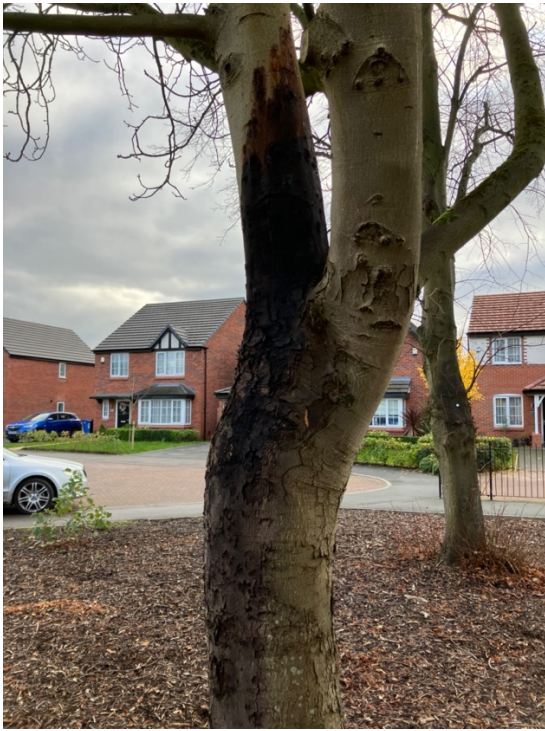
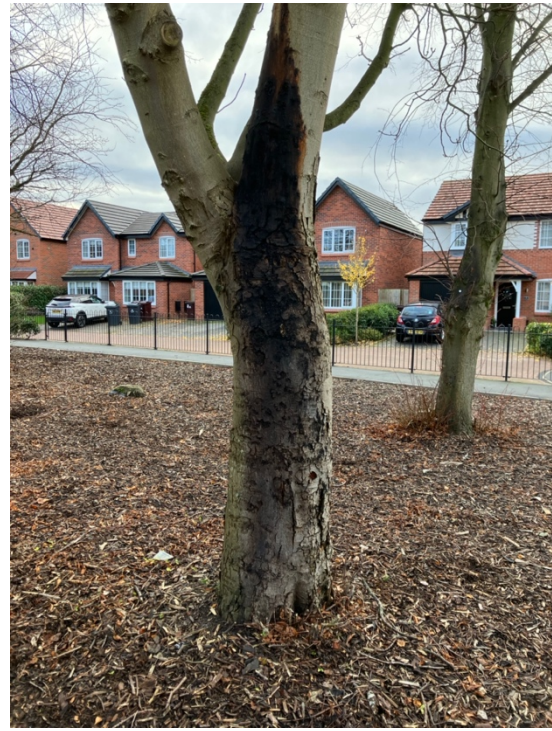
- 8.9 Tree T21, Horse chestnut is of concern as it is highly infected by Phytophthora fungus, the tree rapidly declining and at this stage it is highly likely that there may be decay to the root system. This tree should be removed at the earliest opportunity.
- 8.10 The trees have been recorded in the tables below. Please see the appendix for keys. Trees that require immediate intervention, - these have been classified as high (red) and should have the recommended work carried out as soon as practically possible.
- 8.11 The tree works have been classified upon work priority and phased accordingly.

| Tree/Tag no | Species | Height (m) | DBH (cm) | Crown_Spread (m) | Age_Class | Buds/Twigs | Scaffold | Stem | Roots/ Butresses | Overall_Condition | Recommendations | Priority |
|---|---|---|---|---|---|---|---|---|---|---|---|---|
| T21-0166 | Horse Chestnut | 13 | 50 | N6,E5,S3,W3 | Semi Mature | Fair | Fair | Poor, advance stage of phytophthora | Poor, decay at base | Poor | Fell and replant | High |

Tree T21, Horse Chestnut, advanced stage of Phytophthora

| Tree-tag Number | Tree Species | Work Required | Date Work Completed |
|---|---|---|---|
| T21-0166 | Horse Chestnut | Poor, advance stage of phytophthora fungus, fell and replant | |
