## Design, Access, and Heritage Statement

Huyton and Prescot Golf Club

Boundary Wall - Huyton and Prescot Golf Club

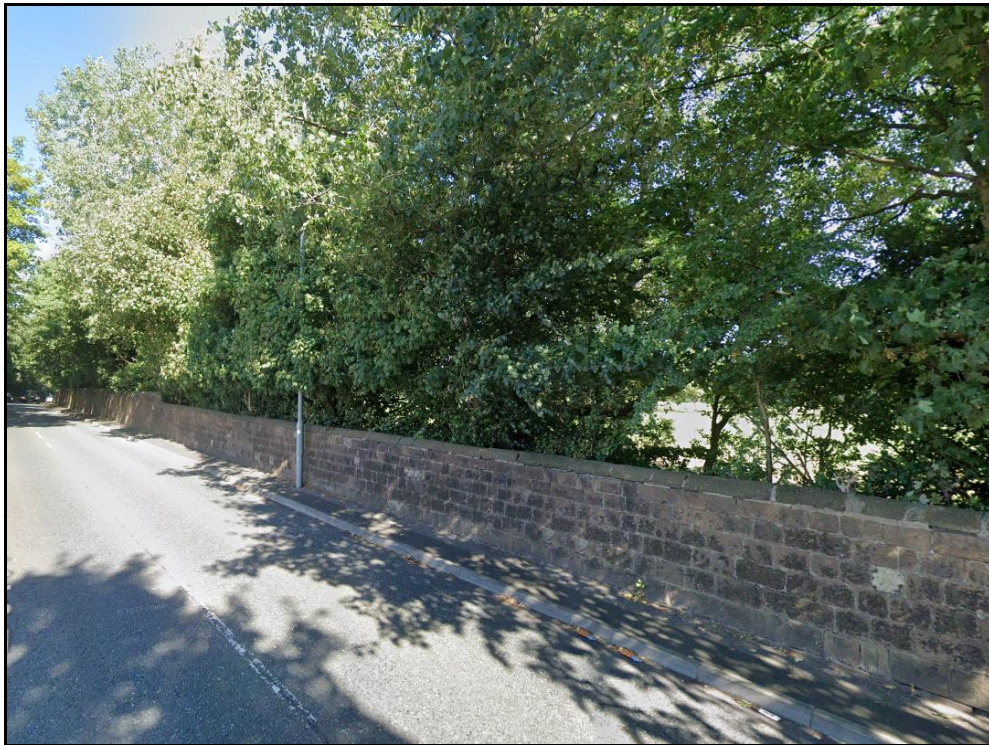
The section of damaged wall measures approximately W3500mm H1500mm D300mm and appears to be constructed with coursed Bunter Pebble Beds medium-grained red sandstone blocks, in a lime mortar with the head of wall finished with red sandstone radius/half round coping stones.

Two of the stone blocks towards the top of the wall have been displaced completely. One of the coping stones to the left of the displaced stone blocks has taken considerable damage. Elsewhere at least five of the stone blocks have damage to their faces. The remainder of the stone blocks have been partially dislodged, and cracks are visible to both vertical and horizontal joints in the area, which extend down towards ground level.

As well as the main damaged area of walling, there appear to have been repairs made in the past with a mixture of lime and cement-based mortars in localised areas. Some of the vertical joints to the coping stones have been eroded due to weathering.

The proposal is to clean the existing stone and rebuild the damaged section of wall using the existing stone. Due to the nature and extent of the damage and the potential for some of the remaining intact section of wall to suffer further collapse, it may be necessary to locally dismantle approximately a further 600mm of intact wall on either side of the visible impact area if it is found on closer inspection or during the course of the repair works to be structurally unsound or in poor condition.

- Document and/or photograph damaged section of walling. Label or mark blocks before removal to enable the damaged wall section to be rebuilt in the same configuration of stone as the existing section of wall.

- Carefully remove, clean and set aside any remaining compromised stone on the wall for reuse (approximately 5.25m<sup>2</sup>)
- Carefully remove existing mortar bed joints to enable reinstatement of the damaged wall section.

- Rebuild section of wall as existing coursing and coping in lime mortar (potentially NHL 2 1:3 Lime/Sand - medium coarse texture) using existing stone blocks.

- Where stone is too severely damaged to be repaired, supplement with reclaimed red sandstone to match existing style, colour and dimensions.
