# Prescot to Cronton

Road Safety Audit Designer's Response

Project number: 60629784  
60629784-REP-30-PC-CT-0014

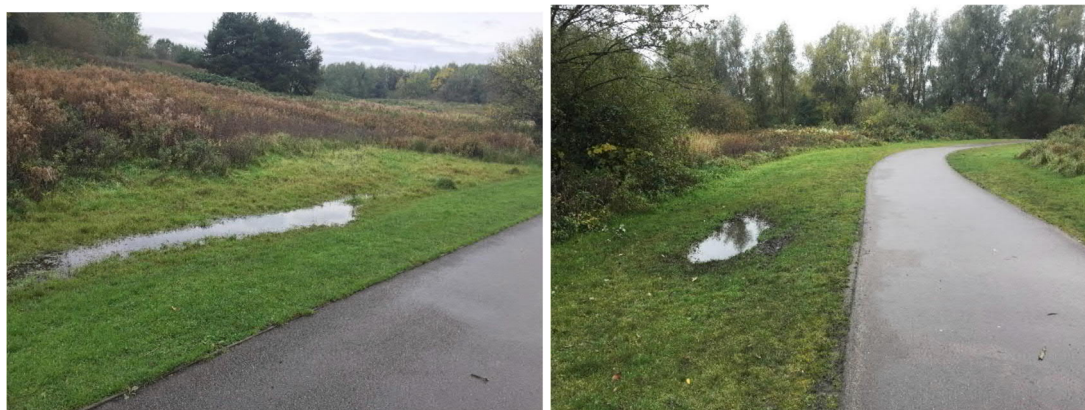
**Summary:** Risk of injury to pedestrians / cyclists resulting from slip, trip or fall related incidents, due to ponding near shared use route. In cold weather, the ponding / standing water may freeze, forming ice, creating an unstable surface across the footway / cycleway.

During the site inspection, sections of ponding / standing water were noted within the verge, extending along both sides of the existing footpath. Should the level of ponding increase in periods of heavy rainfall, there is a risk that the standing water may spread over the footway / cycleway. In freezing temperatures, ice may form and create a slippery / unsafe surface for pedestrians and cyclists. As such, there is a risk of slip, trip or fall related incidents occurring.

The ponding identified is found off the hard-standing extents and is sitting within the soft landscape area of the public open space.

From the design of the path being higher, it is thought that there has been a swale like feature incorporated and water is expected to sit within the depressions while the water percolates through the ground.

It is recommended that a review of the existing drainage provision is carried out, to identify and then provide additional drainage improvements where ponding / standing water is an issue.

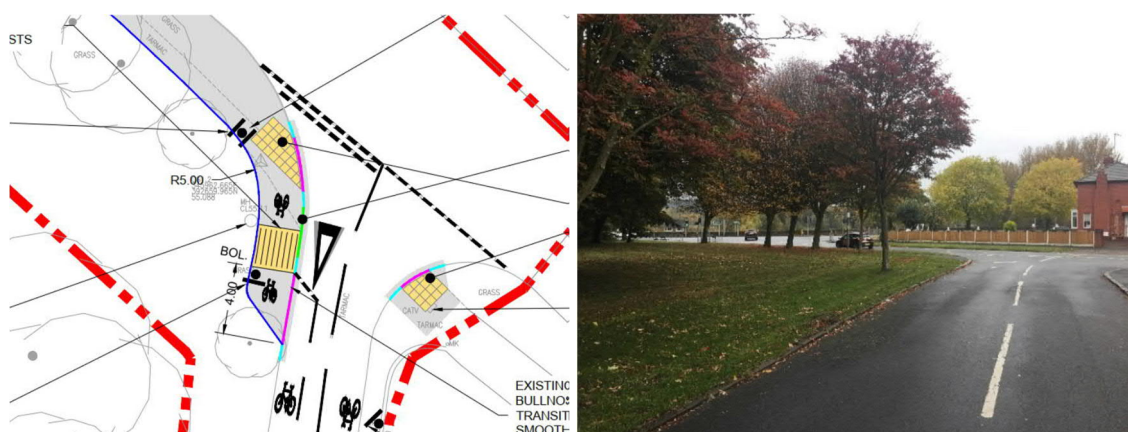
The location of the dropped kerbs is such that a cyclist approaching from the northwest, travelling along the shared use footway / cycleway towards South Avenue, will need to look behind them to check if a motorist is turning right from Manchester Road to South Avenue. They will also need to check if a motorist is turning left from Manchester Road to South Avenue, and if a cyclist is turning from South Avenue onto the shared use route. In addition to this, they will also have to negotiate pedestrians using the shared use route.

The Audit Team has concern due to the level of possible conflicts at the cycle transition point, particularly as cyclists will need to look behind them to join South Avenue. The design may result in collisions between pedestrians and cyclist and / or cycles and turning vehicles.

It is recommended that separate pedestrian and cycle routes are provided, utilising the area of landscaping to the south of Manchester Road, west of South Avenue. Alternatively, it is recommended that the cycle transition point is relocated to minimise the risk of conflict between pedestrian, cyclists and road users identified.

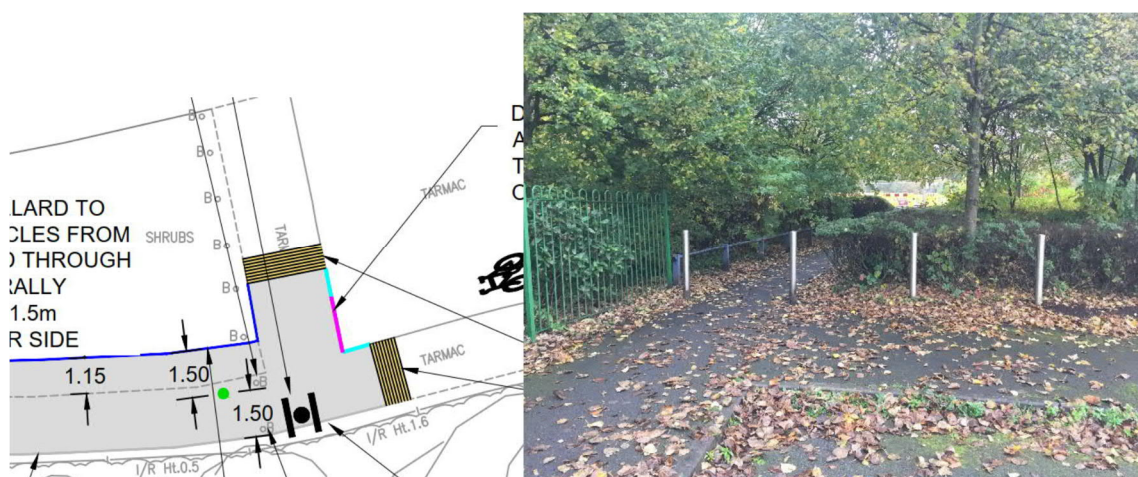
**Summary:** Risk of injury to pedestrians and cyclists using the shared use footway / cycleway, due to collisions, caused by a narrow width / pinch point at the end of Wood Lane, with two-way cycle transition plus a pedestrian through route.

The location of the dropped kerbs is where the two pedestrian routes, the off-carriageway cycle route and the new shared use route intersect. As such, the proposed design may create a pinch point within which pedestrians and cyclists will interact. There is a risk that this interaction may result in collisions when pedestrian and cycle flows are high. Furthermore, the arrangement provided could be hazardous to vulnerable users particularly visually impaired pedestrians, as they could walk straight onto Wood Lane via dropped kerbs without encountering any corduroy paving. This may lead to injury to both pedestrians and cyclists.

It is recommended that separate pedestrian and cycle routes are provided at the western end of Wood Lane to remove the interaction point shown on current proposed layout.

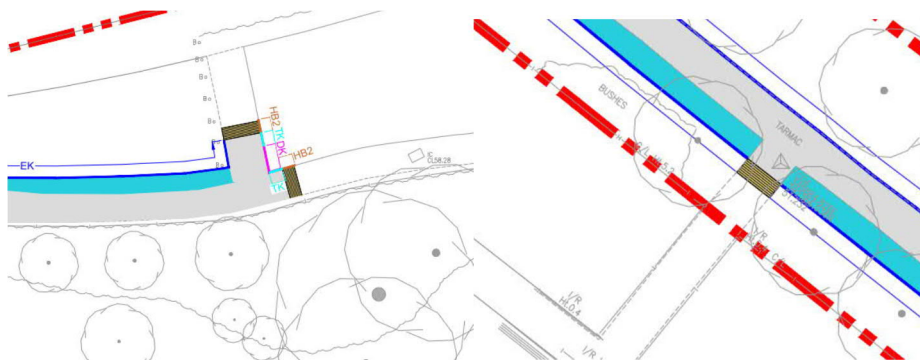
In some locations, the depth of the paving looks to be too shallow. As such, there is a risk that visually impaired pedestrians approaching the shared use route in a direct line, may overstep the buff coloured warning corduroy tactile and in doing so, not realise the possibility of cyclists within the (shared) footway. This may lead to collisions, causing injury to pedestrians and cyclists.

It is recommended that buff coloured warning corduroy tactile paving is provided in accordance with latest design standards, to delineate the start and end of the shared use route.

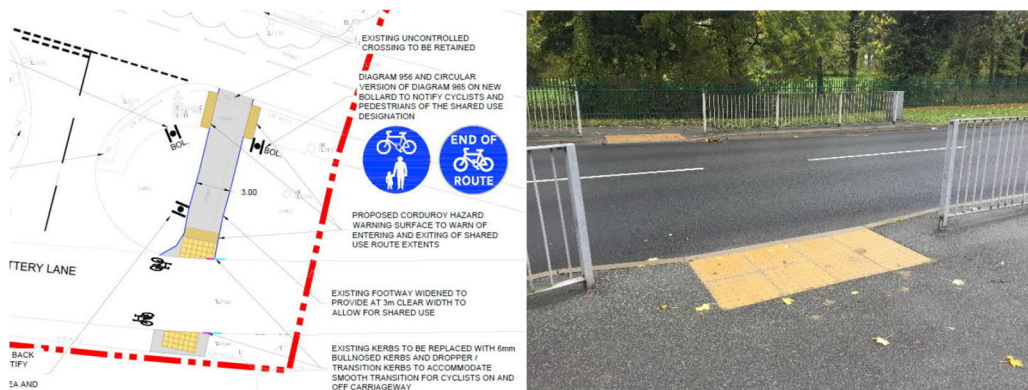
On site observations indicate that the minimum depth of the buff coloured tactile paving is less than the required 1200mm. The area of tactile paving should be enough to provide the necessary warning to a visually impaired pedestrian, approaching the crossing at a normal walking pace. At no point across the flush dropped kerbs should the depth be less than 1200mm.

If less than 1200mm depth is provided, there is a risk that visually impaired pedestrians may overstep the tactile paving and enter the carriageway, unaware that vehicles may be present. Should this occur, there is a risk of a collision with vehicle on Pottery Lane.

It is recommended that an adequate depth of tactile paving (1200mm) is provided to appropriately warn visually impaired pedestrians of the hazard.

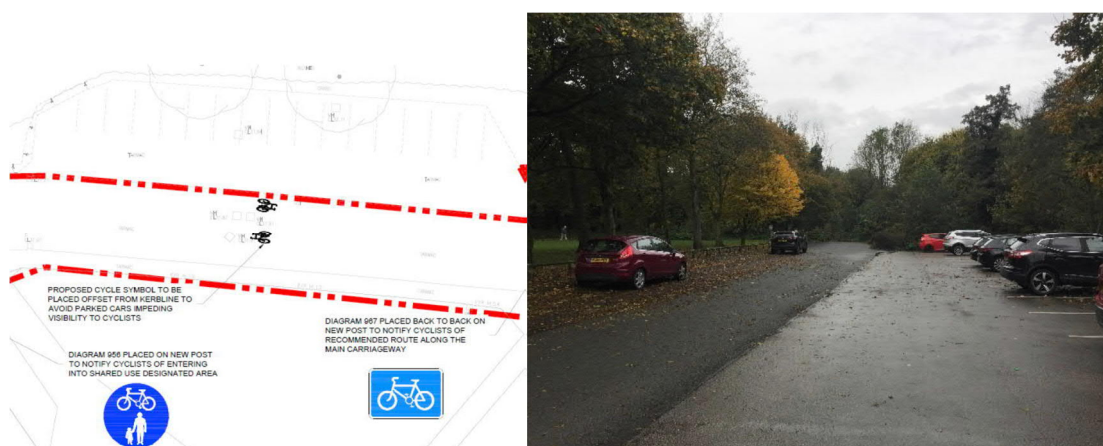
On site observations suggest that drivers drive into the parking bays, therefore requiring them to reverse out when leaving. Due to this observation and the alignment of the cycle route, as a driver exits from the parking bay, there is a risk that they may not have full visibility of a cyclist passing behind them. This may result in a collision, potentially causing an injury.

It is recommended that the hatched markings are amended to provide additional merge length without compromising the Charles Edward Road junction.

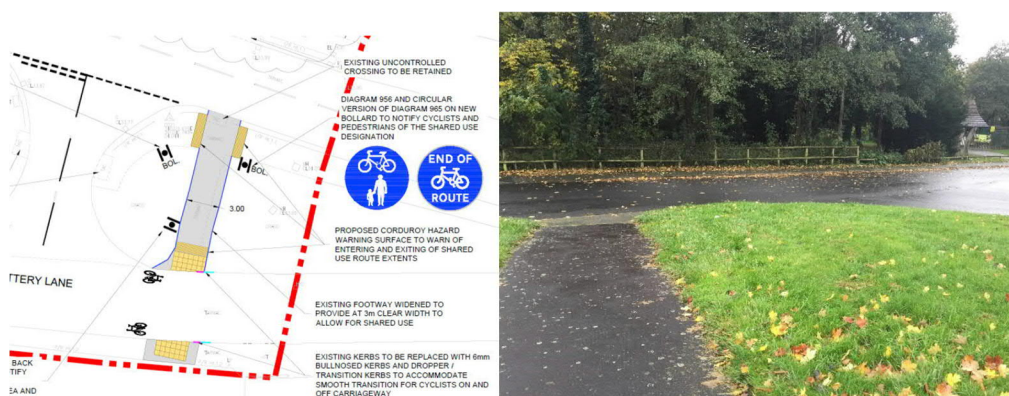
From a review of the information provided, cyclists will enter and exit the shared use section of footway / cycleway via a dropped kerb at the southern extent of the footway. In this same location, pedestrians will cross Pottery Lane as they enter / exit the Stadt Moers Park car park.

The Audit Team has concern due to the level of possible conflicts at the cycle transition point. Conflicts between cyclists and pedestrians may lead to collisions, potentially resulting in injury.

It is recommended that separate pedestrian and cycle routes are provided, removing the risk of conflicts between pedestrians and cyclists.

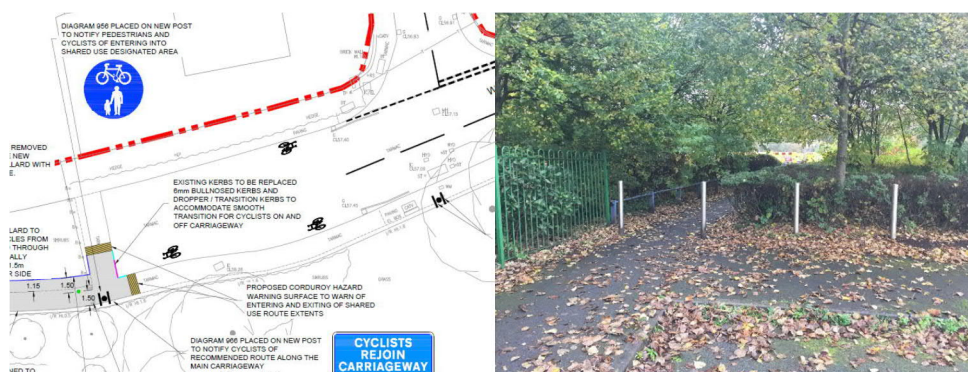
The orientation of the signs is such that the shared use route sign is facing pedestrians and cyclists approaching from the west, positioned at the end of the shared use section, and the 'Cyclists Rejoin Carriageway' sign faces cyclists already on the route extending along Wood Lane, approaching the shared use area, from the east. Due to the orientation of the proposed signs, there is a risk that pedestrians and cyclists may become confused or disorientated, causing hesitation. This may lead to collisions between pedestrians and cyclists, with a risk of causing injury.

It is recommended that the orientation of the signs reflects the proposed extents of shared use footway / cycleway and where cyclists are guided to cycle on carriageway.

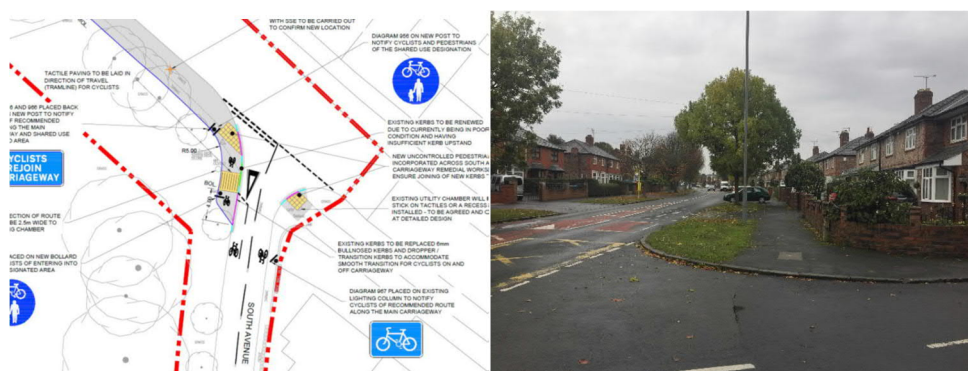
Buff coloured warning corduroy paving is proposed on the north west side of the Manchester Road / South Avenue junction. However, there is no provision of warning paving on the south east side of the junction. As such, should a pedestrian walk north along Manchester Road, across the junction of South Avenue and onto the upgraded shared use footway / cycleway, they will do so, unaware that they're entering an area of shared use. This may result in collisions with oncoming cyclists, or with those joining from South Avenue.

It is recommended that buff coloured warning corduroy tactile paving and associated shared use signing is provided to delineate the start / end of the shared use route on Manchester Road / South Avenue.

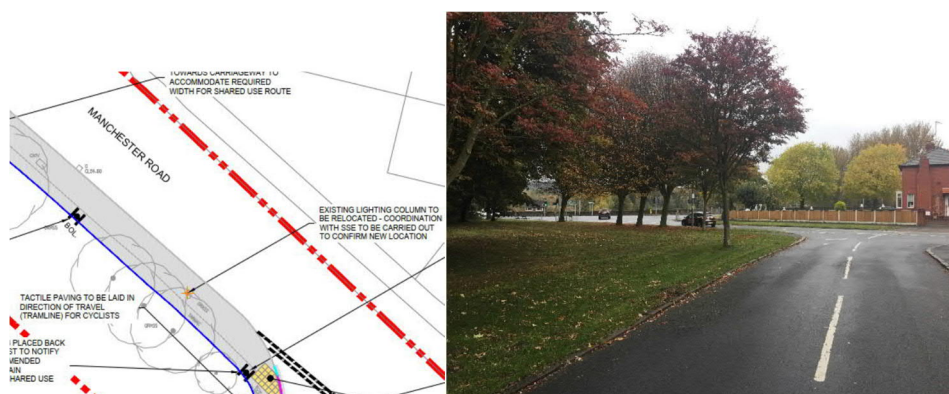
Without sufficient levels of lighting along the shared use route, there is a risk that an unlit area will be created. During hours of darkness, this may cause pedestrians and possibly cyclists to feel vulnerable and unsafe and in doing so, may deter use of the footway / cycleway due to concerns over personal safety.

It is recommended that an alternative location for the street lighting column is confirmed, providing sufficient levels of light along the length of the shared use footway / cycleway.

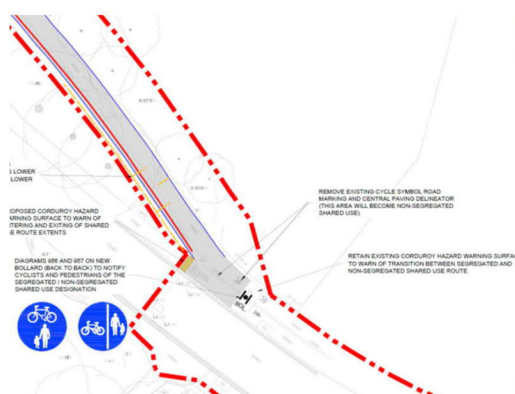
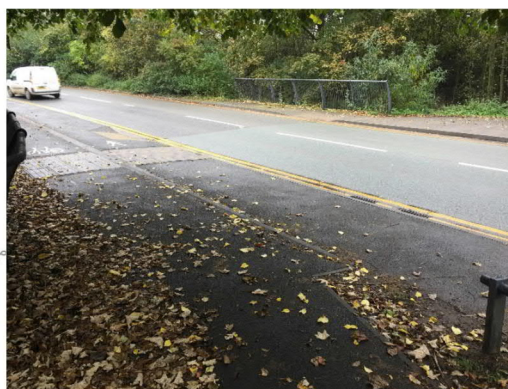
Following a review of the proposed design and from observations made during the site inspection, the Audit Team are of the opinion that the bollard with back to back signs is located too far from the point where the route transitions from shared to segregated. There is a risk that pedestrians, approaching from the footway along Carr Lane, may not realise the route becomes shared at the point where the footway intersects with the shared use route. There is therefore a risk that collisions between pedestrians and cyclist may occur at this intersection point.

It is recommended that a shared use sign is provided at the end of the footway, at the point where the footway intersects with the shared use route.

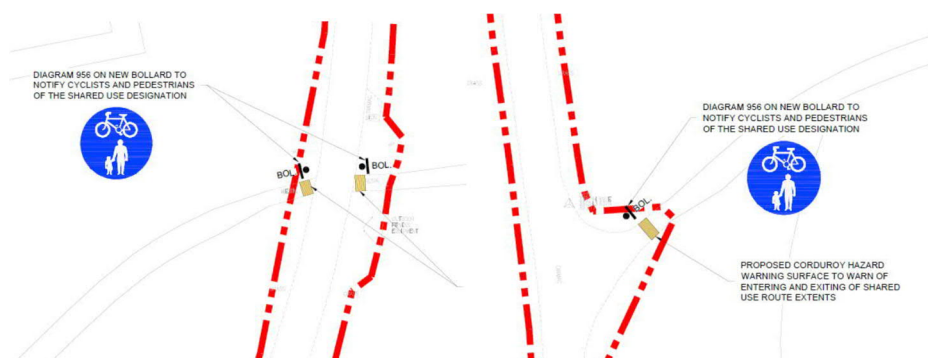
Without the 'End of Cycle Route' signs in place, cyclists may not realise that the route becomes pedestrian only at locations along the length of Phase 6. In doing so, there is risk that cyclists will attempt to continue their journey along pedestrian only routes, into the path of pedestrians. Should this happen, there is a risk of collisions, resulting in injury. Furthermore, there is a risk that the terrain along the pedestrian only routes is unstable or unsuitable for cyclists. If so, there is a risk of fall related incidents occurring for cyclists.

It is recommended that a consistent approach is adopted and where 'End of Cycle Route' signs (dia. 965) are provided at all locations where the cycle route terminates to avoid cyclists colliding with pedestrians along footpath facility.

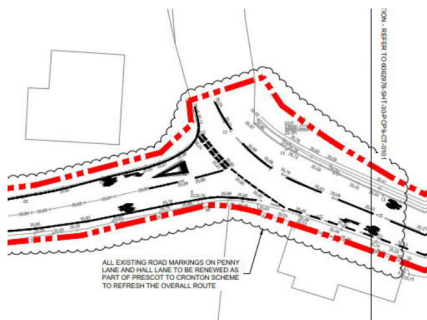
**Description:** Drawing 60629784-SHT-30-PCP8-CT-0113 shows the proposed on carriageway cycle route along Hall Lane and Penny Lane. During the site inspection the Audit Team noted that vehicle speeds on the approach to this junction were high and evidence of collisions was also noted.

The Audit Team has concerns that should vehicle speeds remain high in the vicinity of this junction, there may be an increased risk of pedestrian / cycle / vehicle collisions once the scheme has been implemented and this is a promoted pedestrian and cycle route.

It is recommended traffic calming measures are implemented on Hall Lane and Penny Lane to reduce traffic speeds.

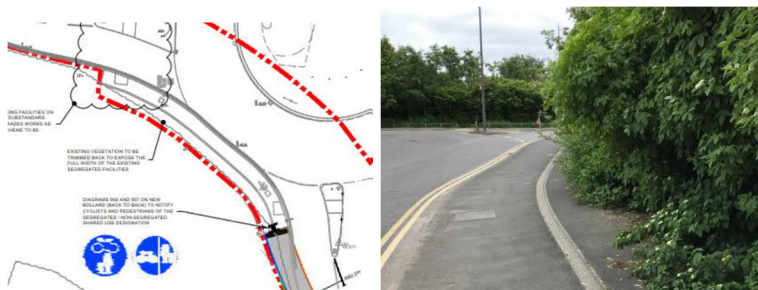
During the site inspection, the Audit Team noted that the vegetation adjacent to the existing segregated facility was overgrown and significantly reducing its effective width.

The Audit Team has concerns that the reduction in effective width of this facility may increase the risk of pedestrian / cycle collisions, should cycles enter the pedestrian only area.

It is recommended the vegetation is maintained so that the full width of the shared use footway / cycleway can be used.

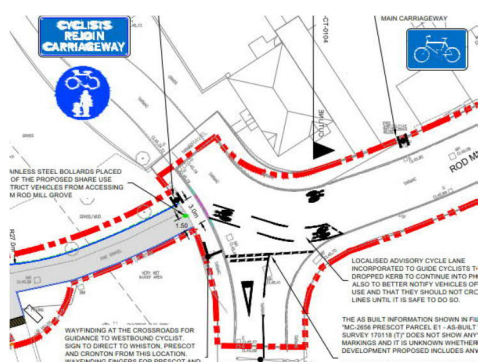
The Audit Team has concerns that the alignment of the advisory cycle lane, guides westbound cyclist into the middle of the carriageway in the path of vehicles exiting the Cul-de-sac to the north. This arrangement may increase the risk of cycle / vehicle collisions.

It is recommended that the advisory cycle lane is realigned to follow the edge of carriageway.

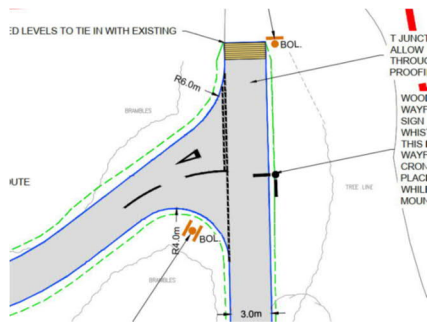
The Audit Team has concerns that this proposed formal control may be confusing to users, particularly pedestrians. User confusion at this interaction point may result in hesitation, potentially increasing the risk of pedestrian / cycle collisions.

It is recommended the 'Give Way' markings are omitted, and the alignment revised to suit the need of all users.

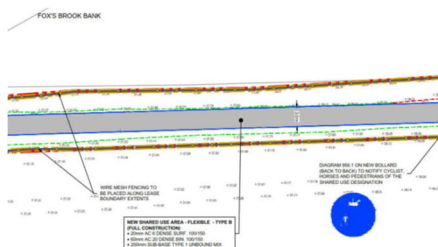
**Description:** Drawings 60629784-SHT-30-PCP8-CT-0102, 0103, 0104, and 0105 show the proposed multiuser route through an existing green field site connecting Penny Lane with the proposed Pegasus crossing on Fox Bank Lane. During the site inspection the Audit Team noted that vegetation adjacent to the proposed path is overgrown.

The Audit Team has concerns that low / overgrown vegetation may increase the risk of equestrian collisions.

It is recommended the vegetation is maintained at the recommended height for equestrian use.

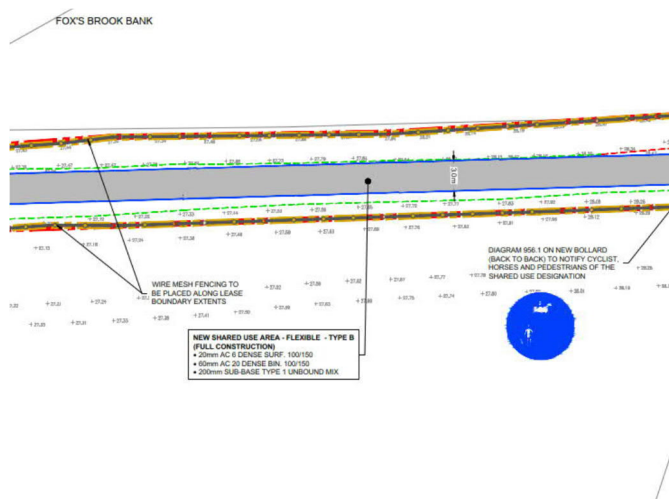
**Description:** Drawings 60629784-SHT-30-PCP8-CT-0102, 0103, 0104, and 0105 show the proposed multiuser route through an existing green field site connecting Penny Lane with the proposed Pegasus crossing on Fox Bank Lane. During the site inspection the Audit Team noted that there is a deep drainage ditch on the northern side of the green field site running adjacent to the proposed multiuser path.

The information provided to the Audit Team does not show any proposed fencing or similar measure, to prevent access into the drainage ditch. The Audit Team has concerns that without protection, there may be an increased risk that pedestrians / cyclist / horse riders may inadvertently enter the ditch, resulting in injury.

It is recommended that fencing or similar protection is provided where the drainage ditch is adjacent to the multiuser path.

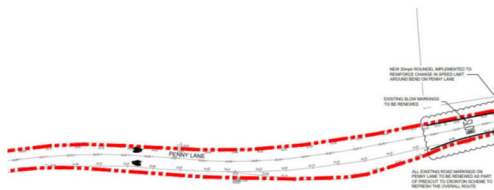
The Audit Team has concerns that providing a 'Quiet Street' cycle route along a section of carriageway with high speeds may increase the risk of cycle / vehicle collisions. It also provides a conflicting message to road users.

It is recommended that traffic calming and a reduction in speed limit is implemented on Penny Lane.

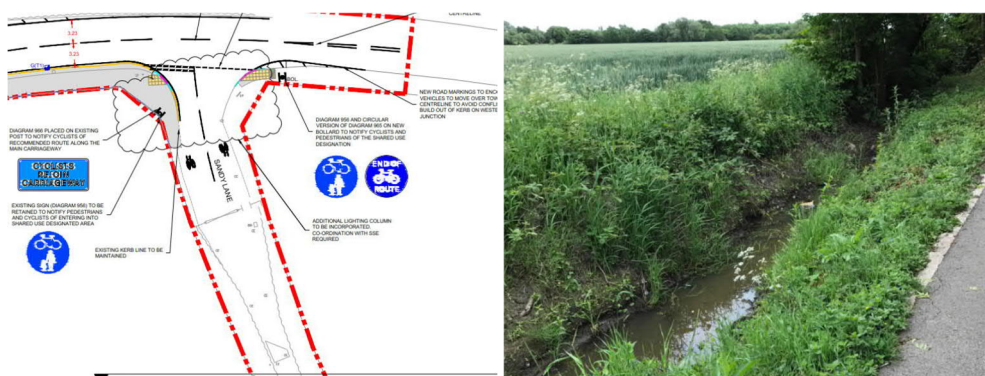
**Description:** Drawing 60629784-SHT-30-PCP9-CT-0108 shows the proposed pedestrian cycle route running along the existing alignment of Sandy Lane. During the site inspection the Audit Team noted that deep drainage channels extend along both sides of Sandy Lane, adjacent to the proposed pedestrian / cycle path. The information provided to the Audit Team does not show any proposed fencing or similar measure to prevent access into the drainage channels.

The Audit Team has concerns that without protection, there may be an increased risk that pedestrians / cyclist may inadvertently enter the channels, resulting in injury.

It is recommended that fencing or similar protection is provided where the drainage channels are adjacent to the pedestrian / cycle path.

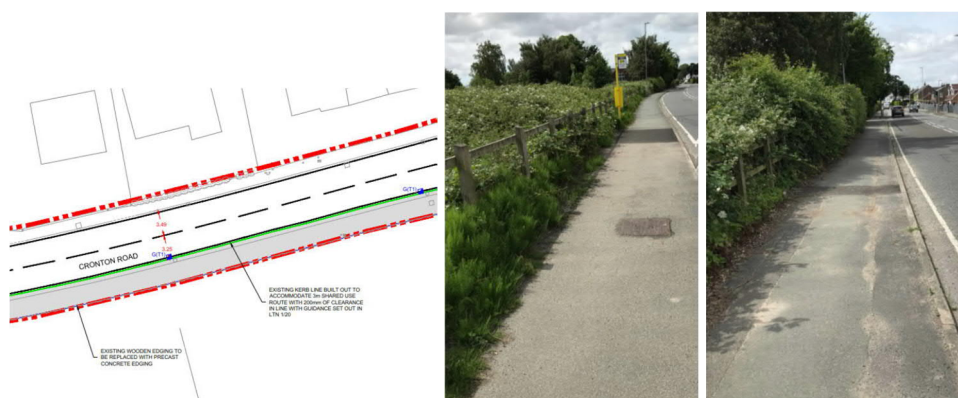
**Description:** Drawing 60629784-SHT-30-PCP9-CT-0107 shows the proposed shared use footway on the southern side of Cronton Road. During the site inspection the Audit Team noted that the existing vegetation obstructs some of the existing footway.

The Audit Team has concerns that the existing vegetation at the back of footway reduces the effective width of the proposed shared use footway. A reduction in the effective width may increase the risk of pedestrian / cycle collisions along the shared use footway.

It is recommended that the existing vegetation is cut back and maintained so that the design width of the proposed shared use footway is not affected.

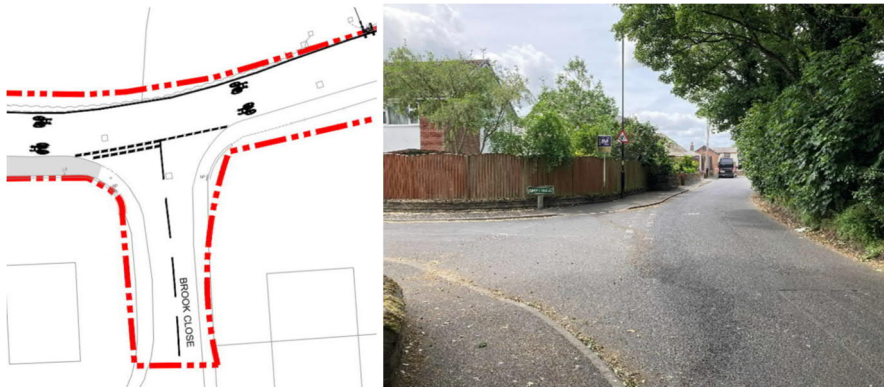
**Description:** Drawing 60629784-SHT-30-PCP9-CT-0101 shows the proposed on carriageway cycle route running along Hall Lane. During the site inspection the Audit Team noted that at the junction with Brook Street, there isn't tactile paving at the pedestrian crossing point and paving is not proposed as part of the scheme.

The Audit Team has concerns that without tactile paving informing pedestrians, particularly the visually impaired, of the hazard, there may be an increased risk of pedestrian / vehicle collisions.

It is recommended that tactile paving is provided at the crossing point on Brook Close.

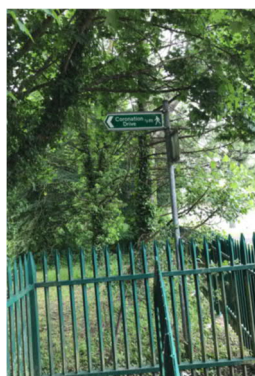
The Audit Team has concerns that without the correct wayfinding signing to direct cycles and pedestrians along the propose route there may be an increased risk of users deviating from the proposed route potentially increasing the risk of pedestrian / cycle collisions.

It is recommended a revised wayfinding signing strategy is provided for the proposed cycle and pedestrian route.
