## ASBESTOS REFURBISHMENT SURVEY REPORT

| <b>Site</b> | Unit C Sovereign Industry Park, Wilson Road, Huyton, Liverpool, L36 6AD |
| <b>Survey reference</b> | J723744 |

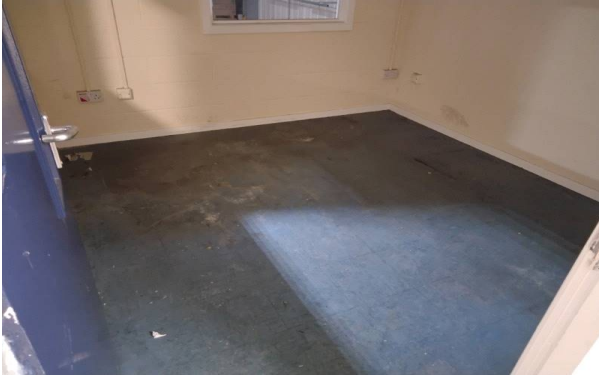
| <b>Item / Inspection Ref:</b> | #1 | <b>Material Assessment</b> | <b>Product type:</b> | | |

| <b>Item Description:</b> | Blue vinyl floor tiles and adhesive | | <b>Extent/amount:</b> | | |
| <b>RISK CODE:</b> | <b>No Asbestos</b> | | <b>Time in Area:</b> | | |

| <b>Action:</b> | None required | | <b>Frequency of Use:</b> | | |

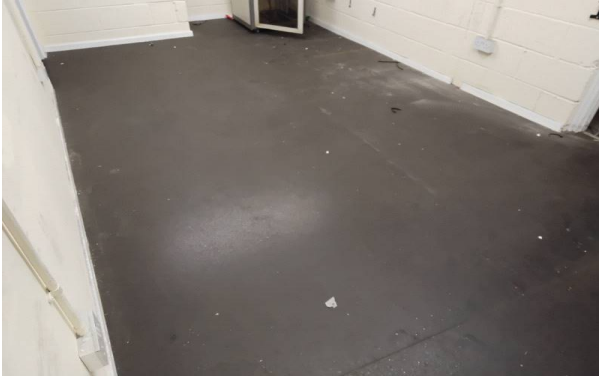
| <b>Item / Inspection Ref:</b> | #2 | <b>Material Assessment</b> | <b>Product type:</b> | | |

| <b>Item Description:</b> | Blue vinyl floor tiles and adhesive | | <b>Extent/amount:</b> | | |
| <b>Level of Identification:</b> | STRONGLY PRESUMED | | <b>Number of Occupants:</b> | | |
| <b>RISK CODE:</b> | <b>No Asbestos</b> | | <b>Time in Area:</b> | | |

| <b>Action:</b> | None required | | <b>Frequency of Use:</b> | | |

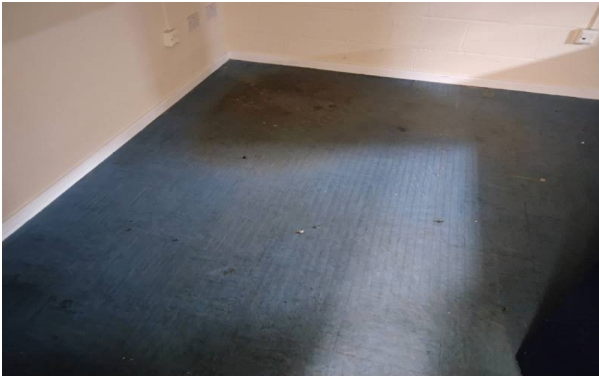
| <b>Item / Inspection Ref:</b> | #3 | <b>Material Assessment</b> | Product type: | | |

| Item Description: | Blue vinyl floor tiles and adhesive | | Extent/amount: | | |
| Level of Identification: | STRONGLY PRESUMED | | Number of Occupants: | | |
| <b>RISK CODE:</b> | <b>No Asbestos</b> | | Time in Area: | | |

| <b>Action:</b> | None required | | Frequency of Use: | | |

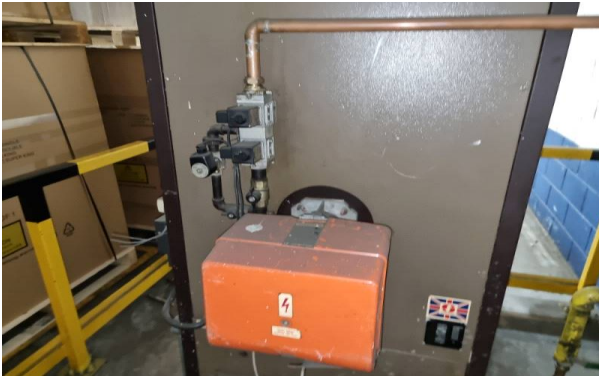
| <b>Item / Inspection Ref:</b> | #4 | <b>Material Assessment</b> | Product type: | 2 | |

| Building | Unit C Sovereign Industrial Park, Liverpool | | | | | | | | Room Notes |
|---|---|---|---|---|---|---|---|---|---|
| Ground Floor | Warehouse | #4 | Gaskets | To front of powrmatic heater | Chrysotile | 1no. | C | Monitor and manage | Composite sheet steel roof, sheet steel & masonry walls MMMF insulation in cavities, concrete floor. Modern rubber gaskets to pipework. |

| Item Description: | Gaskets | | Extent/amount: | 1 1no. | |
| <b>RISK CODE:</b> | <b>C</b> | | Time in Area: | 0 | |
| | | <b>Total Score:</b> | <b>9</b> | | |

| <b>Action:</b> | Monitor and manage | | Frequency of Use: | 0 | |

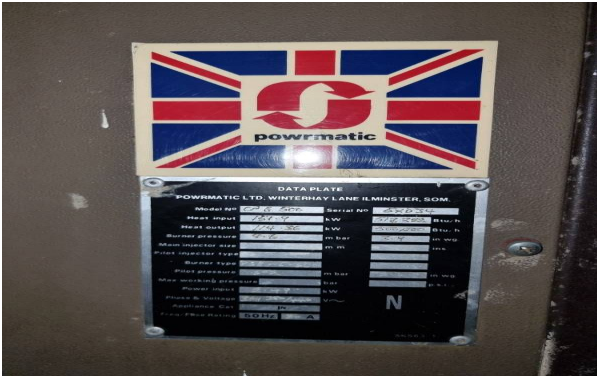
| Item / Inspection Ref: | #5 | Material Assessment | Product type: | |

| Building | Unit C Sovereign Industrial Park, Liverpool | | | | | | | | Room Notes |
|---|---|---|---|---|---|---|---|---|---|
| Ground Floor | Warehouse | #5 | No access | Within live powrmatic heater | Inaccessible, Presume asbestos | 1no. | No Access | | |

| Position: | Within live powrmatic heater | | Accessibility: | |
| Item Description: | No access | | Extent/amount: | 1no. |
| Level of Identification: | INACCESSIBLE (PRESUMED) | | Number of Occupants: | |

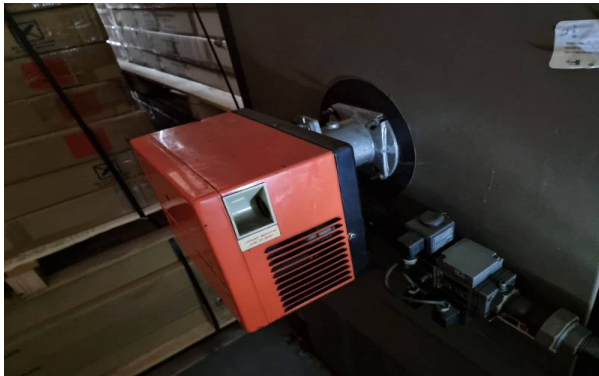
| Item / Inspection Ref: | #6 | Material Assessment | Product type: | 2 | |

| Building | Unit C Sovereign Industrial Park, Liverpool | | | | | | | | Room Notes |
|---|---|---|---|---|---|---|---|---|---|
| Ground Floor | Warehouse | #6* | Gasket | To front of powrmatic heater | Chrysotile* | 1no. | C | Monitor and manage | |

| | | | Total Score: | 10 | |

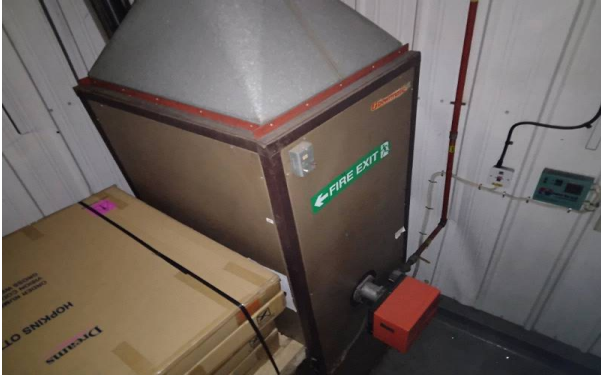
| <b>Item / Inspection Ref:</b> | #7 | <b>Material Assessment</b> | Product type: | | | |

| Building | Unit C Sovereign Industrial Park, Liverpool | | | | | | | | Room Notes |
|---|---|---|---|---|---|---|---|---|---|
| Ground Floor | Warehouse | #7 | No access | Within powrmatic heater to rear of warehouse | Inaccessible, Presume asbestos | 1no. | No Access | | |

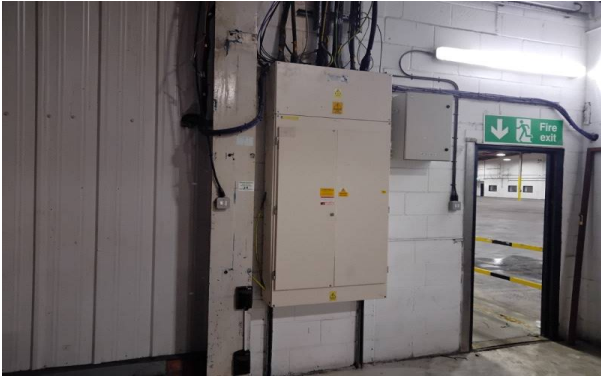
| <b>Item / Inspection Ref:</b> | #8 | <b>Material Assessment</b> | Product type: | | | |

| Building | Unit C Sovereign Industrial Park, Liverpool | | | | | | | | Room Notes |
|---|---|---|---|---|---|---|---|---|---|
| Ground Floor | Warehouse | #8 | No access | Within live electrical equipment throughout | Inaccessible, Presume asbestos | 12no. | No Access | | |
