## ASBESTOS DEMOLITION SURVEY REPORT

| <b>Site</b> | Unit E (Offices) Sovereign Industry Park,<br>Wilson Road, Huyton, Liverpool, L36 6AD |
| <b>Date report issued</b> | 26th May 2022 |
| <b>Survey reference</b> | J723762 |

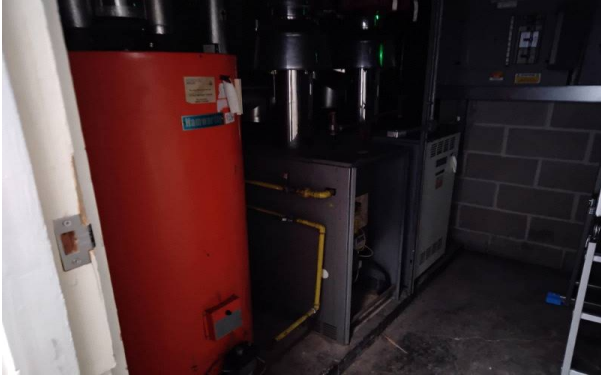
| <b>Item / Inspection Ref:</b> | #5 | <b>Material Assessment</b> | Product type: | | |

| Building | Unit E Sovereign Industrial Park, Liverpool | | | | | | | | Room Notes |
|---|---|---|---|---|---|---|---|---|---|
| Ground Floor | Boiler room | #5 | No access | Within handworthy water heater and 2 floor standing handworthy boilers. | Inaccessible, Presume asbestos | 3no. | No Access | | Concrete soffit, masonry walls, concrete floor. |

| <b>Comments:</b> | No access due to live gas and electrical equipment | | | | |

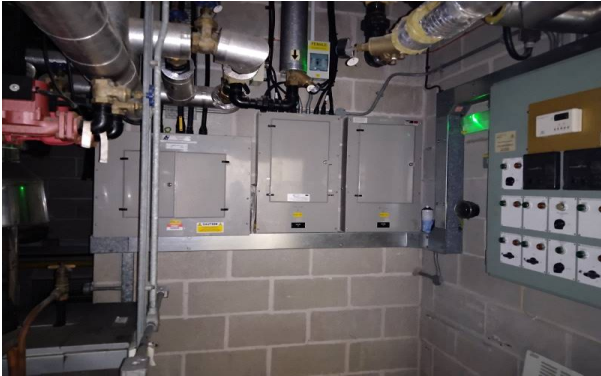
| <b>Item / Inspection Ref:</b> | #6 | <b>Material Assessment</b> | Product type: | | |

| Building | Floor level | Room | Item / Inspection Reference | Item Description | Position | Comments |
|---|---|---|---|---|---|---|
| Unit E Sovereign Industrial Park, Liverpool | Ground Floor | Boiler room | #6 | No access | Live electrical equipment throughout | |

| Building | Unit E Sovereign Industrial Park, Liverpool | | | | | | | | Room Notes |
|---|---|---|---|---|---|---|---|---|---|
| Ground Floor | Boiler room | #6 | No access | Live electrical equipment throughout | | 3no. | No Access | | |

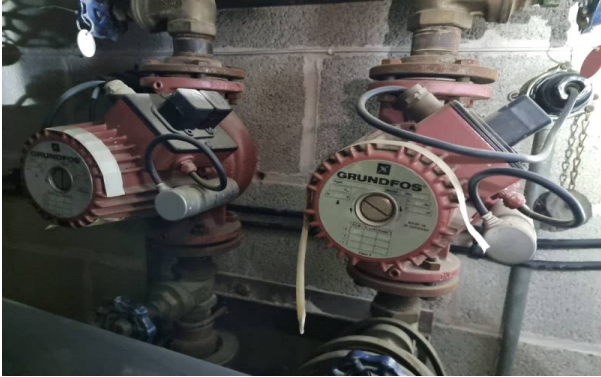
| <b>Item / Inspection Ref:</b> | #8 | <b>Material Assessment</b> | Product type: | 2 | |

| Building | Floor Level | Room | Item/Inspection Reference | Item Description | Risk Category | Recommended Action |
|---|---|---|---|---|---|---|
| Unit E Sovereign Industrial Park, Liverpool | Ground Floor | Boiler room | #8 | Gasket | D | Remove |

| | | <b>Total Score:</b> | 7 | | |

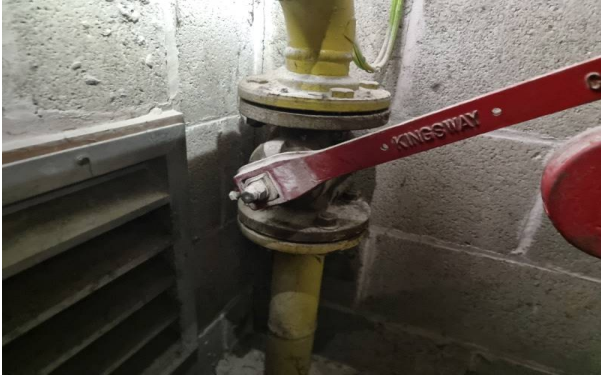
| <b>Item / Inspection Ref:</b> | #9 | <b>Material Assessment</b> | Product type: | 2 | | |

| Building | Floor Level | Room | Item/Inspection Reference | Item Description | Risk Category | Recommended Action |
|---|---|---|---|---|---|---|
| Unit E Sovereign Industrial Park, Liverpool | Ground Floor | Boiler room | #9 | Gaskets | C | Remove |

| | | <b>Total Score:</b> | 9 | | | |
| <b>Comments:</b> | No sample taken due to live gas pipework | | | | | |

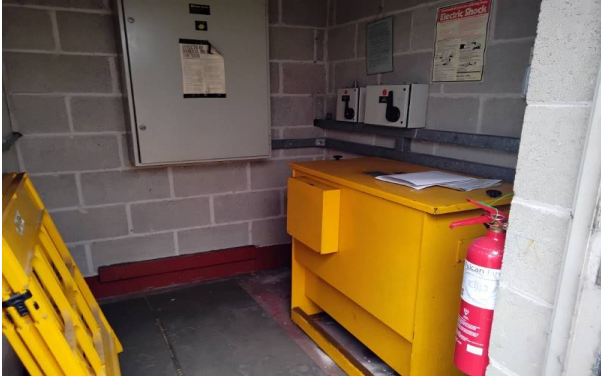
| <b>Item / Inspection Ref:</b> | #10 | <b>Material Assessment</b> | Product type: | | | |

| Building | Floor level | Room | Item / Inspection Reference | Item Description | Position | Comments |
|---|---|---|---|---|---|---|
| Unit E Sovereign Industrial Park, Liverpool | Ground Floor | Lift motor room | #10 | No access | Within live electrical lift machinery | |

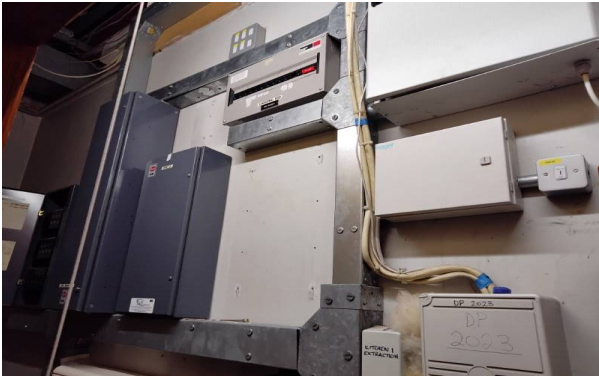
| <b>Item / Inspection Ref:</b> | #14 | <b>Material Assessment</b> | Product type: | | |

| Building | Floor level | Room | Item / Inspection Reference | Item Description | Position | Comments |
|---|---|---|---|---|---|---|
| Unit E Sovereign Industrial Park, Liverpool | 1st Floor | Electrical cupboard | #14 | No access | Within live electrical equipment throughout | |

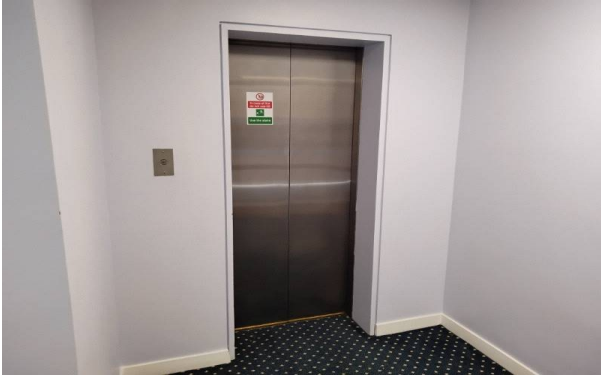
| <b>Item / Inspection Ref:</b> | #17 | <b>Material Assessment</b> | Product type: | | |

| Building | Floor level | Room | Item / Inspection Reference | Item Description | Position | Comments |
|---|---|---|---|---|---|---|
| Unit E Sovereign Industrial Park, Liverpool | 1st Floor | Lift lobby | #17 | No access | Lift shaft all levels including pit | No access as the lift was live at the time of the survey and there was no lift engineer present |

| <b>Comments:</b> | No access as the lift was live at the time of the survey and there was no lift engineer present | | | | |
