## ASBESTOS REFURBISHMENT SURVEY REPORT

| <b>Site</b> | Unit F Sovereign Industry Park, Wilson Road, Huyton, Liverpool, L36 6AD |
| <b>Date report issued</b> | 26th May 2022 |
| <b>Survey reference</b> | J723749 |

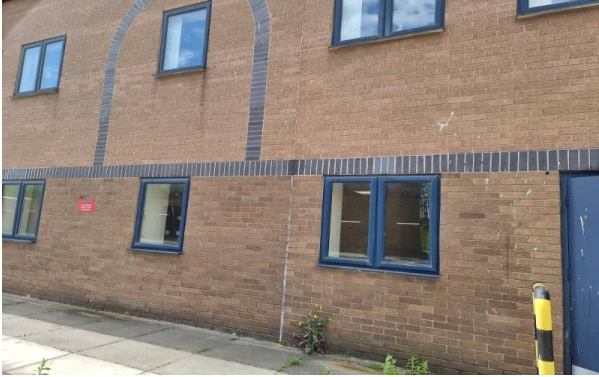
| <b>Item / Inspection Ref:</b> | #1 | <b>Material Assessment</b> | Product type: | | |

| Building | Unit F Sovereign Industrial Park, Liverpool | | | | | | | | Room Notes |
|---|---|---|---|---|---|---|---|---|---|
| External | Exterior of the building | #1 | Mastic | Expansion joints to front elevation wall | No Asbestos Detected | | | None required | Modern green mineral felt to flat roofs at rear. Steel roof soffits. Modern mastic to door and window surrounds. Modern mastic to metal & plastic gutter & downpipes. |

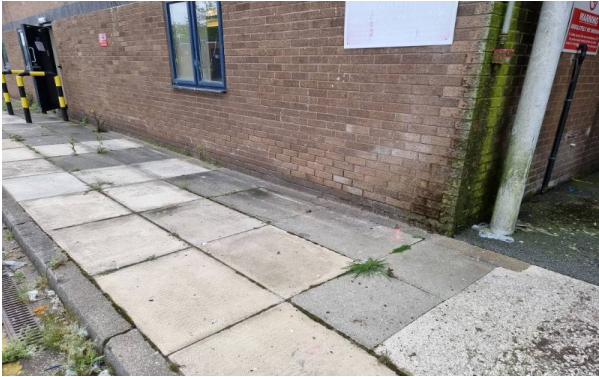
| <b>Item / Inspection Ref:</b> | #2 | <b>Material Assessment</b> | Product type: | | |

| Building | Unit F Sovereign Industrial Park, Liverpool | | | | | | | | Room Notes |
|---|---|---|---|---|---|---|---|---|---|
| External | Exterior of the building | #2 | Damp proof course | Low level walls throughout | No Asbestos Detected | | | None required | |

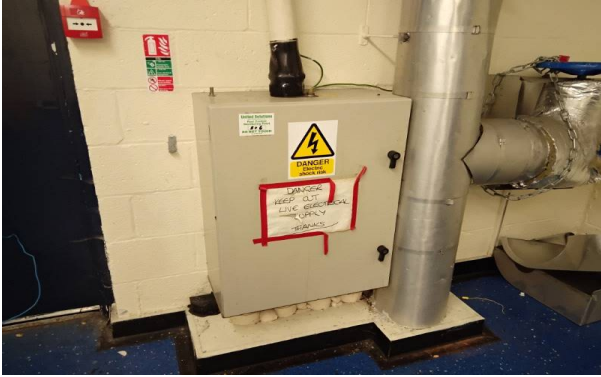
| <b>Item / Inspection Ref:</b> | #3 | <b>Material Assessment</b> | Product type: | | |

| Building | Floor level | Room | Item / Inspection Reference | Item Description | Position | Comments |
|---|---|---|---|---|---|---|
| Unit F Sovereign Industrial Park, Liverpool | Ground Floor | Front left hand side stairwell | #3 | No access | Within live electrical switch boxes throughout building | |

| Building | Unit F Sovereign Industrial Park, Liverpool | | | | | | | | Room Notes |
|---|---|---|---|---|---|---|---|---|---|
| Ground Floor | Front left hand side stairwell | #3 | No access | Within live electrical switch boxes throughout building | | | No Access | | Modern fibreboard tiles to ceiling grid with steel structure above with chipboard flooring to the upper level, MMMF insulation throughout ceiling void. Plasterboard stud walls with masonry external wall behind, concrete floor modern anti-slip vinyl covering & nosing to steps. Modern rubber gaskets to large diameter pipework. |

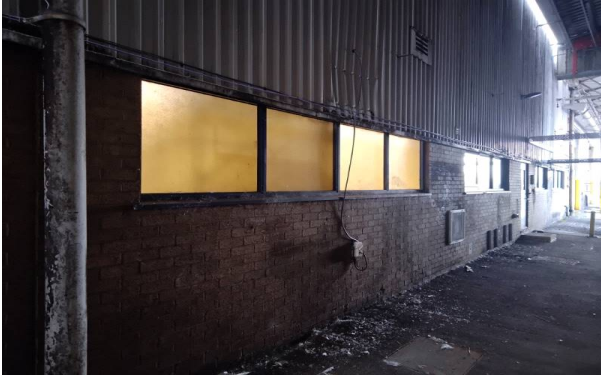
| <b>Item / Inspection Ref:</b> | #7 | <b>Material Assessment</b> | Product type: | | |

| Building | Unit F Sovereign Industrial Park, Liverpool | | | | | | | | Room Notes |
|---|---|---|---|---|---|---|---|---|---|
| External | Exterior of the building | #7 | Damp proof membrane | Within wall around windows & doors | No Asbestos Detected | | | None required | |

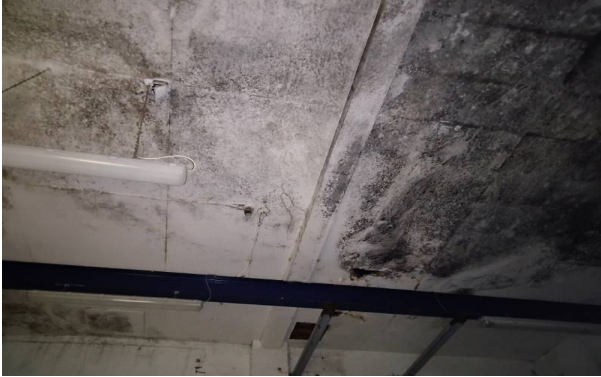
| <b>Item / Inspection Ref:</b> | #8 | <b>Material Assessment</b> | Product type: | | |

| Building | Unit F Sovereign Industrial Park, Liverpool | | | | | | | | Room Notes |
|---|---|---|---|---|---|---|---|---|---|
| External | External store 1 | #8 | Insulating board | Ceiling | No Asbestos Detected | | | None required | Insulating board ceiling, masonry walls, concrete floor. |

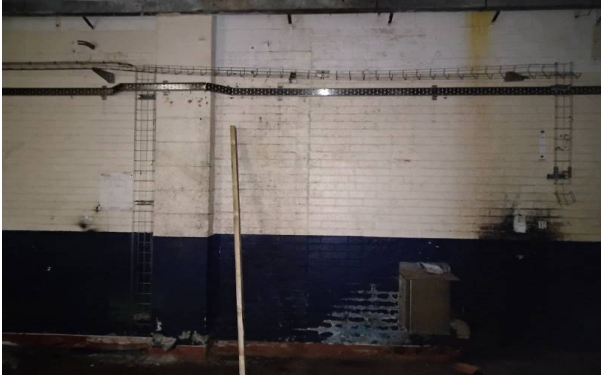
| <b>Item / Inspection Ref:</b> | #9 | <b>Material Assessment</b> | Product type: | | |

| Building | Unit F Sovereign Industrial Park, Liverpool | | | | | | | | Room Notes |
|---|---|---|---|---|---|---|---|---|---|
| External | External store 1 | #9 | Mastic | Expansion joint in wall | No Asbestos Detected | | | None required | |

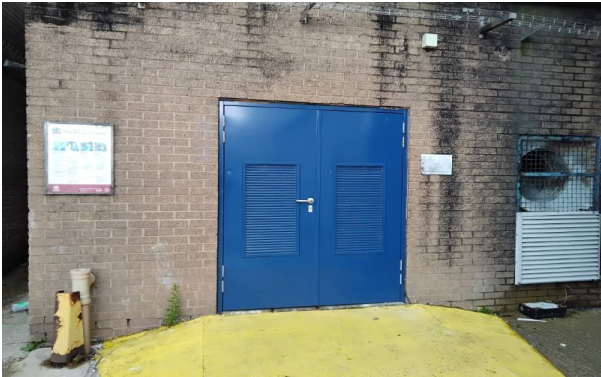
| <b>Item / Inspection Ref:</b> | #10 | <b>Material Assessment</b> | Product type: | | |

| Building | Floor level | Room | Item / Inspection Reference | Item Description | Position | Comments |
|---|---|---|---|---|---|---|
| Unit F Sovereign Industrial Park, Liverpool | External | External store 2 | #10 | No access | | |

| Building | Unit F Sovereign Industrial Park, Liverpool | | | | | | | | Room Notes |
|---|---|---|---|---|---|---|---|---|---|
| External | External store 2 | #10 | No access | There was no key available at the time of the survey | No access to room/area presume asbestos. | | No Access | | |

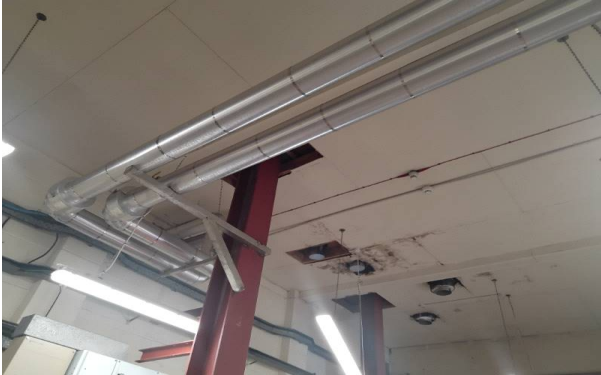
| <b>Item / Inspection Ref:</b> | #11 | <b>Material Assessment</b> | Product type: | | |

| Building | Unit F Sovereign Industrial Park, Liverpool | | | | | | | | Room Notes |
|---|---|---|---|---|---|---|---|---|---|
| External | External switch room | #11 | Insulating board | Ceiling | No Asbestos Detected | | | None required | Insulating board ceiling, masonry walls, concrete floor. |

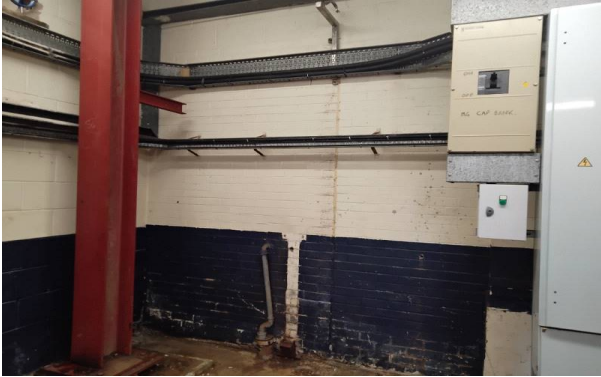
| <b>Item / Inspection Ref:</b> | #12 | <b>Material Assessment</b> | Product type: | | |

| Building | Unit F Sovereign Industrial Park, Liverpool | | | | | | | | Room Notes |
|---|---|---|---|---|---|---|---|---|---|
| External | External switch room | #12 | Mastic | Expansion joints to wall | No Asbestos Detected | | | None required | |

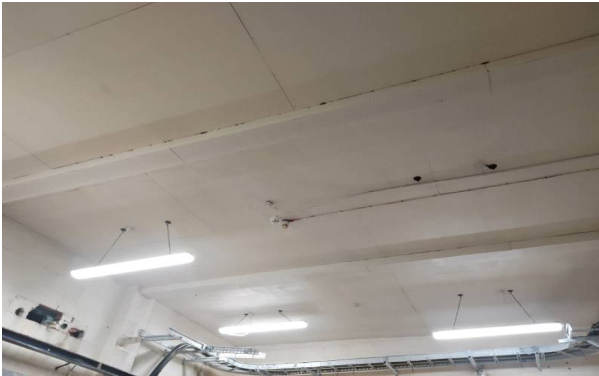
| <b>Item / Inspection Ref:</b> | #13 | <b>Material Assessment</b> | Product type: | | |

| Building | Unit F Sovereign Industrial Park, Liverpool | | | | | | | | Room Notes |
|---|---|---|---|---|---|---|---|---|---|
| External | External store 3 | #13* | Insulating board | Ceiling | No Asbestos Detected | | | None required | Insulating board ceiling, masonry walls, concrete floor. |

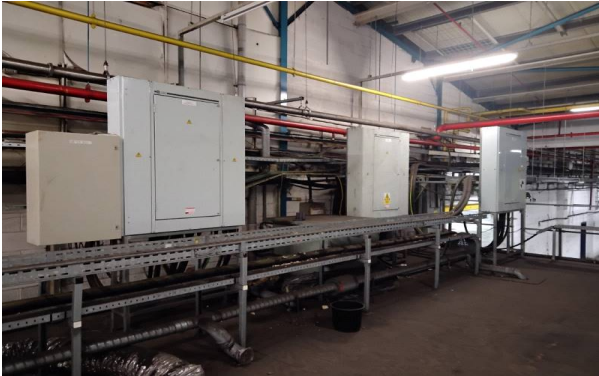
| <b>Item / Inspection Ref:</b> | #14 | <b>Material Assessment</b> | Product type: | | |

| Building | Floor level | Room | Item / Inspection Reference | Item Description | Position | Comments |
|---|---|---|---|---|---|---|
| Unit F Sovereign Industrial Park, Liverpool | 1st Floor | Plant area | #14 | No access | No inspection to live electrical switch boxes throughout | |

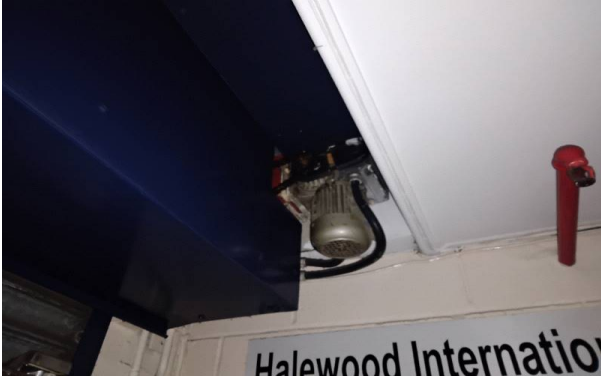
| <b>Item / Inspection Ref:</b> | #16 | <b>Material Assessment</b> | Product type: | | |

| Building | Unit F Sovereign Industrial Park, Liverpool | | | | | | | | Room Notes |
|---|---|---|---|---|---|---|---|---|---|
| Ground Floor | Lobby area to first aid room | #16 | Insulating board | Upstands in ceiling around roller shutter | No Asbestos Detected | | | None required | Plasterboard ceiling, masonry walls with timber boxings, modern anti-slip flooring onto concrete floor. |

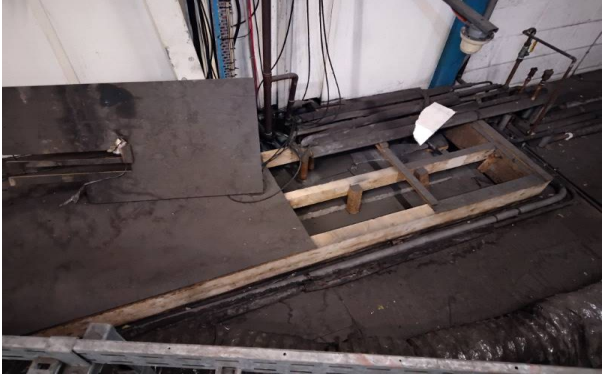
| <b>Item / Inspection Ref:</b> | #17 | <b>Material Assessment</b> | <b>Product type:</b> | | | |

| Building | Unit F Sovereign Industrial Park, Liverpool | | | | | | | | Room Notes |
|---|---|---|---|---|---|---|---|---|---|
| 1st Floor | Plant area | #17* | Insulating board | Upstand in floor | No Asbestos Detected | | | None required | Modern mastic seals to ductwork. MMMF insulation to pipework. |
