## ASBESTOS DEMOLITION SURVEY REPORT

| <b>Site</b> | Warehouse F Sovereign Industry Park,<br>Wilson Road, Huyton, Liverpool, L36 6AD |
| <b>Date report issued</b> | 26th May 2022 |
| <b>Survey reference</b> | J723758 |

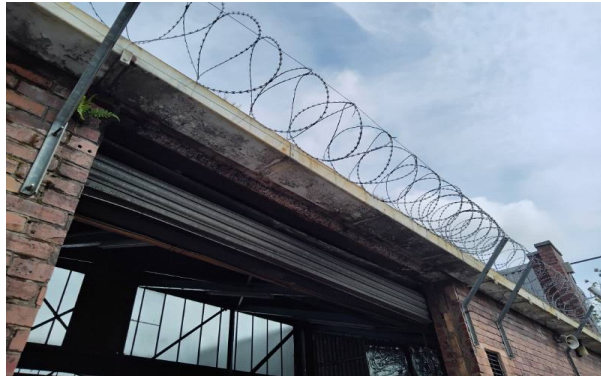
| Item / Inspection Ref: | #6 | Material Assessment | Product type: | 1 | |

| Building | Warehouse F, Sovereign Industrial Park, Liverpool | | | | | | | | Room Notes |
|---|---|---|---|---|---|---|---|---|---|
| External | Exterior of the building | #6 | Cement debris | Loose to floor to rear corner | Chrysotile | <1m² | D | Remove | |

| Position: | Loose to floor to rear corner | | Accessibility: | 0 | |
| Comments: | Less than 1m2 over 10m2 | | | | |

| Laboratory reference | Information provided by customer | | | Type of asbestos detected<br>(results apply only to the sample(s) listed in this table) |
|---|---|---|---|---|
| ERL/492507 | PD001778 | Cement debris loose to floor in hardcore | Ground floor external | Chrysotile (White Asbestos) |

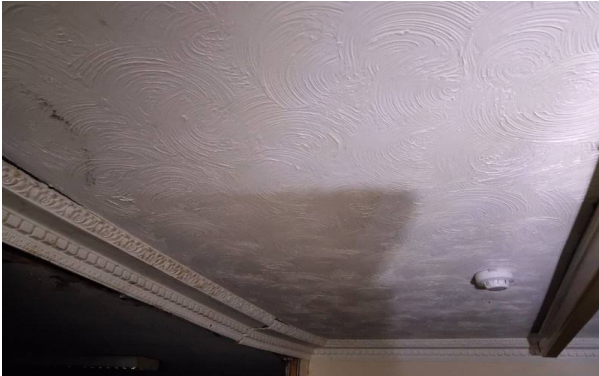
| <b>Item / Inspection Ref:</b> | #16 | <b>Material Assessment</b> | Product type: | | |

| <b>Comments:</b> | Swirl stipple effect. ARSx5 | | | | |

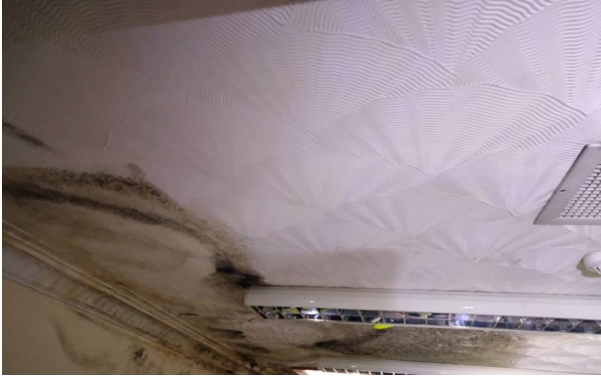
| <b>Item / Inspection Ref:</b> | #17 | <b>Material Assessment</b> | Product type: | | |

| <b>Comments:</b> | Fan stipple effect. ARSx5 | | | | |

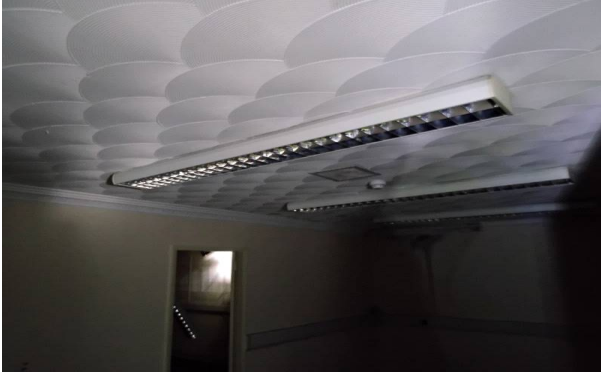
| <b>Item / Inspection Ref:</b> | #18 | <b>Material Assessment</b> | Product type: | | |

| <b>Comments:</b> | Fan stipple effect. ARSx5 | | | | |

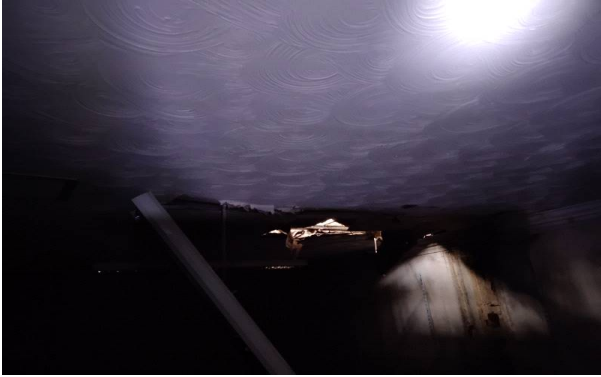
| <b>Item / Inspection Ref:</b> | #19 | <b>Material Assessment</b> | Product type: | | |

| <b>Comments:</b> | Fan stipple effect. ARSx5 | | | | |

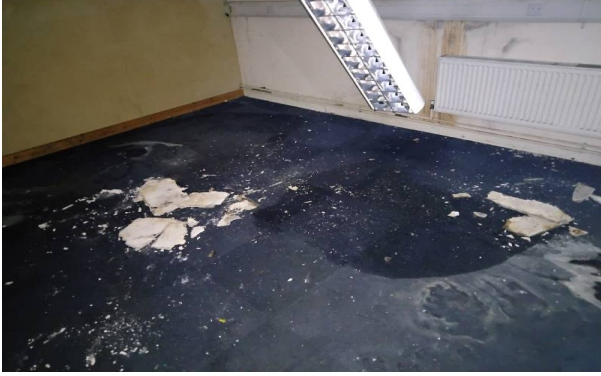
| <b>Item / Inspection Ref:</b> | #20 | <b>Material Assessment</b> | Product type: | | |

| <b>Comments:</b> | Less than 1m2 over 20m2 | | | | |

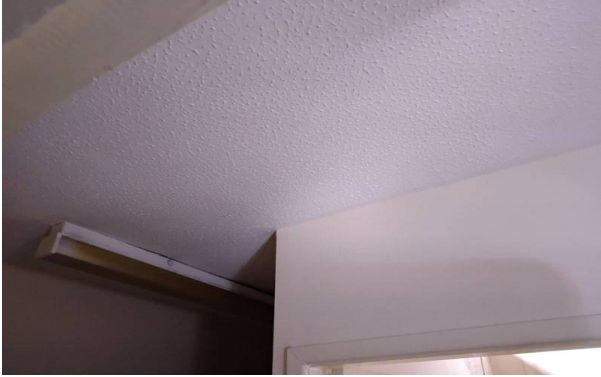
| <b>Item / Inspection Ref:</b> | #25 | <b>Material Assessment</b> | Product type: | | |

| <b>Comments:</b> | Stipple effect. ARSx3 | | | | |

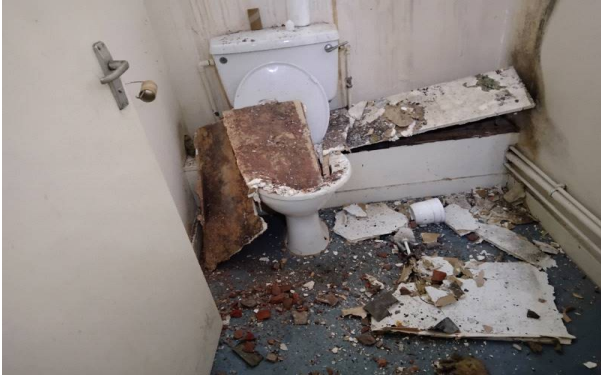
| <b>Item / Inspection Ref:</b> | #27 | <b>Material Assessment</b> | Product type: | | |

| <b>Comments:</b> | Less than 1m2 over 8m2 | | | | |

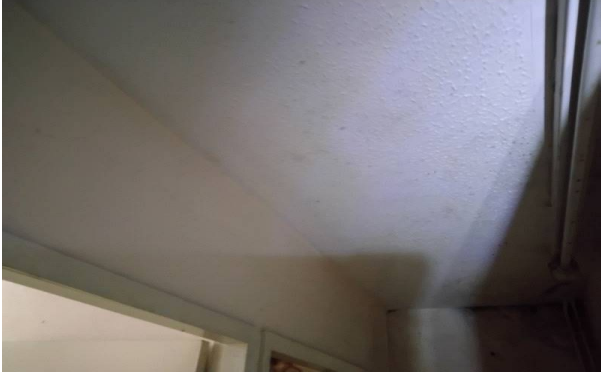
| <b>Item / Inspection Ref:</b> | #28 | <b>Material Assessment</b> | Product type: | | |

| <b>Comments:</b> | stipple effect. ARSx3 | | | | |

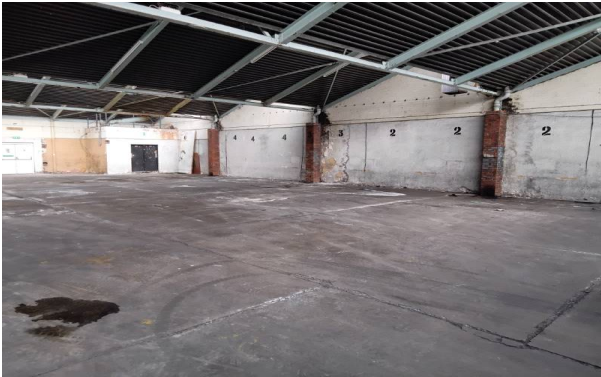
| <b>Item / Inspection Ref:</b> | #34 | <b>Material Assessment</b> | Product type: | | |

| <b>Comments:</b> | Stipple effect ARSx20 | <b>Total Score:</b> | | | |

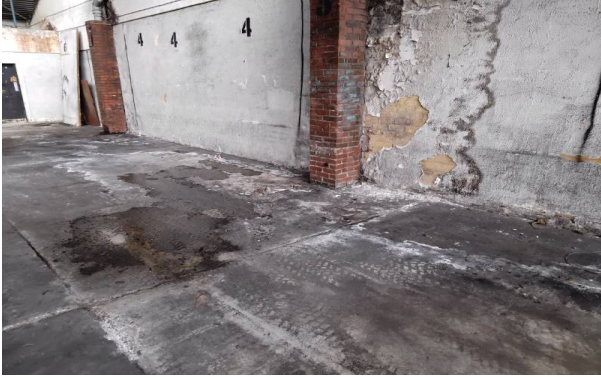
| <b>Item / Inspection Ref:</b> | #35 | <b>Material Assessment</b> | Product type: | | |

| <b>Comments:</b> | Less than 1m2 over 30m2 | | | | |
