## **Statement in support of repairs to a boundary wall**

External works associated with an application for Listed Buildings Consent to repair a curtilage Listed boundary wall at The Orchard, Huyton

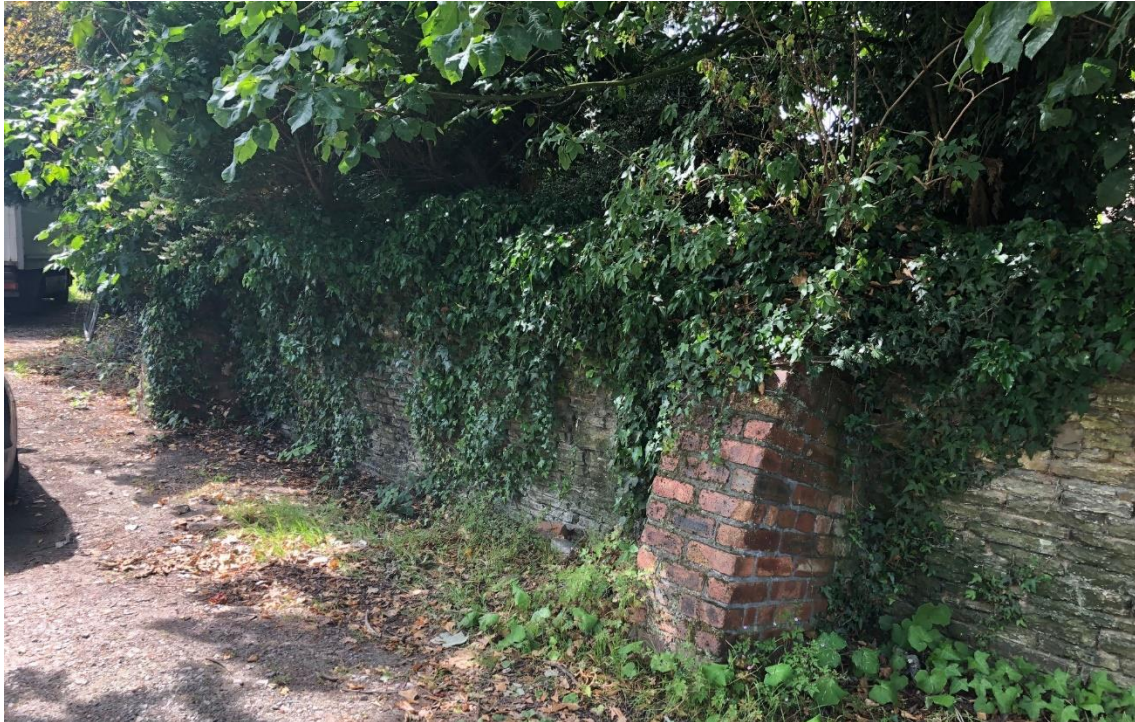
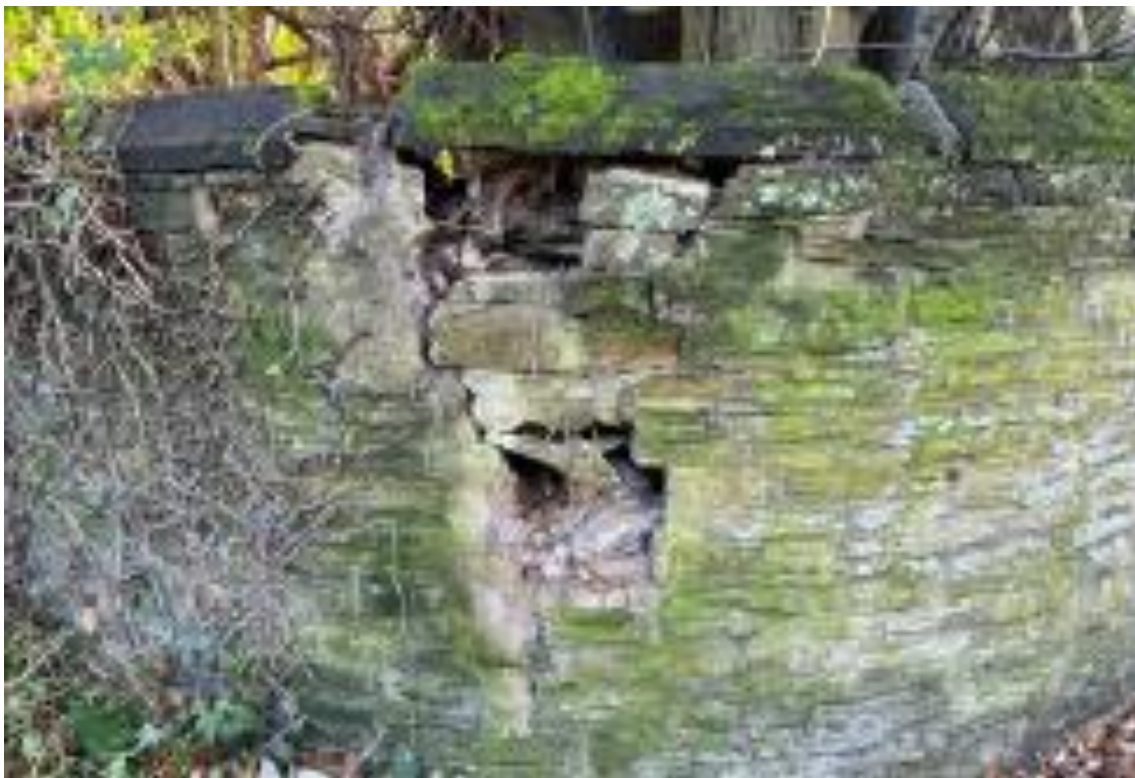
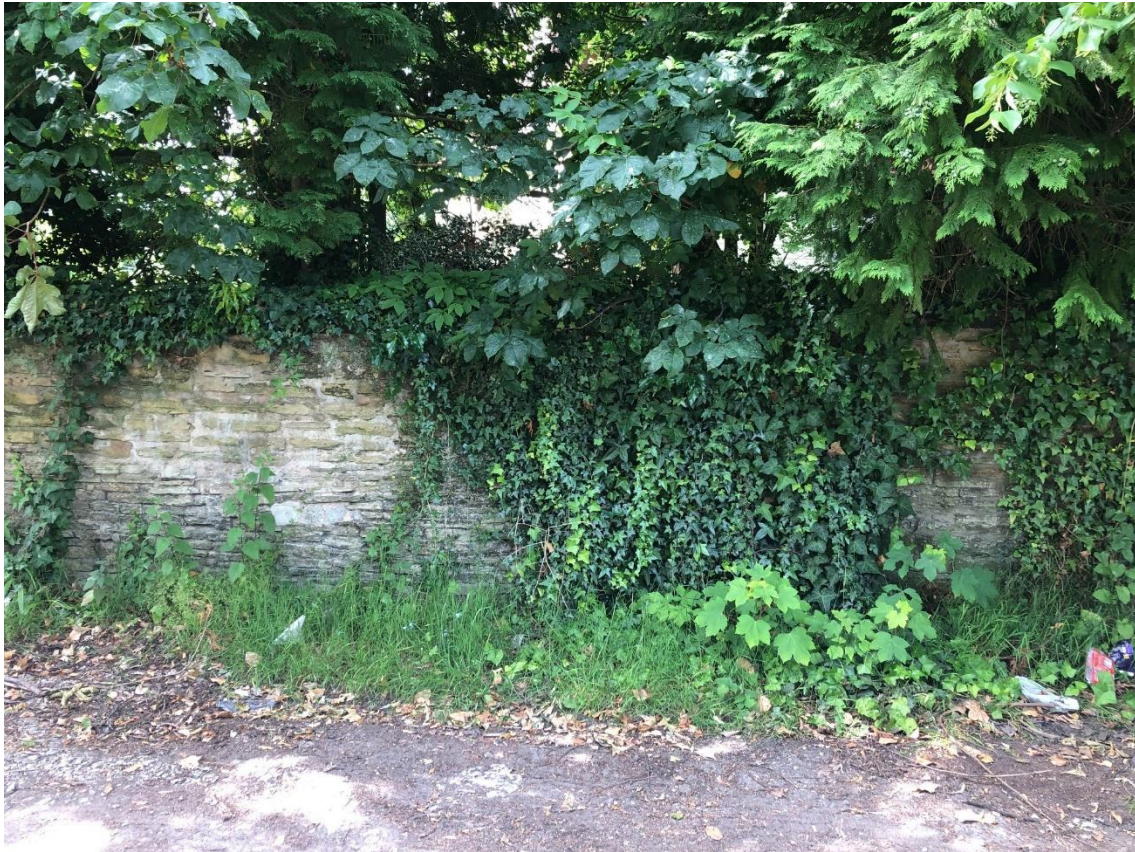
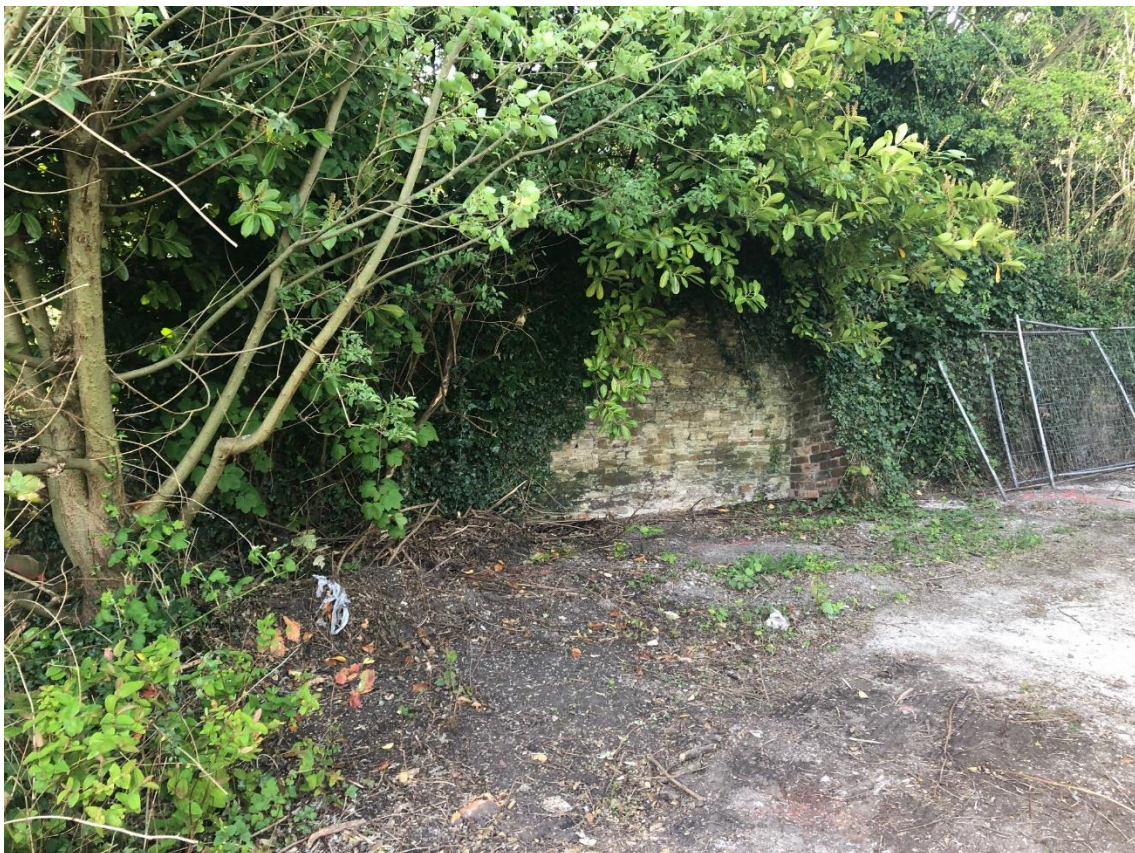
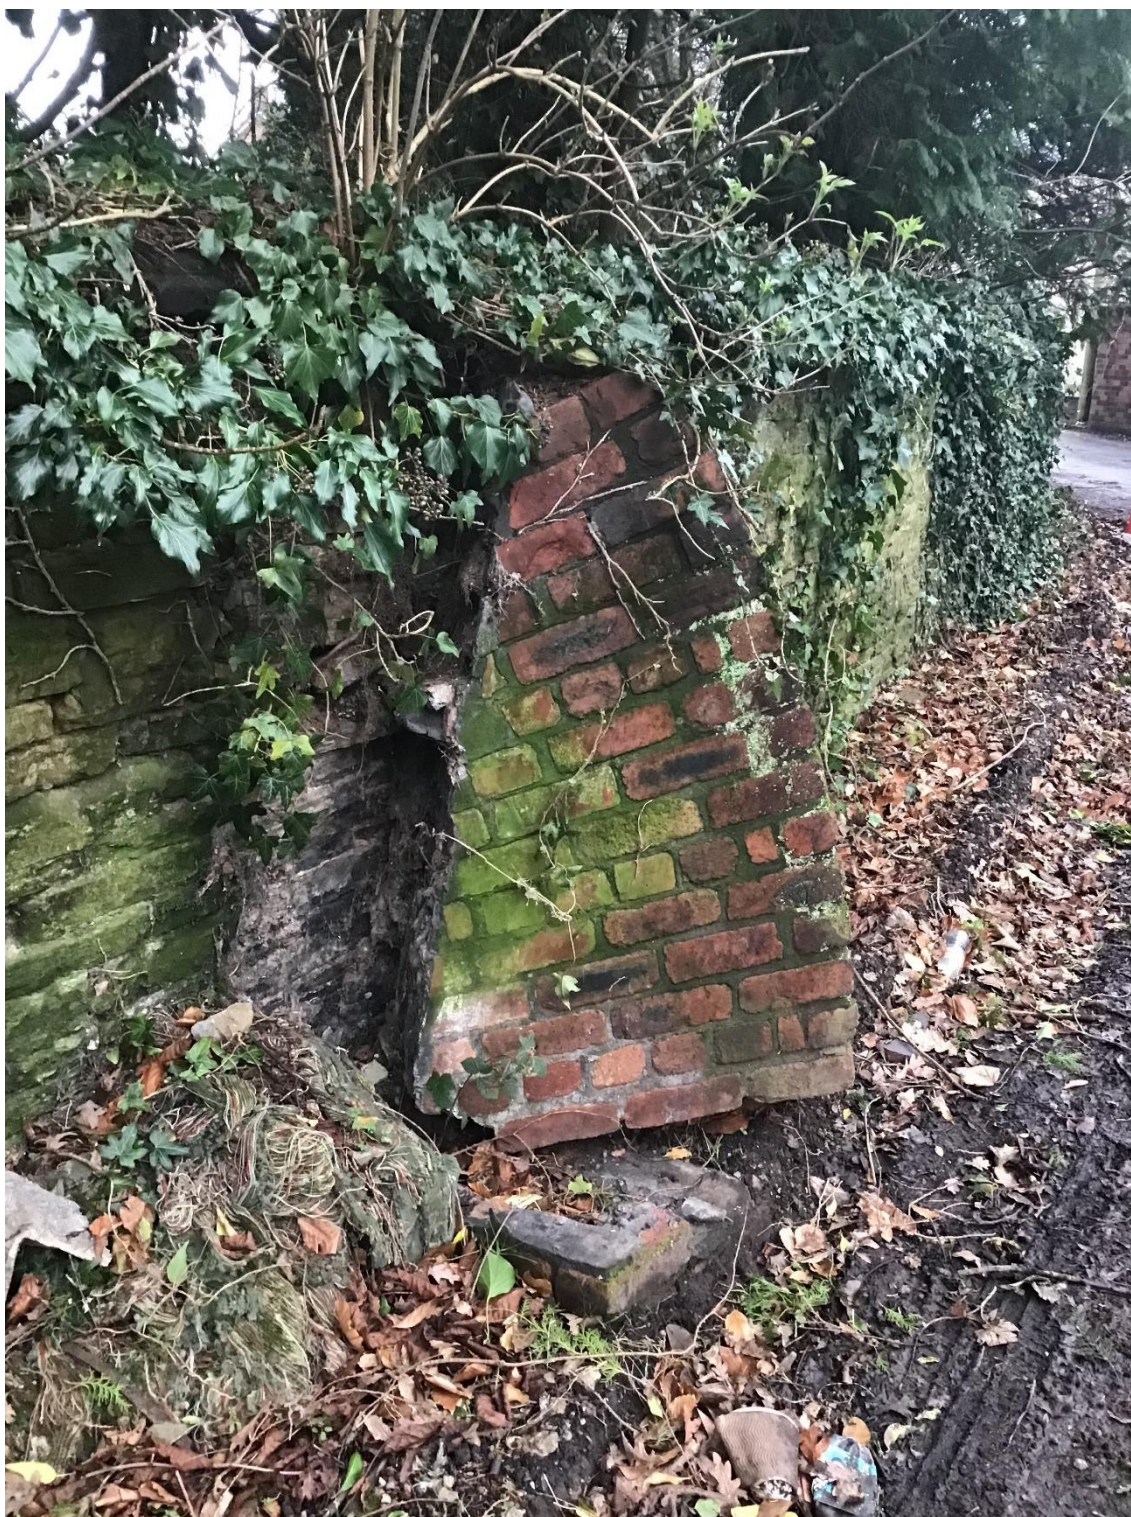
### **Photographs of the wall**

Large brickwork buttresses have been constructed to the access road section of the development site, which have looked to stabilise the wall, more than likely due to the existing trees on the Greenhills Site. The buttresses appear to be built up against the wall and not keyed into the sandstone. It is unknown when the buttresses were built but it is estimated they have been there for over 20 years. It has been confirmed by adjacent landowners that the wall has had a slight lean in middle part of the access road for at least 30 years.

Apart from one section, where a wagon has knocked one buttress, there is no evidence of movement around the buttresses and so it would appear that the installation of the buttresses have stabilised the wall from the trees and heavy vegetation on the adjacent land. However, the wall has been neglected and heavy vegetation, as well as large trees abutting the wall, have caused sections of the wall to collapse. There are also areas where cement mortar has been used to patch the wall over time, causing further issues. It is therefore the intention of the applicant to repair the wall, using conservation principles, in order that the wall can be safely retained for the future.
