**TECHNICAL ASSESSMENT REPORT  
on the  
SCHOOL PLAYING FIELDS  
&  
ASSOCIATED FACILITIES  
at  
PLANTATION PRIMARY SCHOOL  
KNOWSLEY**

Date: 26/2/2014

Report Ref: Plantation\_14

**Site Assessment Visit of:** February 24th, 2014

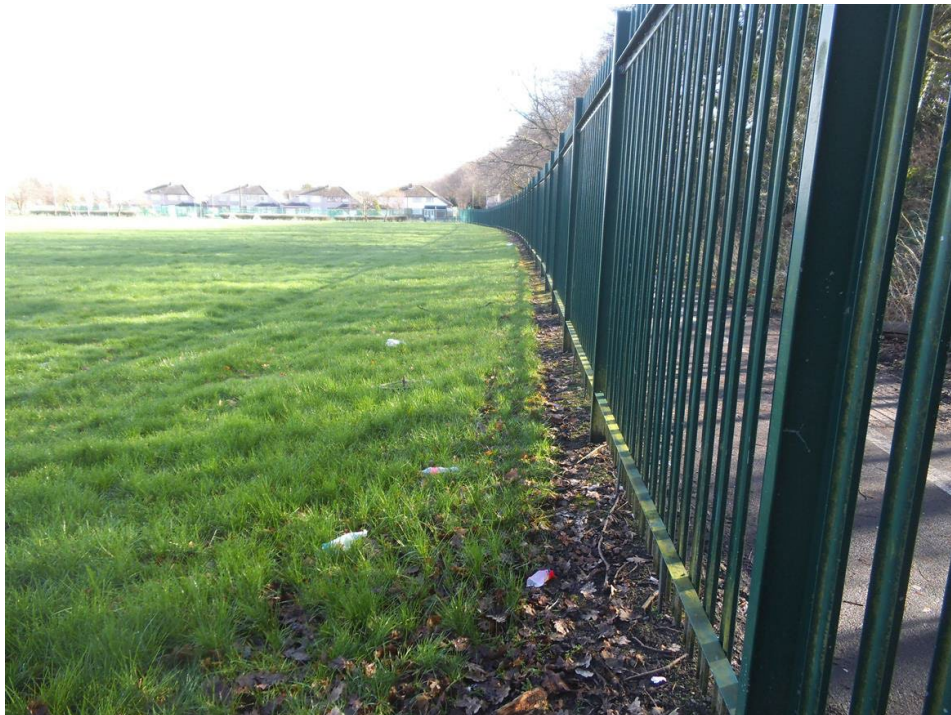
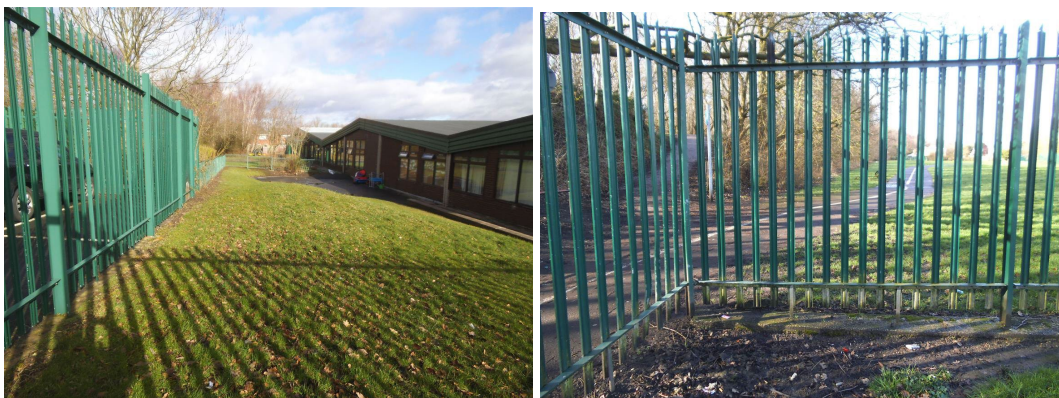
**2.1.3 Boundaries** - The school has a new secure palisade fence all around, installed in 2006, with the informal grass and public footpath beyond this. The grass playing field area is bounded by grass/tree/paths to the west and south, road to the east, and houses to the north.

*Security fencing to the perimeter*

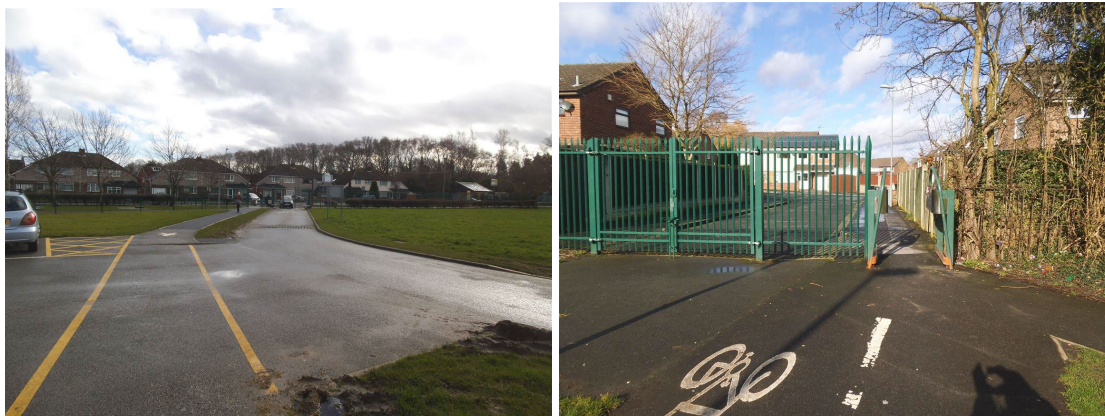
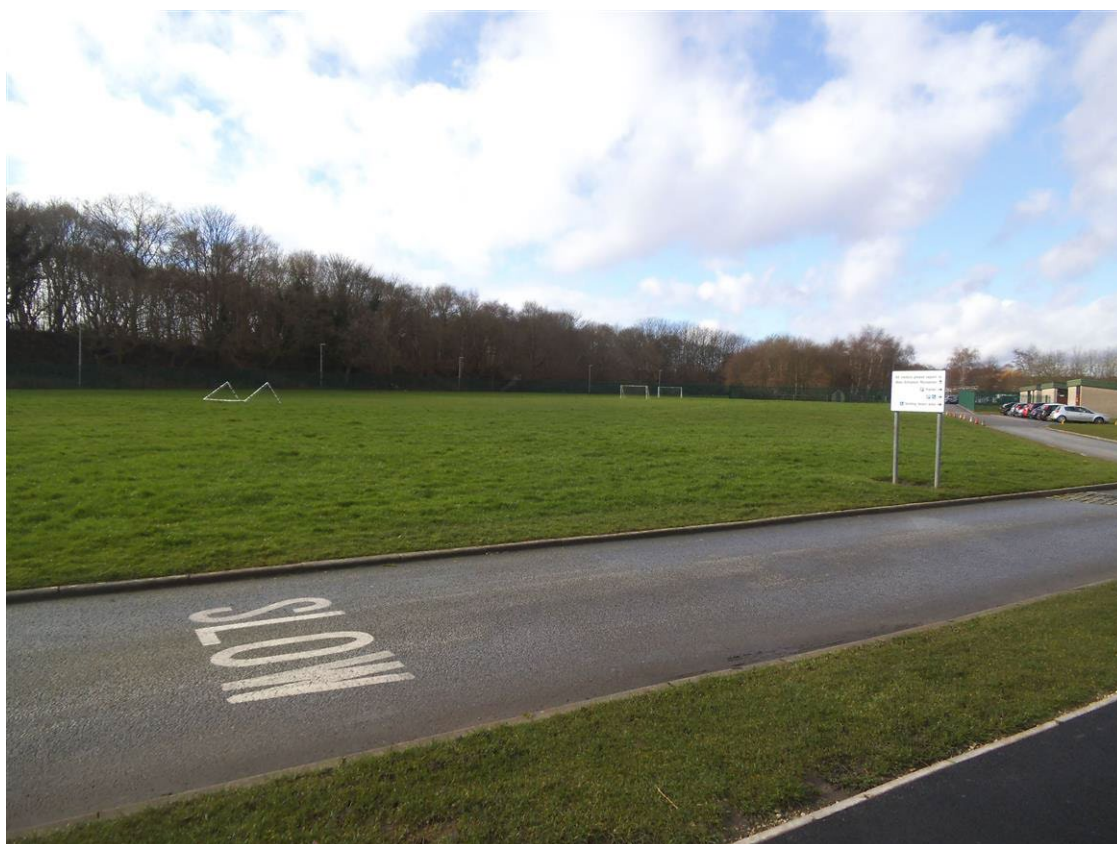
Maintenance and ambulance access is via the main access road .

***Maintenance access gate, Trispan Road service access, & open access to the pitch***

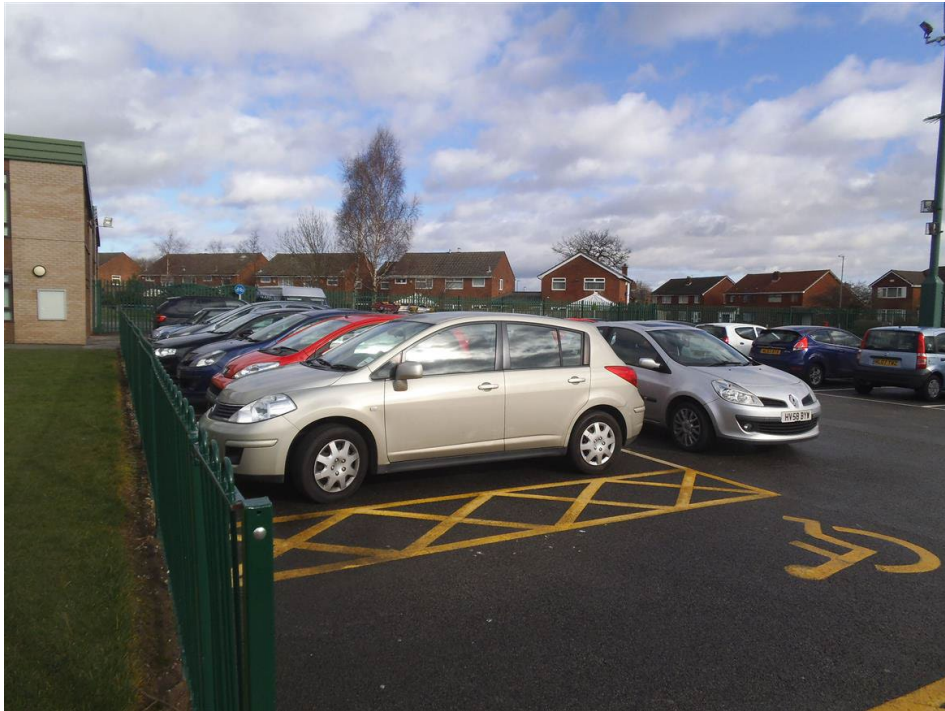
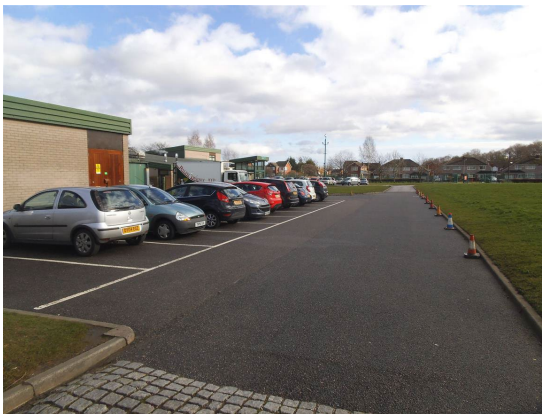
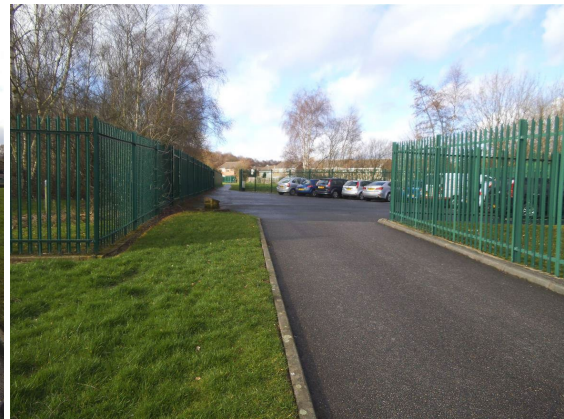
The access road and car-park are in good condition, hard-surfaces, with approximately 40 formal places for cars, additional internal road/other area parking.

***Parking is in three areas***

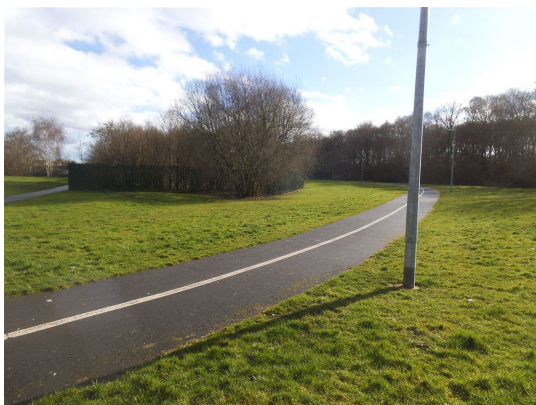
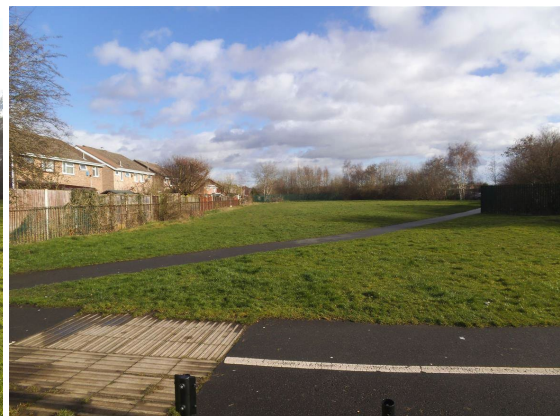
***Grass areas outside the school security fence***

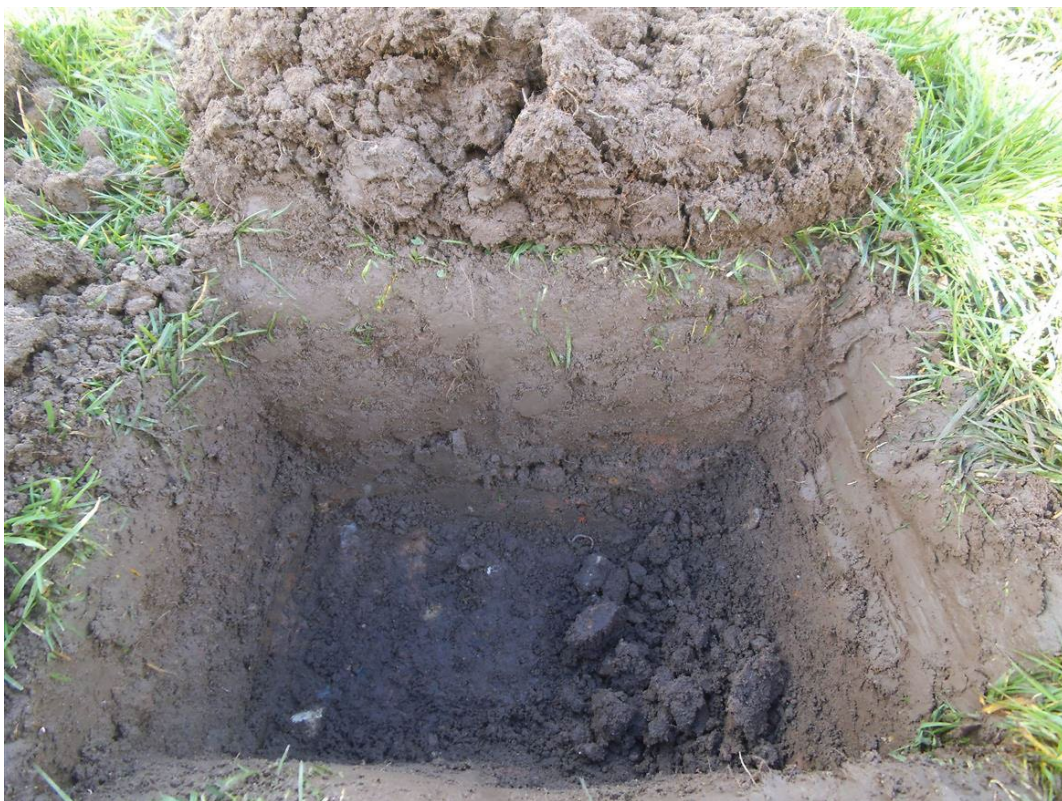
Generally, the topsoil is a dark brown loam, high sand content but with sufficient clay to render it compactable and prone to muddiness, a very variable 100 to 500 mm deep, with a subsoil of light-brown firm clay loam, some problems with stone content. The pH is 6.9, or neutral. Soil investigation results:

***Soil pit showing structured but damp topsoil, firm to sticky subsoil***

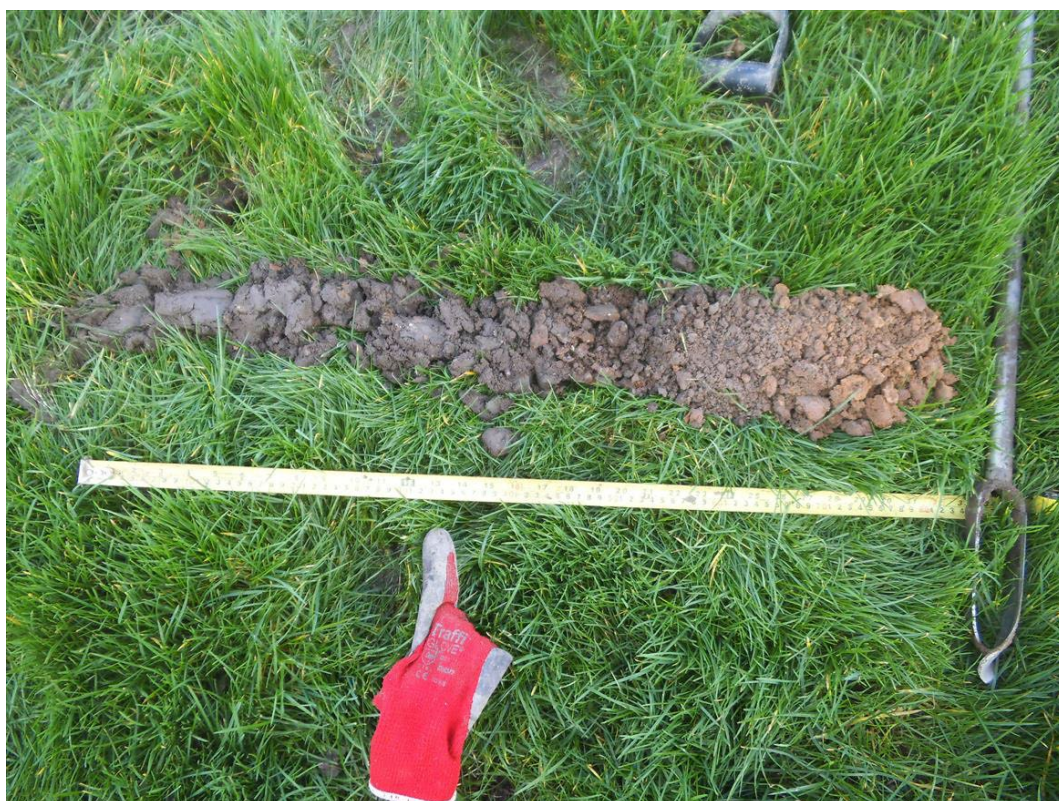
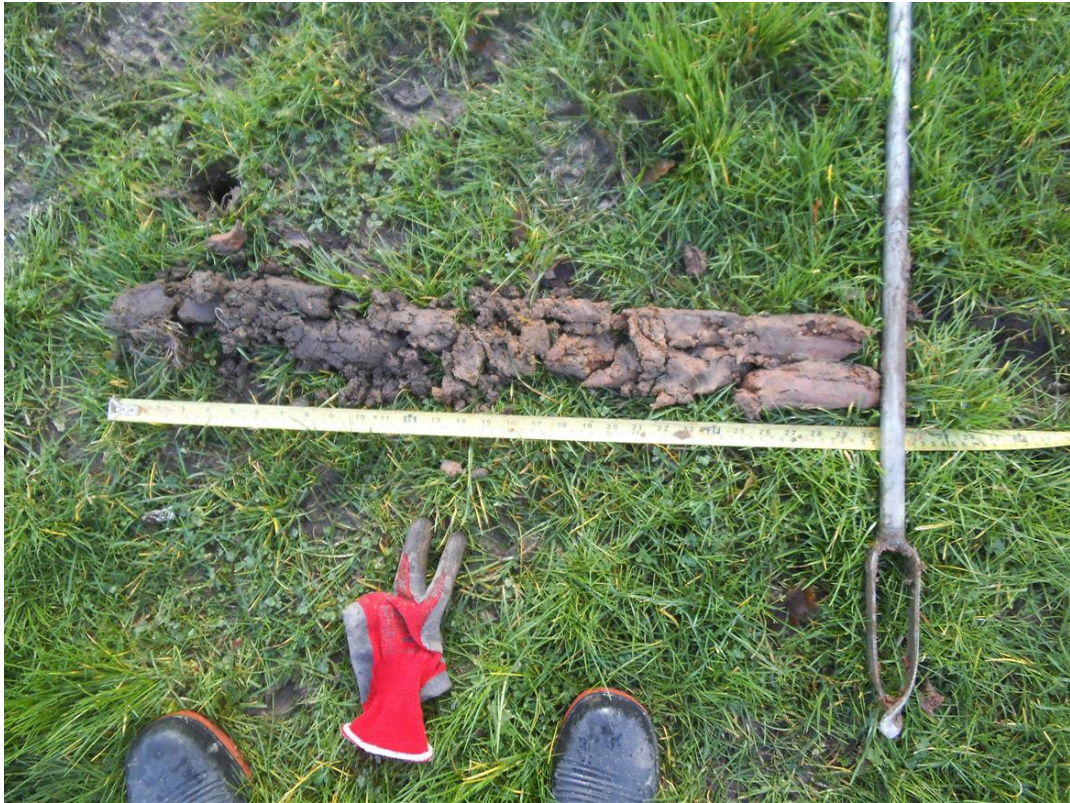
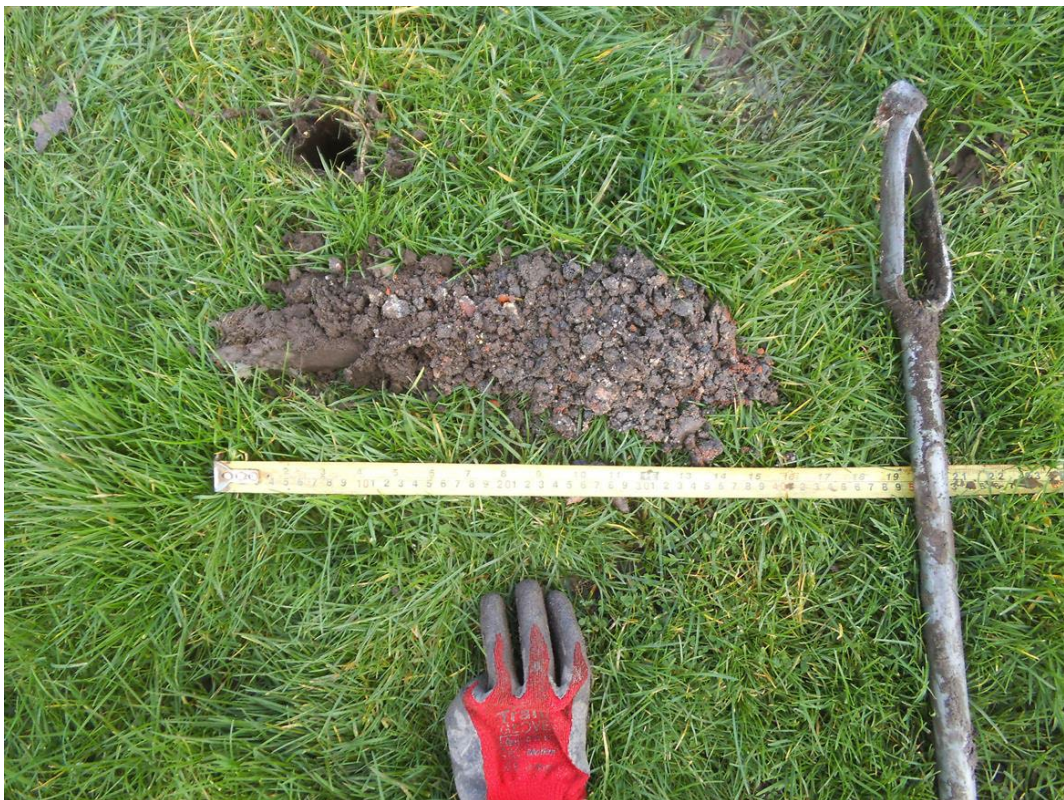
| A1 (auger) | 0 to 0.5m | dark brown Sandy Clay Loam |
| | 0.5 to 0.8m | light brown/orange Silty Clay |
| A2 | 0 to 0.3m | dark brown Sandy Clay Loam |
| | 0.3 to 0.5m | light brown Silty Clay |
| | 0.5 to 0.8m | light brown/pink Clay |
| A3 | 0 to 0.1m | dark brown Sandy Clay Loam |
| | 0.1 to 0.4m | made ground, brick fragments and clinker |

***Below - Auger holes 1, 2 & 3***

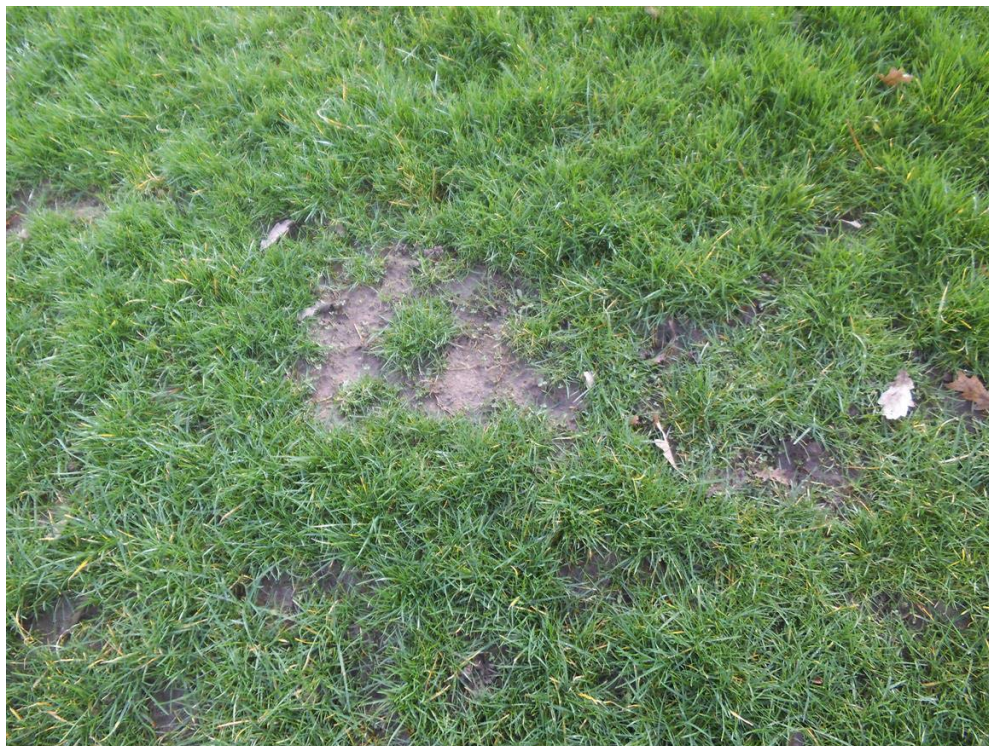
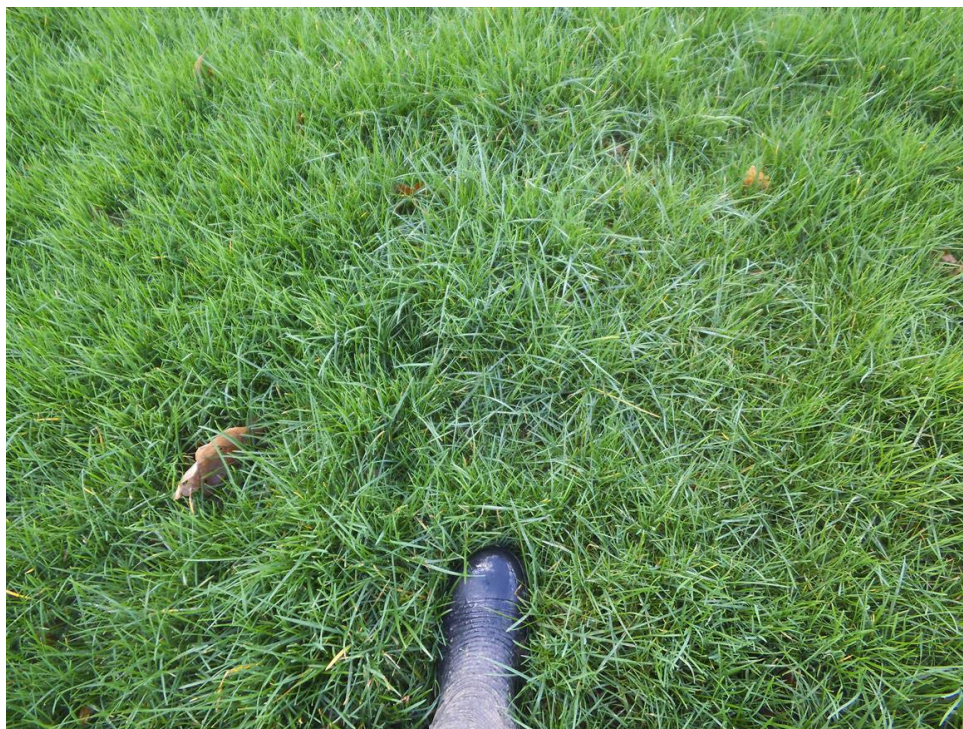
2.3.1 - Grass cover reasonable, patchy, with some wear within the designated pitch area , the damp conditions restricting play. Cover is good, up to 80% overall grass cover, 5% weeds, 15% bare. Ground conditions are spongy, some standing water to the north-west.

The sward is of predominantly Perennial Ryegrass, presumed to be a sportsfield variety, with finer grasses. Weeds are present up to approximately 5% composition of the sward, including daisy, plantain, dandelion, extensive moss indicating long-term damp surface conditions.

The ground is saturated, but with generally no standing water. Sward height was 50mm on the pitch. The area outside the marked pitch is less patchy, has more weeds, the upper north-west section being particularly wet with much standing water and sward height up to 120mm.

The surface would not be acceptable under Sport England requirements without improvements to the surface composition of the sward, and some other additional routine treatments.

***Above & below - Typical playing field surface, pitch and off-pitch areas***

The turf requires additional fertilising, weed and pest control, overseeding, and other standard annual operations, preferably after drainage has been installed.

**4.2** The maintenance programme needs to be re-assessed and improved to bring the grass pitch back up to Sport England standards, which they currently fail on due to turf conditions, and

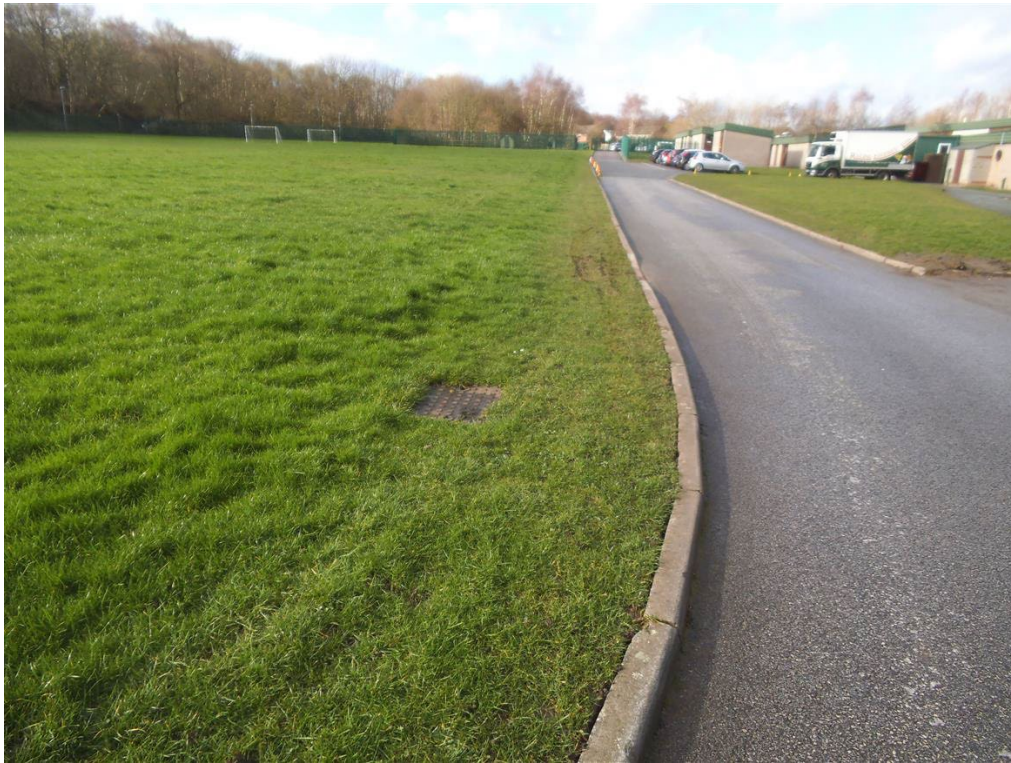
No evidence was found of under-drainage from aerial photos, local knowledge or from the site investigation. A single manhole cover is visible within the field adjacent to the service road but unable to lift cover, presumed to be the outfall point for any existing or future drainage.

***Manhole cover, north-east corner field***

Further assessment needs to be carried out, beginning with lifting the manhole cover in the corner of the field, and tracing of and land-drain found and the main system and ultimate outfall.

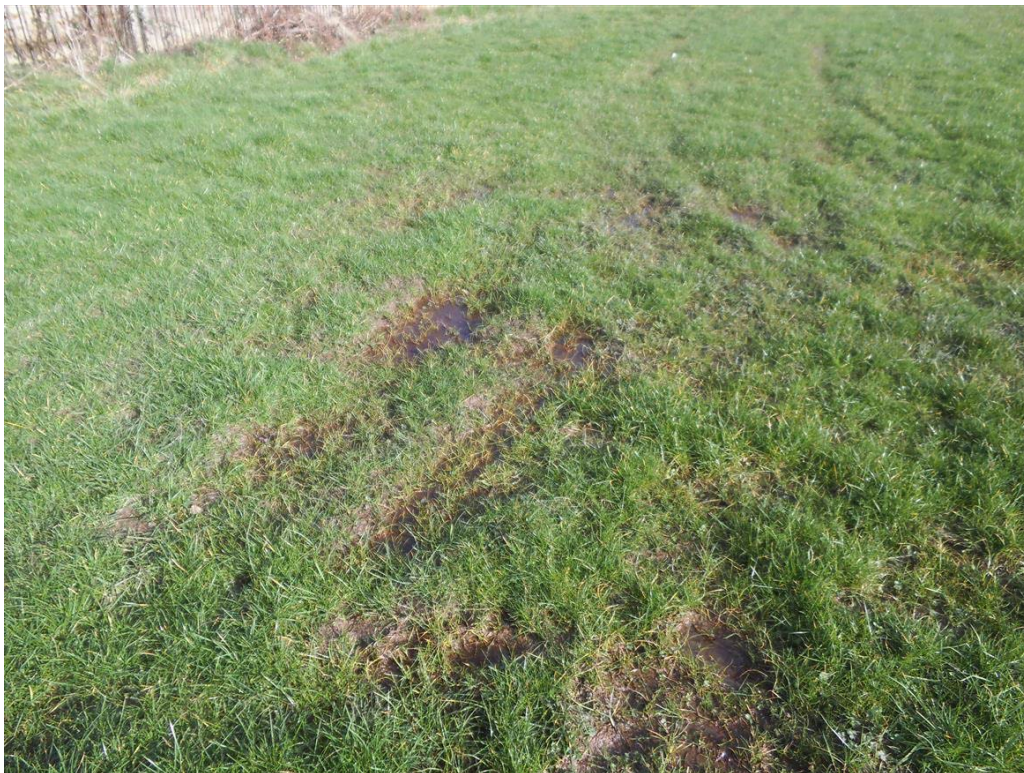
The school owned grassed area outside the palisade fence; the north-west section has historically flooded with run-off to the neighbouring gardens to the northern boundary. A relief drain was installed within the last 2 years which runs along this boundary then underground to a new manhole in the school yard which outfalls then to the north.

**Boggy area, off-site northern grass field**

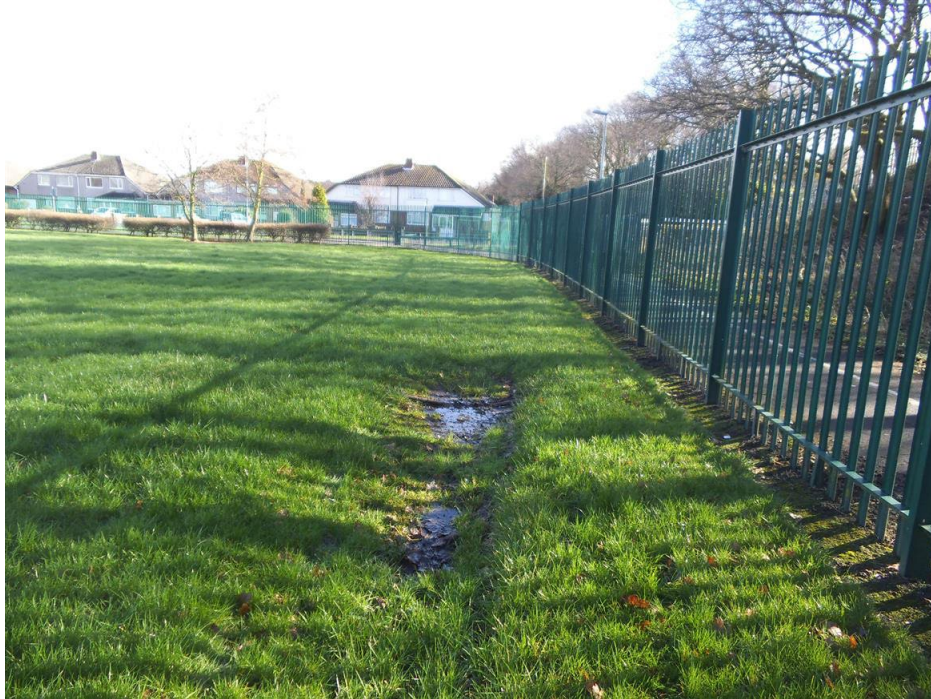
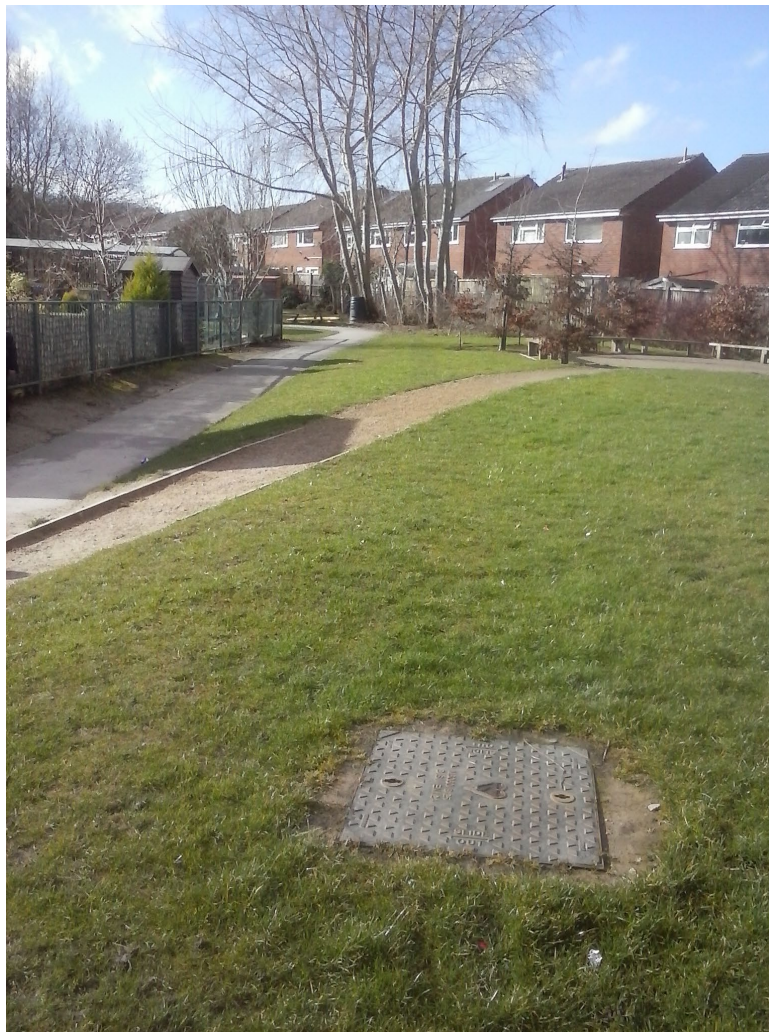
**Presumed outfall for the northern cut-off drain**

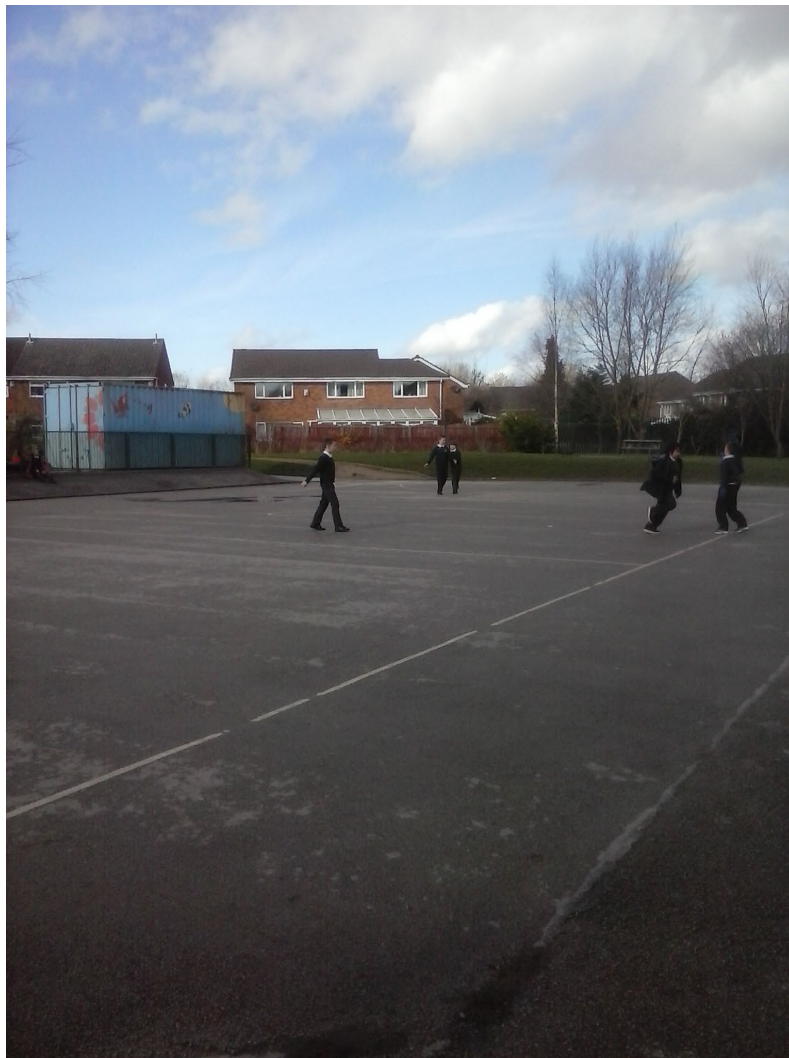
MUGA areas area marked within the playground for general play with various markings. Main Tarmac playground to north of the school building has numerous manholes and drains. There are some standing water issues due to irregular surface gradients.

***Hard surfaced /play area***

**4.3** Assess the option of upgrading a hard-surfaced MUGA to an STP (synthetic) surface.

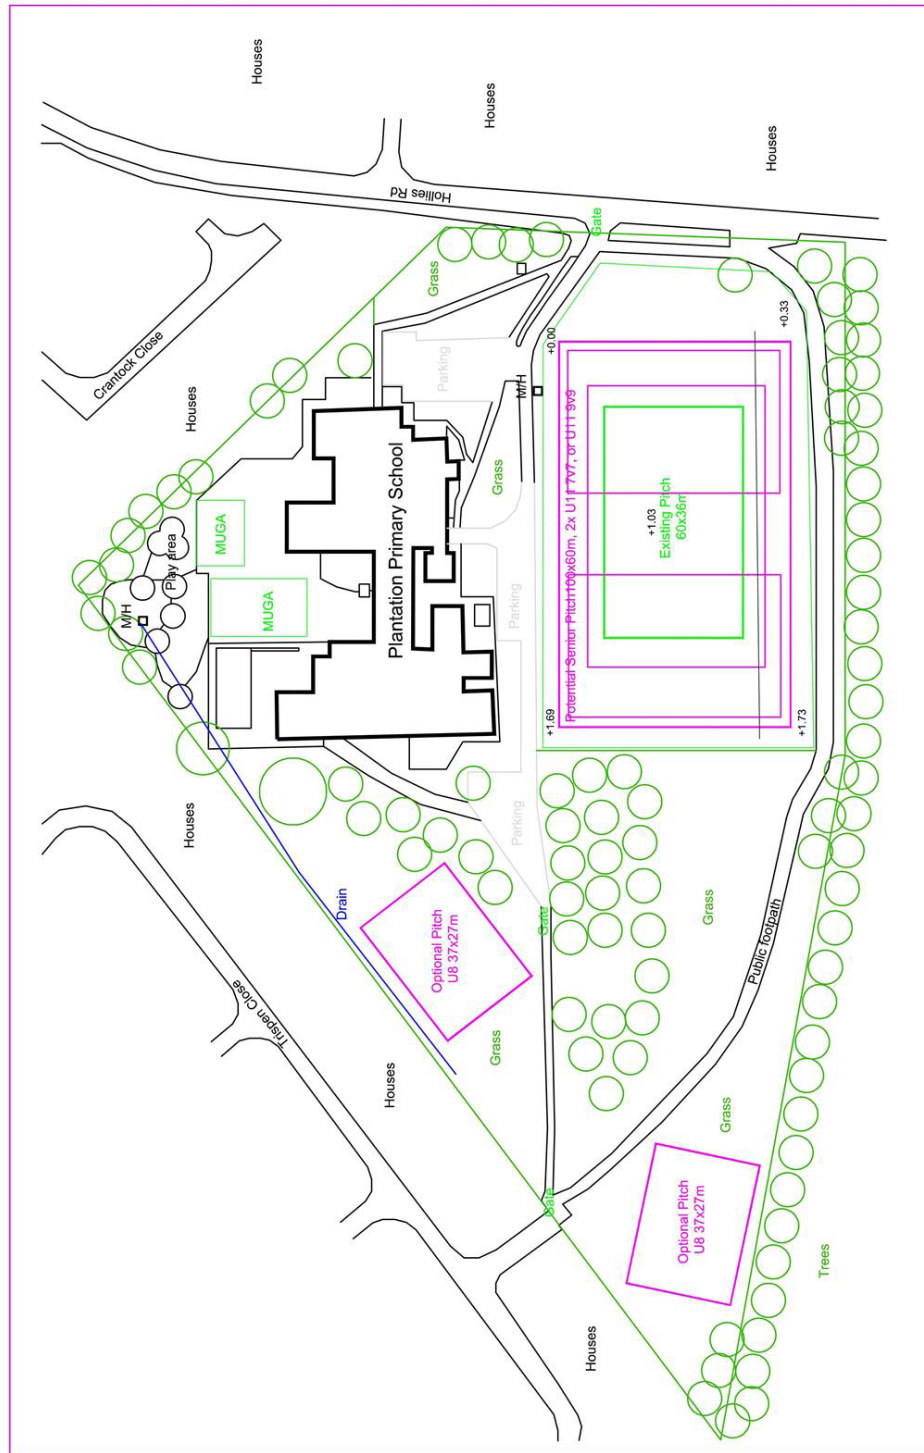
**KEY:** **Green outline** shows both grass and other sports areas  
**Magenta lines** show proposed new pitch area

1) There is scope to drain and renovate an area within the security fence large enough for:

- Two or three Under-11 pitches, a senior pitch overlay
- Two U-8; pitches on the current informal grass
