**P7715/20/06**

**DEMOLITION/RETENTION REPORT**

**LAND ADJACENT TO LAKESIDE SCHOOL, KNOWSLEY, LIVERPOOL**

**WITHERSLACK GROUP LIMITED**

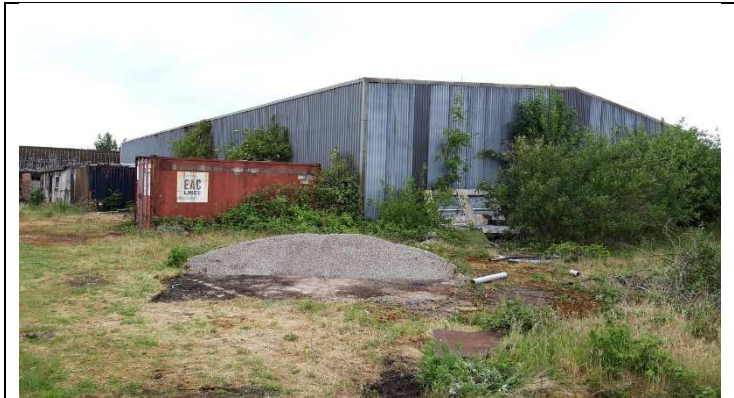
*Fig.03 – Min Portal Seen from South East*

There is minor fire damage along the South side of the main building where it intersects with the lean-to section of building,

All columns were found to be reasonably vertical, and no significant structural main frames was observed.

The steel frame to main portion of building is in good condition and will not pose any difficulties for a competent demolition contractor. The existing roof covering will require assessment for asbestos content, prior to any deconstruction commencing.

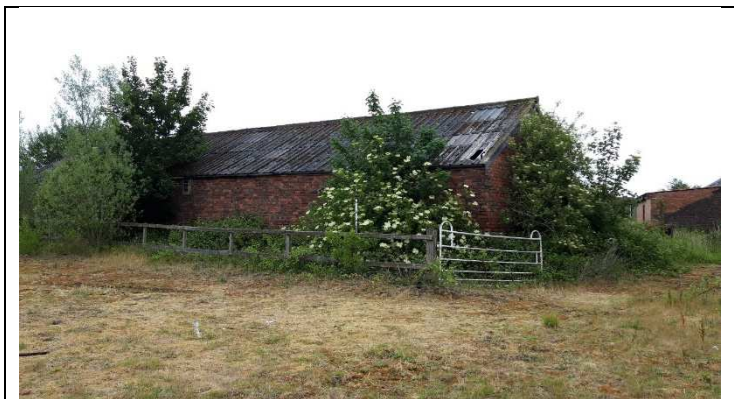
*Fig.04 – Building Viewed from South West*

There is some minor fire damage at South East corner, where a mobile building has been burnt out

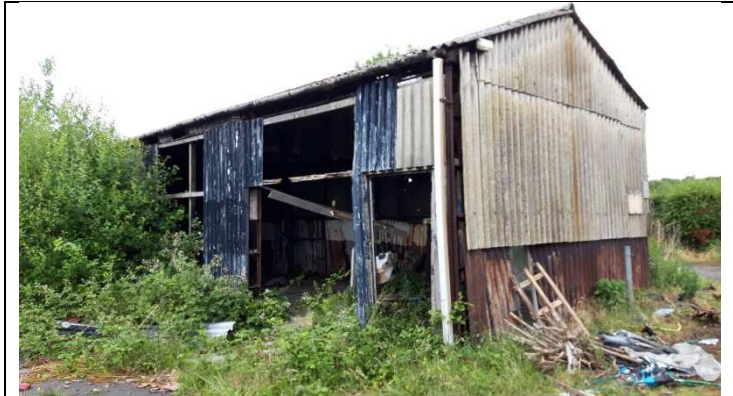
*Fig.05 – Shed at South End of Block, From West*

The steel frame to the south building has extensive surface corrosion to members. No significant defects were noted to the Northern building.

Framed structure to southern half of the building is a lightweight steel structure, which will also be simple to deconstruct for a competent demolition contractor. Roof cladding will again require appraisal for asbestos content, as will the South facing gable wall and the partition wall to the stables. All foundations and flagged floor to be removed as part of the deconstruction.

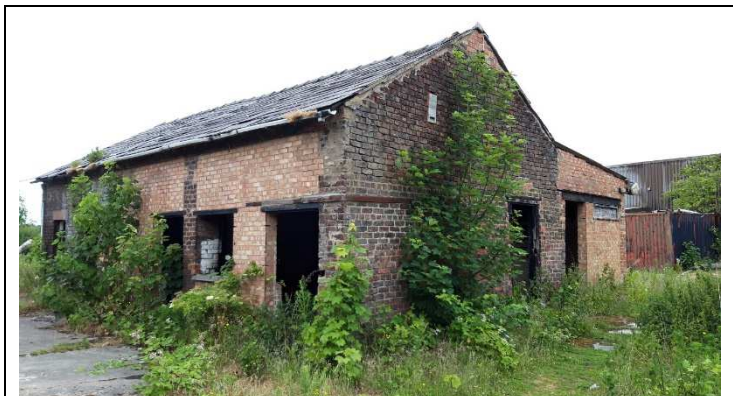
*Fig.06 – Barn Viewed from South East*

There are no major structural defects evident.

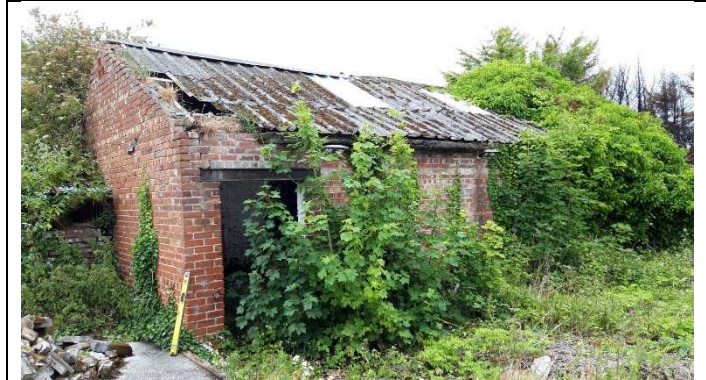
The masonry gable pike to left elevation wall of the East building leans out by up to 1 in 15 at the top.

*Fig.07 – Barn viewed from South West*

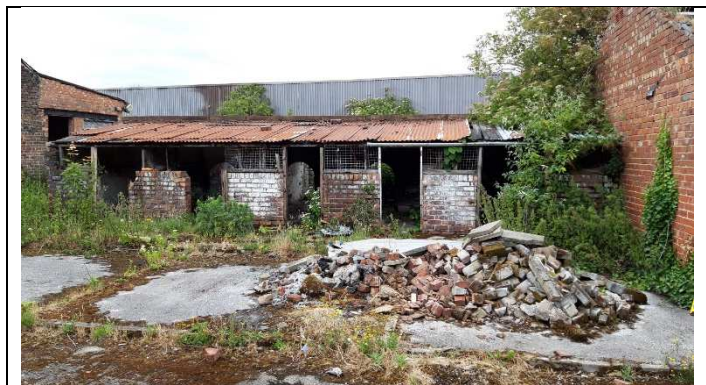
The Western building is somewhat dilapidated but has no obvious structural defects.

*Fig.08 – Western Kennel Building Viewed from South*

The kennel structures are somewhat dilapidated but pose no evident issues for a competent demolition contractor. All substructure elements must be removed as part of the deconstruction works.

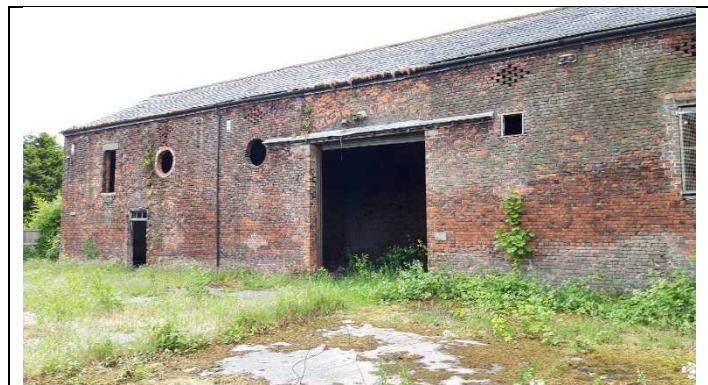
Walls to the external elevations of the main barn are 325mm thick and were found to be reasonably vertical, however; localised areas of the North facing wall lean out by up to 1 in 175. The West elevation wall of the outrigger to the South East leans out by up to 1 in 30, locally to the pier adjacent to the access door. There are no major cracks evident within external walls.

There are a number of areas where brick units are perished due to frost damage. This is predominantly located to the North elevation wall around the access to the Eastern room; wall at base is damaged to right side of door, and feature brickwork above is distorted.

**Fig.09 - Barn Viewed from North West**

There are areas of minor damage to brickwork within the existing external walls. These localised areas will require remediation with some possible reconstruction required.

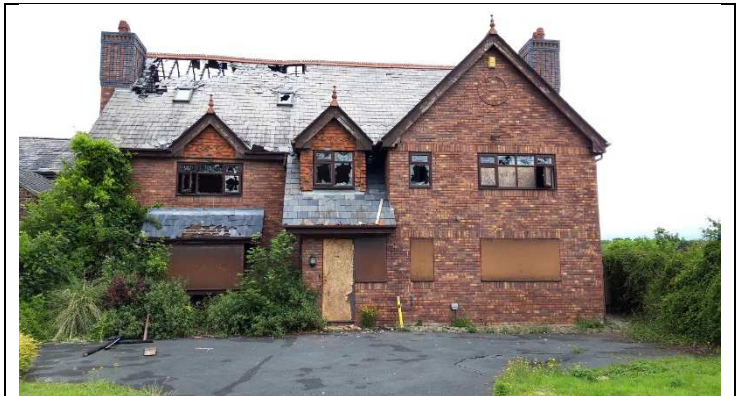
Building has suffered extensive fire damage, particularly at second floor level. Part of the roof has collapsed and been burnt out. Remaining roof structural integrity may be compromised.

**Fig.10 – Dwelling House Viewed from South**

The building is relatively modern, with a slate roof covering. It is, however; possible that there may be asbestos type materials within the structure. A specialist asbestos review is recommended prior to deconstruction works commencing.

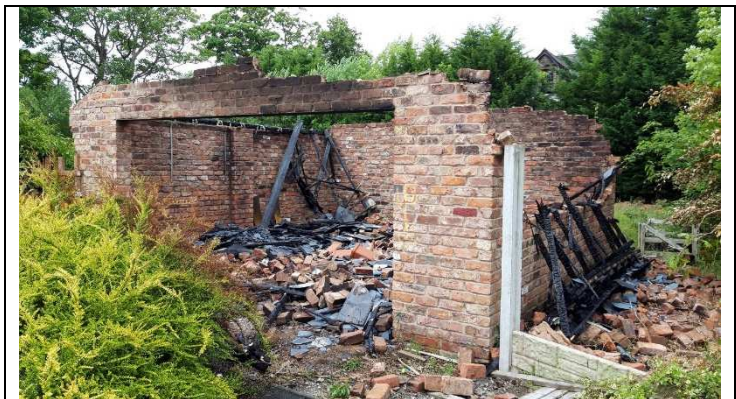
Garage has been extensively damaged by fire. Roof has been lost and there has been partial collapse of the North masonry gable wall.

**Fig.11 – Remains of Garage, Viewed from East**

The garage structure has been extensively damaged by fire, such that the roof has been lost. The remaining walls are currently unstable. A competent demolition contractor will have no trouble removing this building.

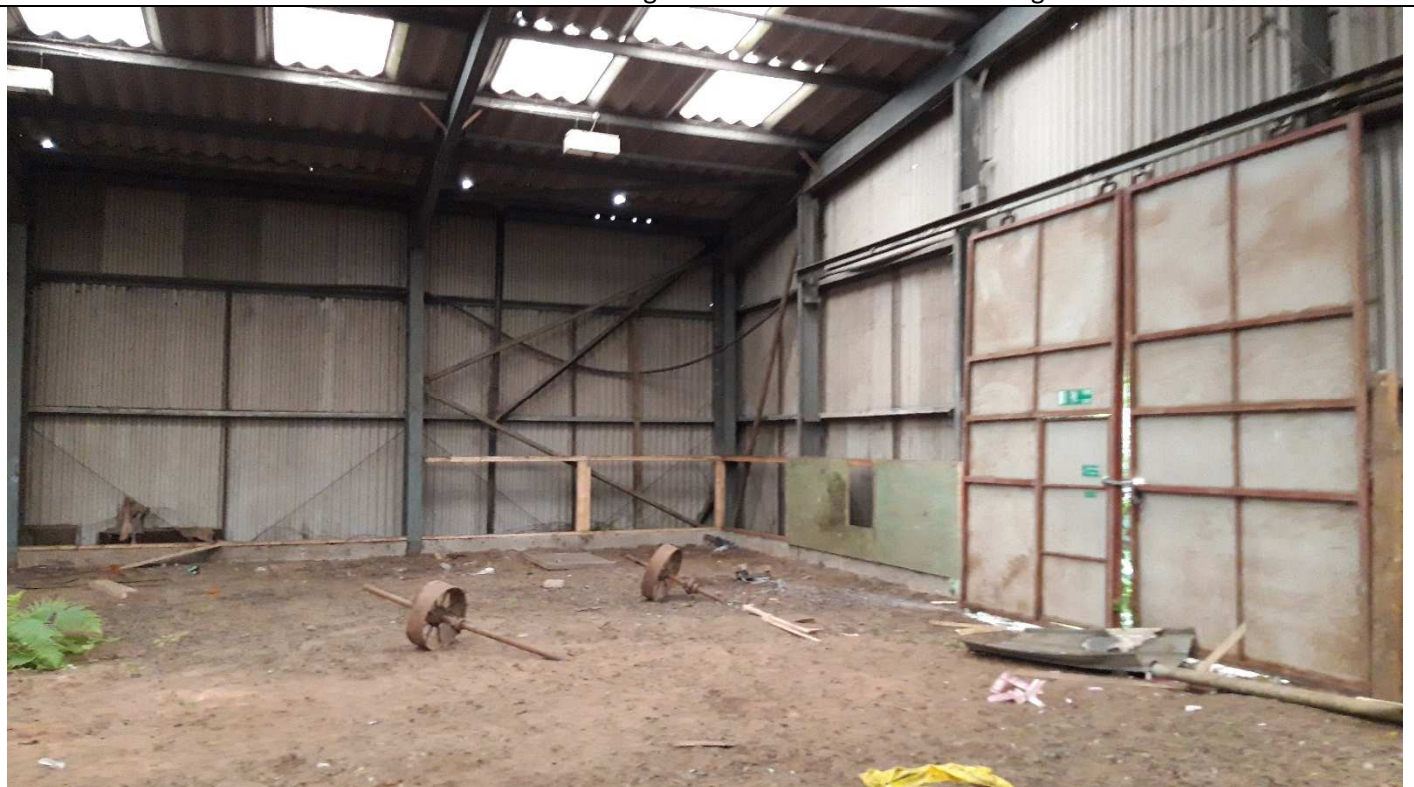
Building F3 – Typical Bracing at Corner of Building & Earth Floor

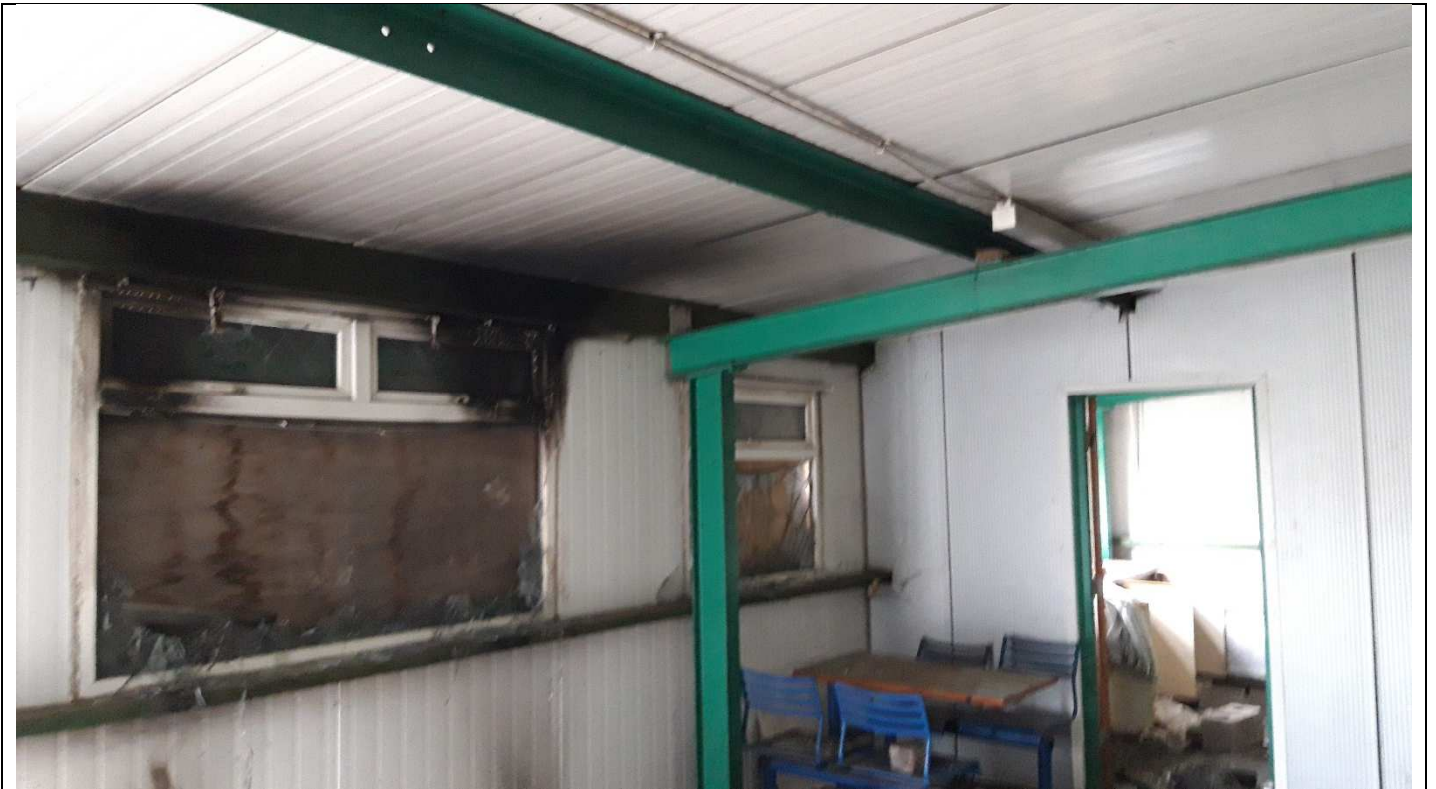
Building F3 – Frame to Lean-To Section

The lean-to frame at the South West is lightweight in nature and relies on the main portal frame for stability. Again, the cladding, particularly to the roof must be assessed for asbestos content, prior to deconstruction works commencing.

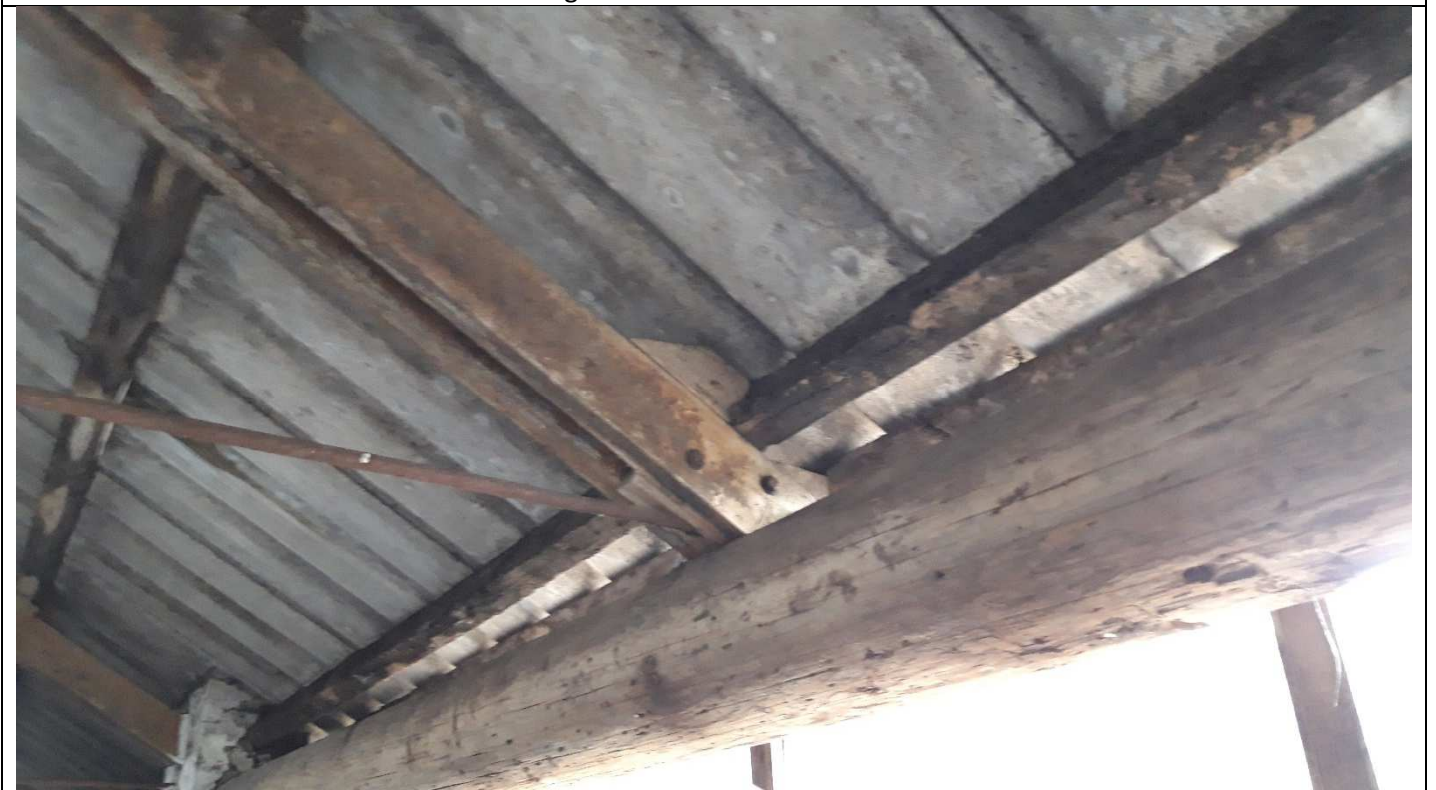
Building F4 – Detail of Truss & Large Eaves Timber Member

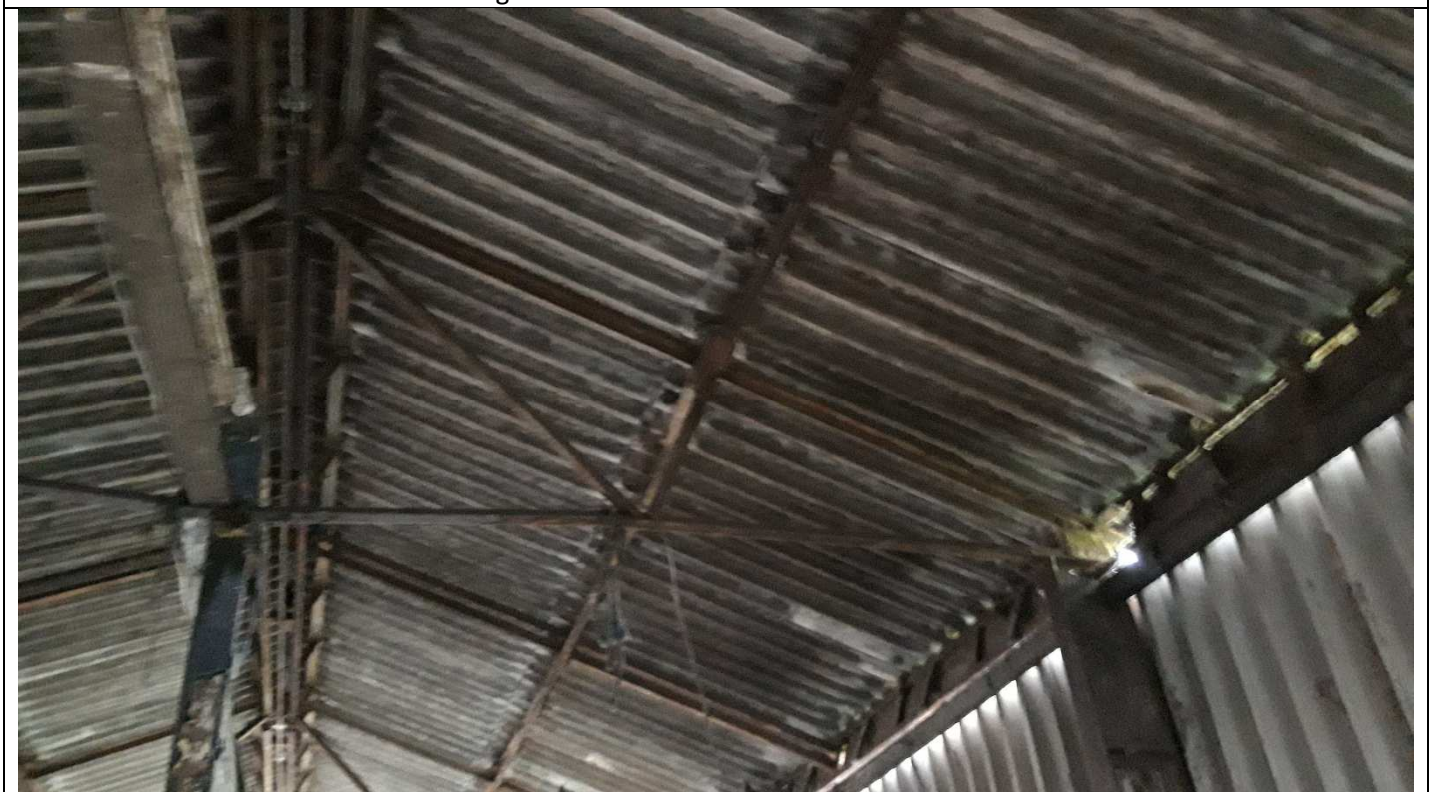
Building F5 – Detail of Framework to South (dilapidated) Storage Shed

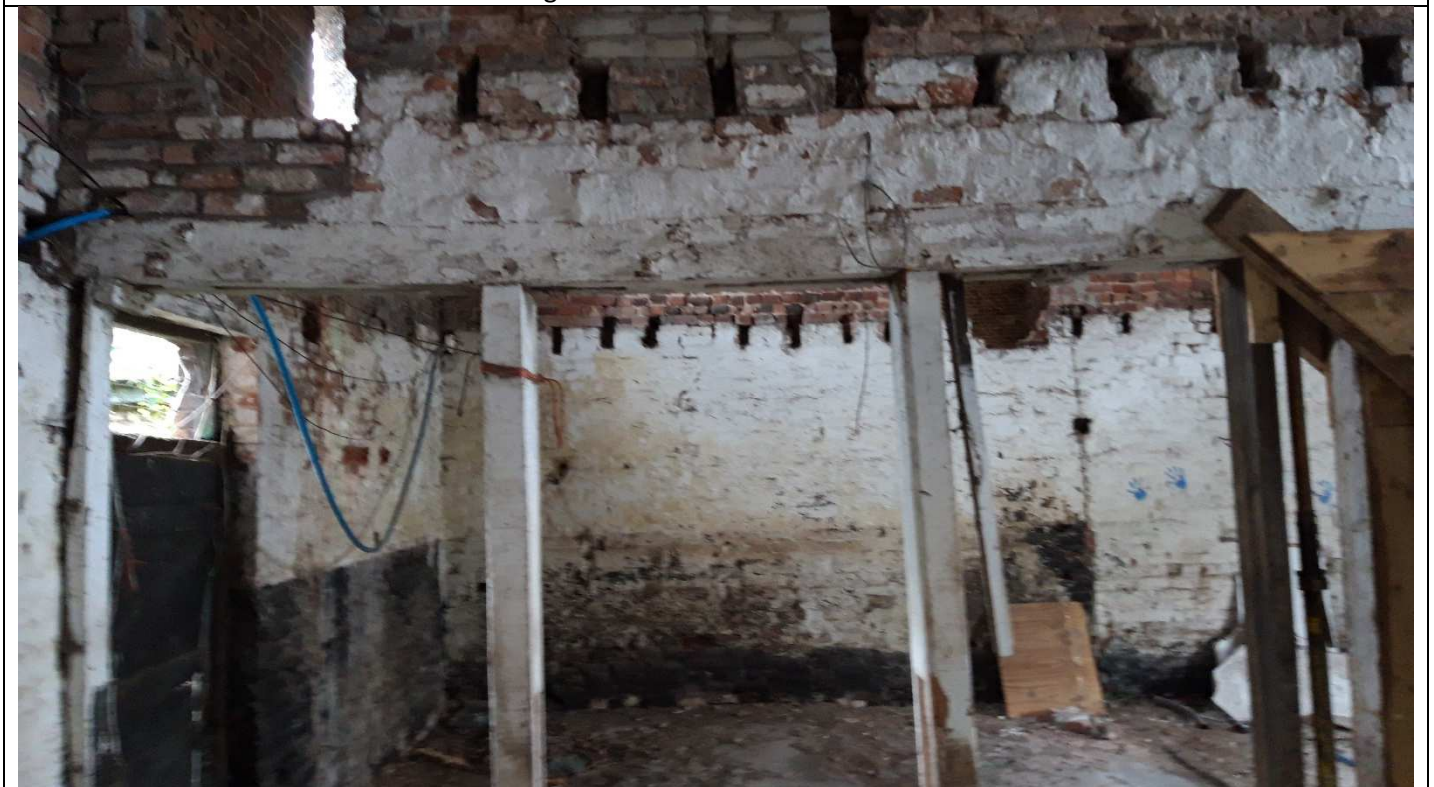
Building F8 – Propping to Partition Wall at East End

The cross walls internally, to the double height wall will require removal. The wall in the East end section of the building is in poor condition, so will require temporary support during deconstruction. The cross walls also serve as support to the roof purlins, so the roof will require removal prior to removal of cross walls. The cross walls also provide lateral support to the external perimeter walls, scaffolding to restrain the external walls is recommended during the removal of the internal walls. External walls can then be taken down as scaffolding is removed.

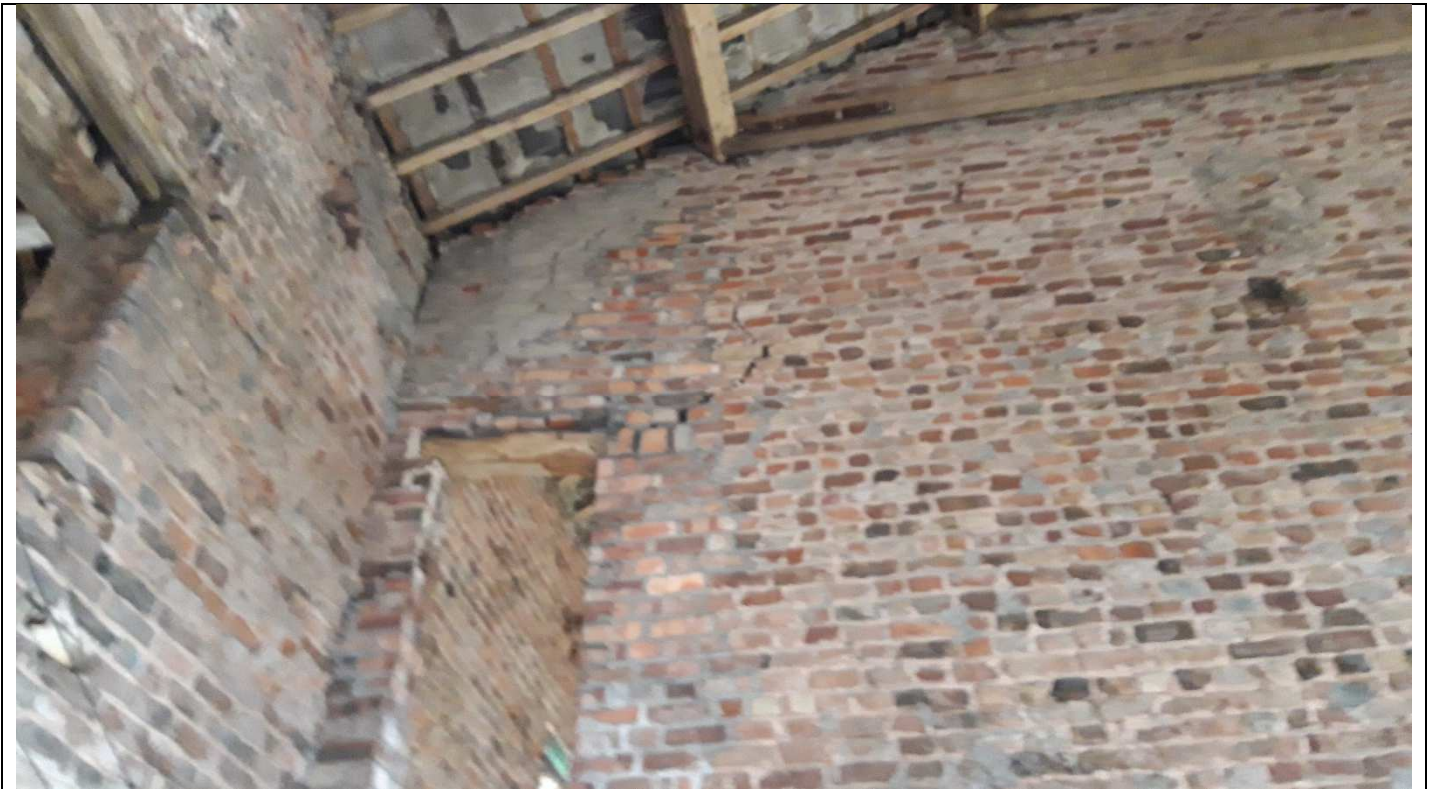
The partition wall at the centre of the East room has openings at ground floor level which have been propped for stability. Diagonal cracks exist at both ends of the wall where it intersects the external wall. These cracks are estimated to be up to 10mm thick. There is minor vertical cracking evident in the partition wall to the central room.

Building F8 – Cracking to Propped Partition Wall at East End

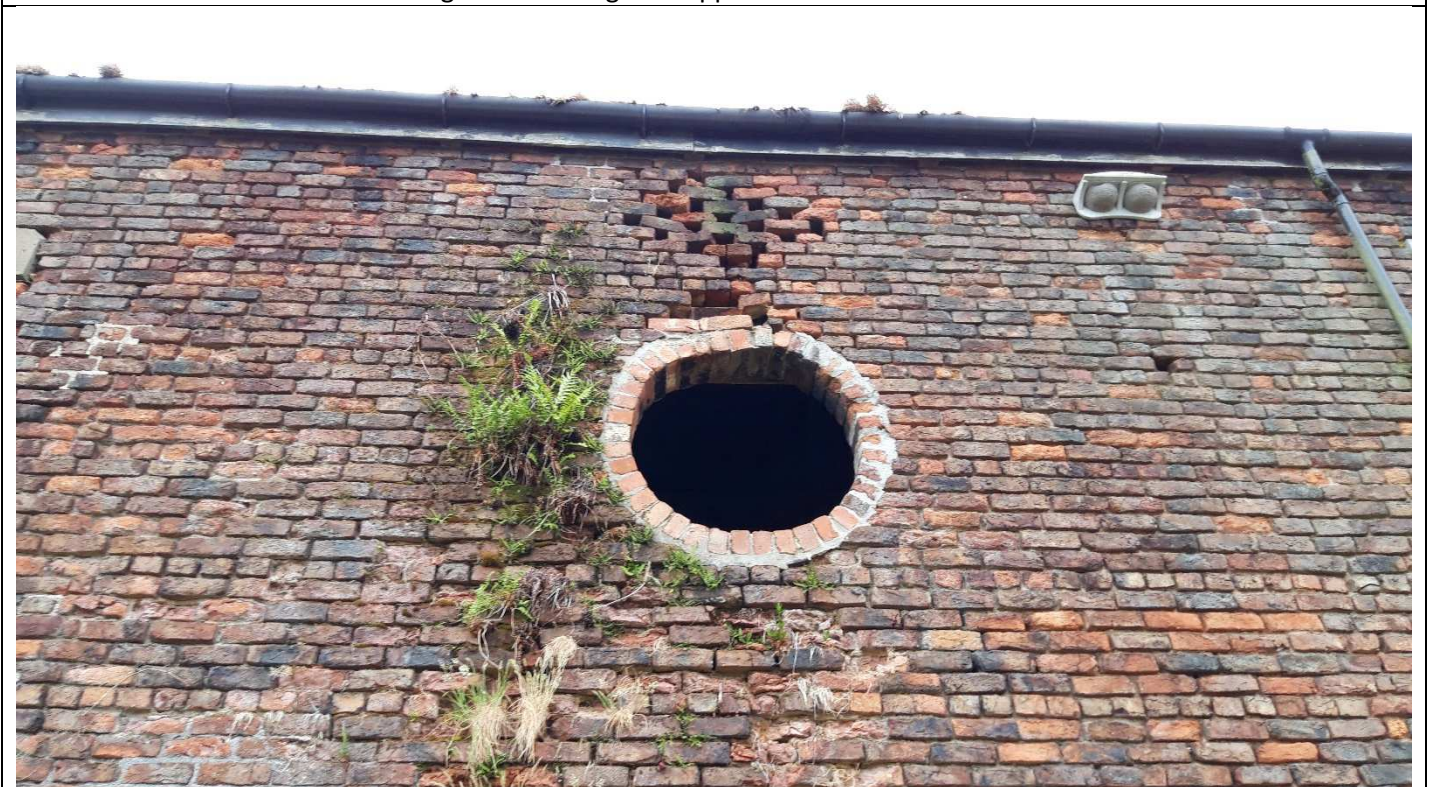
Building F8 – Damage to External Masonry at Eastern End of North Elevation

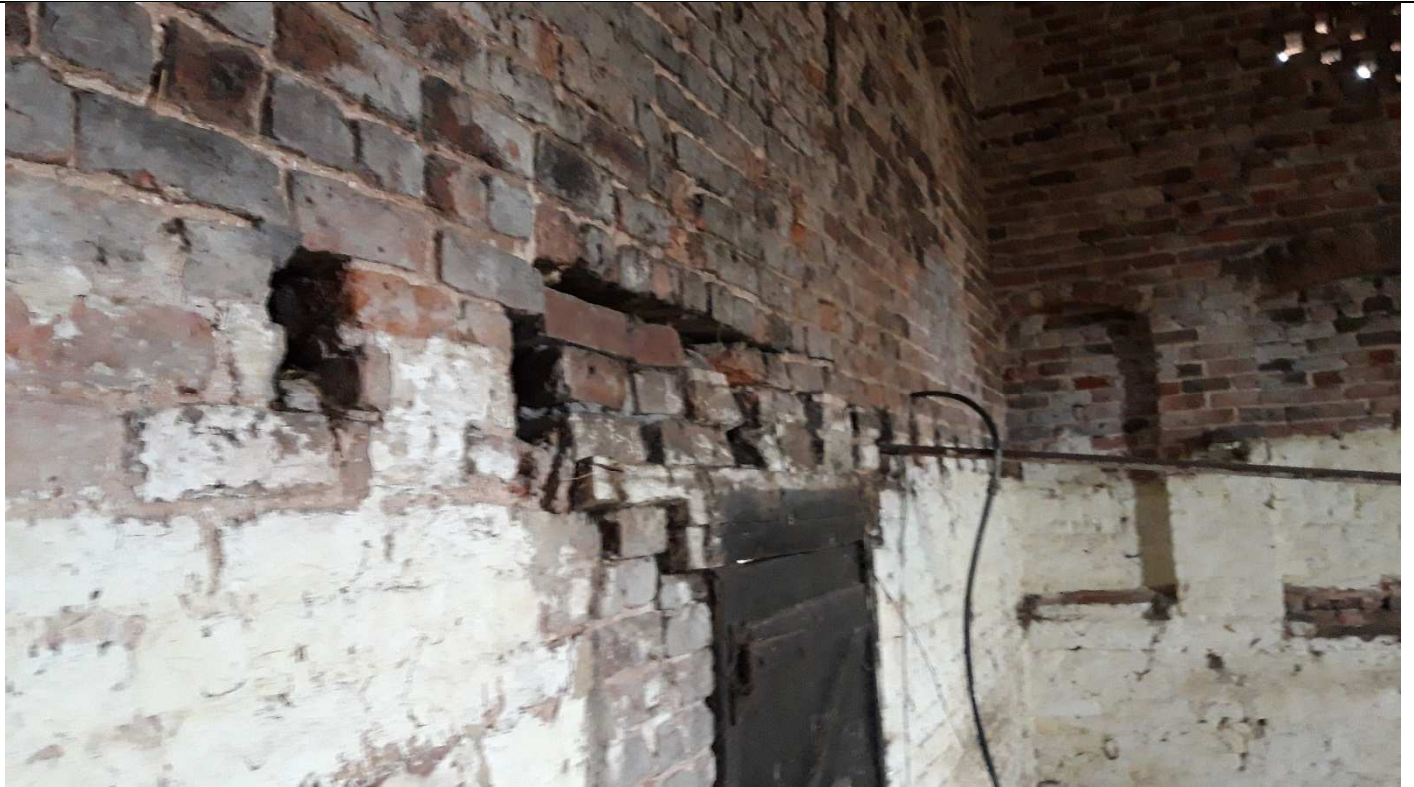
There is distortion to the masonry above the access door in the South elevation wall of the Western room, internally.

Building F8 –Masonry Damage Above Lintel to South Wall in Western Room

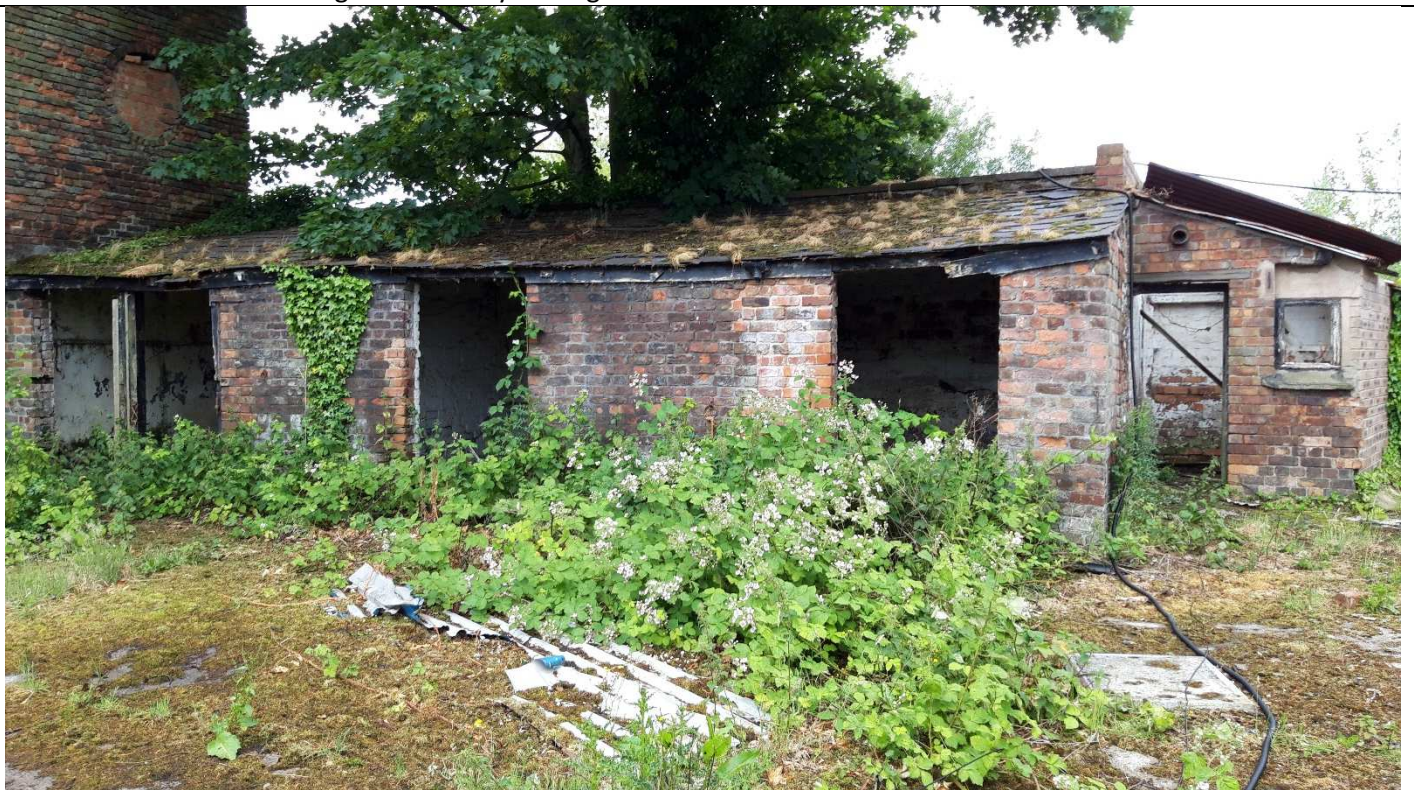
Trusses, purlins and rafters to all areas of the main building and to the outriggers to the south are in reasonably good condition, with no significant defects noted, There is some deflection noted to the outrigger roof to the North West.

Building F8 – Outrigger Required for Removal at North West

There are brick-built outriggers at the North West, South East and midway along the South elevation. These are all of single height construction and should pose no difficulty to remove for a competent demolition contractor.

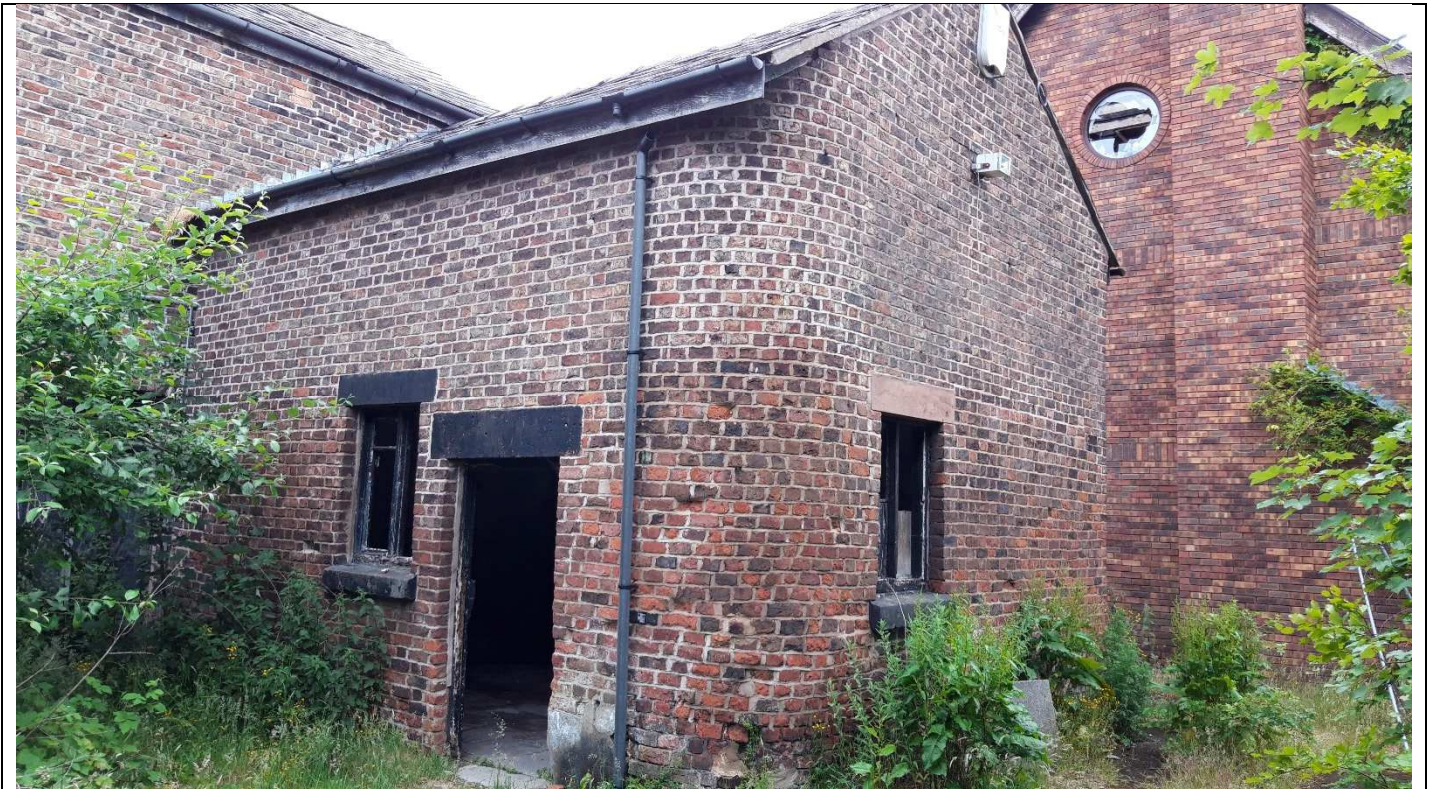
There are separation cracks evident, internally, to the South East outrigger. The crack is up to 10mm wide between the Eastern elevation wall and the partition wall between the main barn and extension.

Building F8 – Outrigger Building to South East

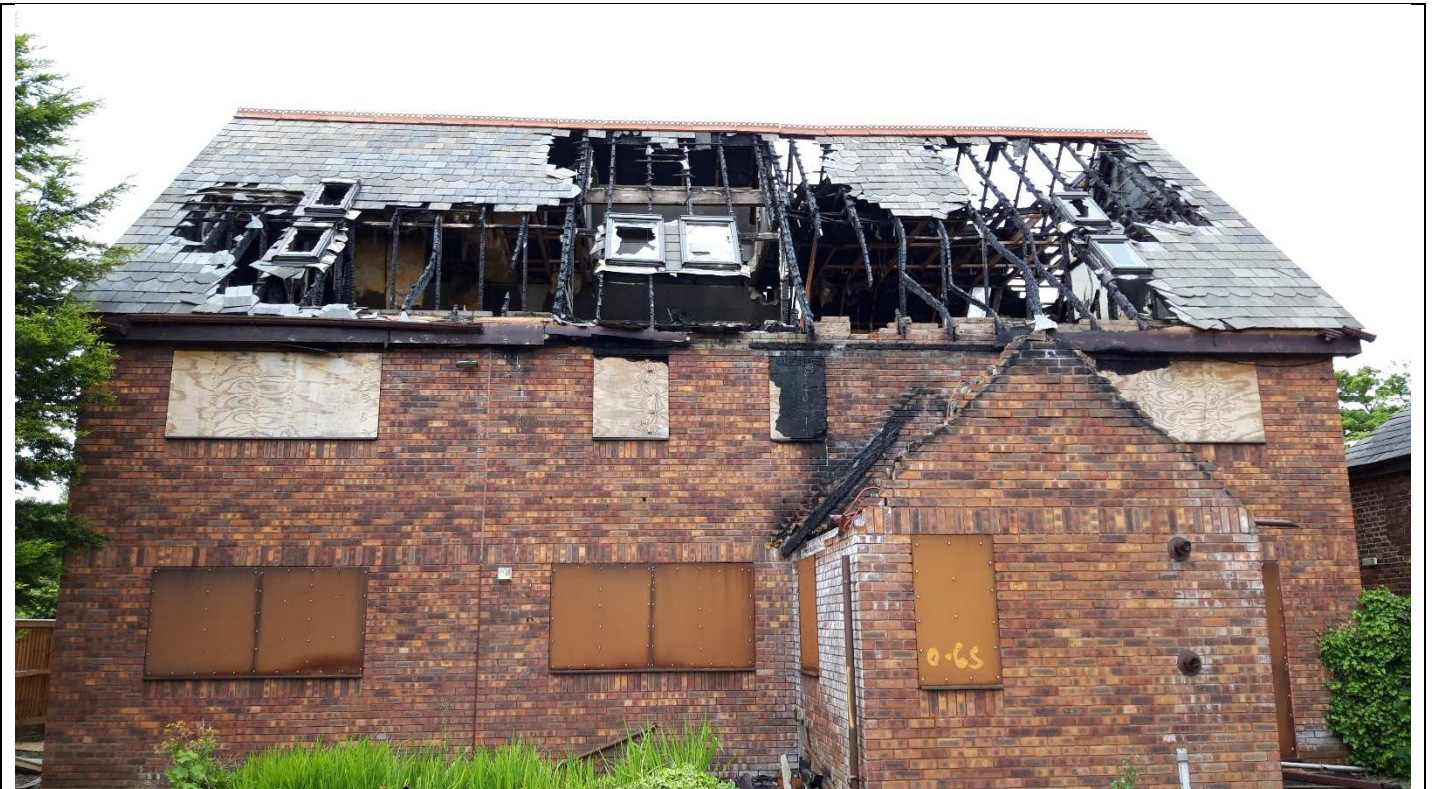
Roof to the single storey outrigger at rear has been lost to fire damage.

Building F9 - Significant Fire Damage to Rear Roof

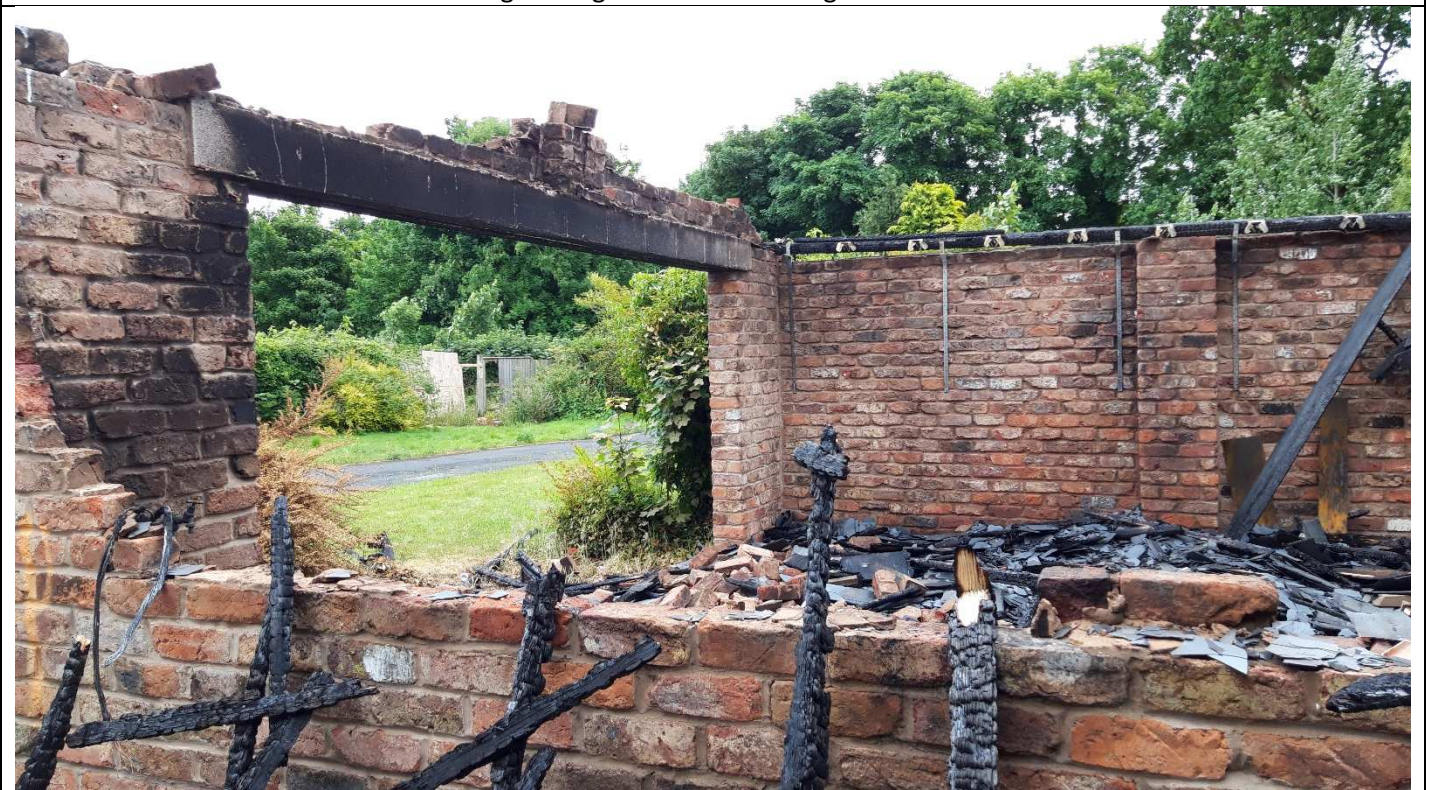
Building F9 – Severe Fire Damage to Garage
