# Feasibility Study

Client: Knowsley Council

Project: New Hutte Neighbourhood Centre

Location: Halewood, Liverpool

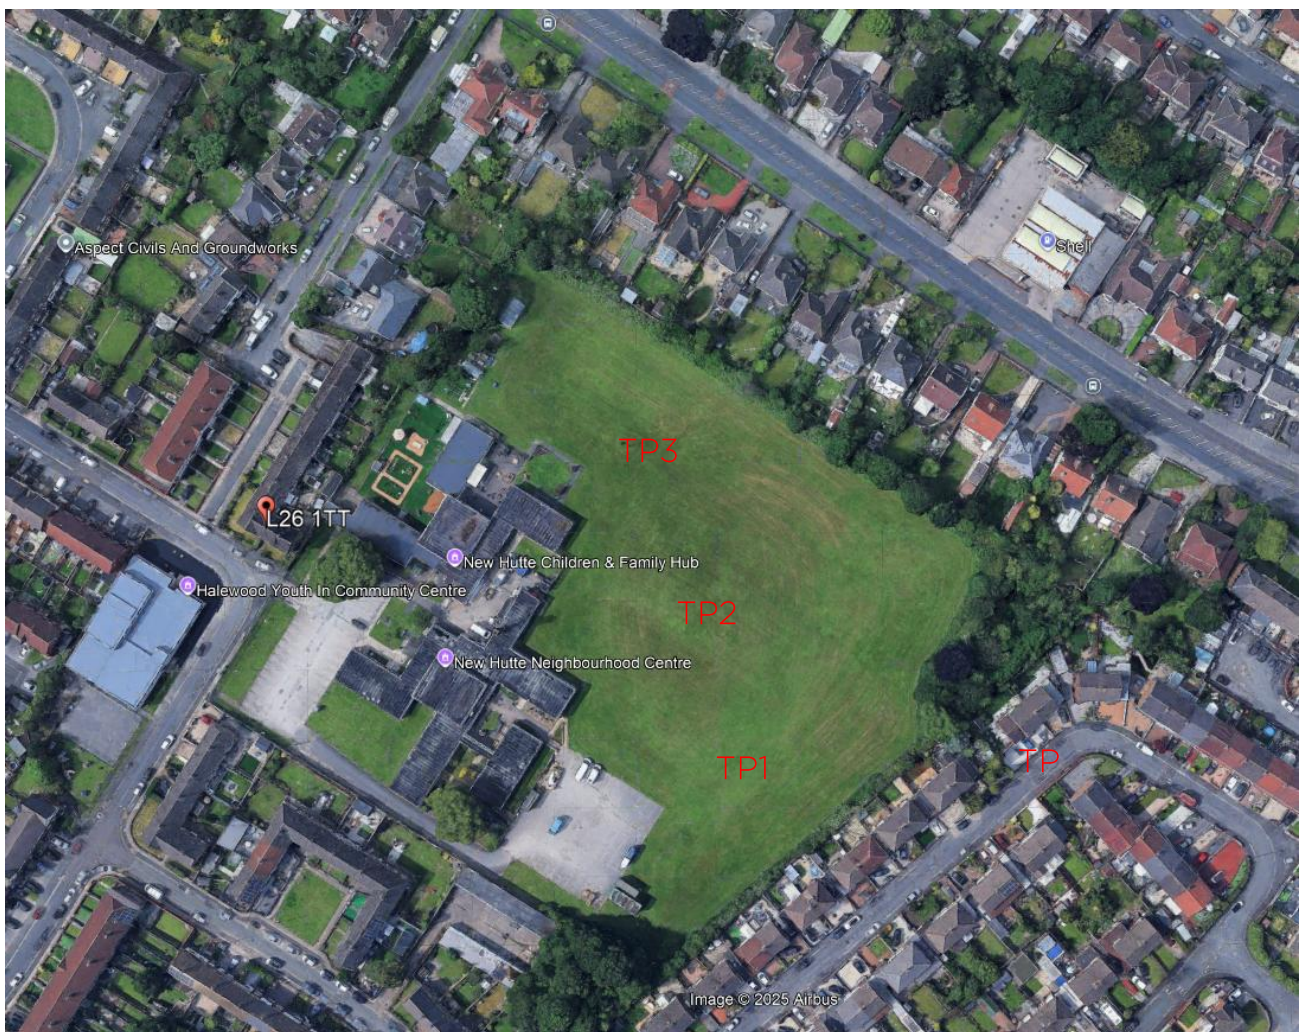
Figure 3 – Trial pit locations

A series of trial pits were excavated by hand at various locations (see Figure 3 below) to confirm the nature of the underlying soil profile. In summary, there was a consistent dark brown sandy loam topsoil across all three test pits excavated. The depth of topsoil was measured to be on average 200 mm and grass rooting extended to a maximum of 90 mm.

The dark brown sandy loam topsoil was overlaying an orange clay subgrade with a clear distinction apparent between the topsoil layer and subsoil layer. No waterlogging was noted in any of the test pits excavated and no contaminants were noted in the form of pottery or glass.

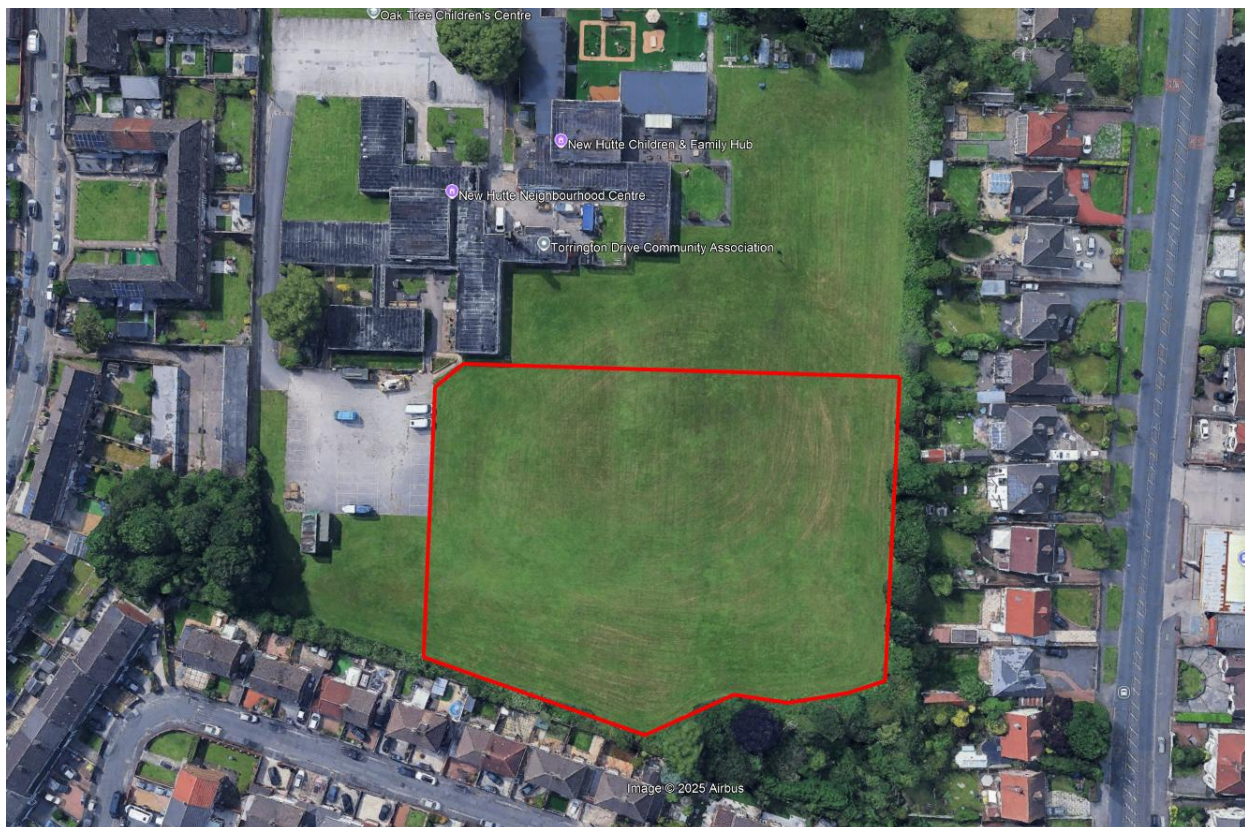
Figure 4 – Priority area to be drained

- The site assessment has concluded that if the area is to be brought back into use for winter sports, it would be recommended that a network of primary drainage would be required to provide a drained playing field area. The LandIS Soilscales Viewer indicates that the existing soils are “Slowly permeable seasonally wet” which further increases the need for a primary drainage system to be implemented across the playing field area. A primary drainage system would mean that the playing field area will be able to sustain a high number of hours in relation to usage.

It is recommended that a primary pipe drainage system be installed comprising of a series of lateral drains running across each area. These would then connect into main carrier drains.

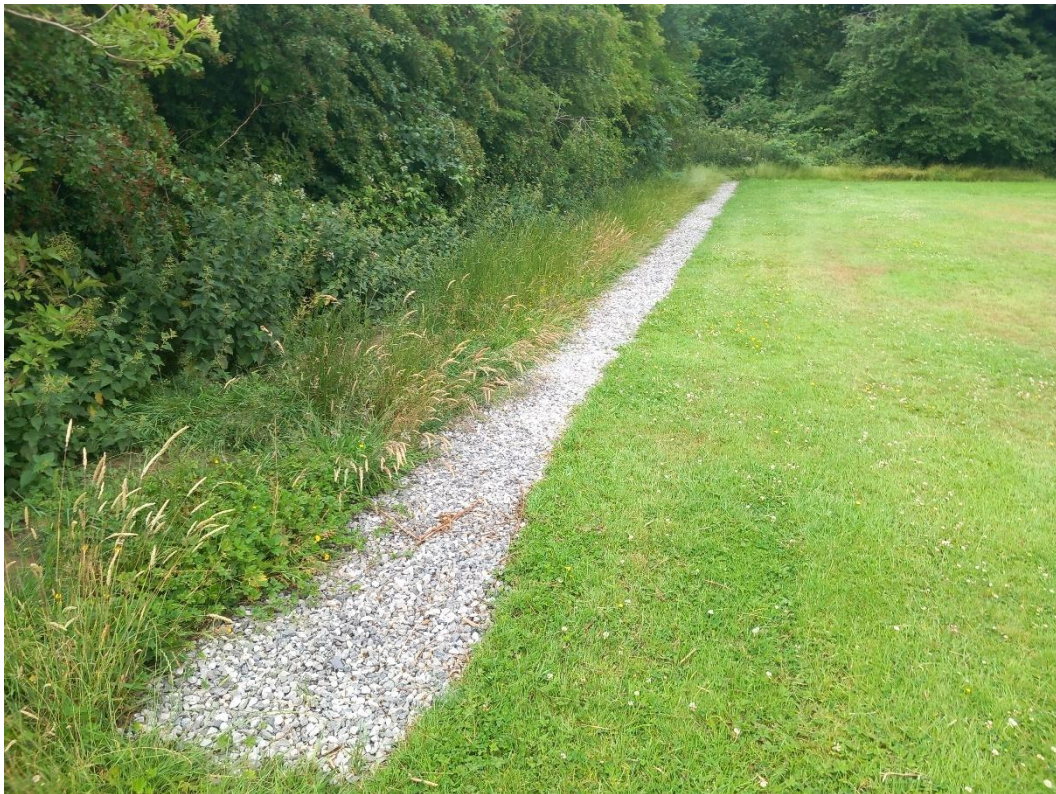
A 'French drain' was observed within the south of the playing field area located in the corner and measured approximately 10 – 15 metres running adjacent to the eastern boundary. This drain appeared to be backfilled with a large MOT aggregate material however it is unknown if any pipe work is underneath the aggregate material.

A 'French drain' was also located in the southern corner of the playing field area however it would need to be understood if any pipe work is located underneath the MOT aggregate material.

Photo 2: French drain

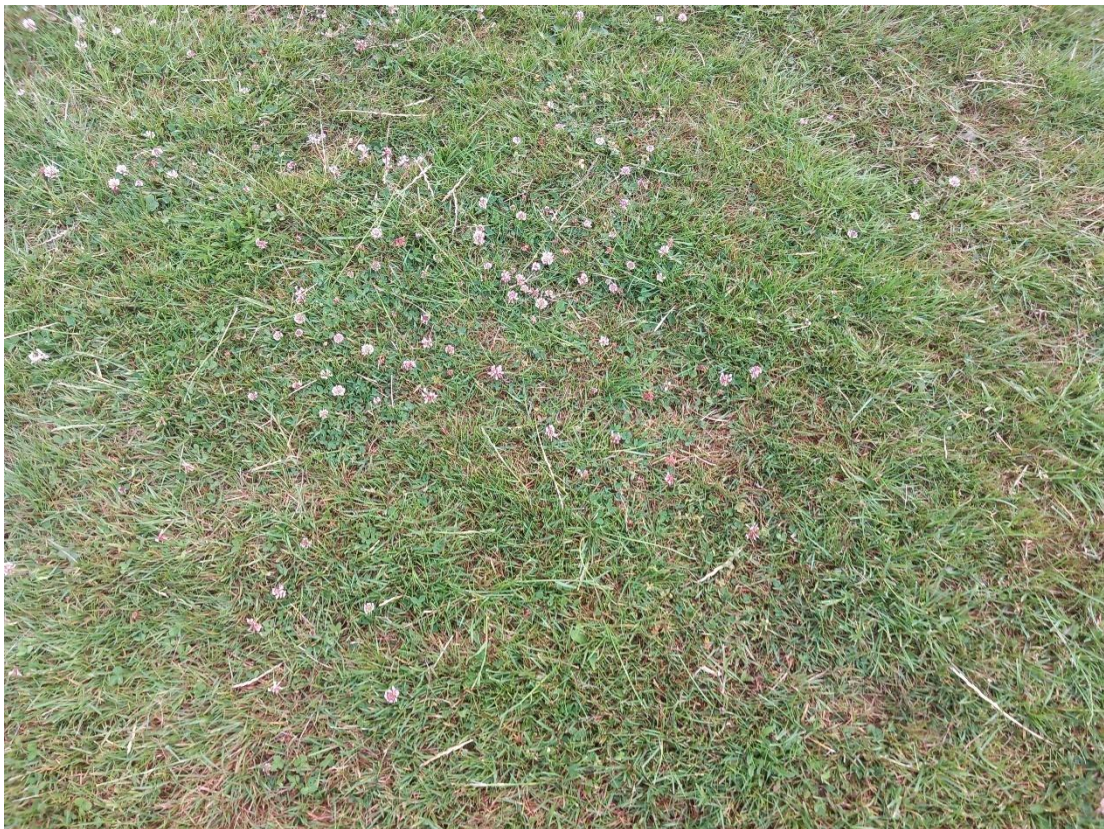
| Agronomic condition: | The agronomic condition of the playing field area was moderate with a high number of broad leaf weeds dominating the surface therefore indicating that little to no key maintenance practices are carried out such as aeration, sand topdressing, fertilising, scarifying and selective herbicide applications. This is to be expected though as the playing field area is only currently used on a recreational basis. |

Photo 4: Broadleaf weed cover

The surface vegetation should be treated with a selective-based herbicide in line with current legislation and COSHH guidelines. This will treat any broadleaf weeds within the playing field area.

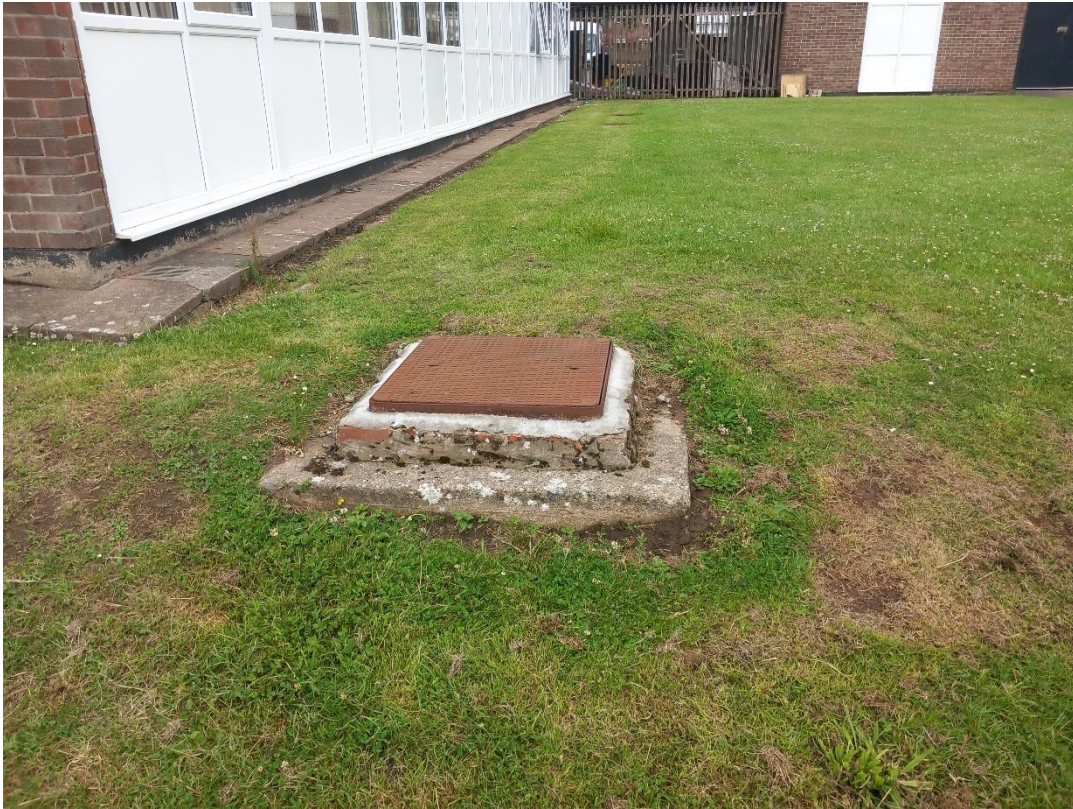
Manholes were discovered however not opened at the time of the site visit and are thought to be connected/related to the building within the south/west of the site. This wider scheme could also be used as a connection point however the relevant permissions would have to be sought before any connection can be made.

Photo 5: Drainage manhole

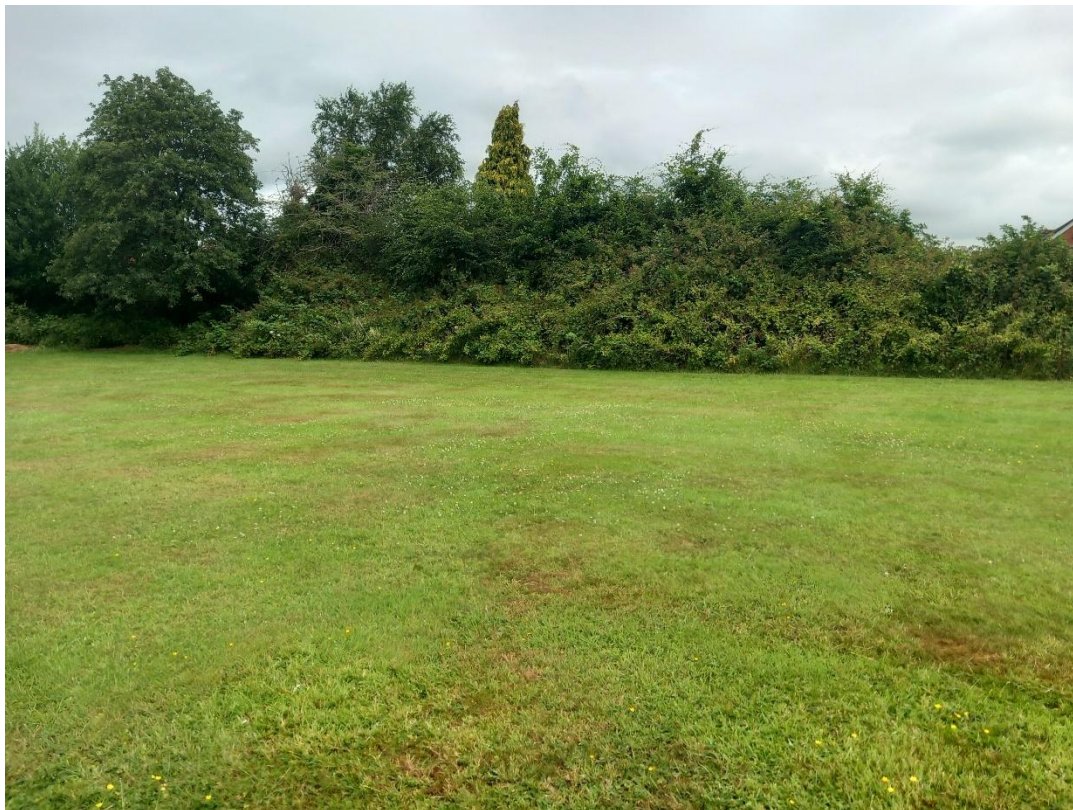
Photo 6: Overgrown vegetation at the lowest part of the site

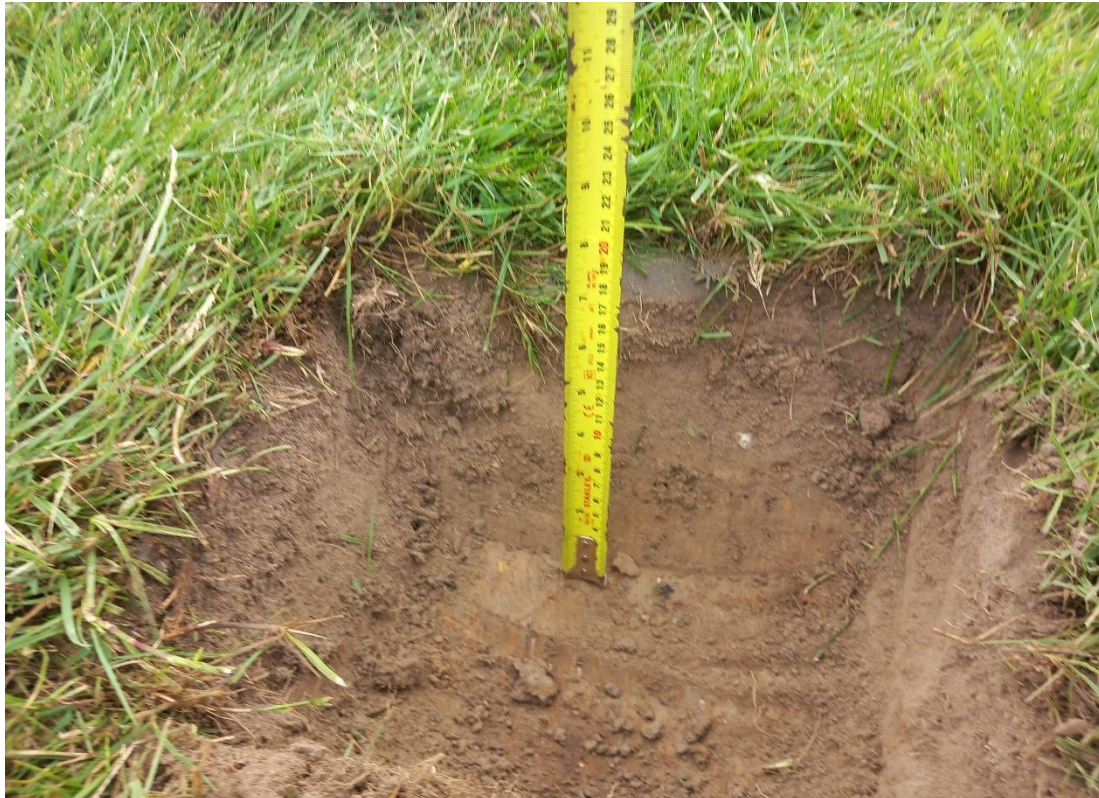
Photo 8: Excavated test pit

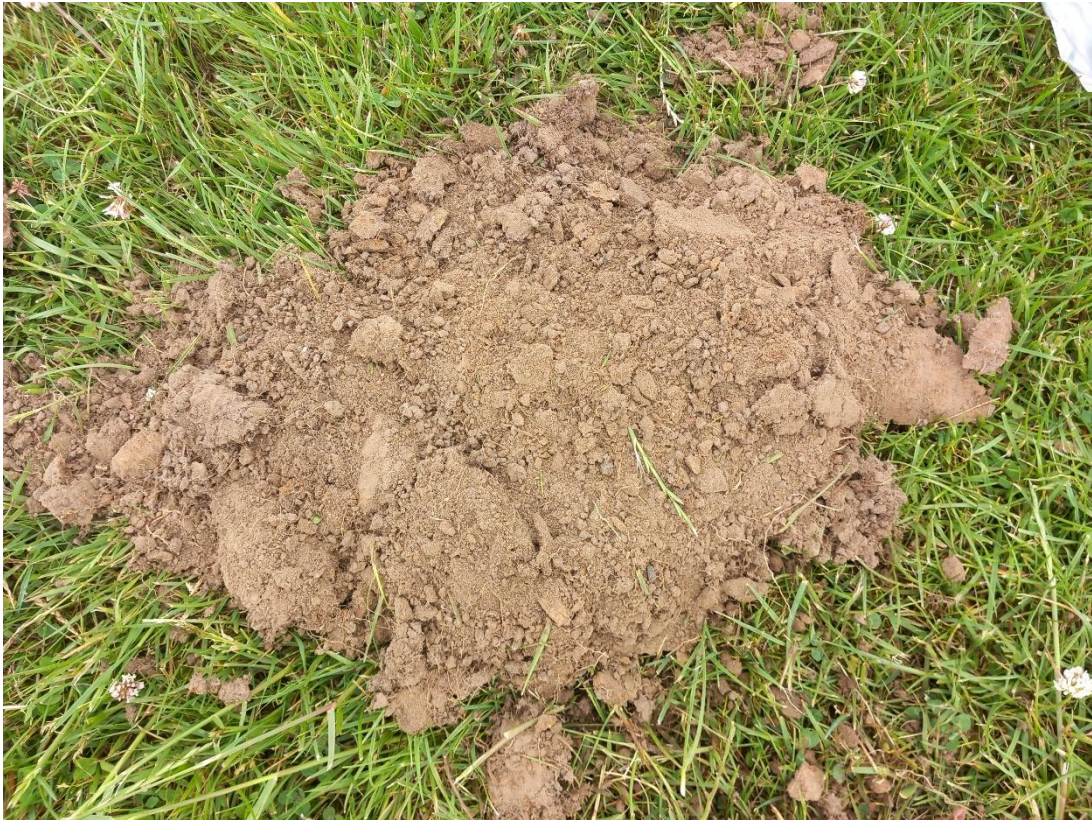
- The existing topsoil was tested by STRI and shows that a sandy loam material is present across the playing field area with a high number of fine particles present such as silt (21)%. The high number of fine particles shown in results show that drainage potential is limited particularly if winter sports are going to be played along with increasing the usage levels therefore further highlighting the need for a primary drainage system to support any increased usage of the playing field area. An orange clay subgrade was observed underlying the existing topsoil material further decreasing drainage potential.

Photo 9: Excavated topsoil

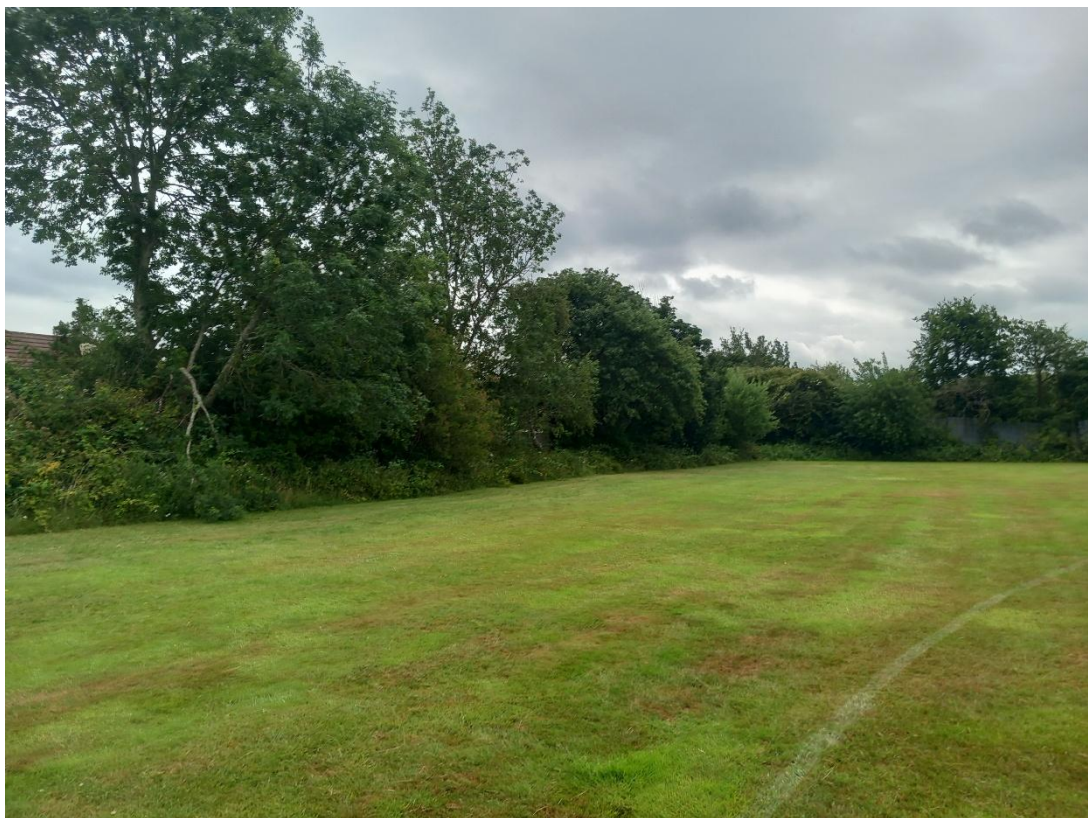
Some mature trees were located along the northern and eastern boundaries however was primarily overgrown vegetation along this boundary. A higher number of mature trees were located along the eastern boundary.

Photo 10: Northern boundary
