# Site Appraisal

**Client:** Knowsley Council

**Project:** Grace Park – Halewood Junior Football Club

**Report date:** 27/11/2024

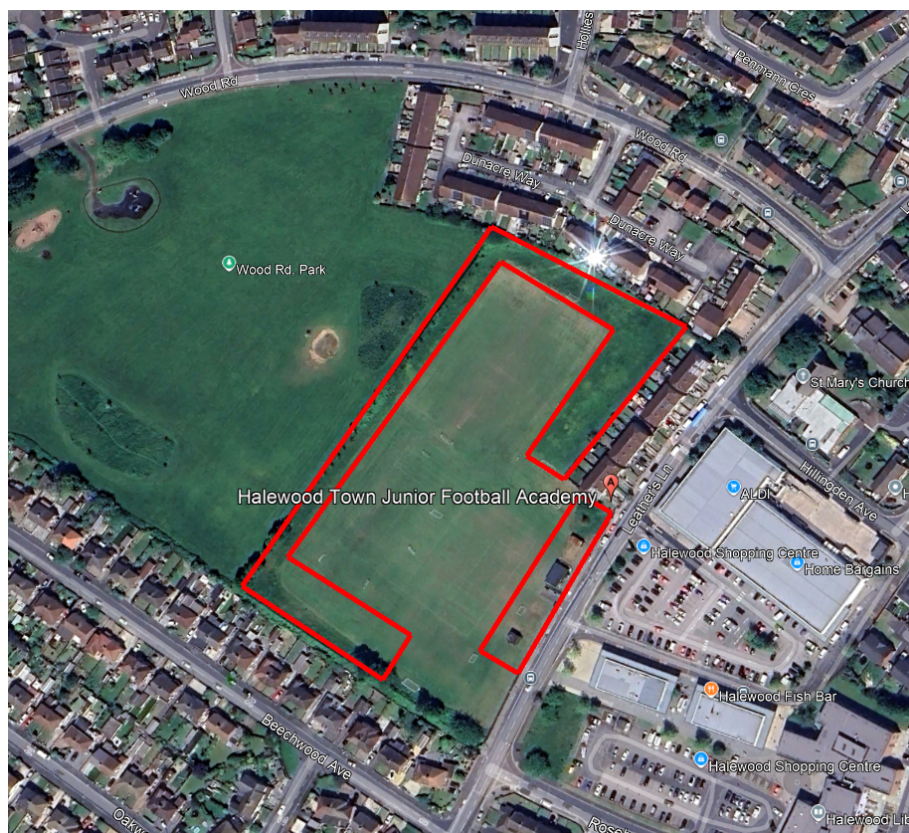
At the time of the visit various areas appeared to be unused by the club due to poor ground conditions which has led to limited layout options for the club and limited usable space. The areas that are not used due to poor ground conditions can be seen within Figure 4 below demarcated within the red lines.

**Figure 4 – Unusable areas by the club due to poor drainage and infrastructure (approximately 9000 sqm of unusable playing field)**

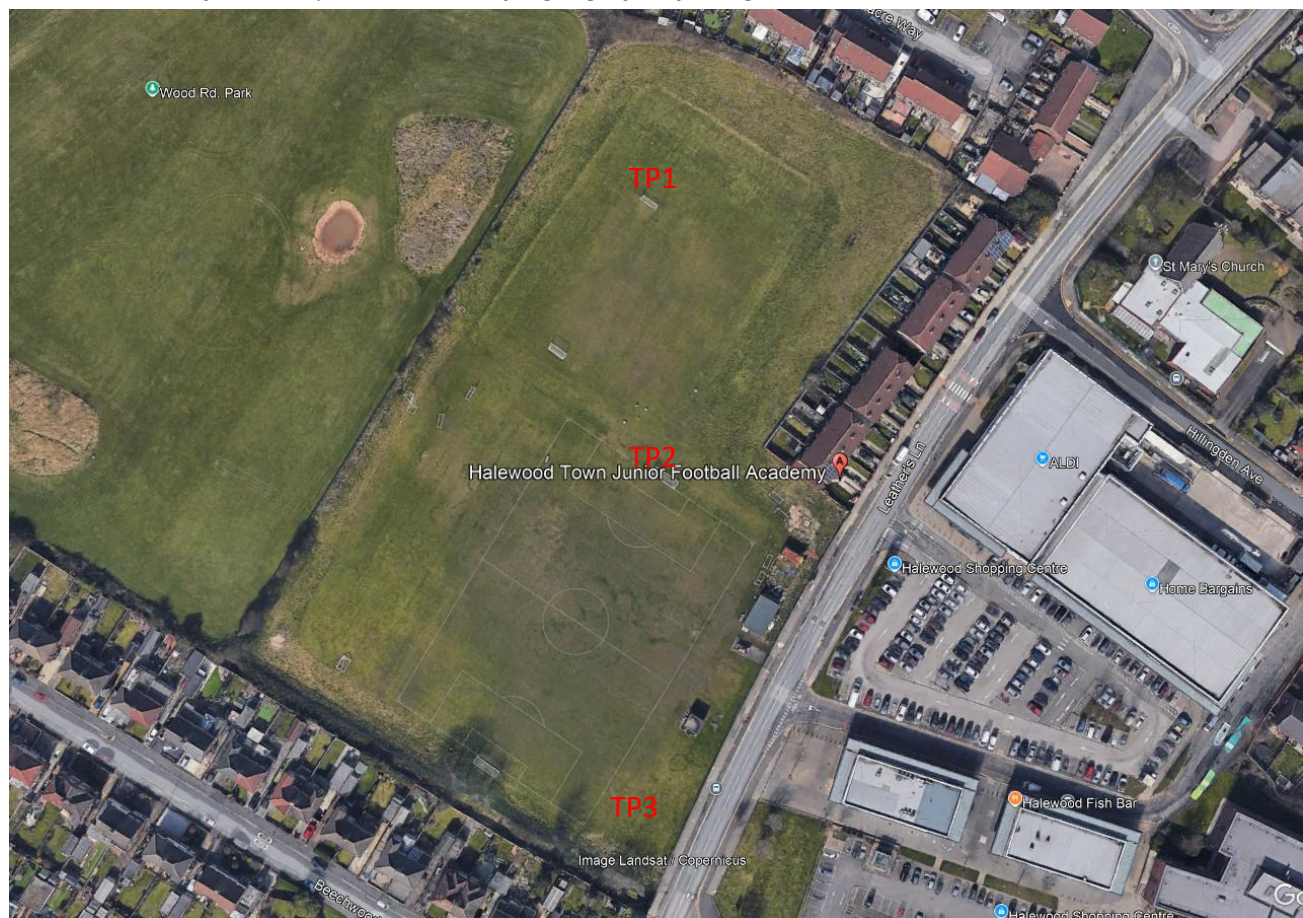
A series of trial pits were excavated by hand at various locations (see Figure 5 below) to confirm the nature of the underlying soil profile. In summary, there was a consistent sandy loam topsoil across all three test pits excavated. The depth of topsoil was measured to be on average 260 mm and grass rooting extended to a

maximum of 190 mm with no large stones observed along with no contamination in the form of glass or pottery.

The brown sandy loam topsoil was overlaying a grey clay subgrade

**Figure 5 – Trial pit locations**

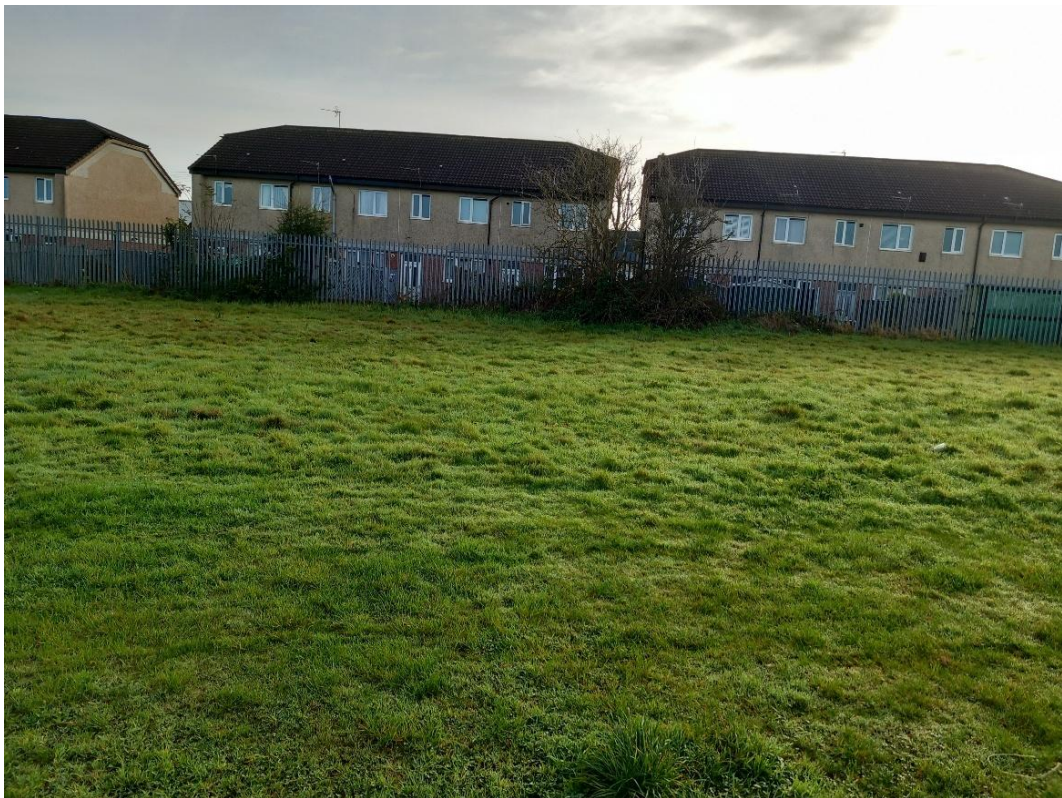
**Photo 2: Unusable area**

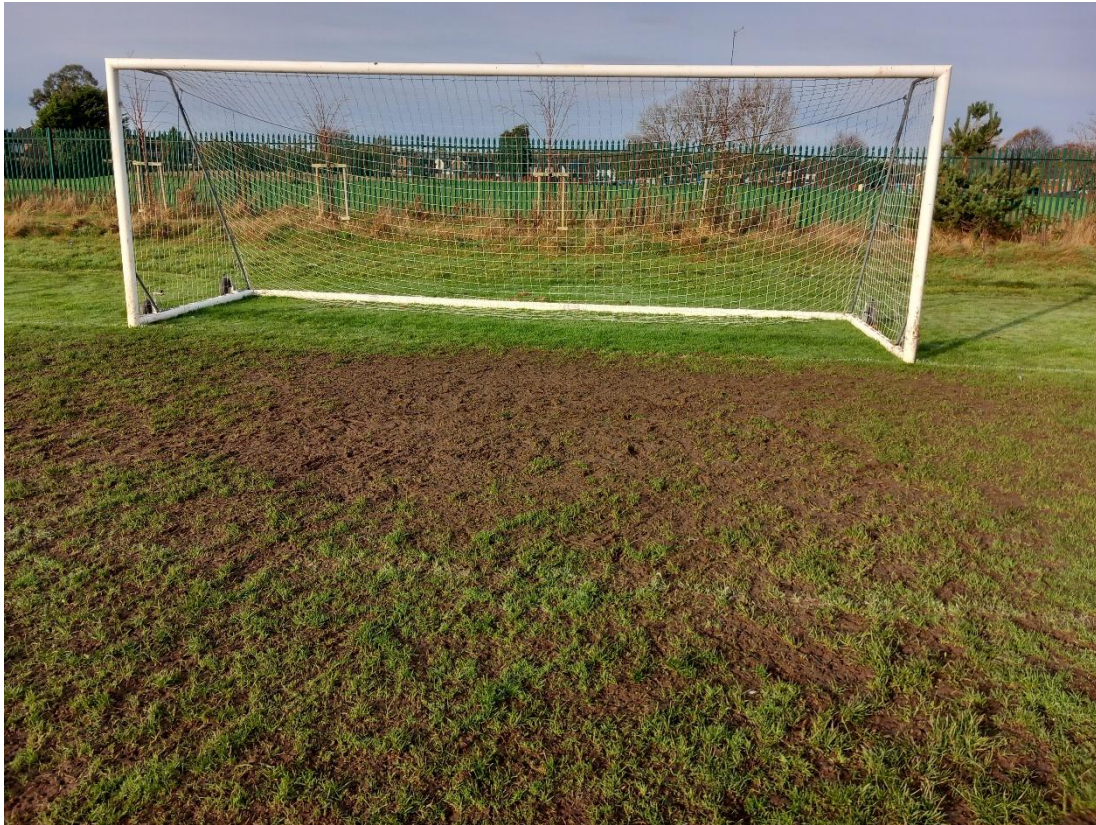
| Agronomic condition: | The agronomic condition of the two youth football pitches was poor at the time of the visit with grass cover averaging approximately 5% within goalmouth areas and approximately 25% in other areas of the pitches. The poor grass cover is thought to be related to the high percentage of clover which is not a hard wearing type of vegetation along with wet surface conditions. At the time of the visit, it was also observed that the disease 'rust' was present within the Perennial ryegrass population which would indicate a lack of fertility within the Ryegrass population. |

**Photo 3: Poor grass coverage in goalmouth**

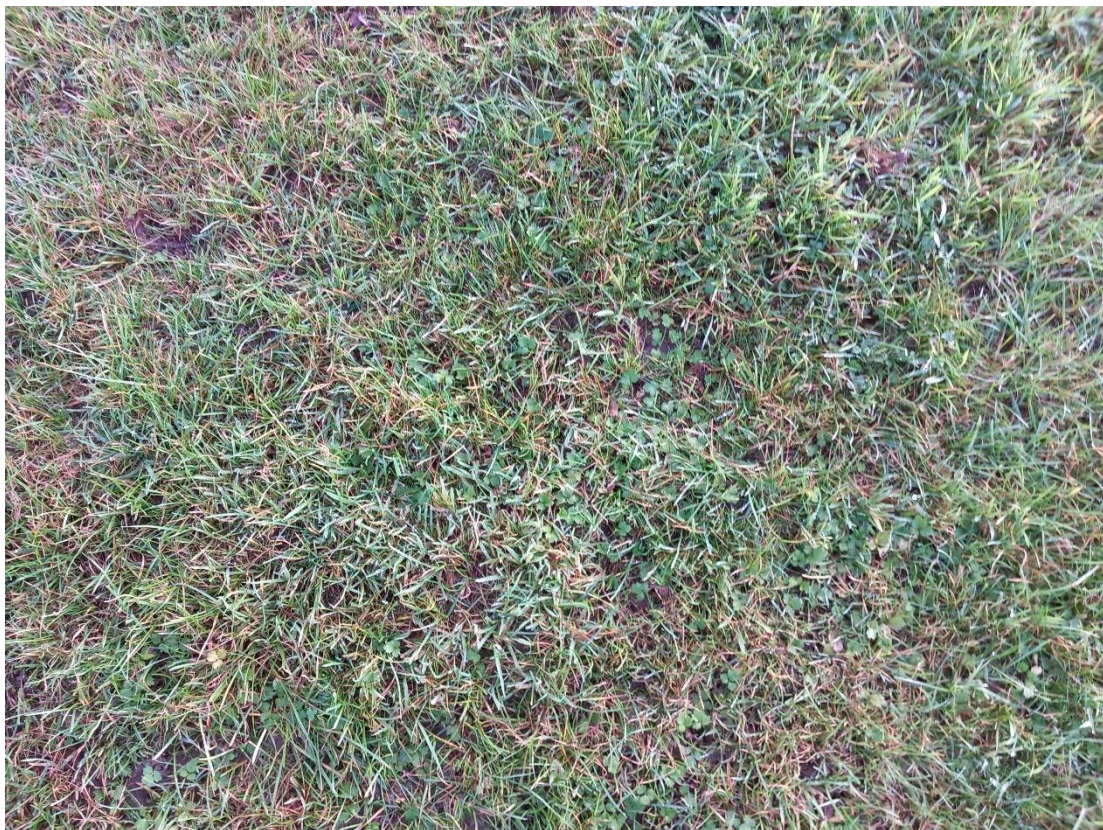
| General: | Existing vegetation was poor across the entire site and across the two existing youth football pitches with broadleaf weeds such as Clover ( <i>Trifolium</i> ), Daisy ( <i>Bellis perennis</i> ), Dandelion ( <i>Taraxacum</i> ) and Ribwort Plantain ( <i>Plantago lanceolata</i> ) present. The main grasses present included a mix of Annual meadow grass ( <i>Poa annua</i> ) and Perennial ryegrass ( <i>Lolium perenne</i> ) however the majority of vegetation cover was clover. |

**Photo 4: Example of broadleaf weed content**

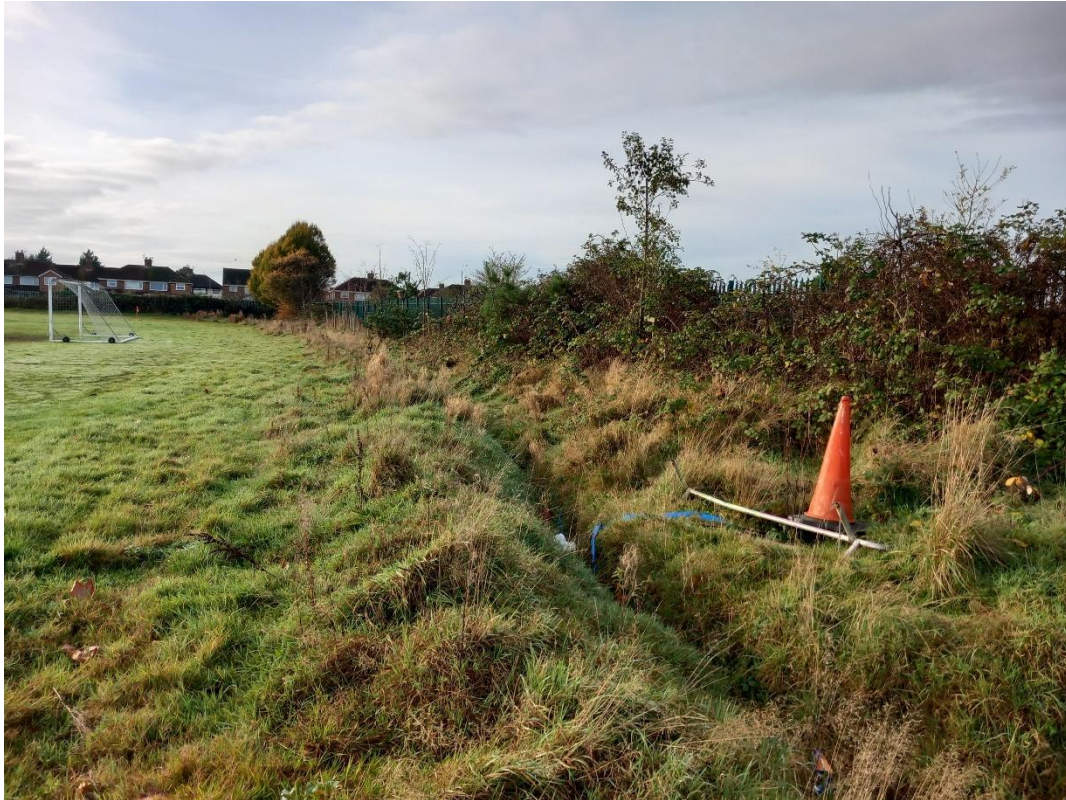
A desktop study shows that no site wide drainage is thought to have been installed across the site at any time. An open ditch was located to the west of the football club site however no drainage was observed to

be in-letting into the ditch at the time of the visit and is thought to be there to aid surface water removal. This would therefore classify the two existing youth football pitches as Type 1 Sport England pitches.

**Photo 5: Existing drainage ditch**

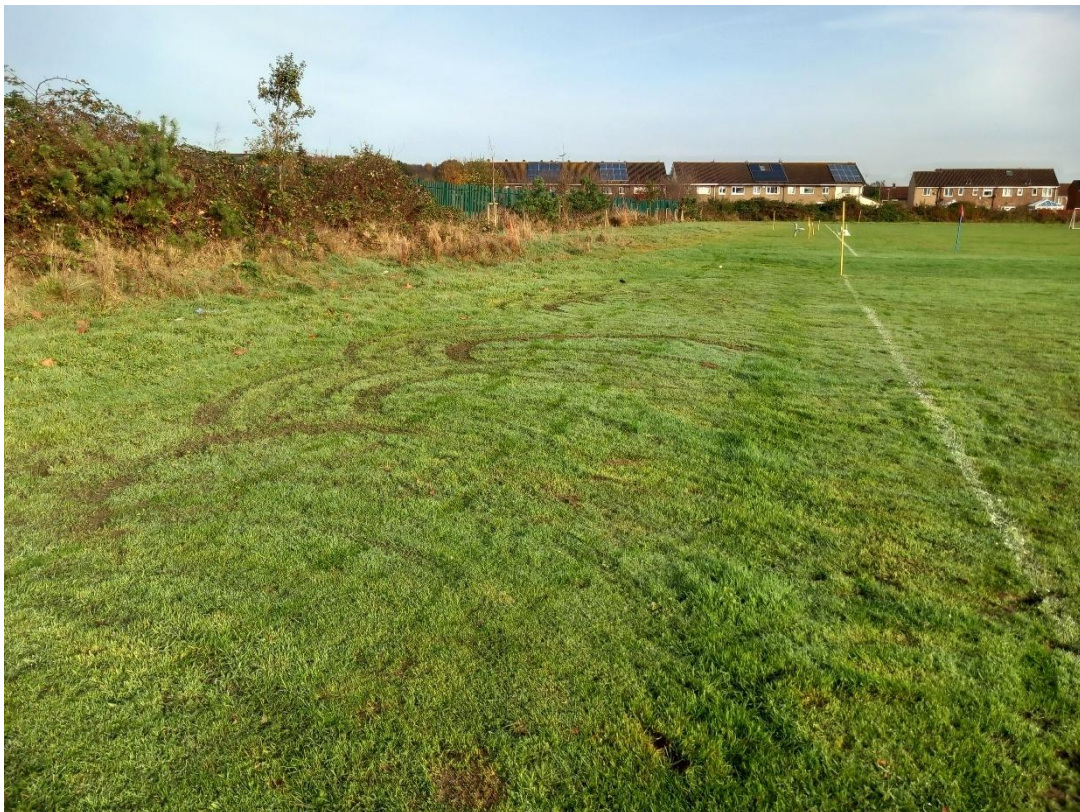
**Photo 6: Evidence of damage from turning machinery**

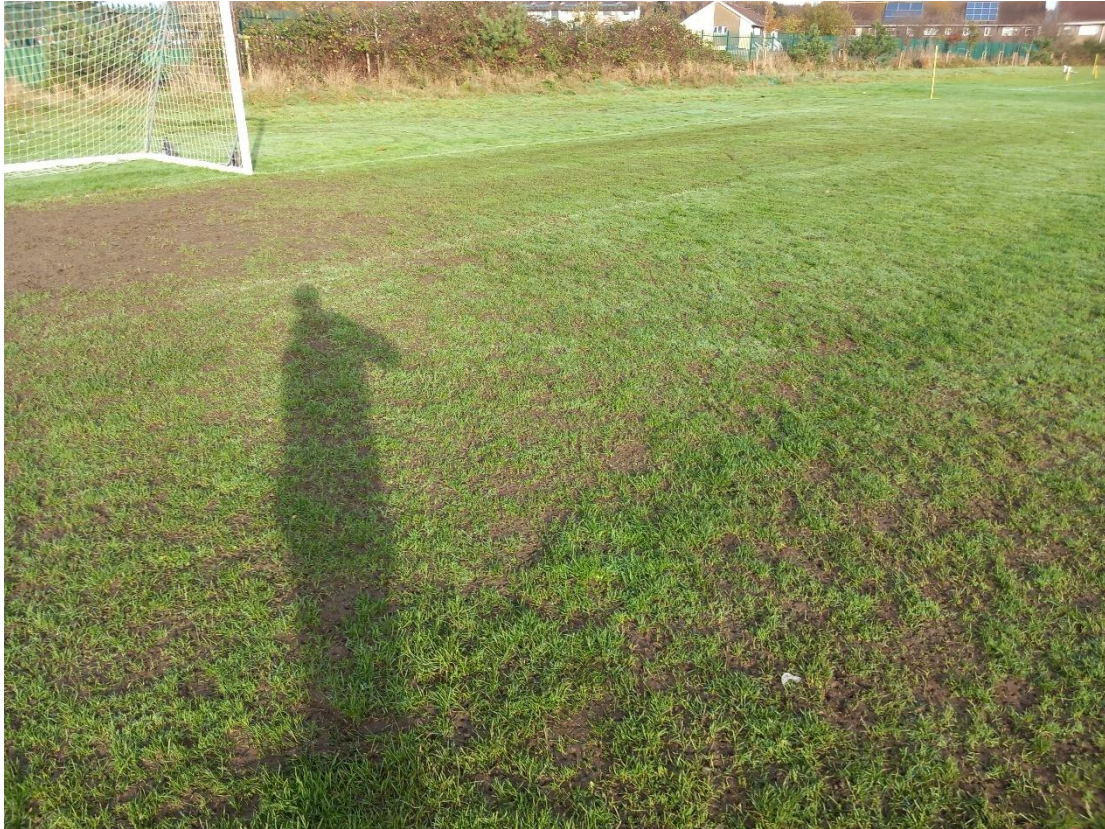
**Photo 7: Poor grass coverage**

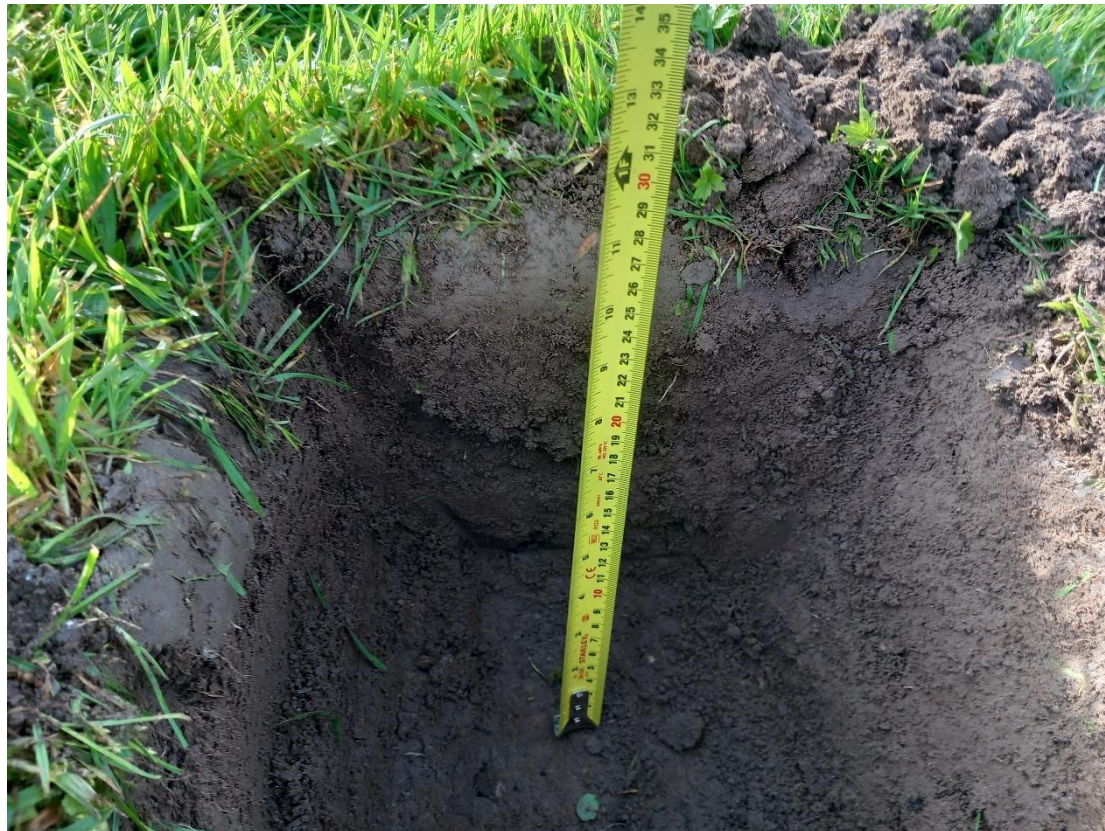
**Photo 8: Excavated test pit**

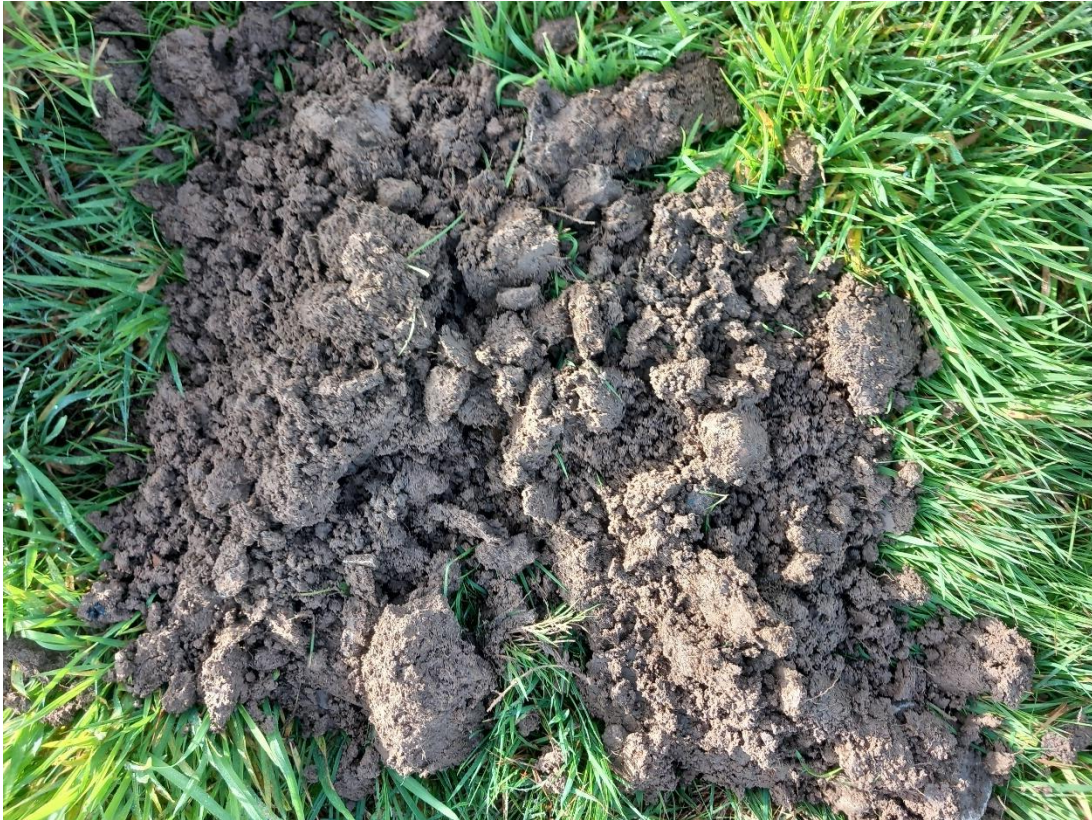
**Photo 9: Topsoil**

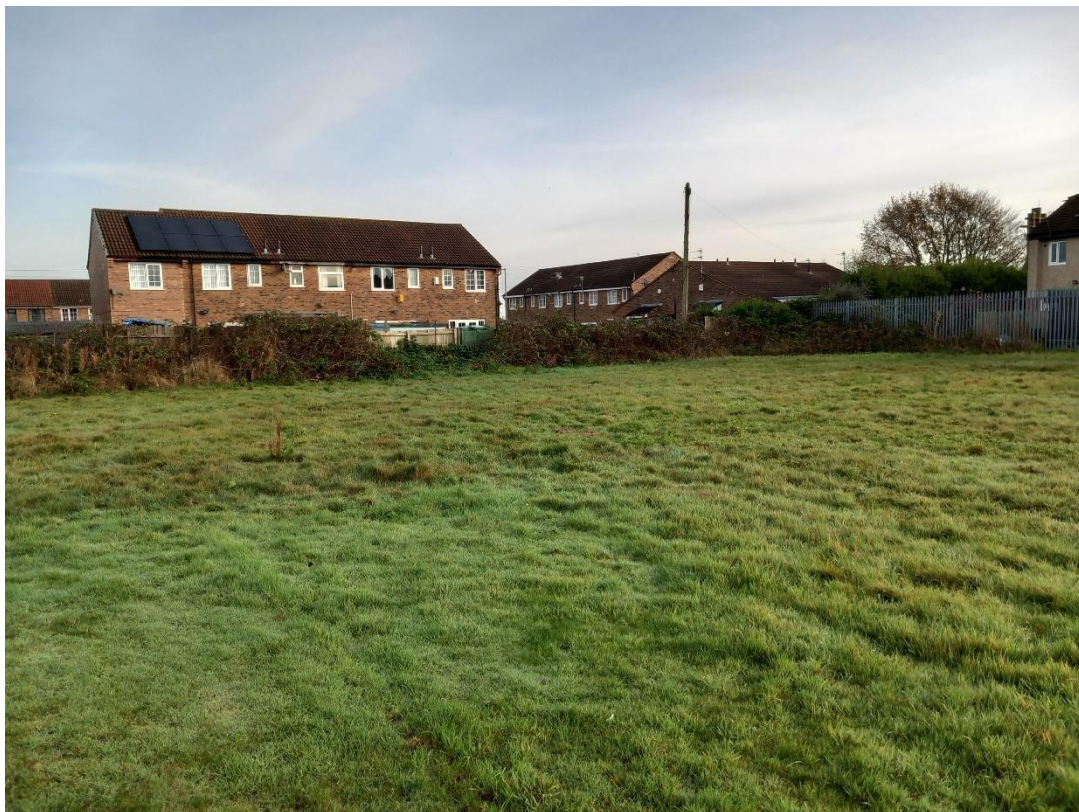
**Photo 10: Unusable area**
