# Equivalent Quality Assessment

Client: Knowsley Council

Project: Grace Park and New Hutte Neighbourhood Centre

Location: Halewood, Liverpool

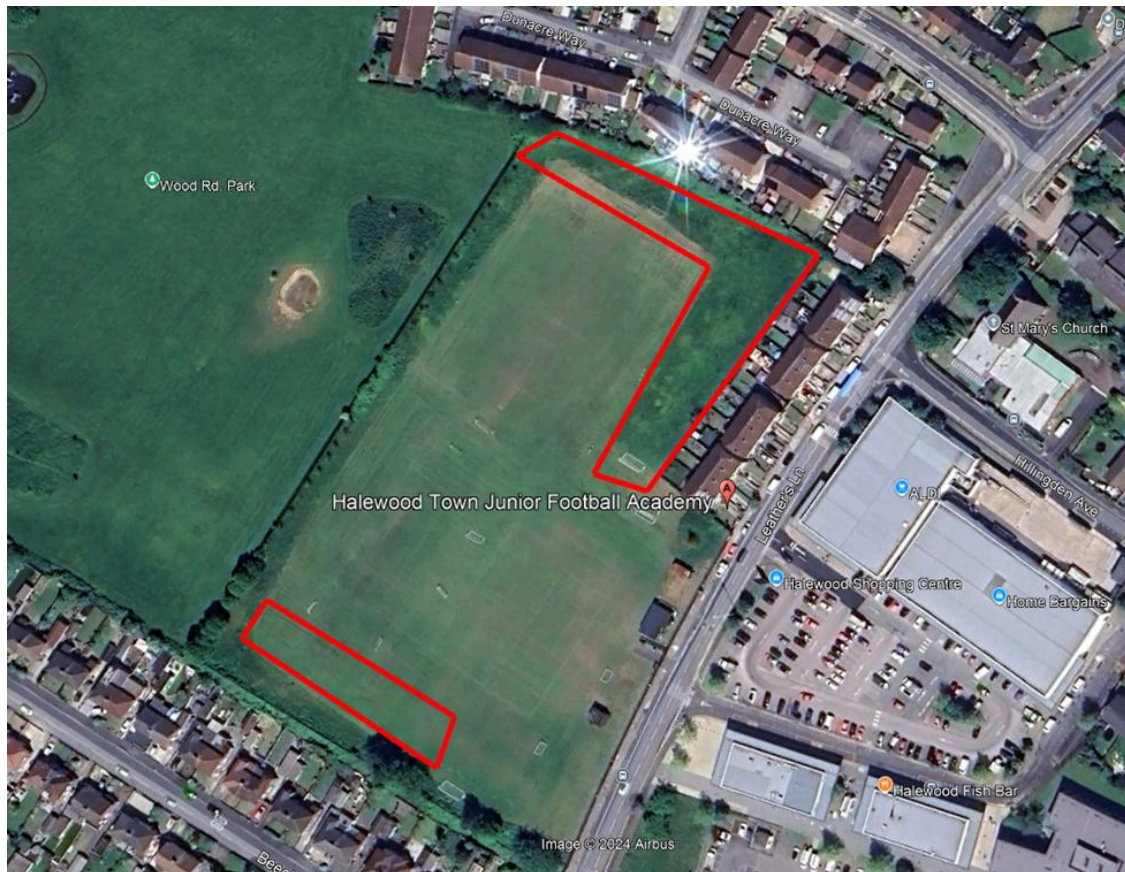
At the time of the visit various areas appeared to be unused by the club due to poor ground conditions which has led to limited layout options for the club and limited usable space. The areas that are not used due to poor ground conditions can be seen within Figure 2 below demarcated within the red lines.

**Figure 2 – Unusable areas by the club due to poor drainage (approximately 4250 sqm of unusable playing field)**

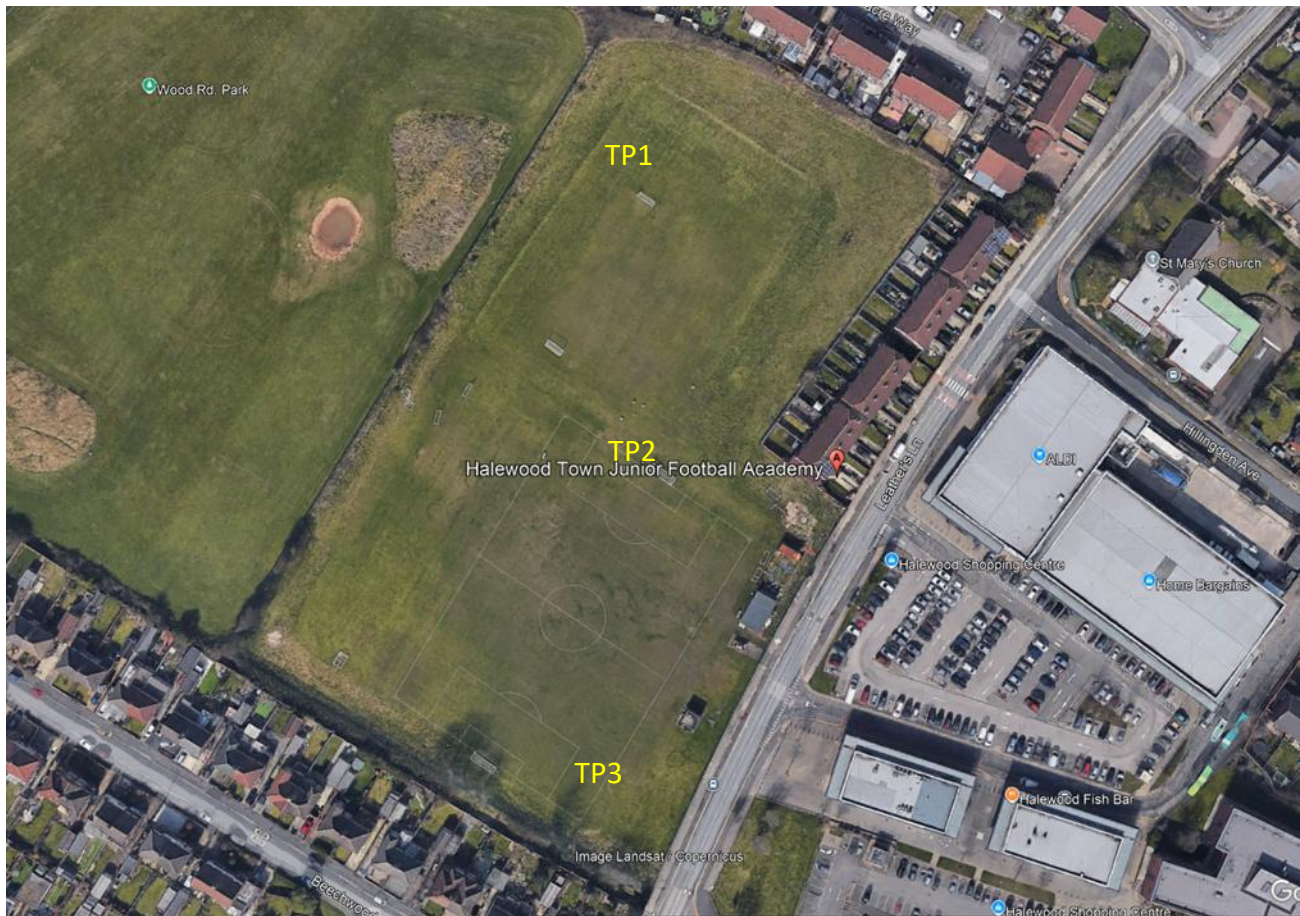
**Figure 3 – Trial hole locations (Grace Park)**

- 2.13 A series of trial pits were excavated by hand at various locations (see Figure 3 below) to confirm the nature of the underlying soil profile. In summary, there was a consistent sandy loam topsoil across all three test pits excavated. The depth of topsoil was measured to be on average 260 mm and grass rooting extended to a maximum of 190 mm with no large stones observed along with no contamination in the form of glass or pottery.

The brown sandy loam topsoil was overlaying a grey clay subgrade.

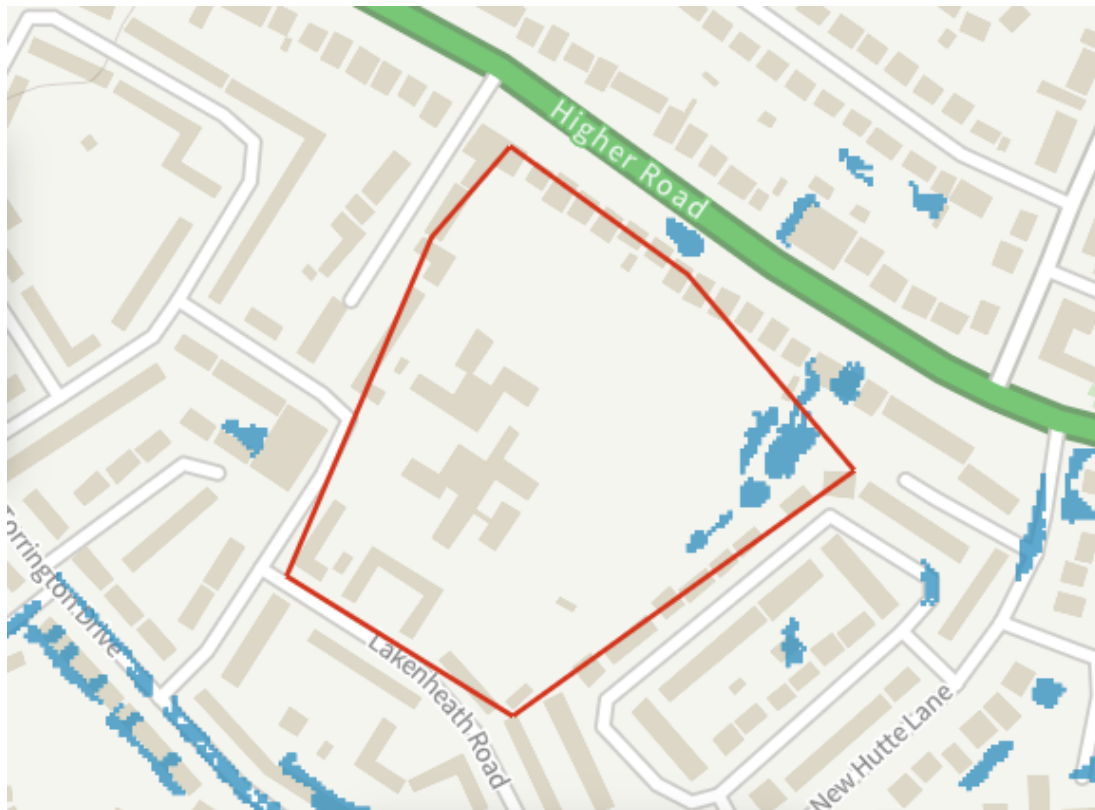
**Figure 7: Surface water flooding within the east of the site**

- 3.18 Ground conditions were very dry at the time however is important to state that the visit was carried out during the summer month of June where rainfall is naturally lower than other times of the year. It has been reported by the client that the ground conditions are soft during the winter months particularly within the eastern area of the playing field area.

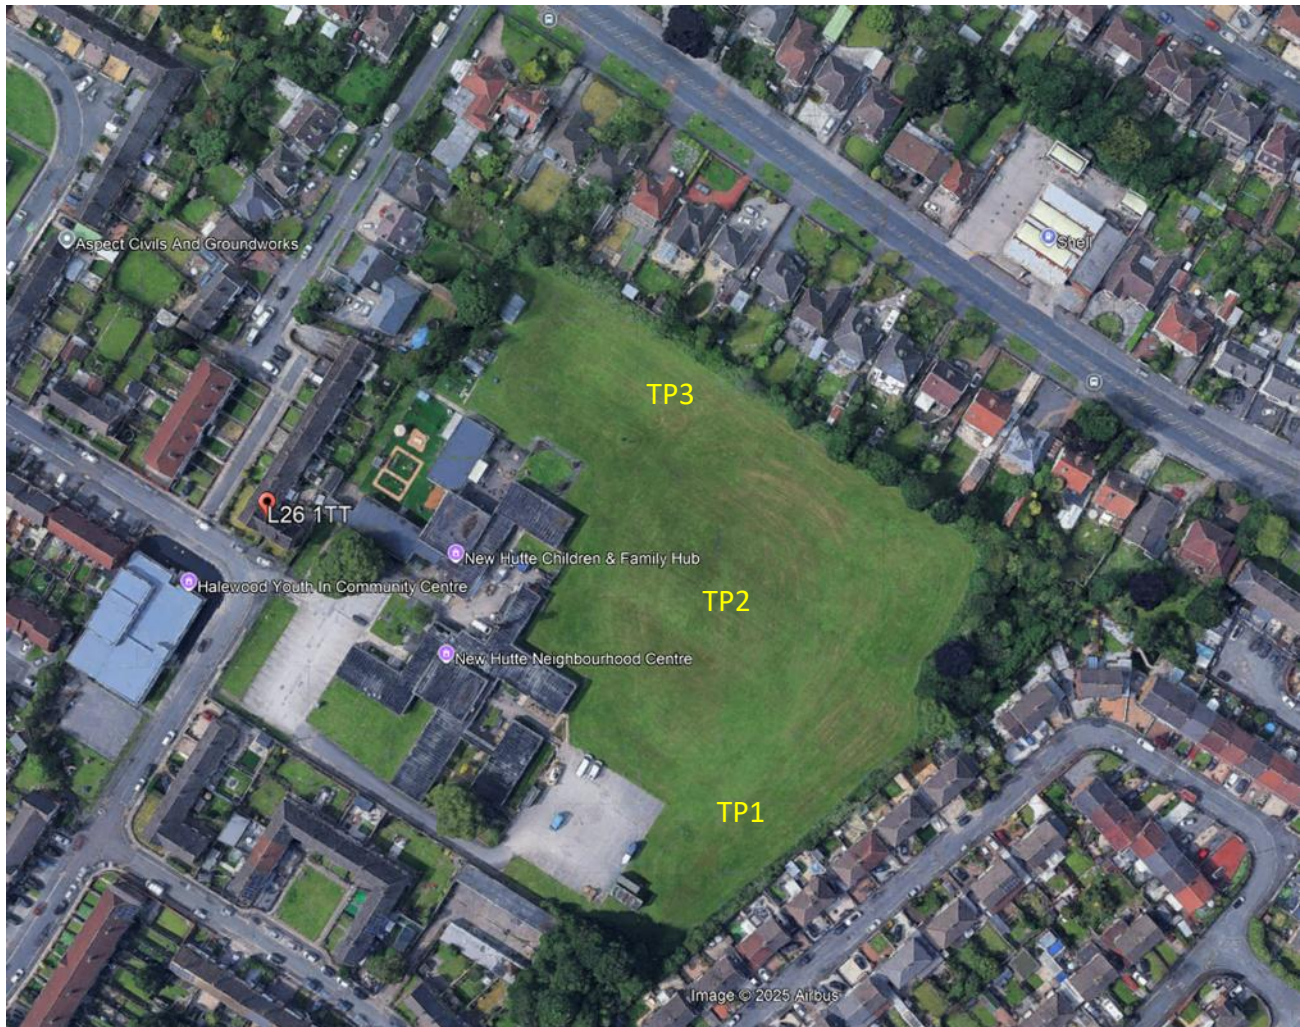
**Figure 8 – Trail Pit Locations**

- 3.19 A series of trial pits were excavated by hand at various locations (see figure 3 below) to confirm the nature of the underlying soil profile. In summary, there was a consistent dark brown sandy loam topsoil across all three test pits excavated. The depth of topsoil was measured to be on average 200 mm and grass rooting extended to a maximum of 90 mm.

The dark brown sandy loam topsoil was overlaying an orange clay subgrade with a clear distinction apparent between the topsoil layer and subsoil layer. No waterlogging was noted in any of the test pits excavated and no contaminants were noted in the form of pottery or glass.

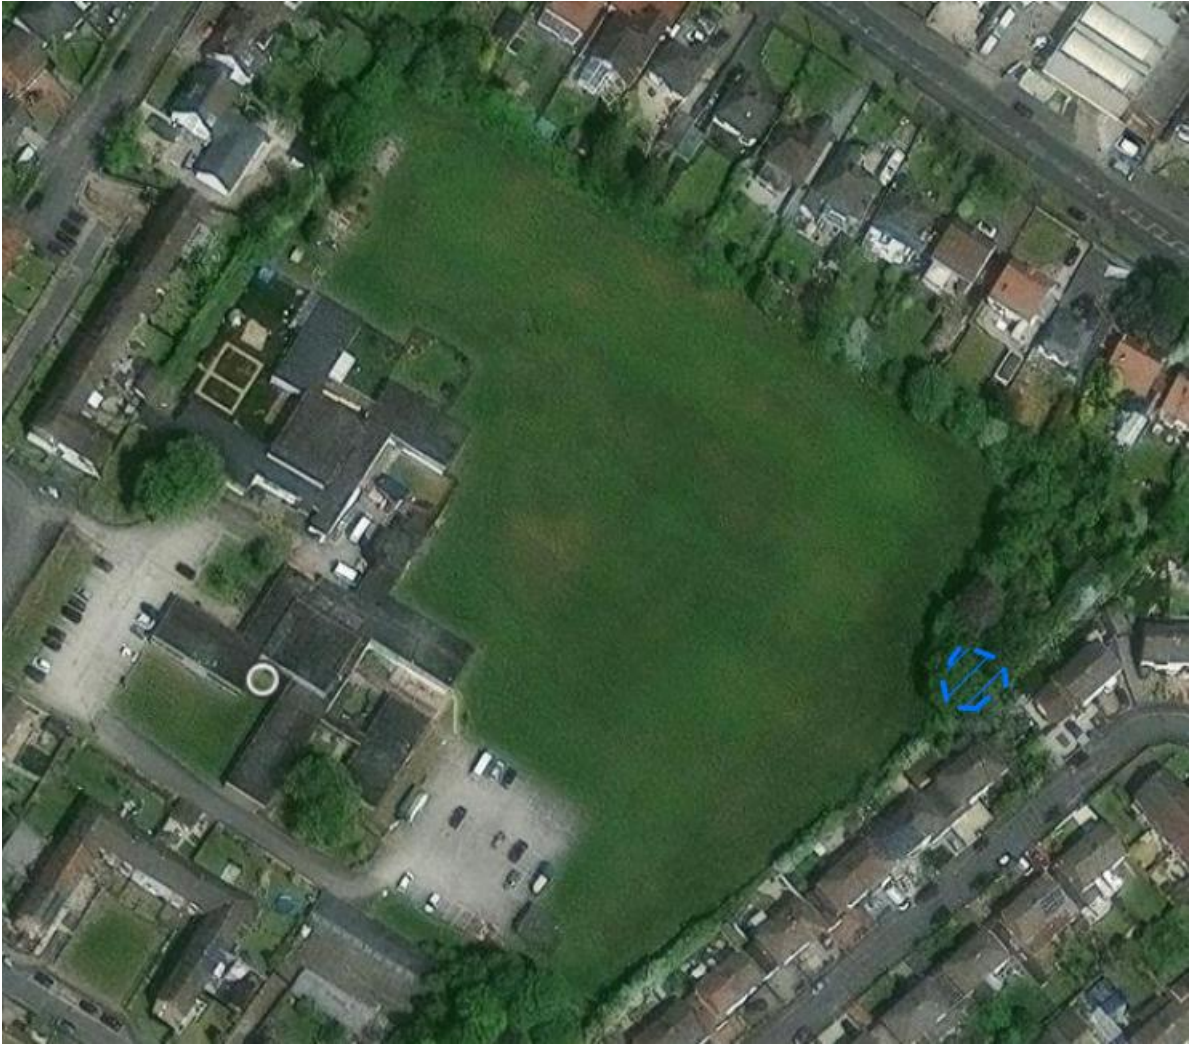
| Potential drainage outfall locations: | <p>As discussed within the table in Section 2.9, a pond was identified when looking at the BGS map viewer within the east of the site. This pond was not identified on site due to restrictions on access through fencing and overgrown vegetation. This area would need to be cleared to observe the depth of the pond and to understand its capacity for holding any water from any proposed pitch drainage system.</p> <p>A 'French drain' was also located in the southern corner of the playing field area however it would need to be understood if any pipe work is located underneath the MOT aggregate material.</p> <p>Manholes were discovered however not opened at the time of site visit and are thought to be connected/related to the building within the south/west of the site. This wider scheme could also be used as a connection point however the relevant permissions would have to be sought before any connection can be made.</p> |

***Figure 9 – Indicative location of the ponded area demarcated in blue***

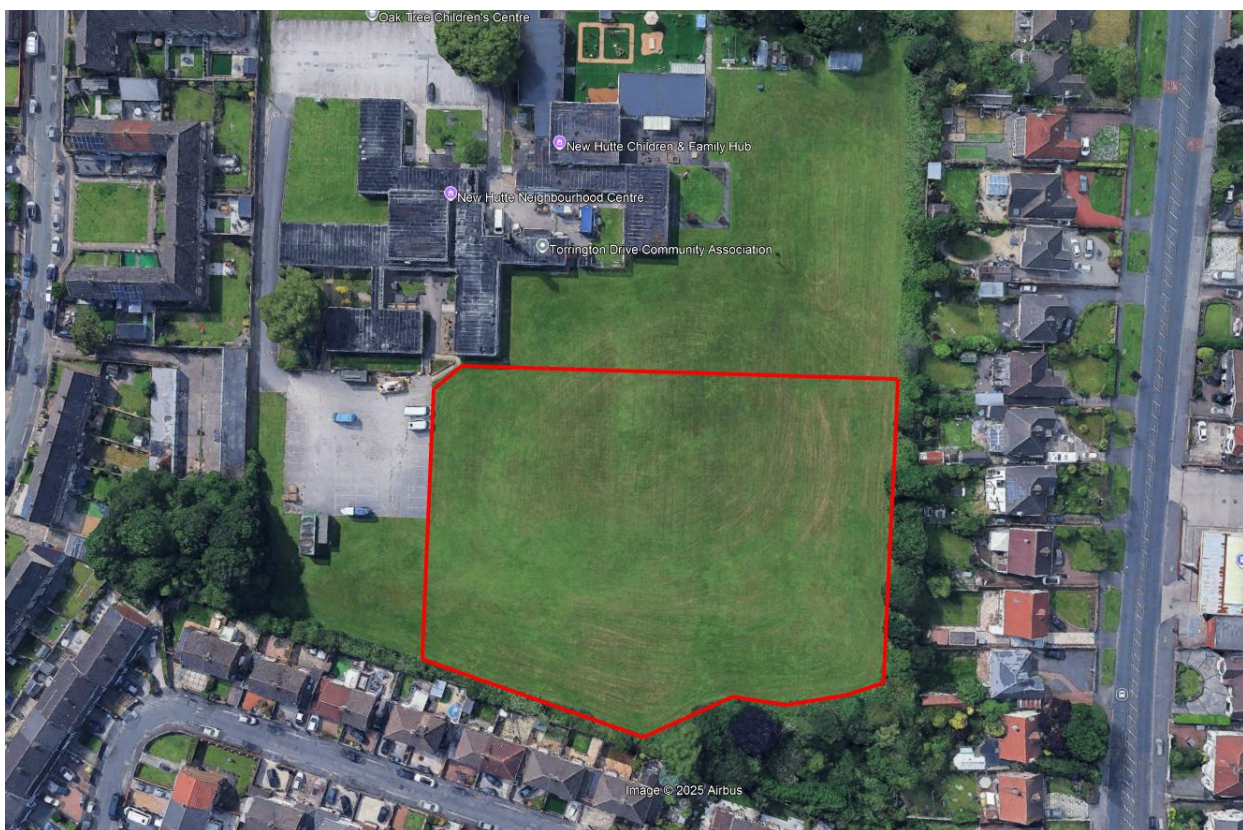
**Figure 11 – Priority area to be drained**

- Before any works are to be carried out, the extent of the existing drainage infrastructure and potential outfall options would need to be determined.. It would be recommended that a primary drainage system is to installed in particular the area demarcated by the red line in figure 4 below. . This is because this is where the pitches will be marked out and is also historically the wettest part of the playing field area. A play park is also to be potentially developed within the area marked blue of the proposed layout seen within appendix 1 of this report. The area of playing field area located directly adjacent to the south of the car park could be extended.

- A secondary drainage system may have to be implemented further down the line dependent on any increased usage levels however this can be done outside of any original scope of works.
- Any works access can be gained via Lichfield Road however it would need to be agreed with the council and the neighbourhood centre that the car park located to the back of the building would not be used by the public and closed for plant equipment and materials storage.
- It would be anticipated that the works would take approximately 1-2 weeks to complete dependent on suitable ground and weather conditions with the playing field recommended to be unused for approximately 8-10 weeks prior to completion of the works to allow appropriate seed establishment along the drain line areas.
