10<sup>th</sup> November 2019

Re: Initial Structural Appraisal of Outbuildings for Renovation to Residential Unit

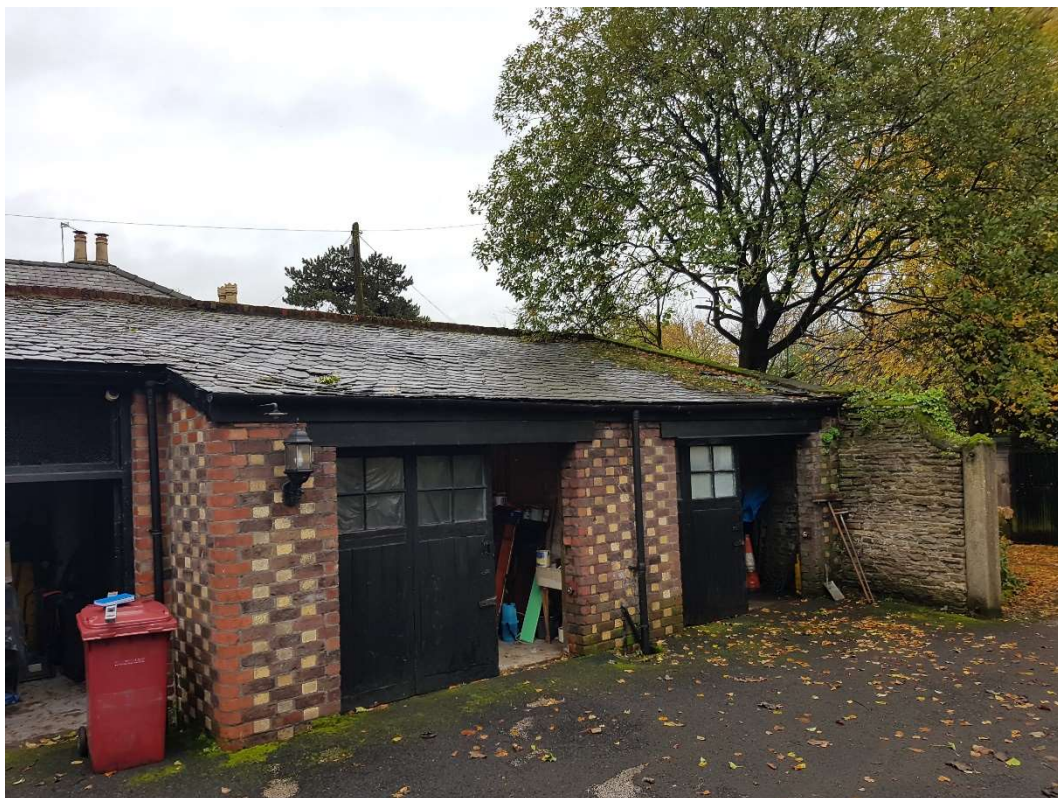
Fig 1.

The out building is a detached garage in brick with a large stone gable wall construction adjacent to the property. See Fig 1-2.

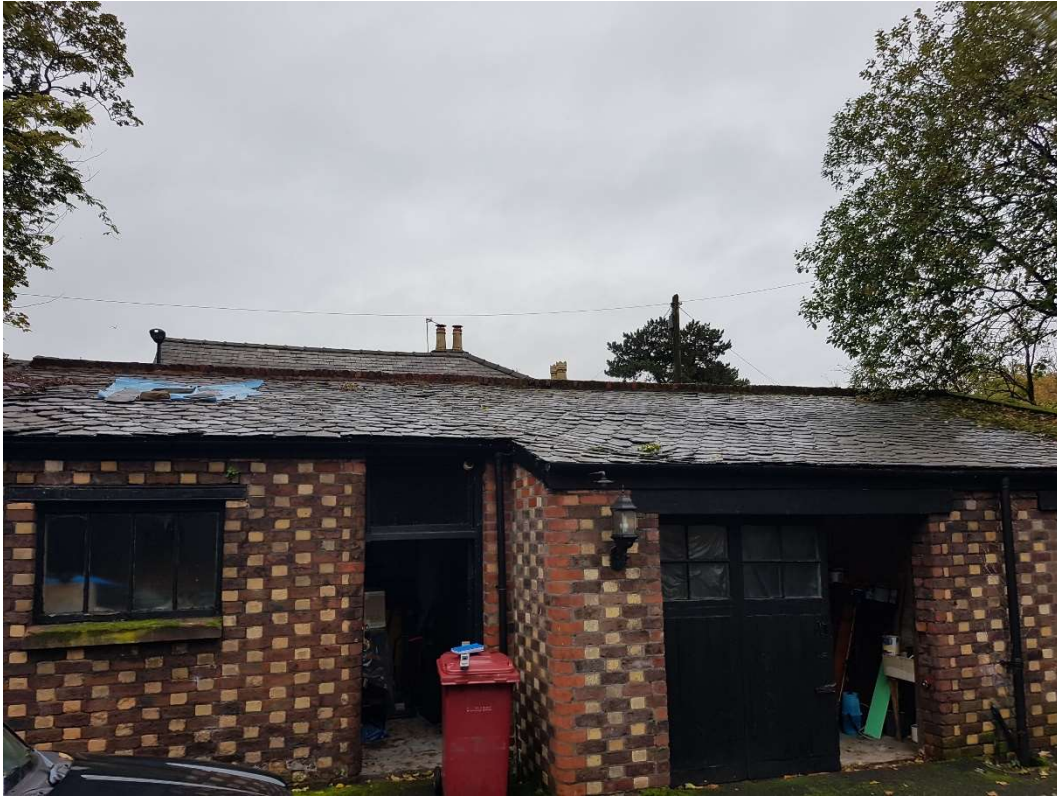
Fig 3.

The main roof is traditional mono pitch in slate pitching into property courtyard, and large areas of roof finishes are missing causing water ingress and severe wet rot to the timber rafters more noticeably at the lower yard eaves. See Fig 3

The current condition does pose risks to safe entry and future deterioration is likely meaning action to remove and reinstate or reprofile roof for proposal are urgently required. The purlins have been replaced with steel beams which are supported from the internal masonry partitions and are in good condition.

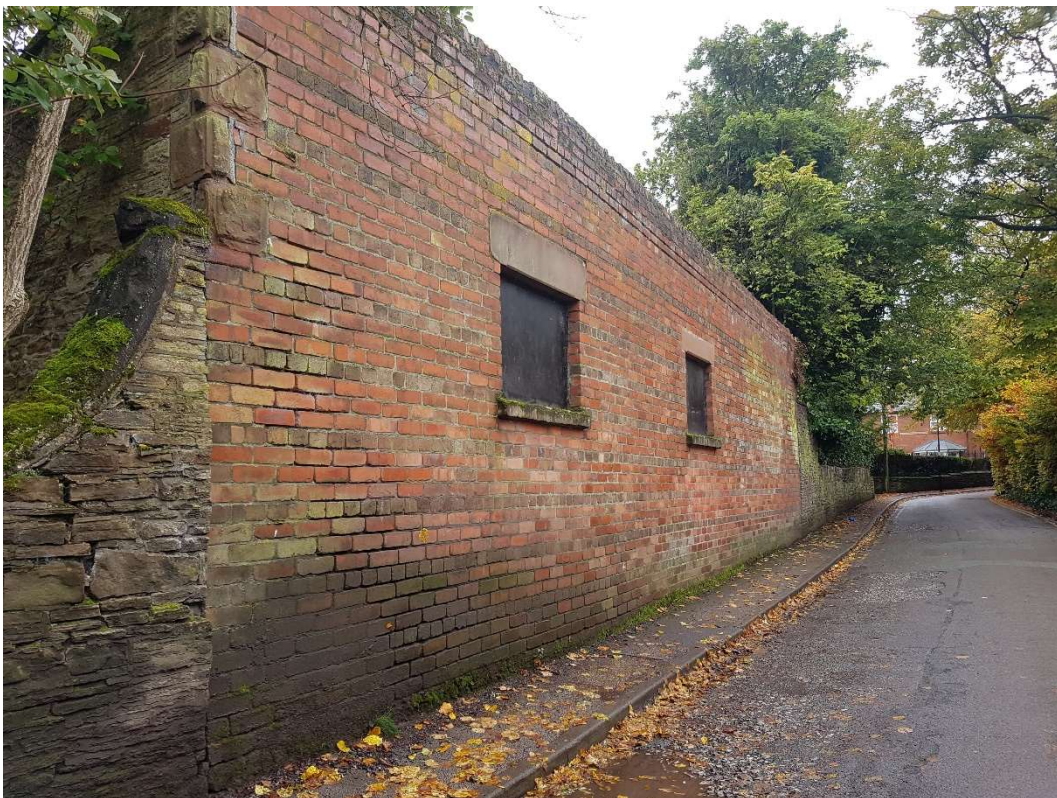
Fig 4.

The condition of the masonry is generally fair to the courtyard elevations, the boundary wall to the highway appears to have been raised previously and has some areas of mortar loss and weathering at high level and also at the lower region adjacent to the entrance. No significant signs of movement or defects are evident at this time other than the displacement between adjacent boundary wall and garage structure. See fig 4-5

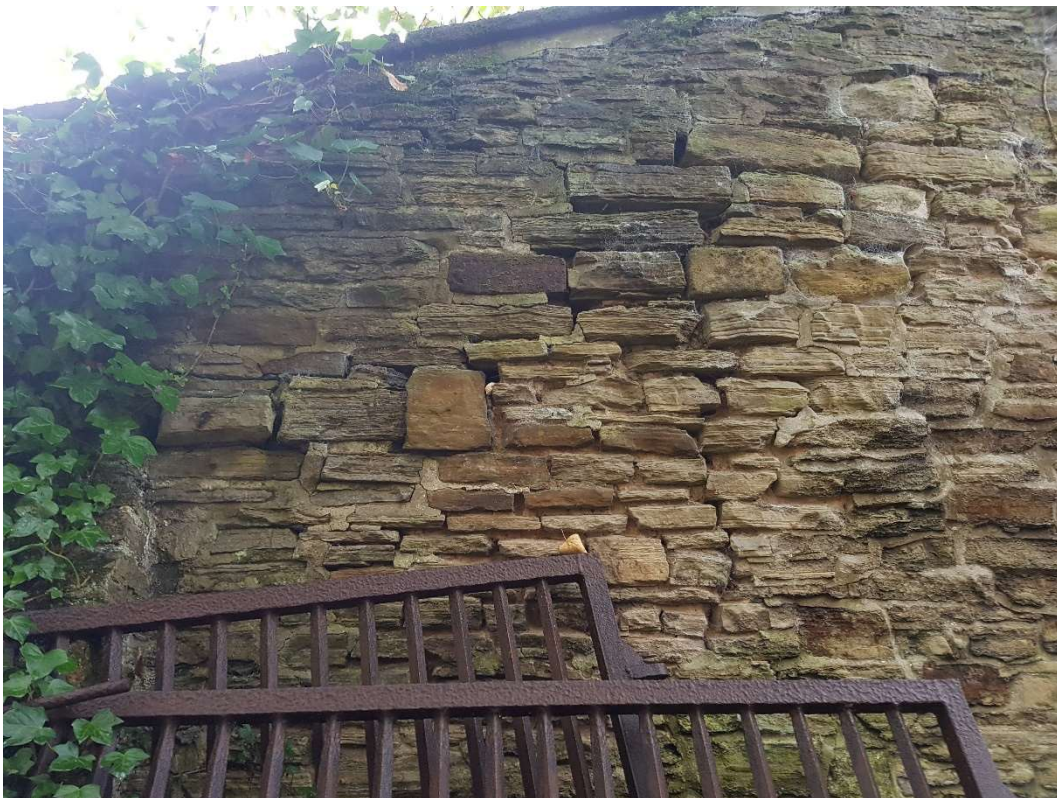
Fig 6.

The Gable wall adjacent to the entrance is however of different construction and whilst lined internally in brickwork has a considerable yorkstone construction with two buttress arrangements. This wall has a significant vertical crack between the buttresses and also lateral across the buttress nearer the tree and boundary wall. A large mature Elder is located within 0.5m of the wall and it appears that root growth has caused some significant movement to the masonry. See fig 6-7. This tree is also immediately behind the boundary wall and the root growth has caused outward movement and cracking to this wall.

The condition of the two walls is poor and as part of any renovation we feel that simply repairing and or rebuilding the walls in materials salvaged from deconstruction will not be suitable. We therefore suggest that authority be requested to remove this tree and root growth prior to carrying out the works on the boundary wall and gable walls.

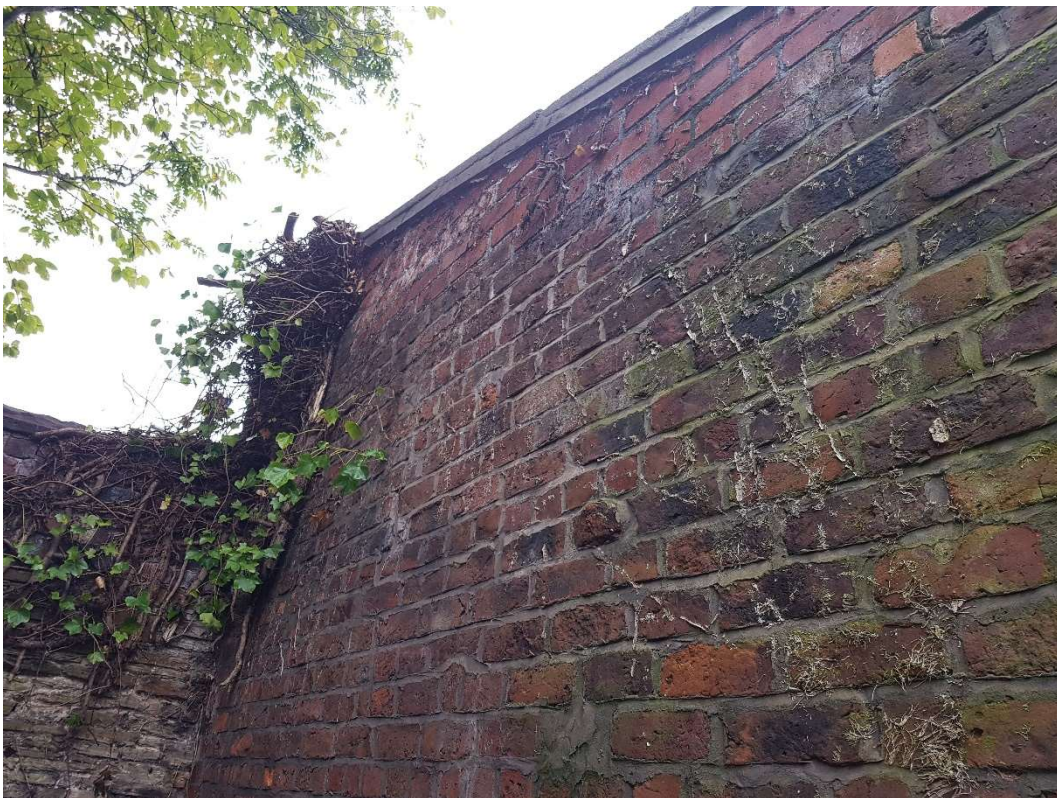
Fig 8.

The opposing gable wall is of traditional 9" brickwork and has had some outward movement and had mortar repairs, however any new renovation would include recommendations for additional restraint strapping at new floor height and making good of defective mortar joints. See fig 8.

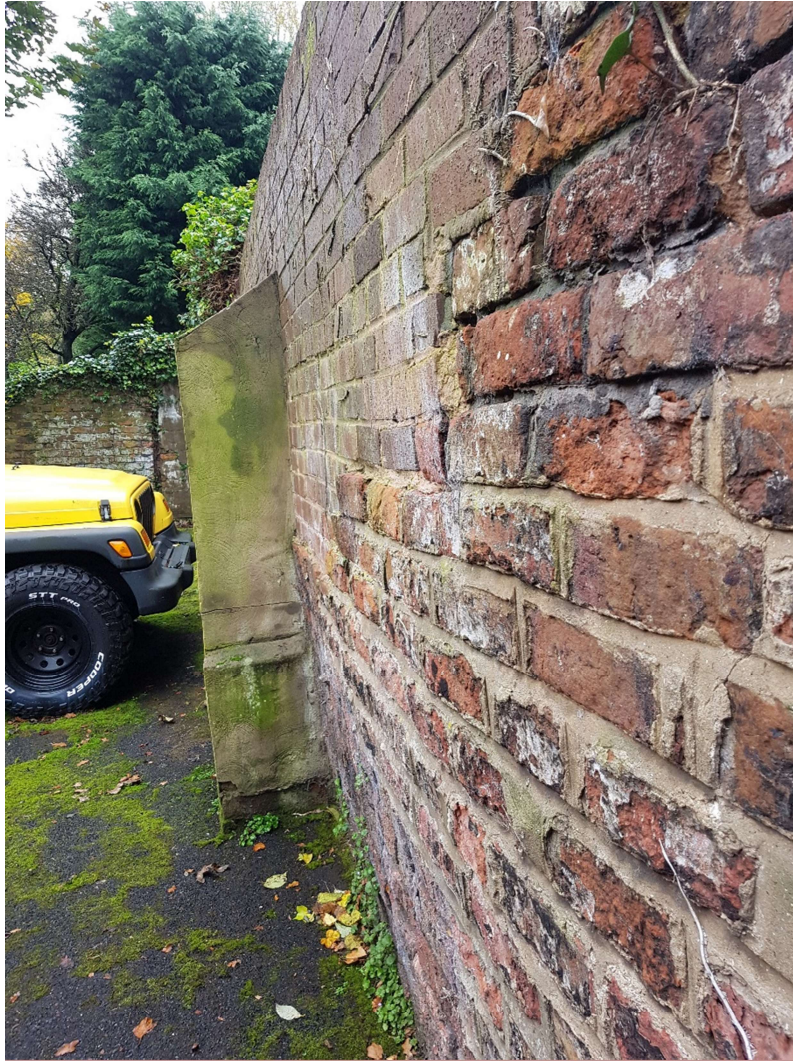
Fig 9.

The boundary wall to the adjacent property has an inward lean evident which has been identified and new piers built to strengthen the wall and resistance to further movement, see fig 9. We suggest therefore that any new proposal gives suitable clearance to the new masonry and foundations allowing a suitable pathway for potential drainage or service runs etc.
