## JUBILEE PARK, LIVERPOOL

## ARBORICULTURAL IMPACT ASSESSMENT (AIA)

**Revision A – July 2024**

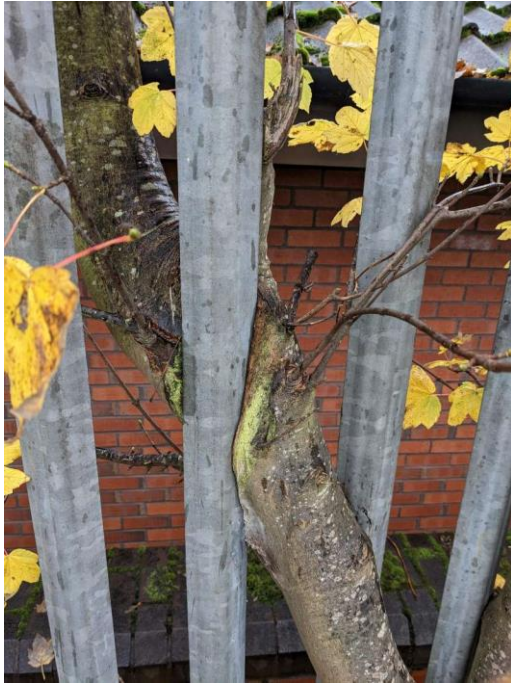
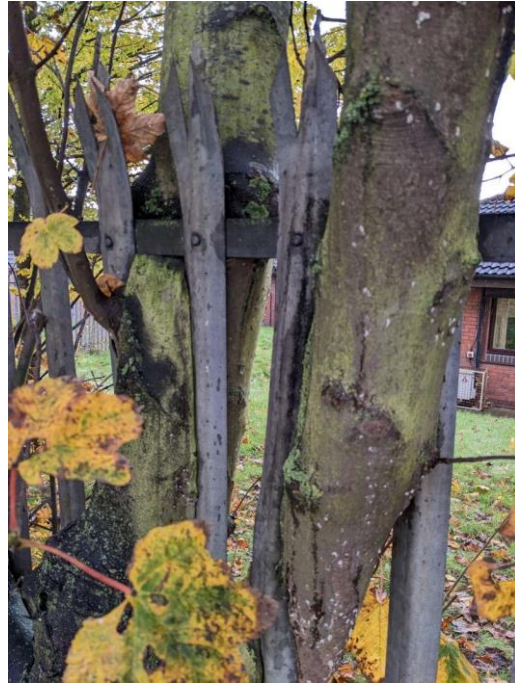
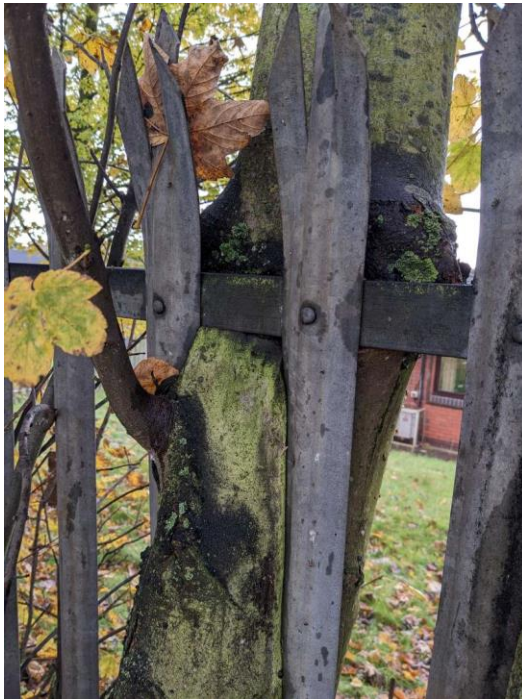
| G28 | Sycamore | Acer pseudoplatanus | 7 | 3 | - | 100 | N | C2 | Young | 10-20 | 2no. Previously pruned to base. Palasade fence girdling. |
| G30 | Sycamore | Acer pseudoplatanus | 8 | | 0.5 - 2 | 200 | | C2 | Early-Mature | 10-20 | 4no. Major palasade fence girdling. |

*Girdling with palisade fence present on G28 & G30.*

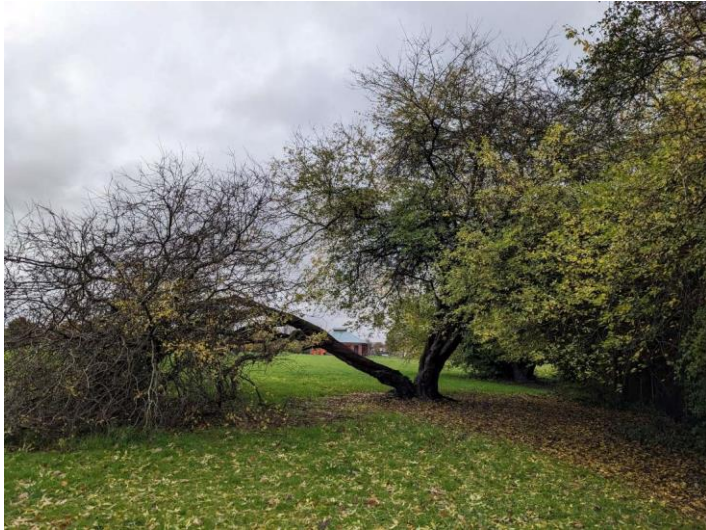
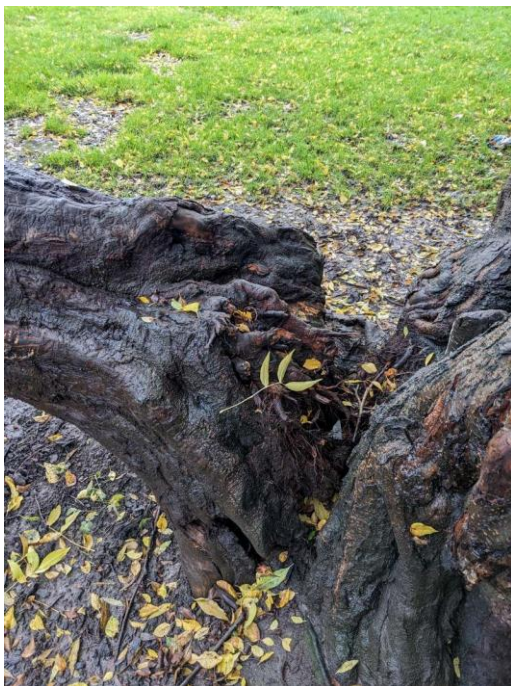
| NO | TREE SPECIES | TREE SPECIES | HEIGHT | SPREAD | Clear | DIA | N | CAT. | Life | Life | NOTES |
|---|---|---|---|---|---|---|---|---|---|---|---|
| T17 | Plum | Prunus domestica | 7 | | - | 690 | N | U | Mature | 0-10 | Multistem. Previous pruning work. Large 350 dia fallen limb from base (still attached). Cracked at base. Fused limbs. Multiple wounds and decay @ 1m. |

*Large limb fallen from T17. Cracked at base.*

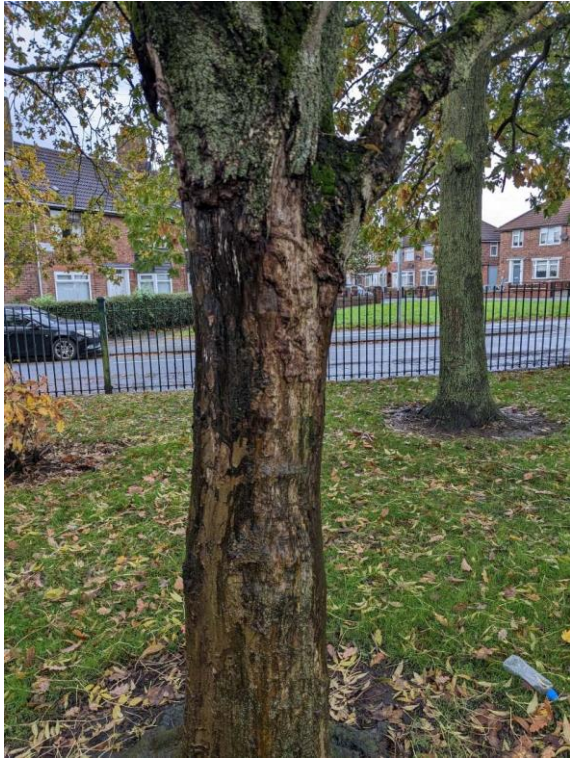
| NO | TREE SPECIES | TREE SPECIES | HEIGHT | SPREAD | Clear | DIA | N | CAT. | Life | Life | NOTES |
|---|---|---|---|---|---|---|---|---|---|---|---|
| T12 | Field Maple | Acer campestre | 12 | | 2 | 350 | | B2 | Mature | 40+ | Major bark stripped |

*Major bark stripping to 1.5m on T12.*

- T2, T3, T4, T5, T6 and T7 form the park boundary planting, but clash with the proposed car park access.
- T12 clashes with the car parking area.
