## **Tree Hazard Assessment**

Roby Park Site Number: 194  
Roby Road  
Liverpool  
L36 4HQ

| <b>Location:</b> Roby Park, Roby Road,<br>Liverpool, L36 4HQ. | <b>Arborcare Ref:</b> 7962 |
| <b>Survey Inspector:</b> Brian Cole | <b>Date of Inspection:</b><br>04/12/2022 |

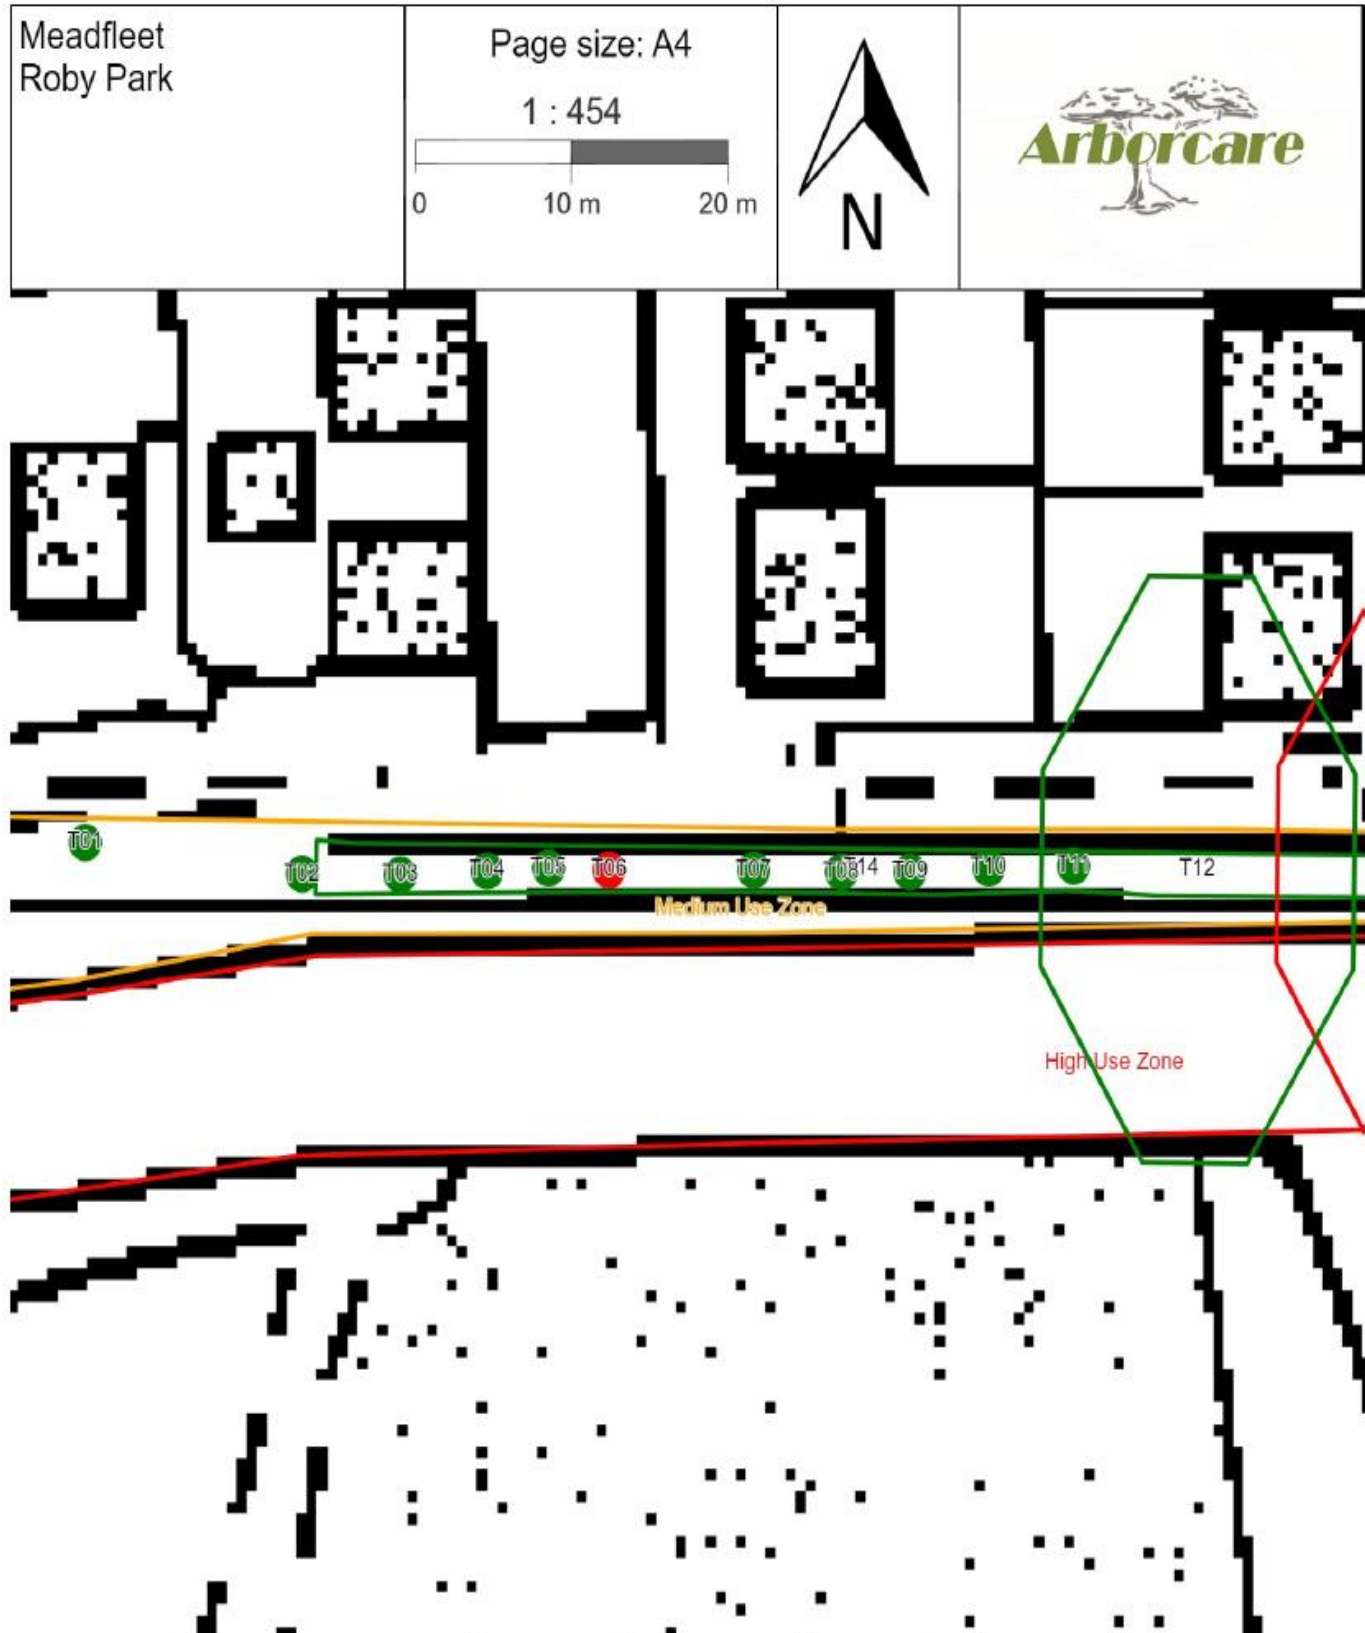
OS Map 2: T01 – T12

| Ref. | Tag | Species | Variety | Target | Age | Height (m) | Structural Condition | Vitality | Life Expectancy | Observations & Defect Assessment | Recommendations | Priority | Photo |
|---|---|---|---|---|---|---|---|---|---|---|---|---|---|
| T06 | No tag | Wild Cherry<br>( <i>Prunus avium</i> ) | | Footpath<br>Highway | Early Mature | 10 to 15 | Poor | Poor | 0-3 | Tree is in decline. | Fell tree. | 1 | |

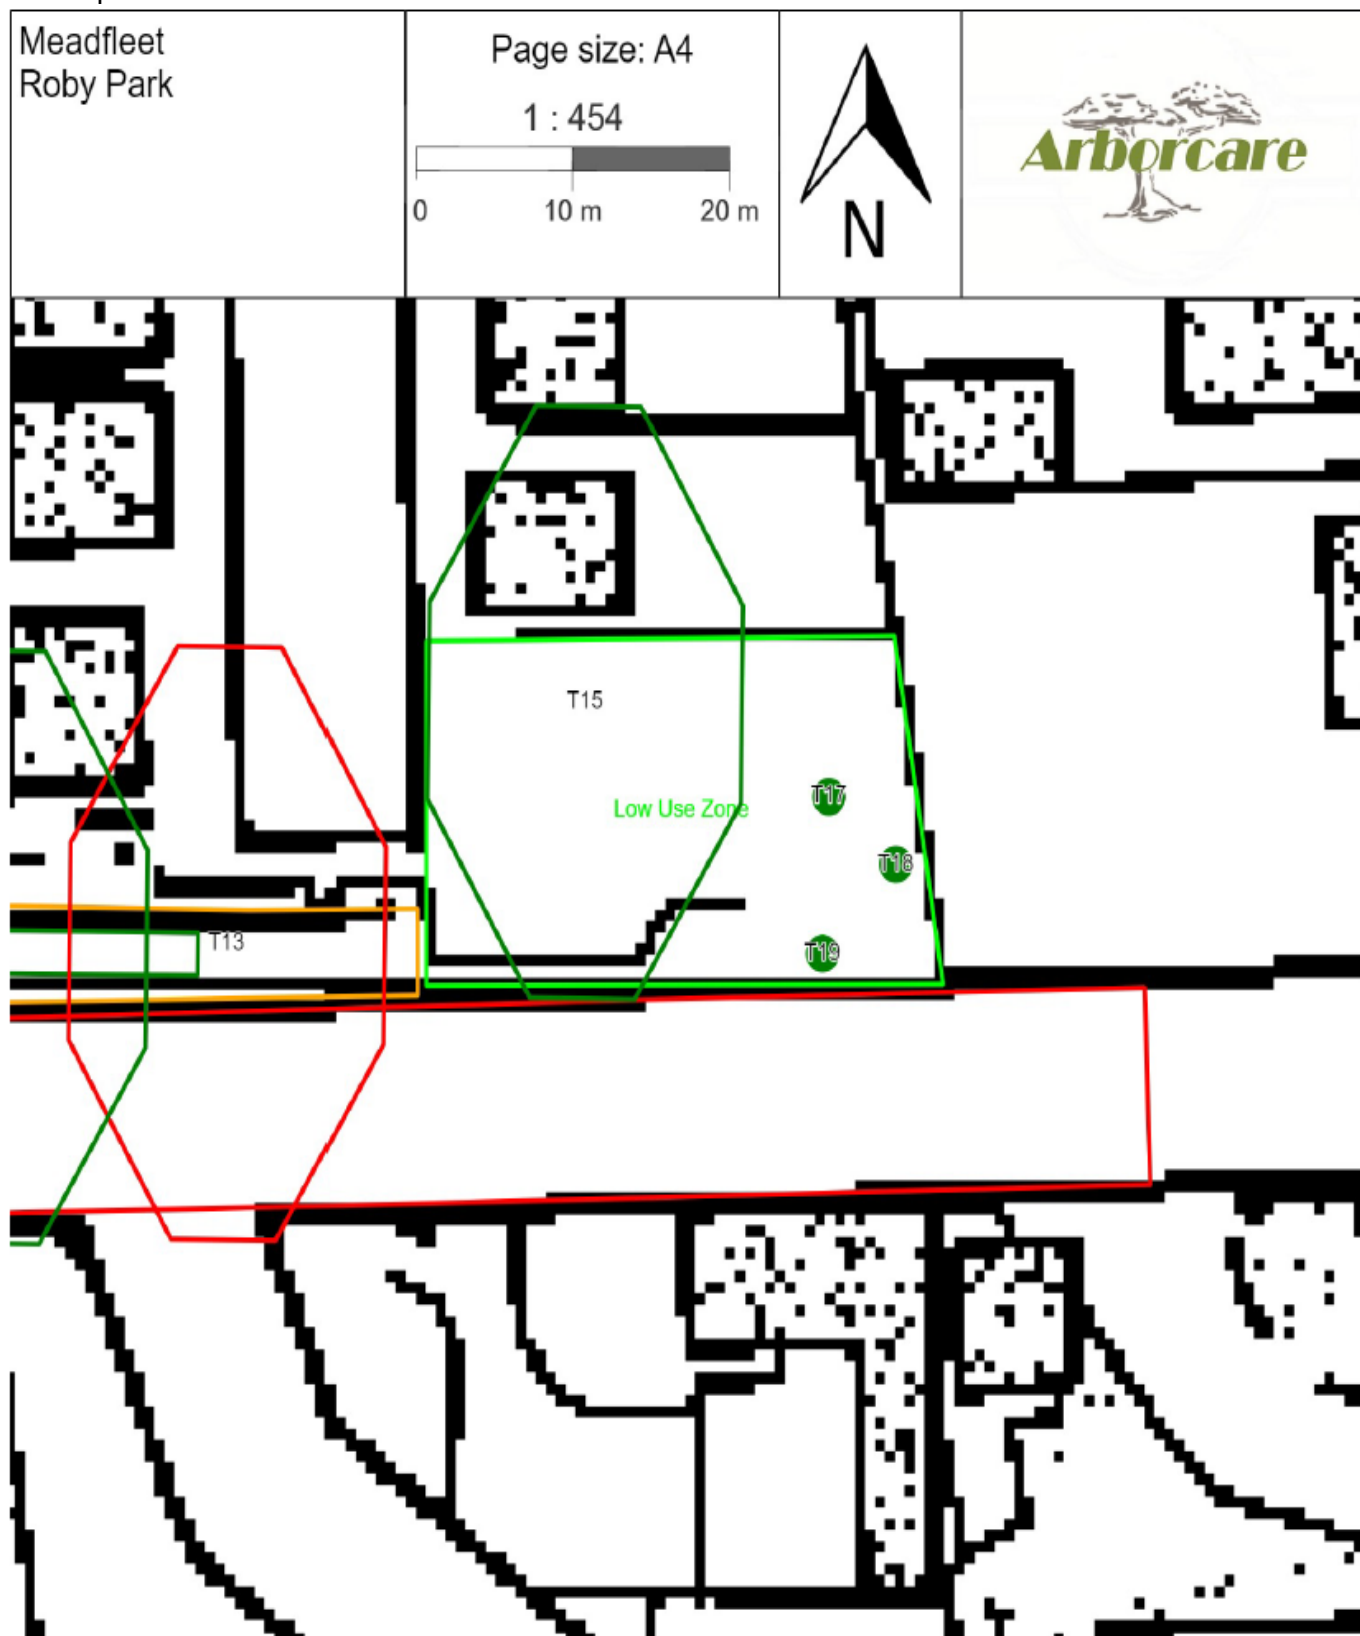
OS Map 3: T13 – T19

| Ref. | Tag | Species | Variety | Target | Age | Height (m) | Structural Condition | Vitality | Life Expectancy | Observations & Defect Assessment | Recommendations | Priority | Photo |
|---|---|---|---|---|---|---|---|---|---|---|---|---|---|
| T13 | No Tag | Norway Maple<br>'Group of 5.'<br>( <i>Acer platanoides</i> ) | Group of 5. | Footpath<br>Highway | Early Mature | 10 to 15 | Poor | Poor | 50+ | 2 x Sycamore in group with dieback.<br>* Load Factors<br>Wind Exposure: Partial.<br>Crown Size: Medium.<br>Crown Density: Normal.<br>Interior Branches: Normal.<br>* Trunk<br>Codominant stems.<br>Included bark. | Fell the 2 x Sycamore. | 1 | |

| Ref. | Tag | Species | Variety | Target | Age | Height (m) | Structural Condition | Vitality | Life Expectancy | Observations & Defect Assessment | Recommendations | Priority | Photo |
|---|---|---|---|---|---|---|---|---|---|---|---|---|---|
| T19 | No tag | Sycamore<br>( <i>Acer pseudoplatanus</i> ) | | Fence<br>Footpath<br>Highway<br>Overhead wires | Early Mature | 10 to 15 | Good | Normal | 50+ | <ul style="list-style-type: none"> <li>* Load Factors</li> <li>Wind Exposure: Partial.</li> <li>Crown Size: Medium.</li> <li>Crown Density: Normal.</li> <li>Interior Branches: Normal.</li> <li>* Trunk</li> <li>Codominant stems.</li> <li>Included bark.</li> <li>Heavy ivy clad.</li> <li>* Crown and Branches</li> <li>Deadwood within crown, not over a target area.</li> </ul> | Sever ivy at base. | 3 | |
