# **Molyneux House 21 High Street Prescot**

**Plastering Schedule For  
Proposed Conversion Of Ground  
Floor Into 2 x Apartments**

**BPS  
DEVELOPMENTS LTD**

**September 2026**

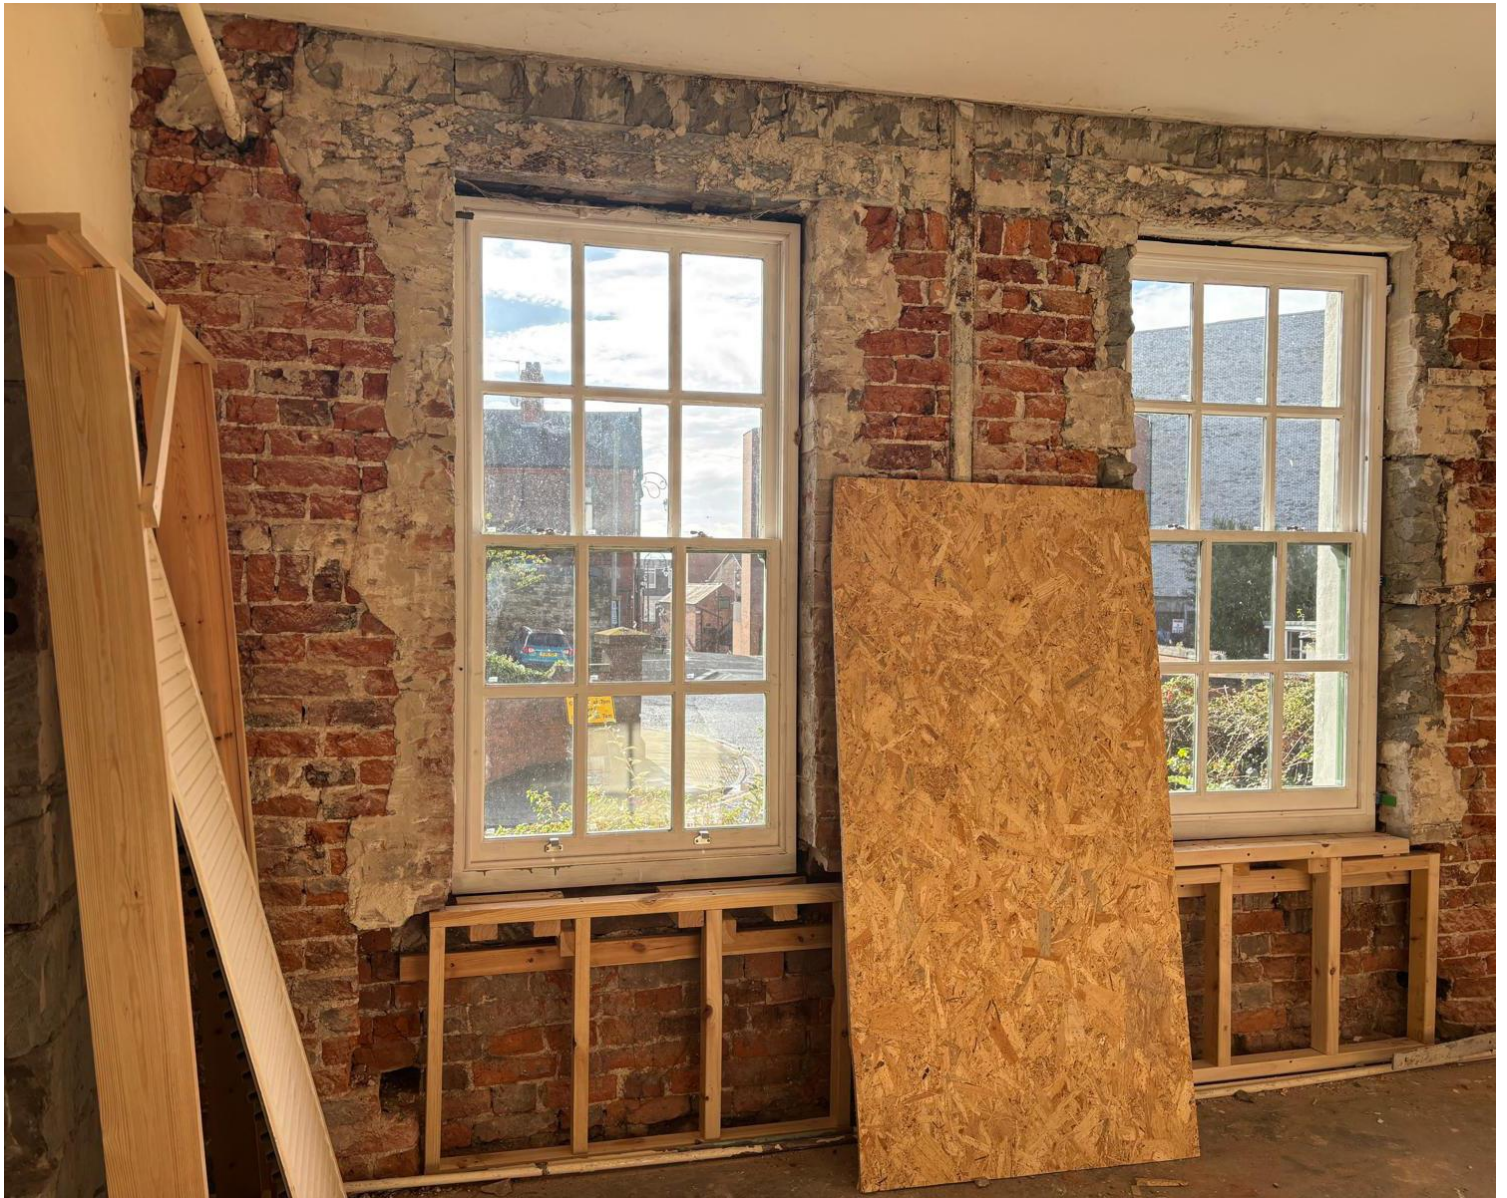
## Living Room/Front Elevation

All sand & cement has been removed from front wall due to extreme mould & to check for dry rot mycelial strands.

Wall is to be refinished in a lime based system comprising lime base coat, lime floating coat & fine lime finish coat.

Studwork beneath frames to be removed & step in wall to be followed with new plasterwork

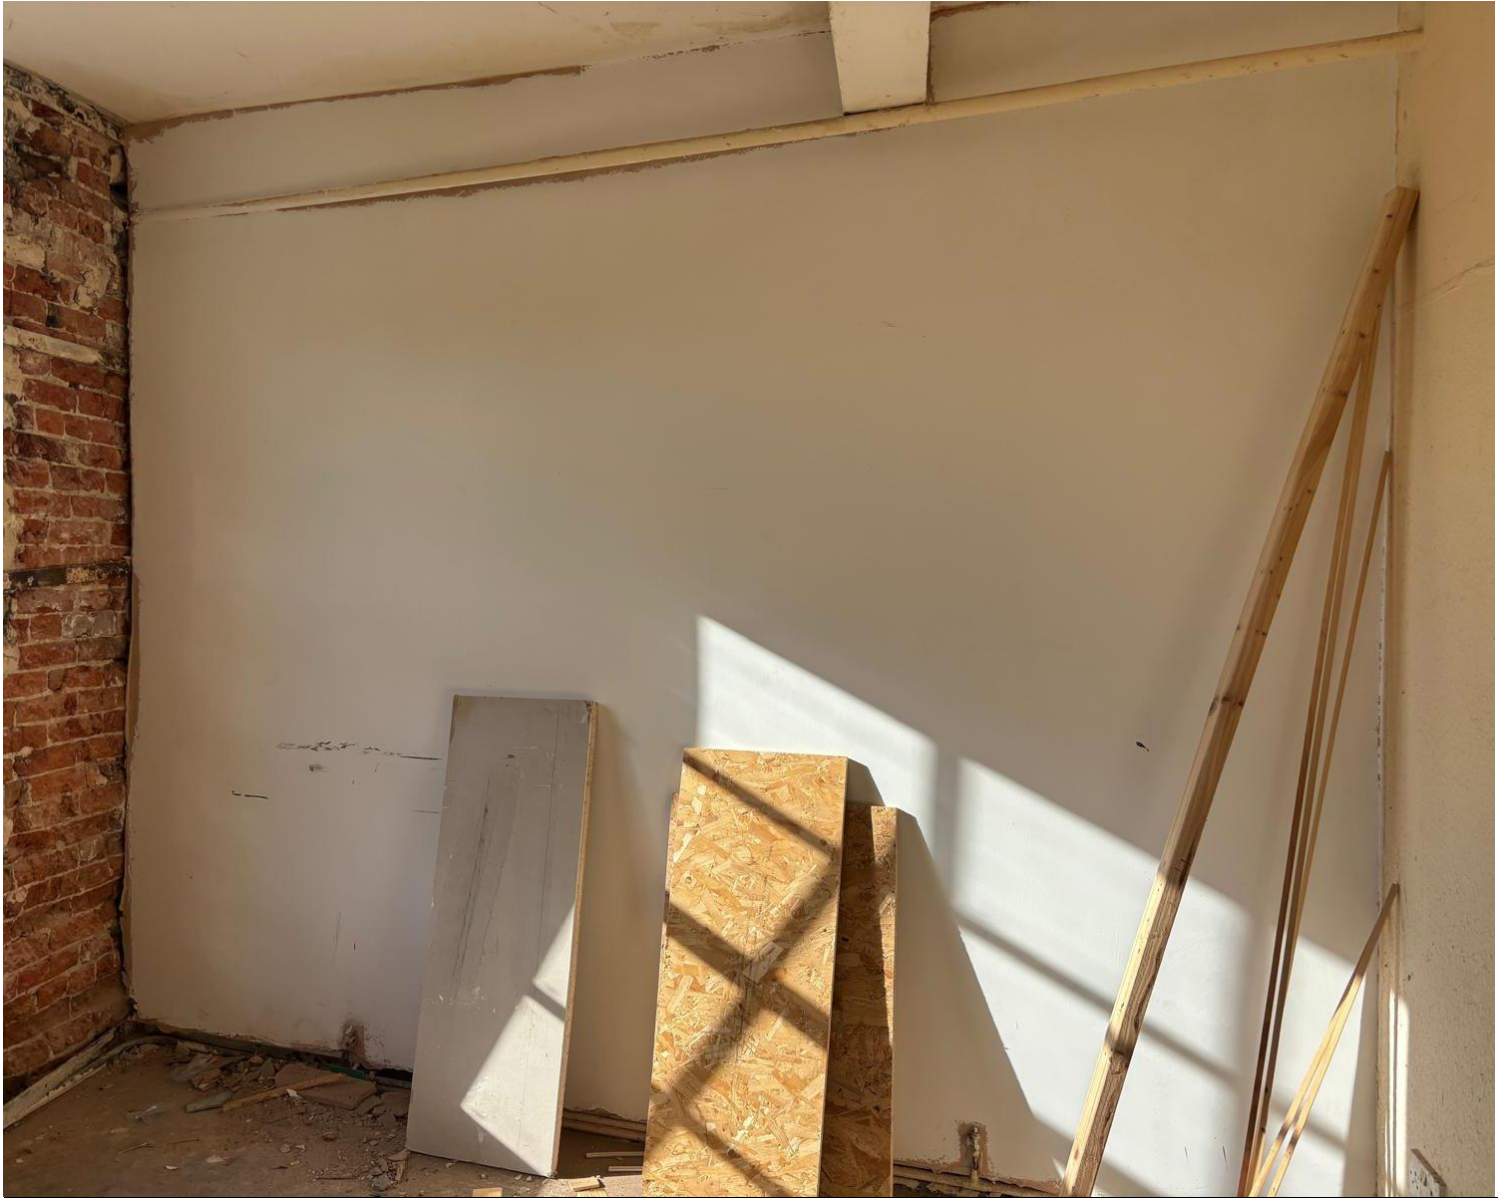
# Plaster To Flat 1 Living Room/Gable

Existing sand & cement wall appears in reasonable condition & is to be retained.

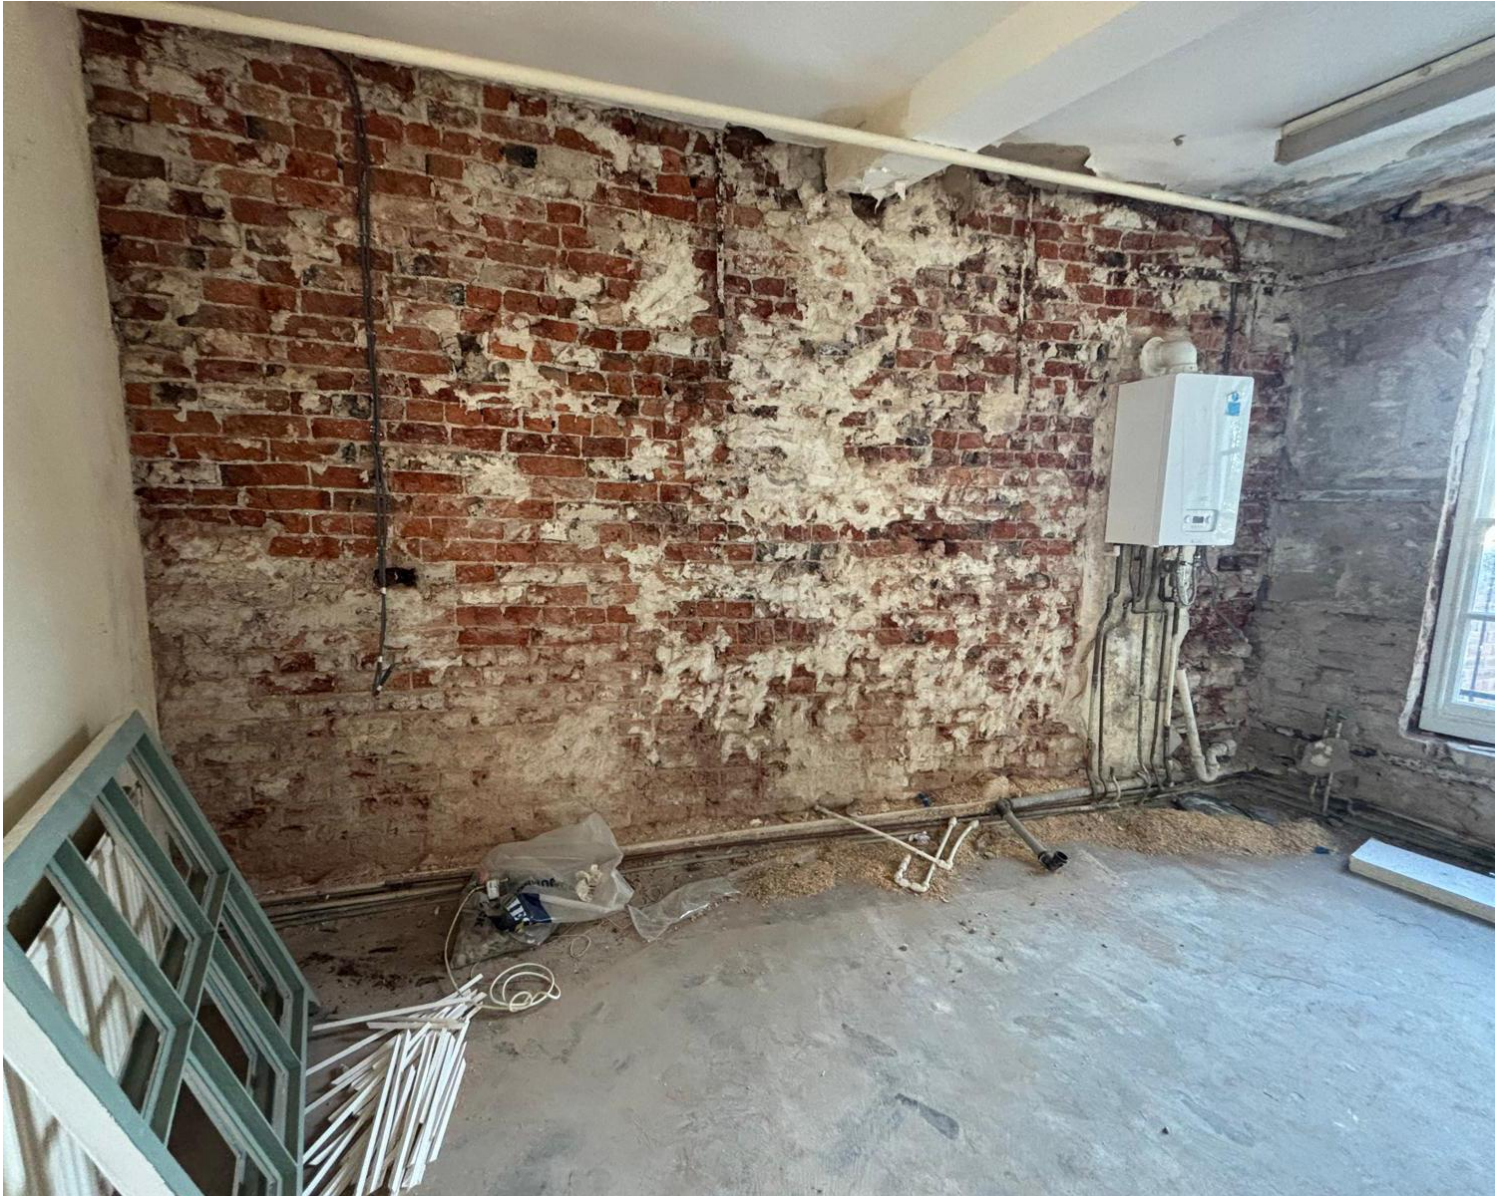
# Plaster To Flat 1 Bedroom/Gable

All sand & cement has been removed from front wall due to extreme mould & to check for dry rot mycelial strands.  
Wall is to be refinished in a lime based system comprising lime base coat, lime floating coat & fine lime finish coat.

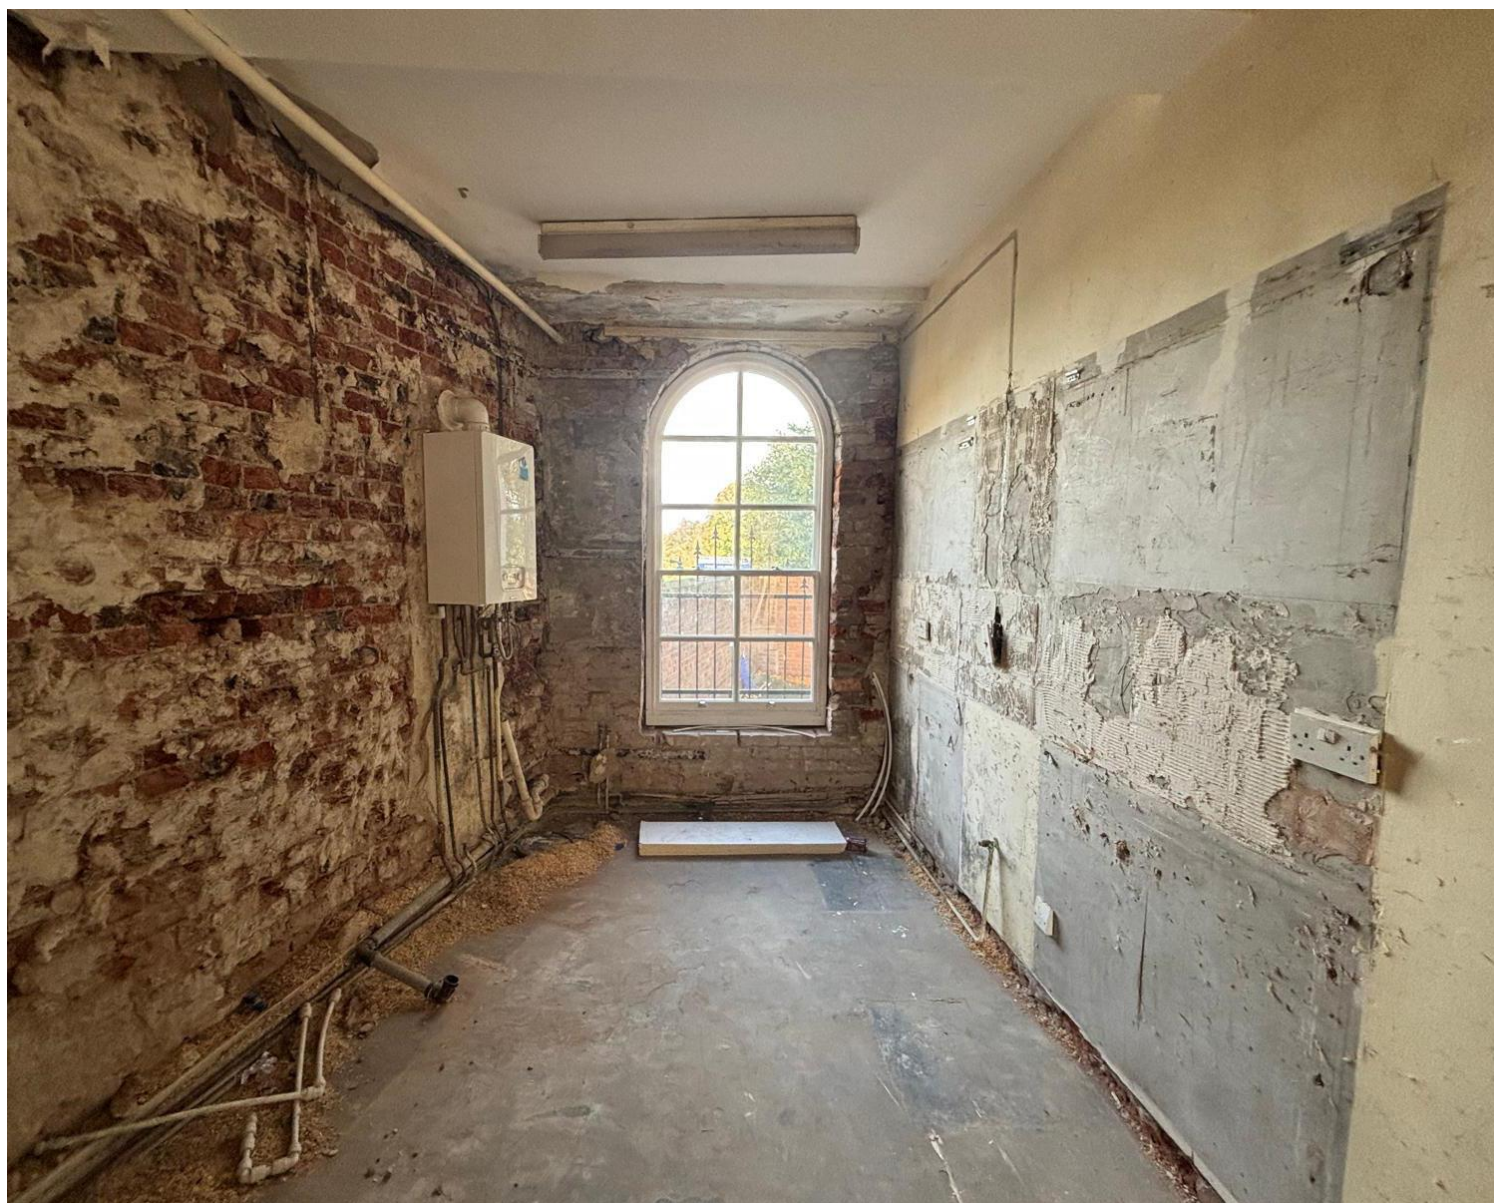
## Plaster To Flat 1 Bedroom Rear Wall

All sand & cement has been removed from front wall due to extreme mould & to check for dry rot mycelial strands.  
Wall is to be refinished in a lime based system comprising lime base coat, lime floating coat & fine lime finish coat.

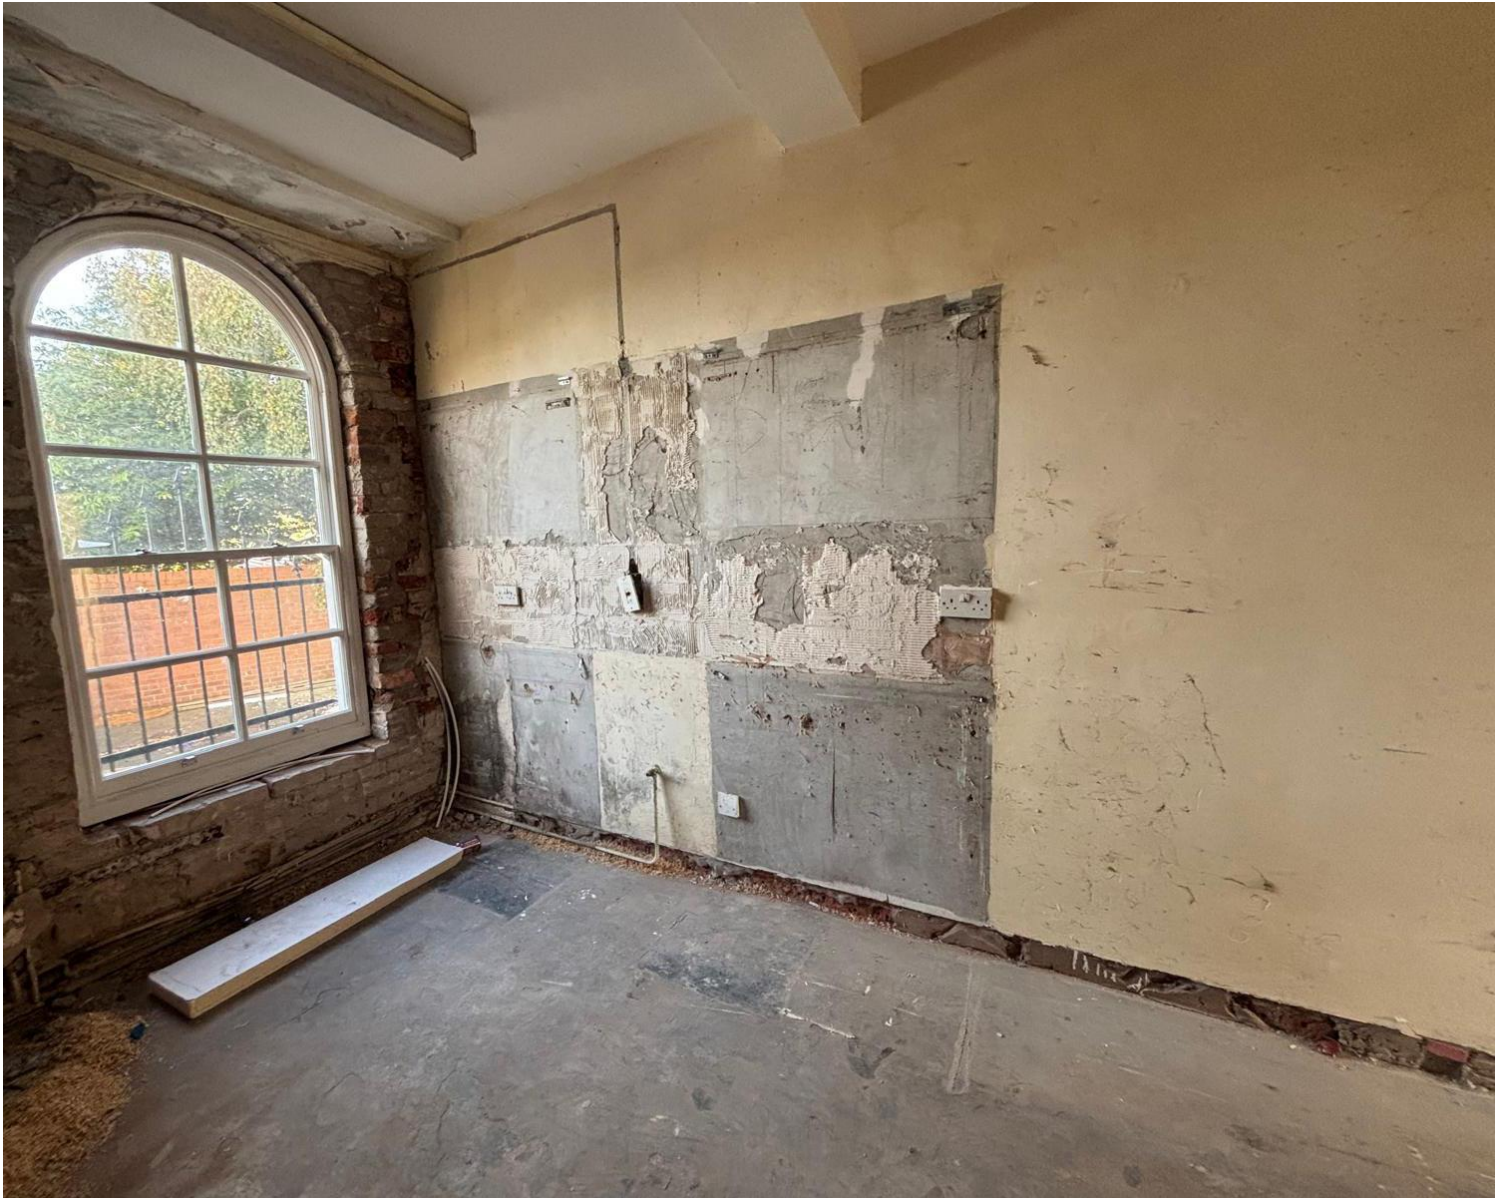
## Plaster To Flat 1 Bedroom/Side Wall

Plasterwork to side wall is in reasonable condition & is to be retained.  
Areas of old tile adhesive is to be scraped back & area to have minimal patch skimming carried out.

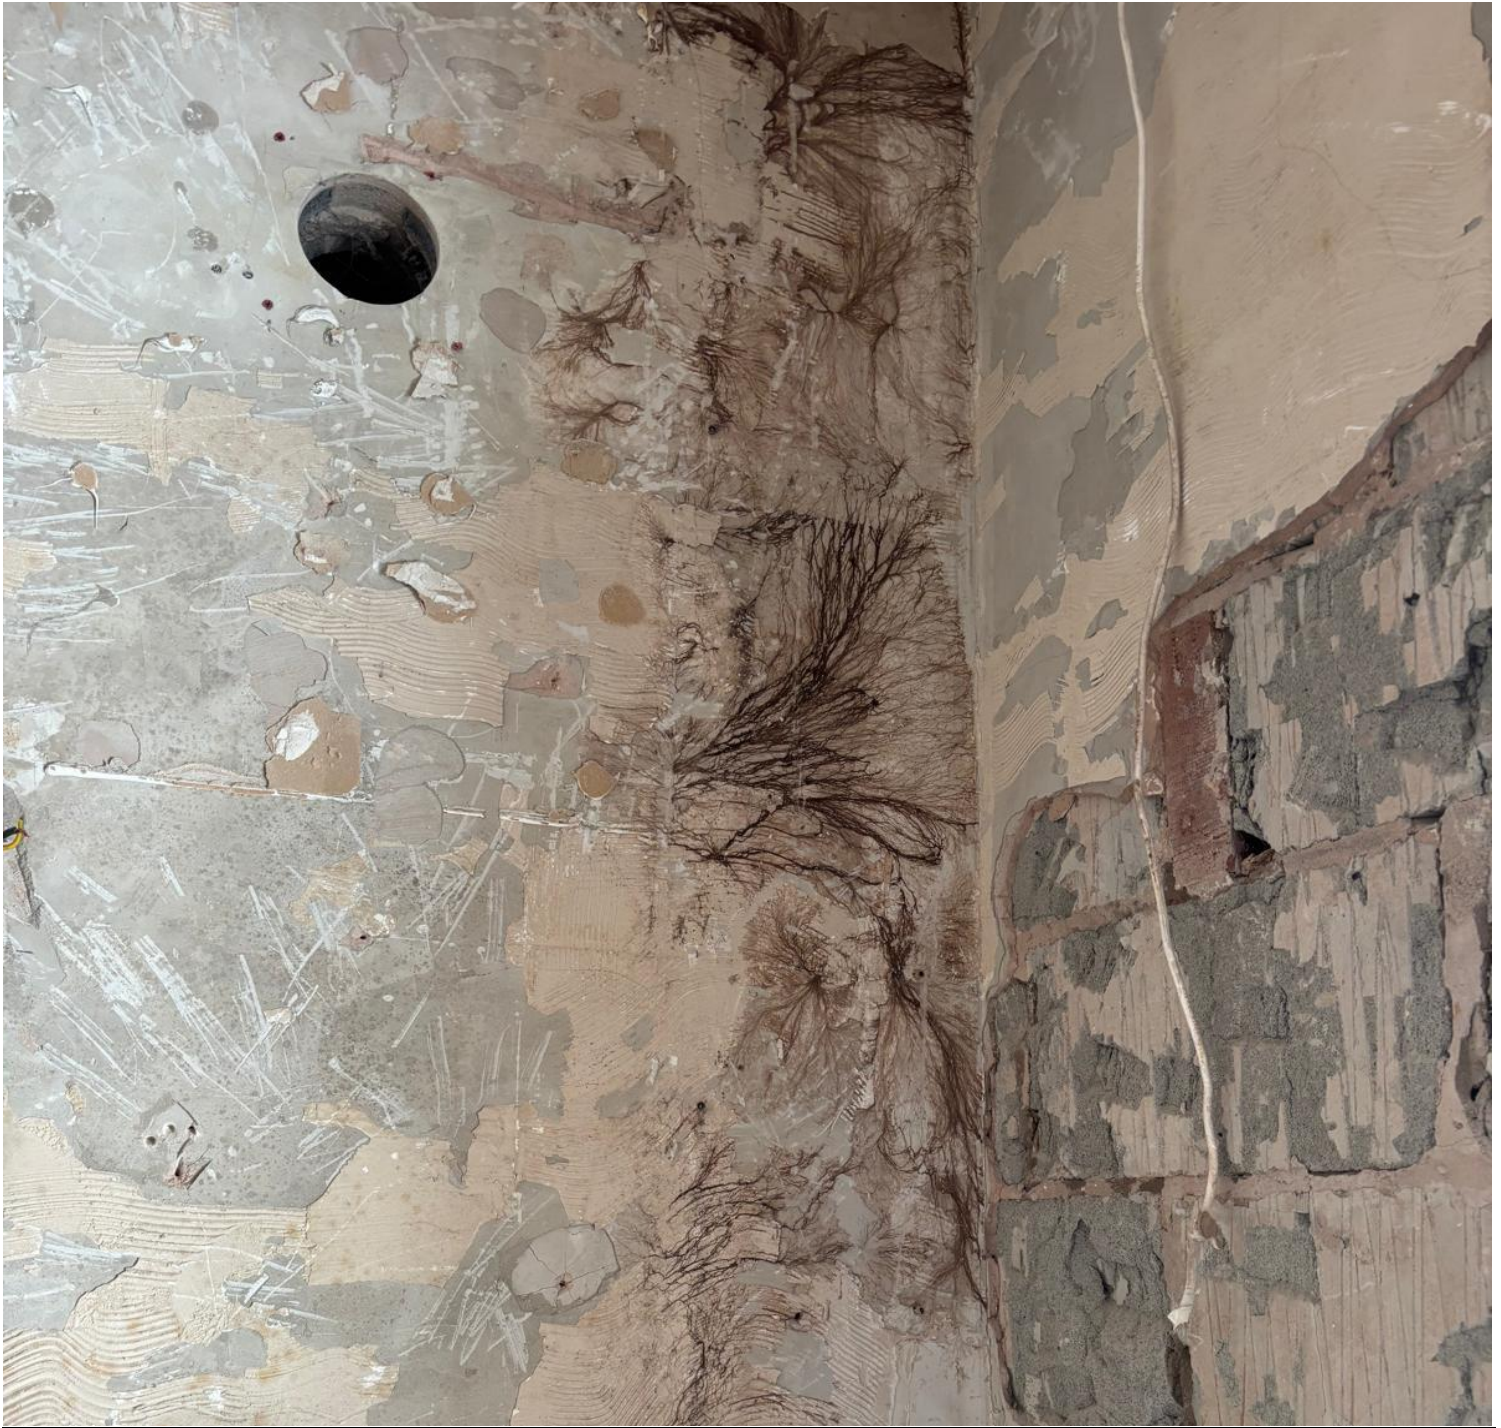
## Plaster To Wall Backing Up Existing Front Door

This image shows block wall that backs up front door that is to be re-opened, highlighting the rot in the area.  
All of the blockwork is to be removed.  
Existing masonry behind is to be refinished in a lime based system.

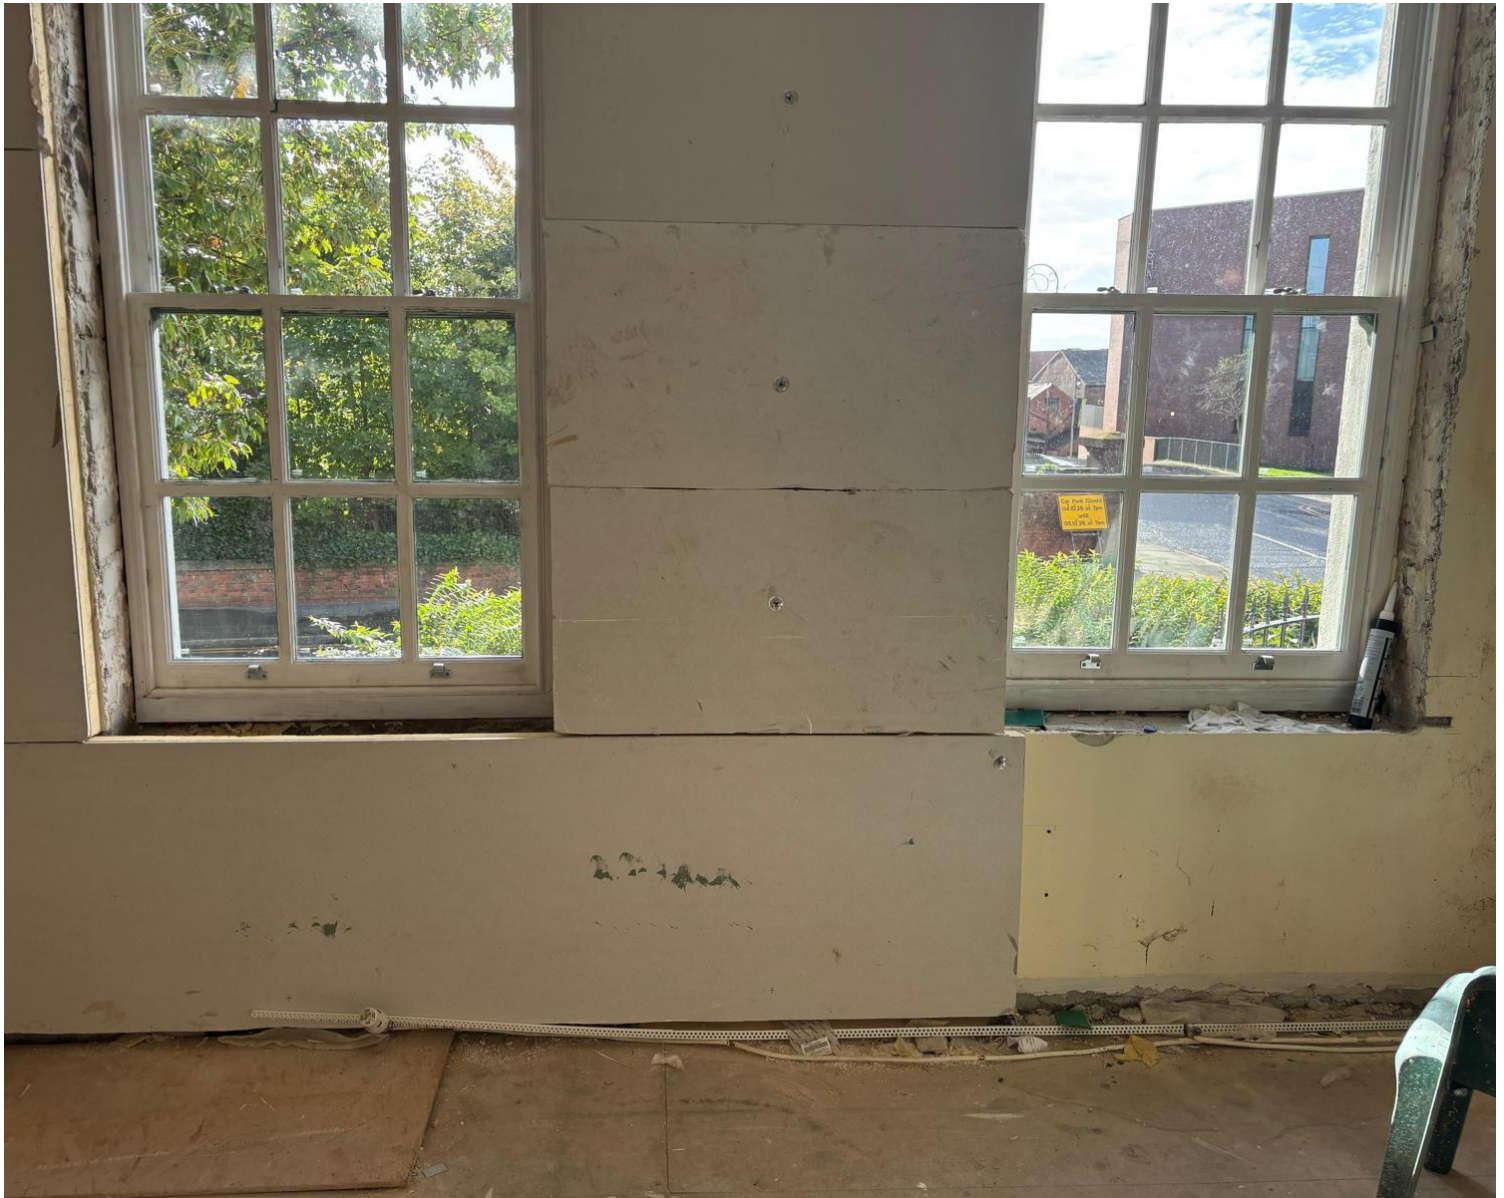
## Living Room/Front Elevation

Wall is finished in sand/cement & some insulation work that commenced in error by maintenance Team. Insulation work to be removed.

1m band of sand/cement is to be removed from wall to check for dry rot mycelial strands (the floor has dry rot)

Following investigation the wall is to be patched in sand/cement & also to window reveals

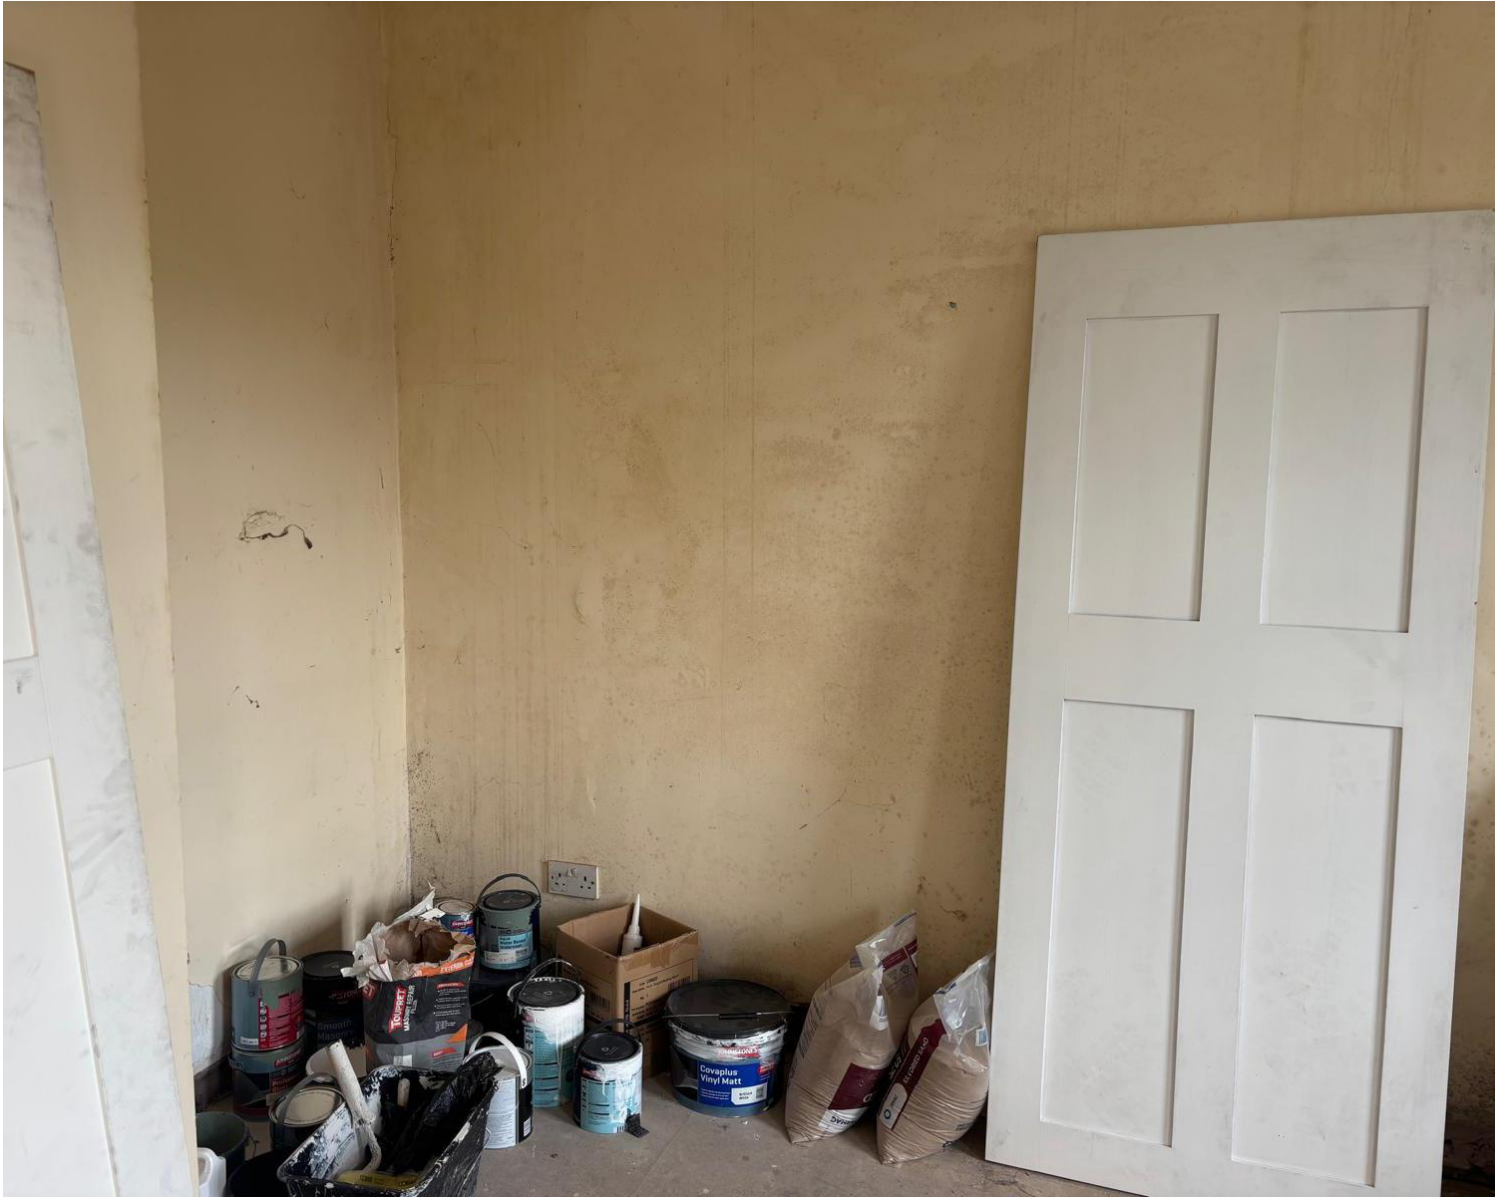
## Plaster To Flat 2 Living Room/Gable

Wall is in sand/cement & is generally in reasonable condition.  
1m high band of the sand/cement is to be removed to check for dry rot  
mycelial strands (the floor has dry rot)  
Following investigation the wall is to be patched in sand/cement.

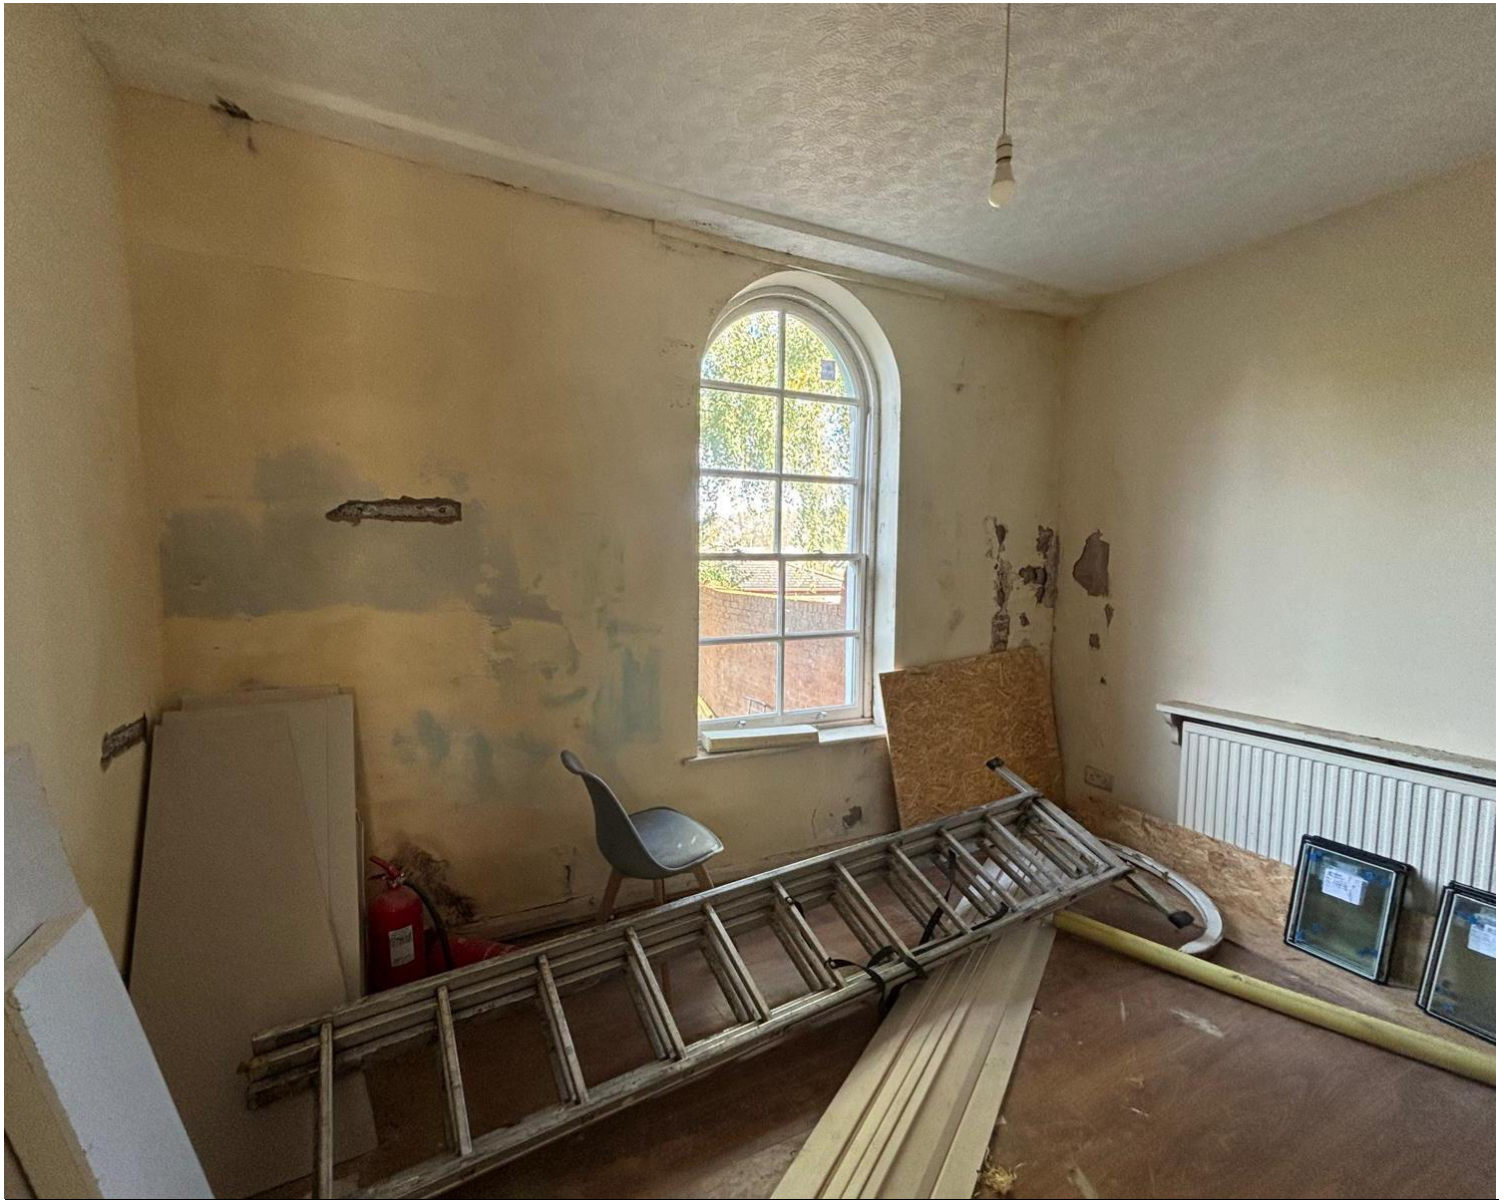
## Flat 2 Bedroom / Rear Wall

The rear elevation is in sand/cement & is in a poor condition, showing signs of damp in areas.

A 1m band needs to be removed to check for dry rot, so it is felt that so much is proposed to be removed that this should be removed fully.

Consequently renewal will be in a lime based system

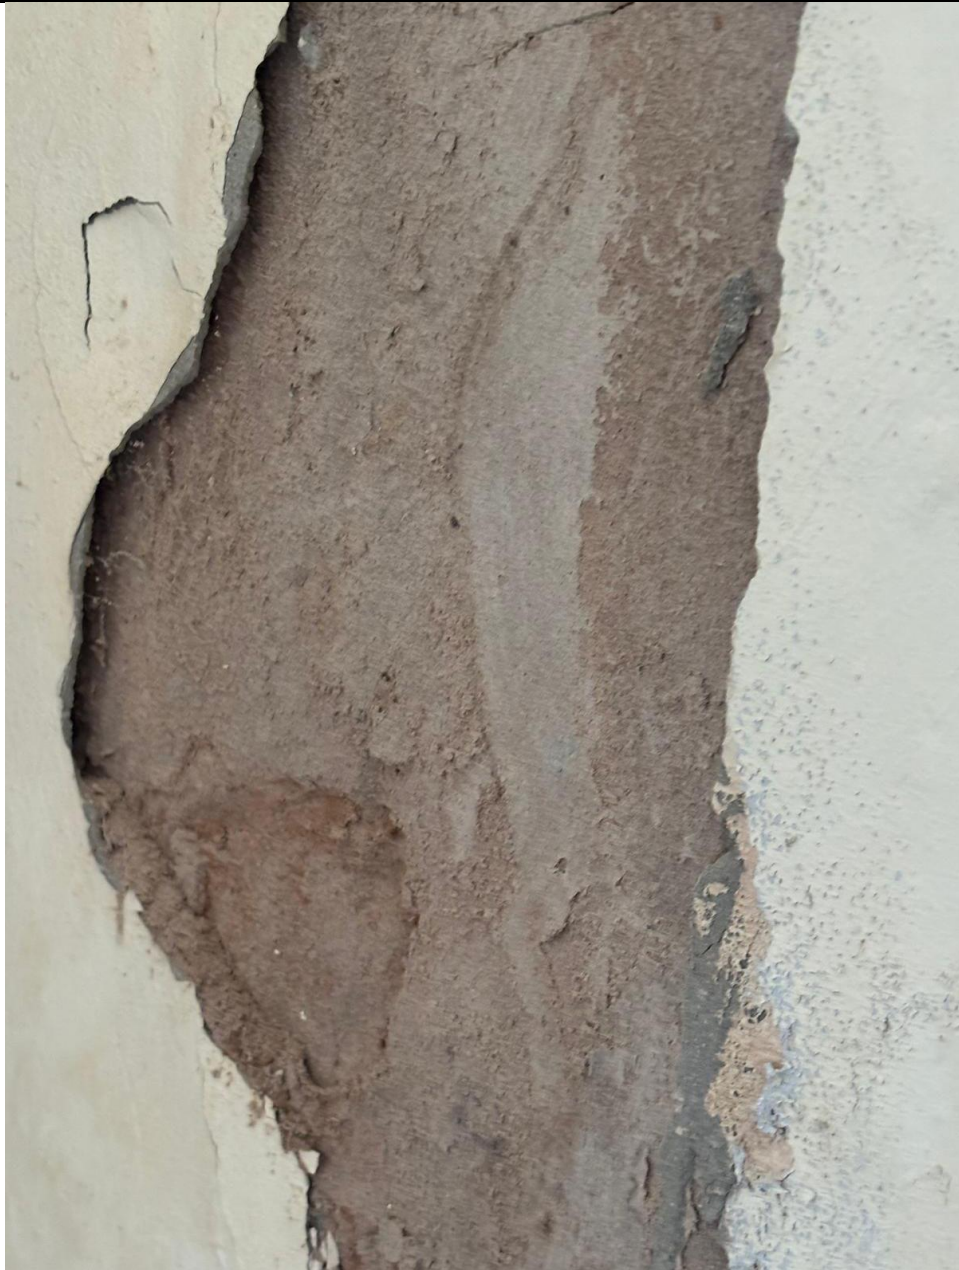
## Flat 2 Bedroom / Side Wall

Side wall to bedroom is in sand/cement.

There is a patch in the corner that is damp & needs to be removed, but other than that is Generally sound.

A 1m high band needs to be removed to check the dry rot mycelial strands, but this still leaves The majority of the wall in fair condition so patching in sand & cement is proposed.
