## HERITAGE STATEMENT

on behalf of Ms Anita Allen

November 2021

This Heritage Statement supports a planning application to repair and restore 7, Market Place in accordance with the principles of the High Streets Heritage Action Zone initiative.

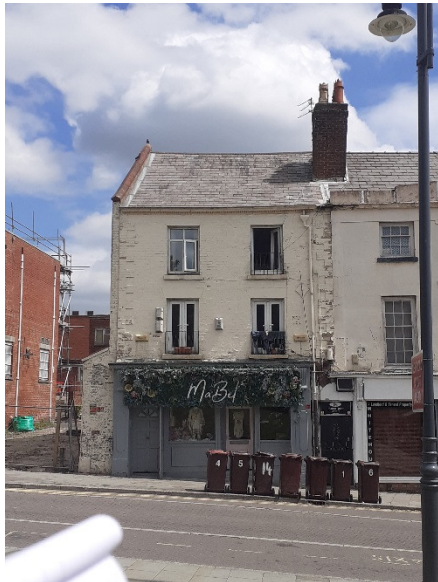
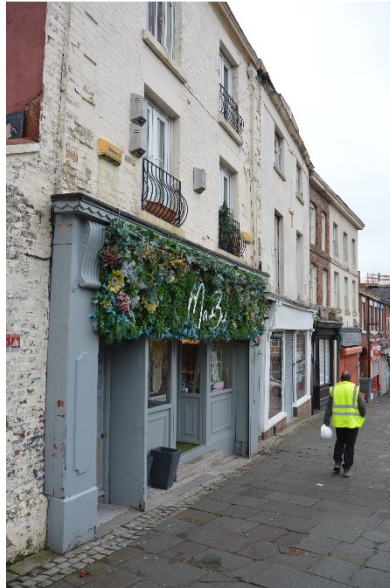
- The wall construction to the front elevation is 9" solid loadbearing clay brick with brick quoins to each side and stone cills and heads to the windows. The ground floor front elevation has a continuous timber shopfront extending across the full width of the property, including on the left hand side an access door to the flats above.

- The first floor external wall is presumed to sit on a concealed bressumer beam. The wall has deflected outwards and is currently restrained in by a triangular tie on the right hand side. The masonry has been painted and it is not possible to establish the type or condition of the pointing.

- The windows at both first and second floors have been replaced with modern UPVC, however older photographs suggest that these were originally vertical sliding sash with Georgian panes (2 panes over 2).

- The wall to the front elevation is capped by a carved stone eaves cornice, the top of which is dished and lined in lead to form a gutter. The lead lining appears to have failed causing some staining and deterioration to the wall below.

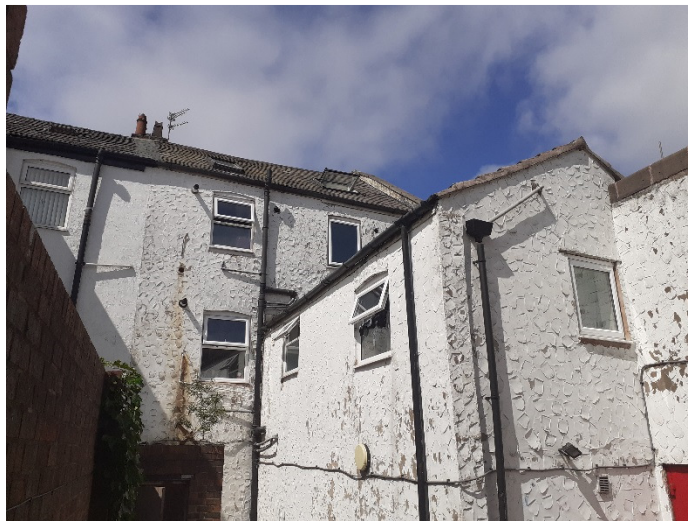
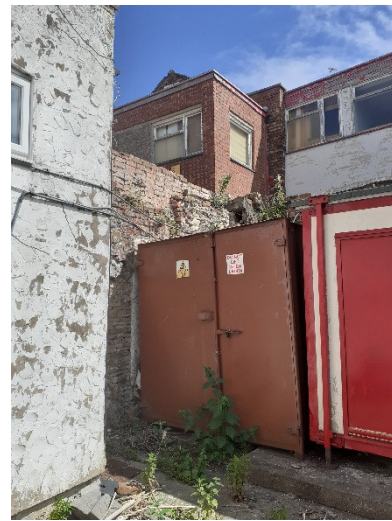
- The brickwork to the rear elevation is coated in sand cement painted render. There are no original windows and it is not apparent which openings are original, although some have arched heads which suggests that these are original. The outrigger, some of which is likely to have been original, is similarly rendered and fenestrated.
- The general condition of the rear of the property is poor, with PVC rainwater goods, missing fascias to the eaves and badly stained, cracked render.

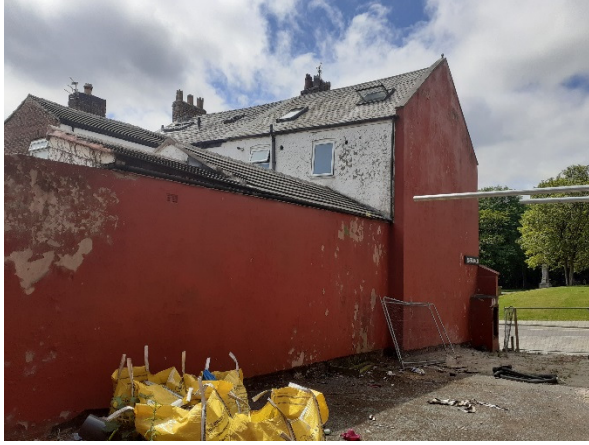
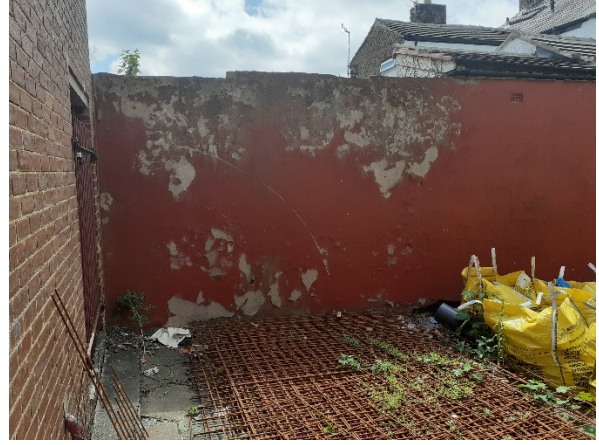
- The side/gable elevation to the main building, the outrigger and rear boundary wall is coated in sand cement painted render, in varying condition. It is apparent that the internal face of the wall to the main house, which is partially retaining, is damp at lower level.
- Stone copings which cap the gable verge do not appear to have sufficient overhang to the face of the render to provide full weathering. The copings to the front slope differ from those to the rear.
- The boundary wall is in very poor condition and appears to be unstable and in need of rebuilding in the upper portion.

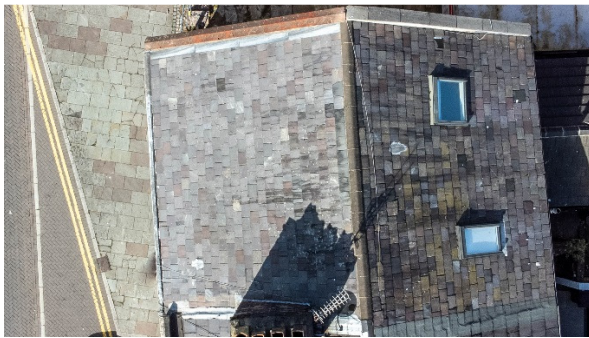
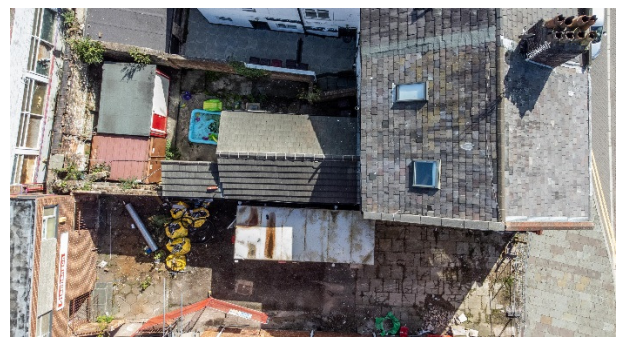
- The main roof is in traditional Welsh slate. The roof slopes require a further walk-over survey accompanied by a competent roofing contractor before finalising the scope of work. Similarly, the flashings should be inspected. Observed from ground level and from drone photographs however, it appears that the front slope has been re-laid and is in better condition than the rear, which has number of dislodged slates. The rear slope has two roof lights which appear to be poorly installed. The copings and flashings to the gable, flashings to the chimney on the adjacent property and ridge tiles are likely to need replacing.

- Rainwater goods and roof drainage appears to be in need of repair and/or replacement. The linings and condition of all the gutters should be replaced and flashings inspected.

- The rear outrigger has a pitched roof with concrete tiles to the outer slope and either slate or concrete tiles (tbc) to the inner slope. Further inspection of this element is also recommended by a competent roofer.

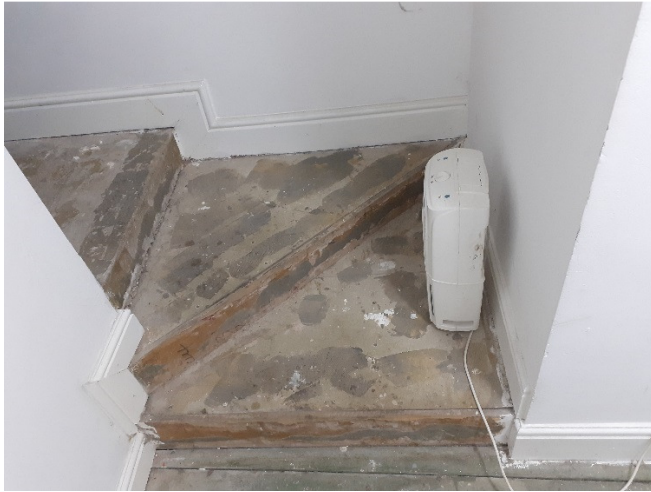
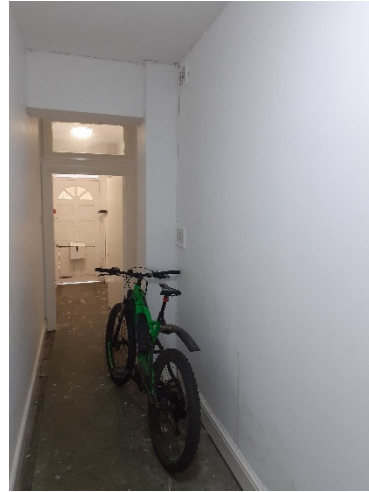
- The retail unit is functioning and in a tidy and clean condition.
- There are no original decorative features apparent.
- The access corridor and stairwell to the flats on the upper floors has areas of significant dampness apparent, particularly to the lower part of the gable elevation wall on the northern side. It is likely this is caused by a combination of rising damp and damp from the retained earth outside, exacerbated by the application of impermeable sand/cement render and inadequate ventilation. This requires further investigation.

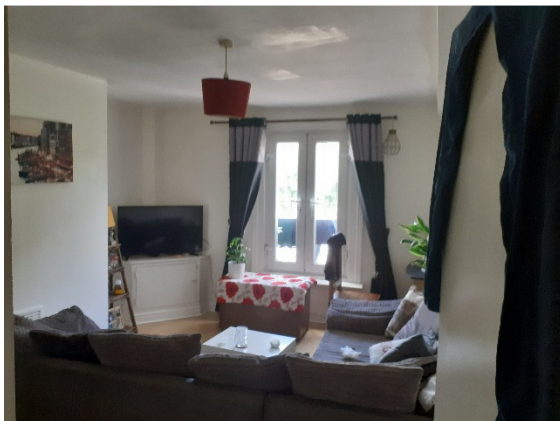
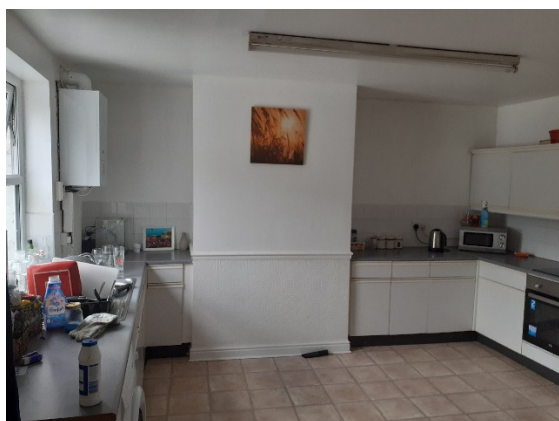
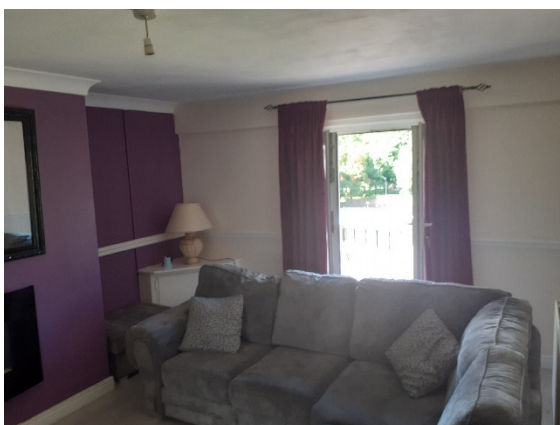
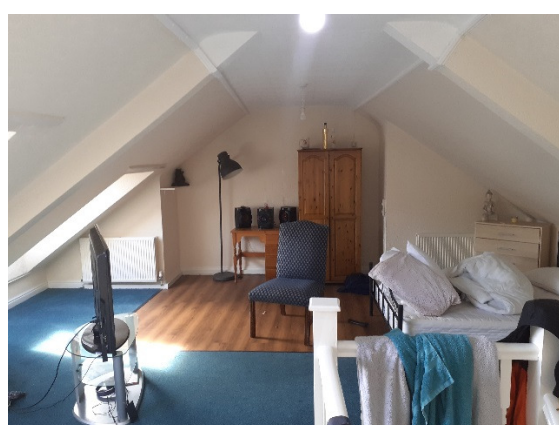
- The upper floors are occupied residential flats and are in a clean and tidy condition. The roof space has been converted to provide a mezzanine level to the second floor flat.
- There are no original features apparent.
