65215060  
INDURENT PARK, MOORGATE POINT,  
ALCHEMY BUSINESS PARK, KNOWSLEY  
STAGE 1 ROAD SAFETY AUDIT

65215060-SWE-GEN-ZZ-AS-PC-00001

12 November 2025

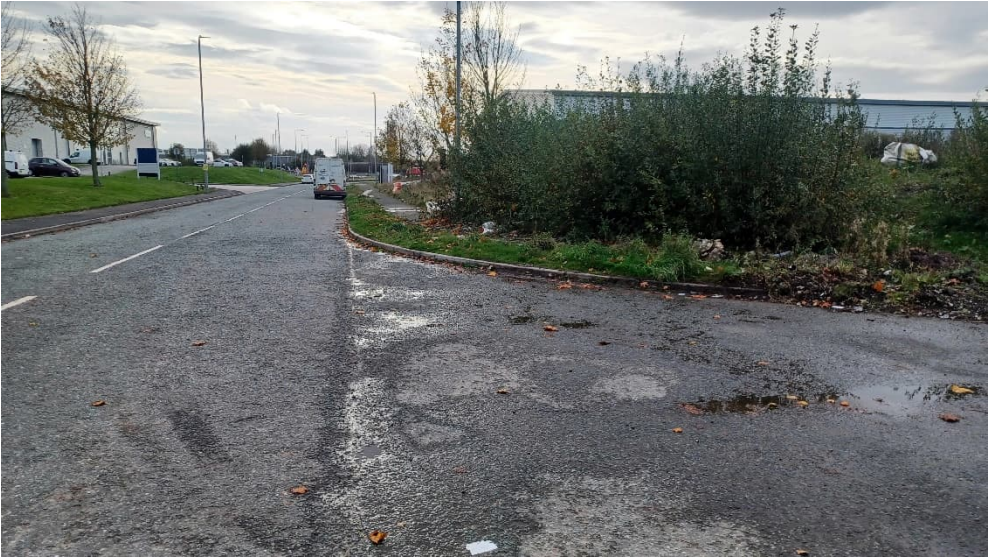
| Reference | Location | Type of collision | Description | Recommendation | Photographs / Plans |
|---|---|---|---|---|---|
| 3.1 | Existing bellmouth on western side of Alchemy Way. | Pedestrians trip and fall. | At present the footway along the western side of Alchemy Way is routed along the back of the side road stub. Pedestrians walking along the footway, north to south or vice versa will take the shortest route and potentially trip and fall at the kerblines as they cross the bellmouth. | Provide dropped kerbs and tactile paviments on the desire line crossing the bellmouth. | <div></div> <div>View looking south along western side of Alchemy Way, existing bellmouth on the right of the picture.</div> |

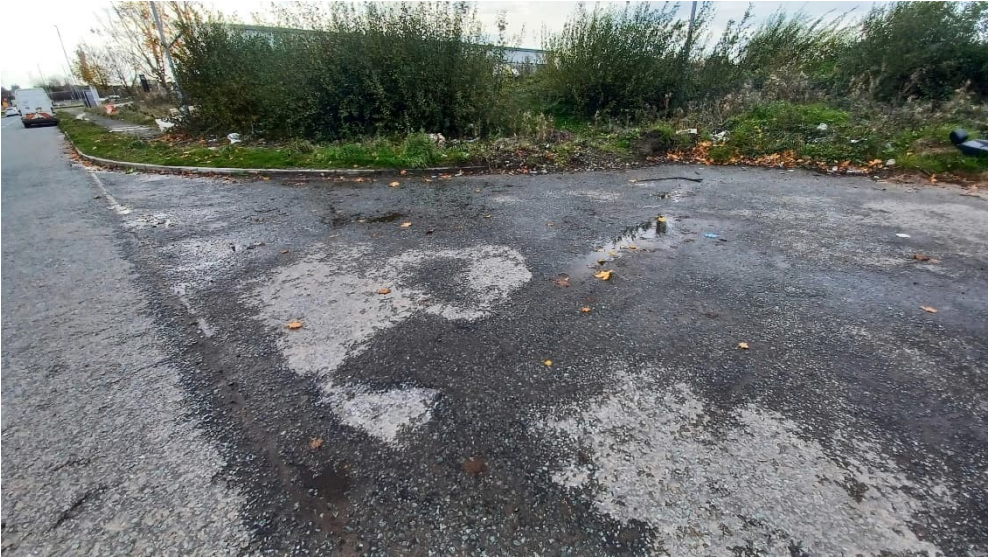
| Reference | Location | Type of collision | Description | Recommendation | Photographs / Plans |
|---|---|---|---|---|---|
| 3.2 | Existing bellmouth on western side of Alchemy Way. | Single vehicle loss of control skids. | The existing surfacing in the side road stub is in a very poor condition, with spalling and breaking up throughout the entire area. | Re-surface the bellmouth to remove level differences, 'bird baths', etc. | <div></div> <div>View looking at existing bellmouth; note poor surfacing throughout.</div> |

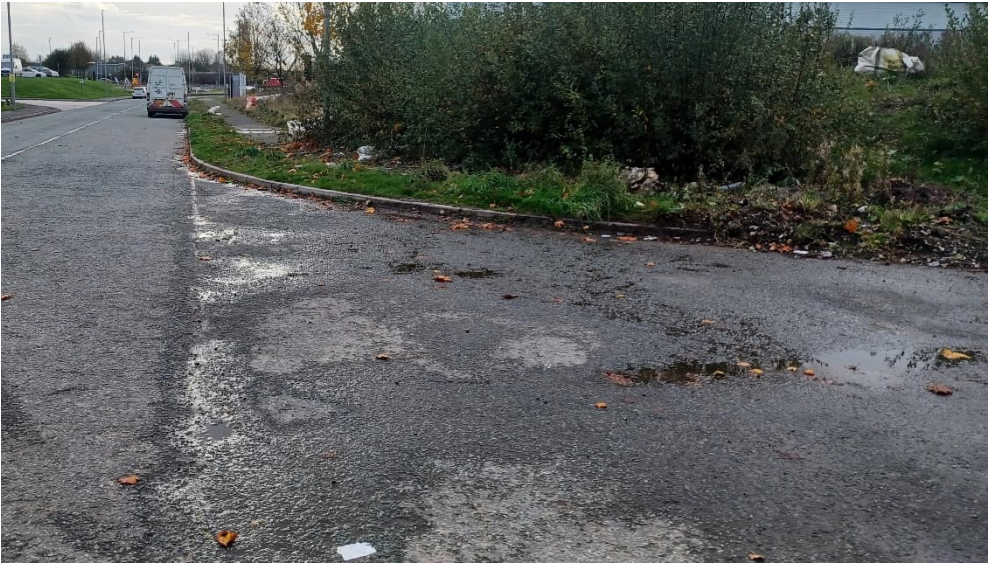
| Reference | Location | Type of collision | Description | Recommendation | Photographs / Plans |
|---|---|---|---|---|---|
| 3.3 | Existing stub arm on western side of Alchemy Way. | Single vehicle loss of control skids. | The site visit took place after a period of rain and whilst the mainline, Alchemy Way, was dry, the side road stub showed signs of ponding and retention of surface water. It appears that the camber of the mainline sheds water into the side road stub, but the stub is flat in comparison, and therefore susceptible to collecting water. No drainage gullies were visible within the stub, though it is noted that gullies may have been covered over by detritus. | Ensure the side road stub can adequately drain rainwater. | <div><p>View looking at existing bellmouth showing poor surfacing and inadequate surface drainage.</p></div> |

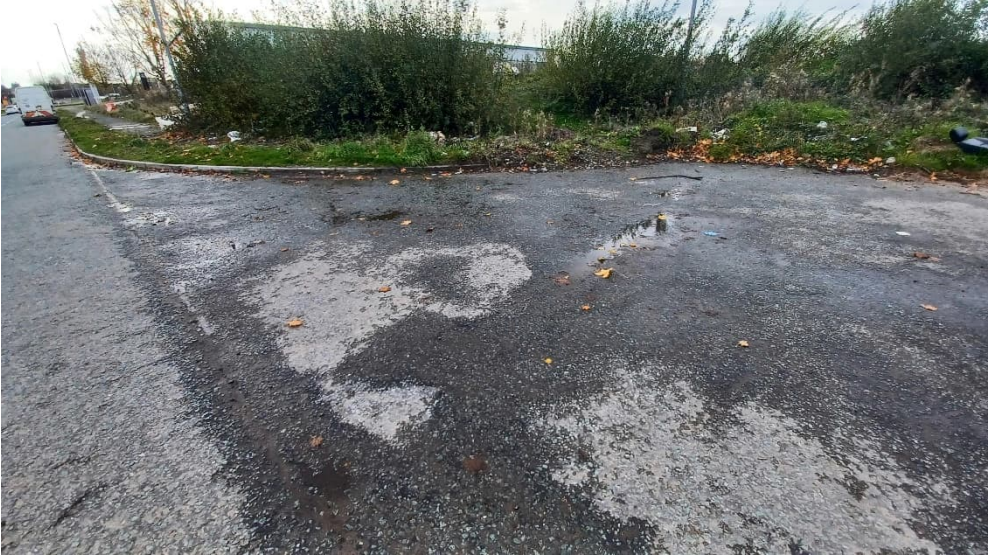
| Reference | Location | Type of collision | Description | Recommendation | Photographs / Plans |
|---|---|---|---|---|---|
| 3.4 | Existing stub arm on western side of Alchemy Way. | Pedestrians struck by turning motor vehicles. | The side road stub is over approximately 30m wide at its' interface with the western channel of Alchemy Way, this would take at least 25 seconds to cross (assuming an average walking speed of 1.2m/s). Once the stub is connected to a new access road there could be significant traffic movements at the junction and pedestrians may struggle to cross the road safely. | Provide a pedestrian refuge in the side road stub, on the desire line, to enable pedestrians to cross the bellmouth in two movements. Ensure the refuge is wide enough and deep enough to safely accommodate all user types. | <div></div> |

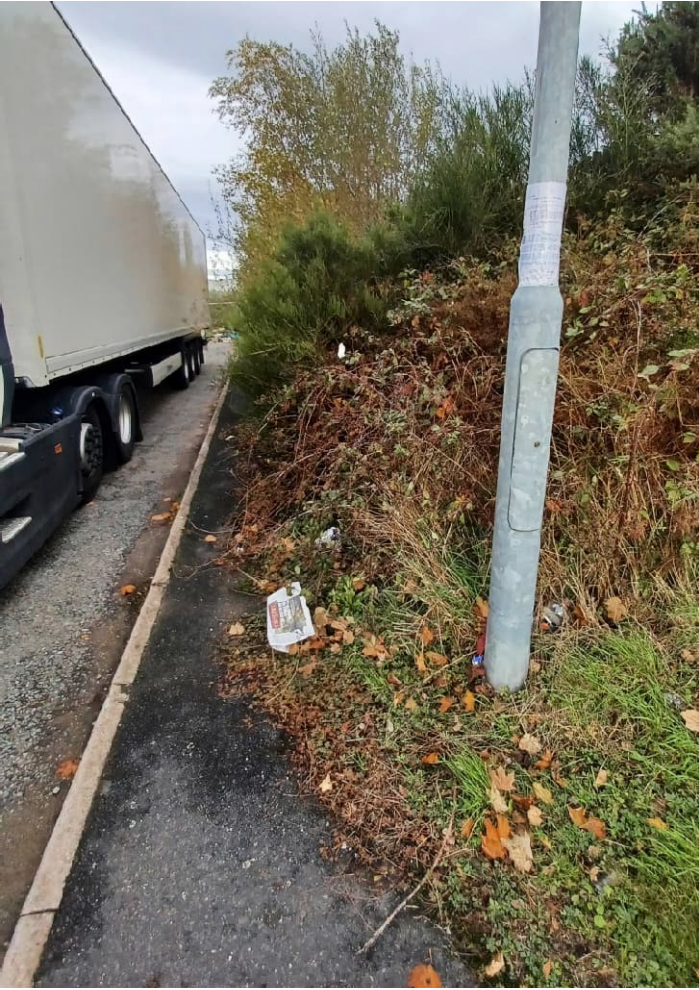
| Reference | Location | Type of collision | Description | Recommendation | Photographs / Plans |
|---|---|---|---|---|---|
| 3.5 | Eastern footway. | Pedestrians trip and fall and pedestrians struck by motor vehicles. | <p>At the north-eastern end of Alchemy Way vegetation has encroached onto the existing footway, so reducing its effective width.</p> <p>If vegetation is not maintained pedestrians will walk closer to the kerb edge which may result in them tripping and falling into the carriageway or a parked vehicle, or choosing to walk in the carriageway into the path of oncoming vehicles.</p> | Cut back the vegetation to a point well beyond the back of the footway and maintain this width. | <div></div> <p>View looking north along eastern side of Alchemy Way.</p> |

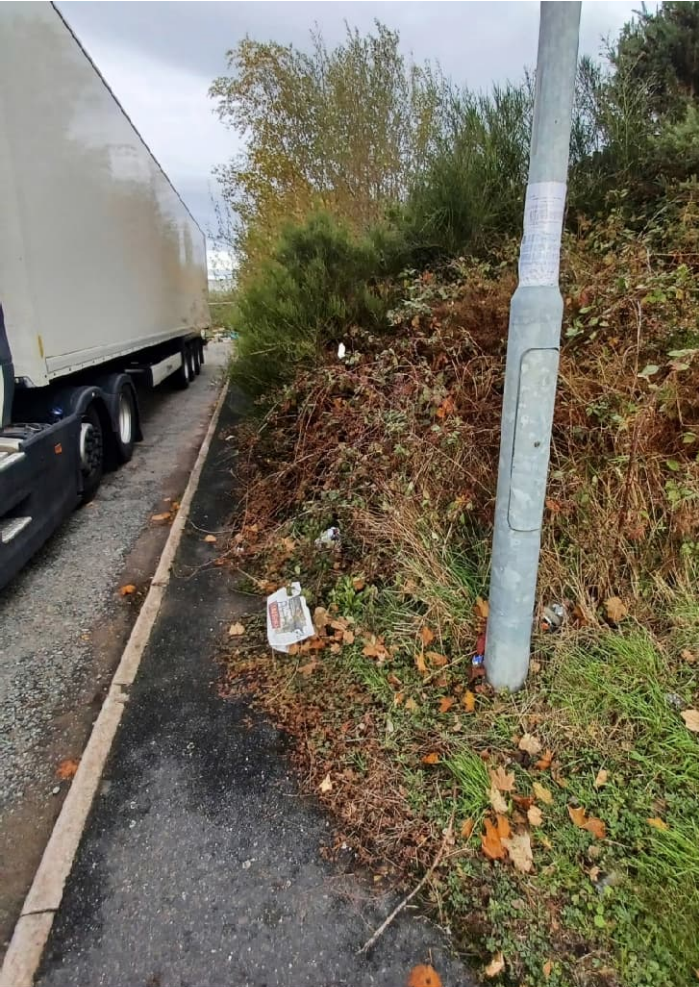
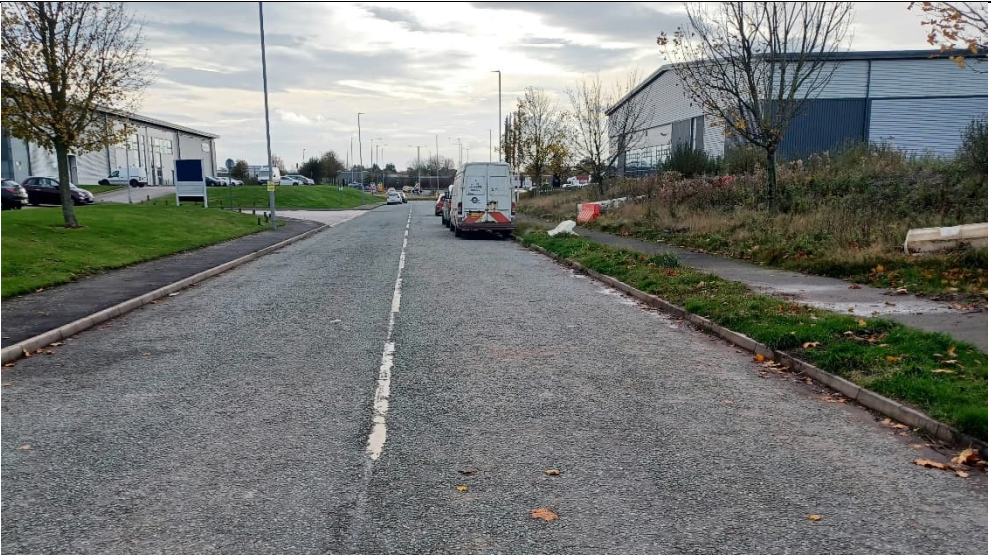
| Reference | Location | Type of collision | Description | Recommendation | Photographs / Plans |
|---|---|---|---|---|---|
| 3.6 | Length of Alchemy Way. | Shunts or side-swipes. | <p>Currently vehicles park on the mainline of Alchemy Way, including HGVs, with an apparent preference to park directly opposite side roads (see photographs).</p> <p>It is unclear whether this is as a result of Alchemy Way's existing cul-de-sac status or whether an increase in use – as proposed following the construction of the scheme – will exacerbate the problem.</p> <p>The worst case would be that on-street parking remains the same or increases at the same time as the development sites accessed via the stub arm and northern end of Alchemy Way are opened to traffic. This could lead to shunts, or side-swipes as drivers attempt to access and egress from the side roads either side of Alchemy Way.</p> | <p>Implement an on-street parking strategy for the whole of Alchemy Way, with a view to providing parking restrictions throughout.</p> <p>Should parking restrictions be implemented then wayfinding for drivers of large vehicles directing them to the closest appropriate 24-hour parking facilities should also be provided.</p> | <div></div> <p>View looking north along the eastern side of Alchemy Way.</p> |

| Reference | Location | Type of collision | Description | Recommendation | Photographs / Plans |
|---|---|---|---|---|---|
| | | | | | <div><p>View looking south along centreline of Alchemy Way.</p></div> |
