# Validation Completion Report

Site: Sonnet Gate, Prescott

Reference:15-292-R1

Date: July 2025

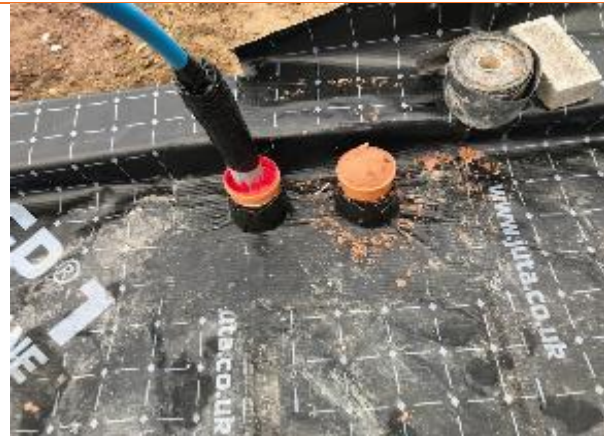
**Verification of Service Penetrations-Good Condition**

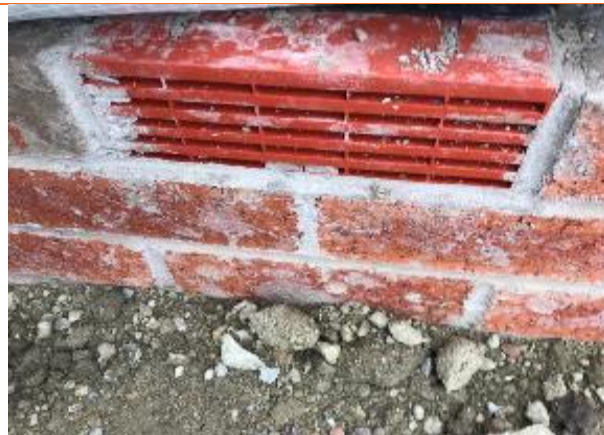
**Verification of Ventilation-Good Condition**

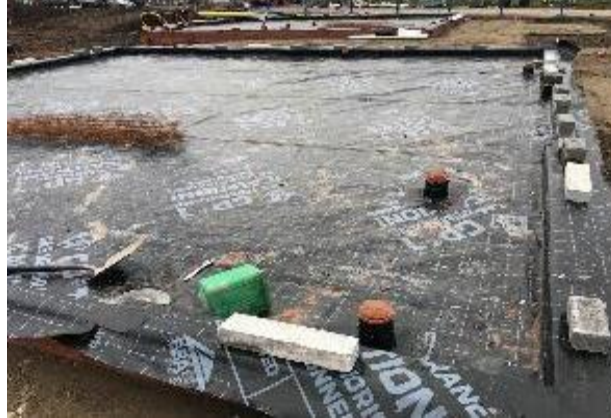
**Plot - 2**

**General Condition of Membrane-Good Condition**

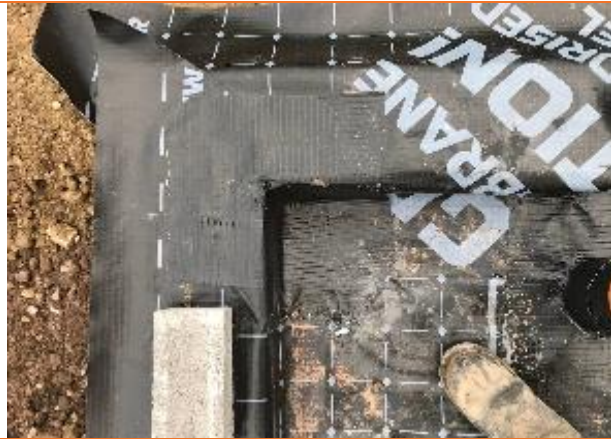
**Verification of Joints and Seals-Good Condition**

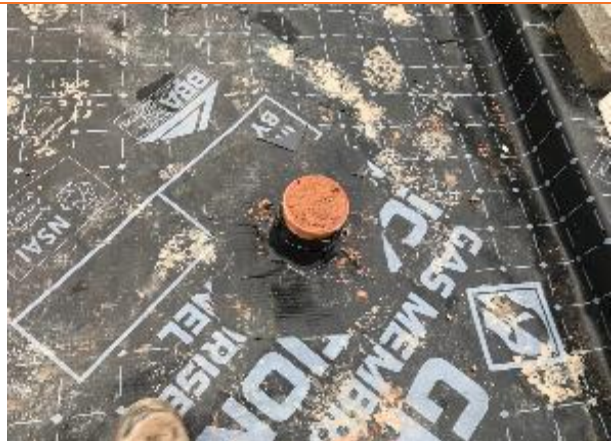
**Verification of Service Penetrations-Good Condition**

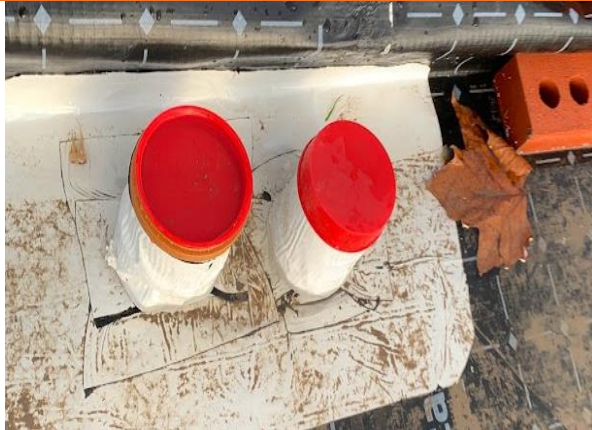
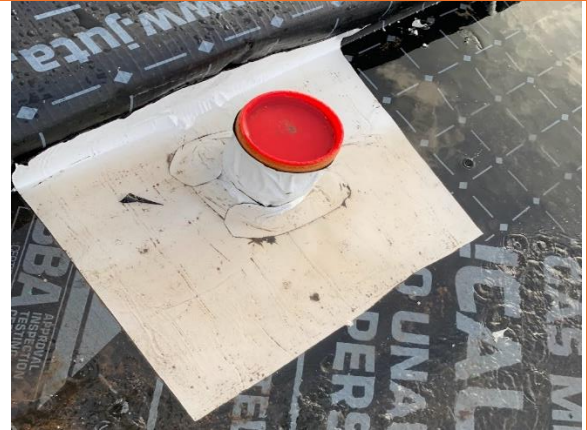
**Verification of Service Penetrations-Good Condition**

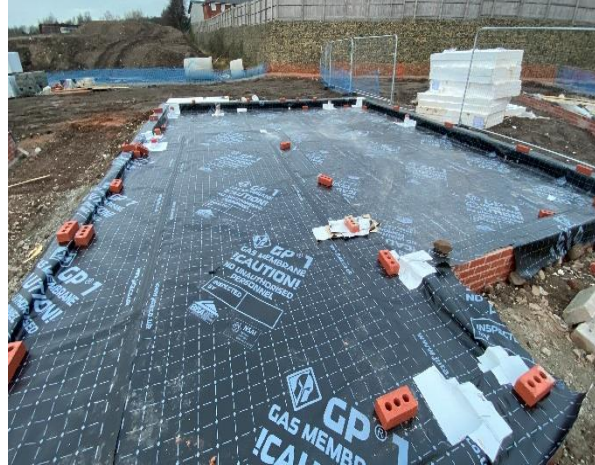
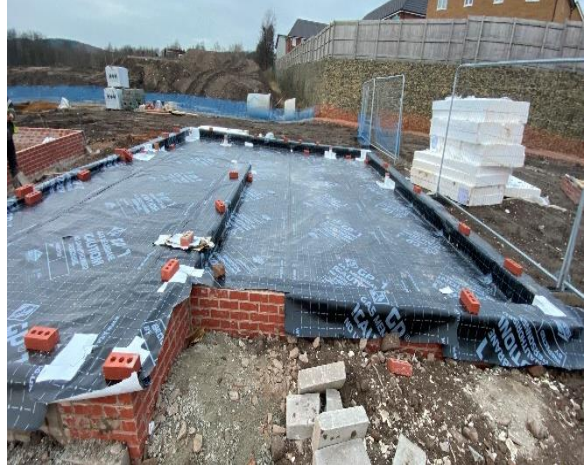
**Plot - 6**

**General Condition of Membrane-Good Condition**

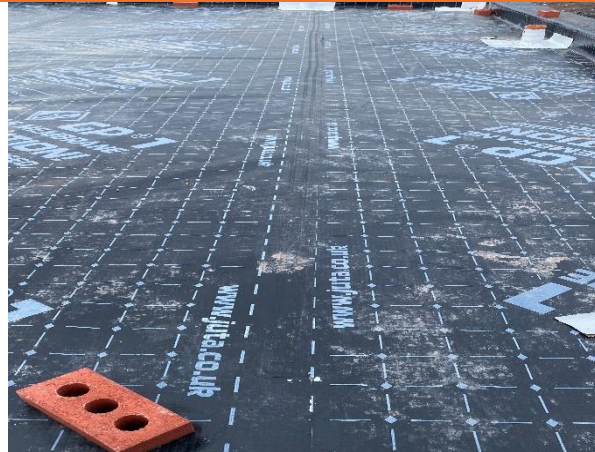
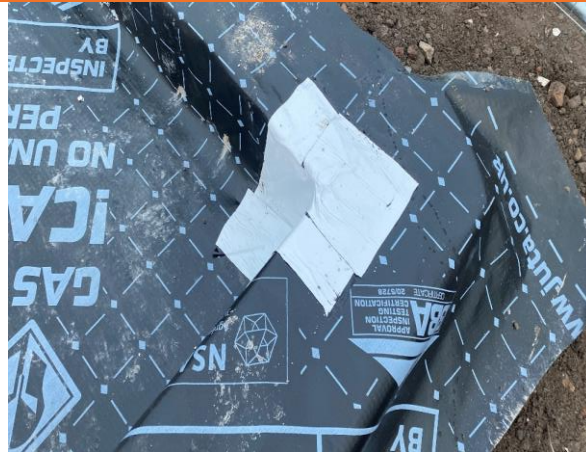
**Verification of Joints and Seals-Good Condition**

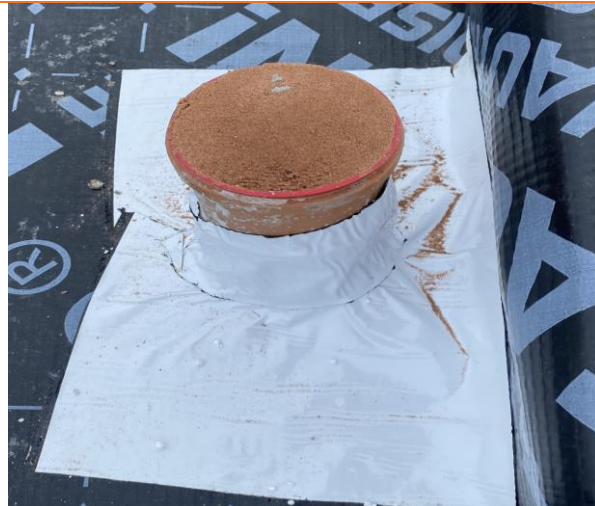
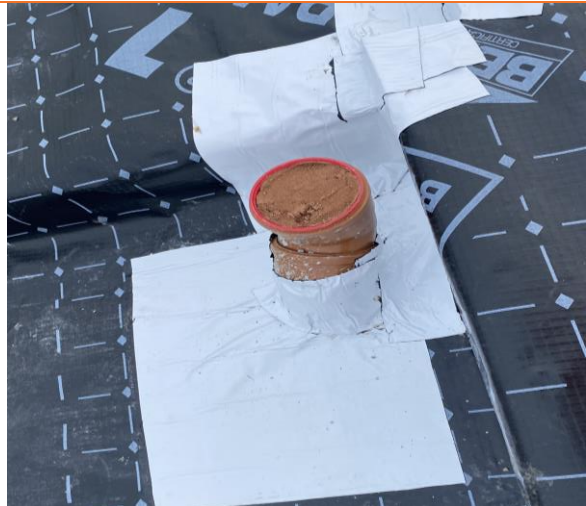
**Verification of Service Penetrations-Good Condition**

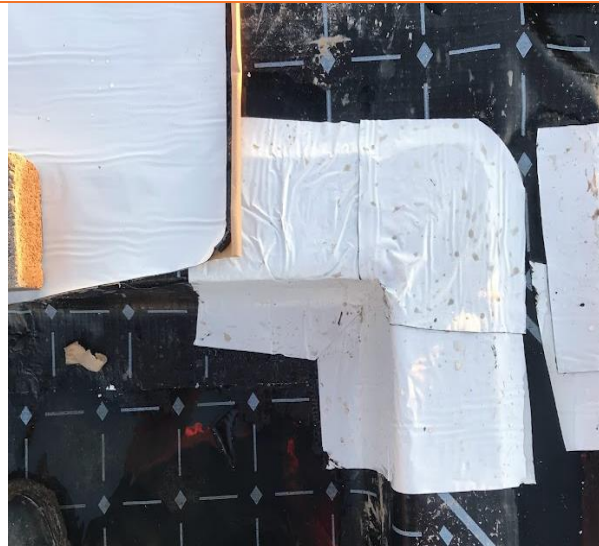
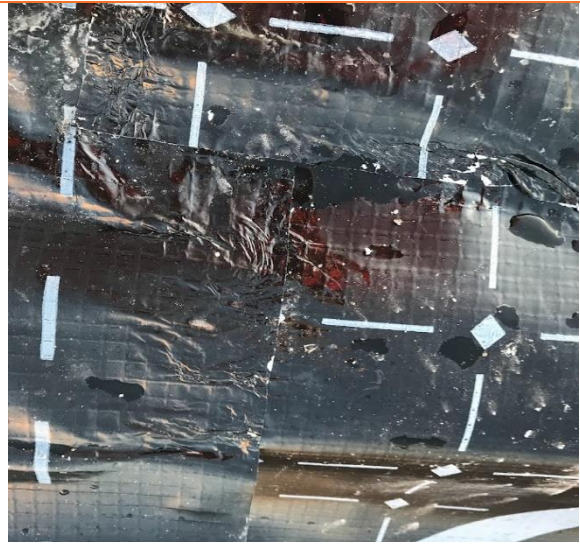
**Verification of Joints and Seals-Good Condition**

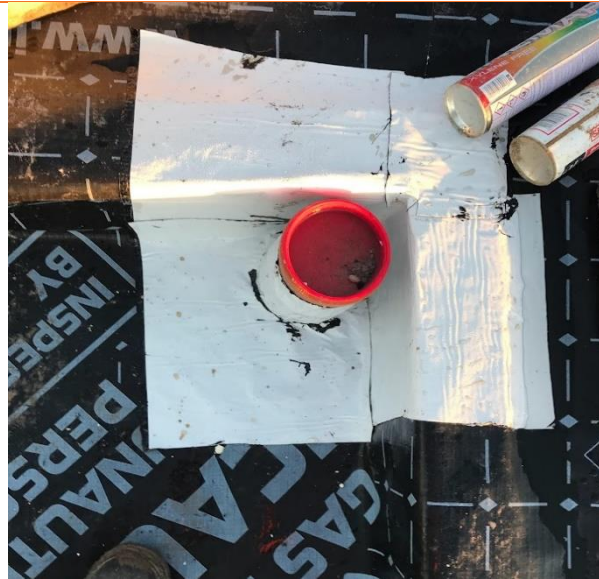
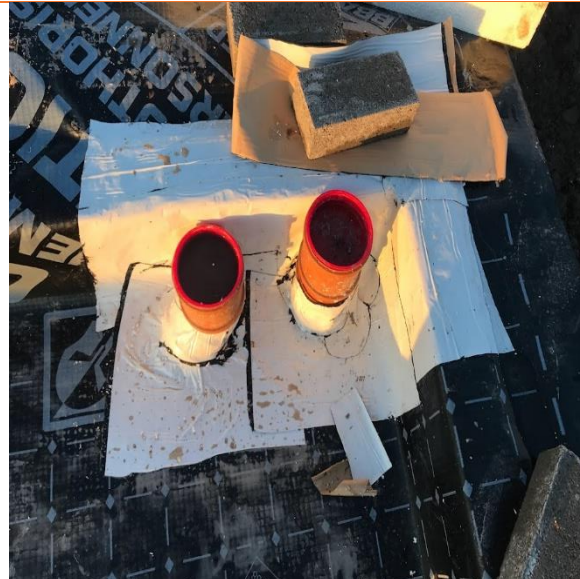
**Verification of Service Penetrations-Good Condition**

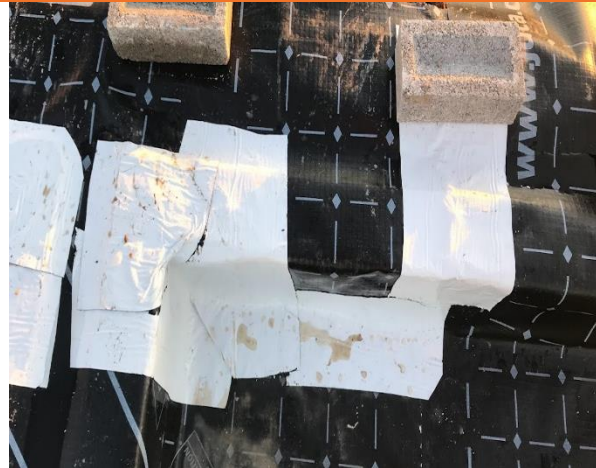
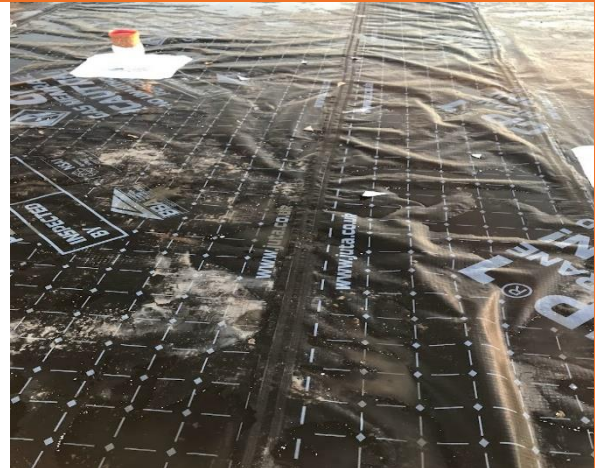
**Plot - 8**

**Verification of Joints and Seals-Good Condition**

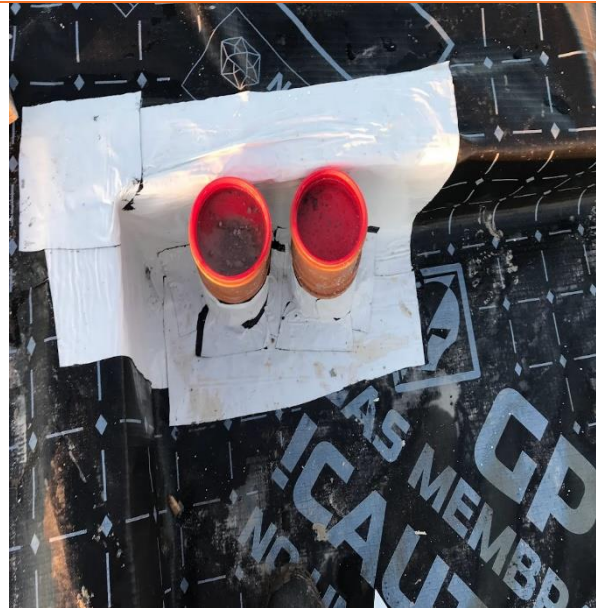
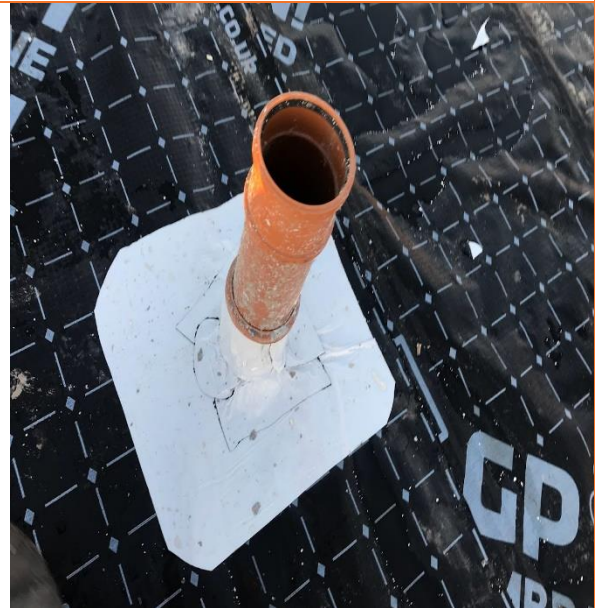
**Verification of Service Penetrations-Good Condition**

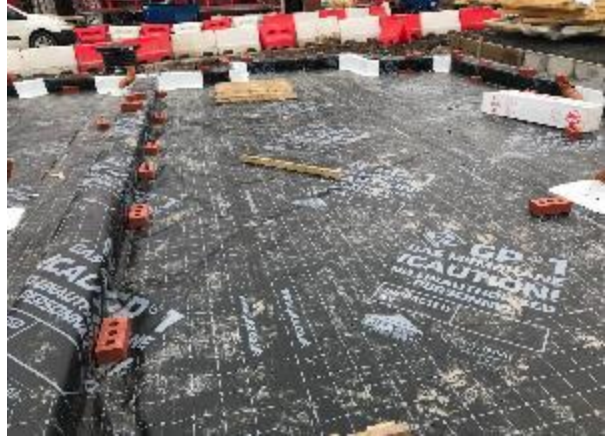
**Plot - 16**

**General Condition of Membrane-Good Condition**

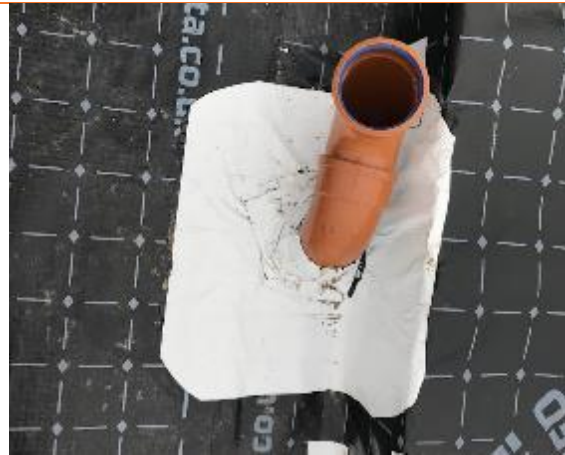
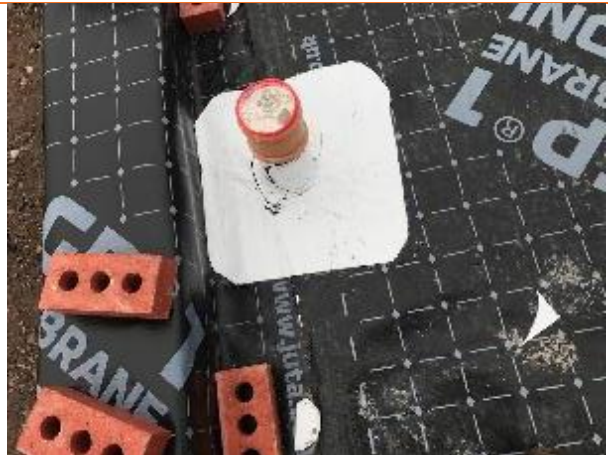
**Verification of Service Penetrations-Good Condition**

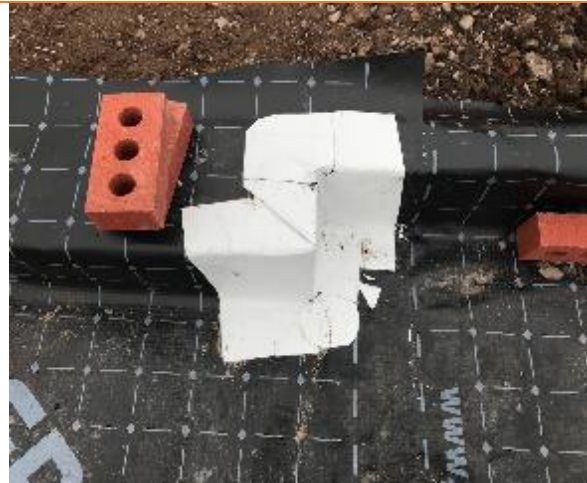
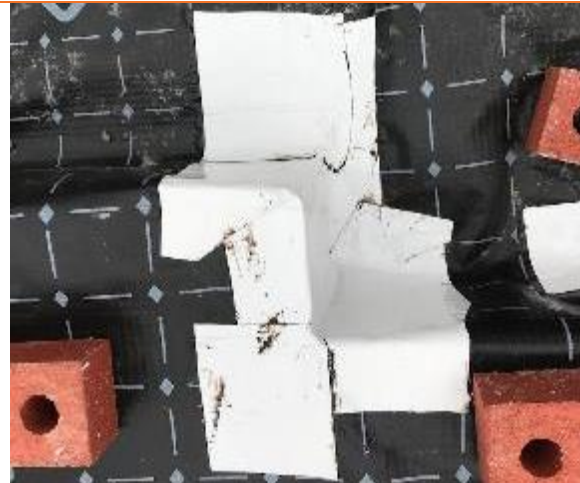
**Plot - 17**

**Verification of Joints and Seals-Good Condition**

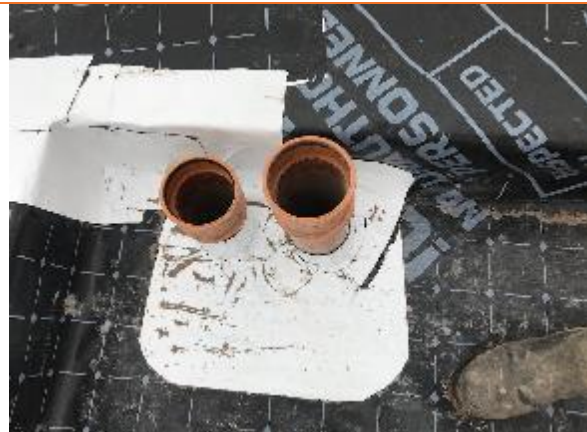
**Verification of Service Penetrations-Good Condition**

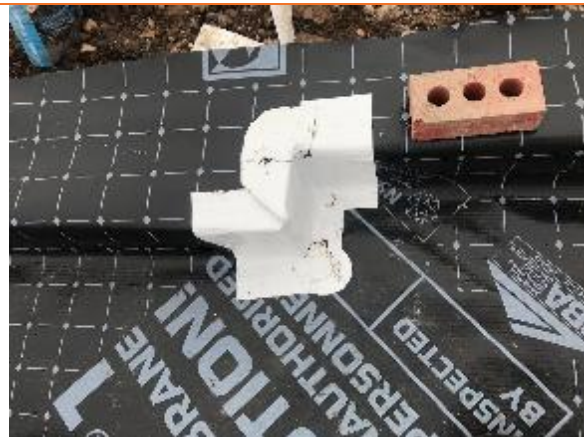
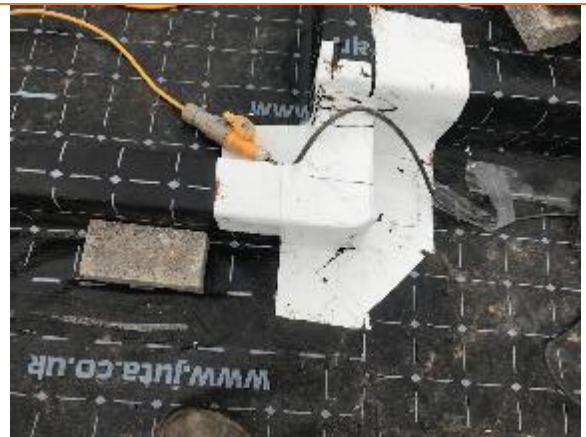
**Plot - 18**

**Verification of Joints and Seals-Good Condition**

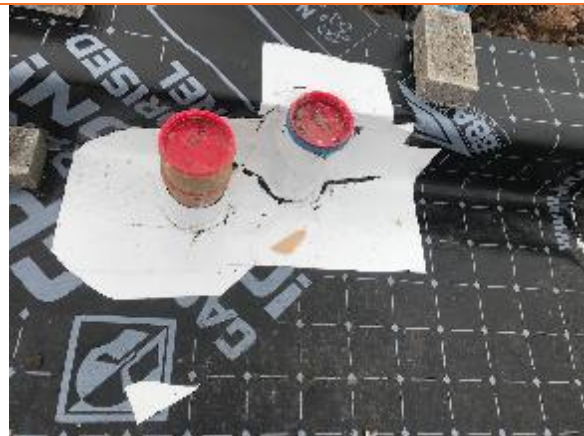
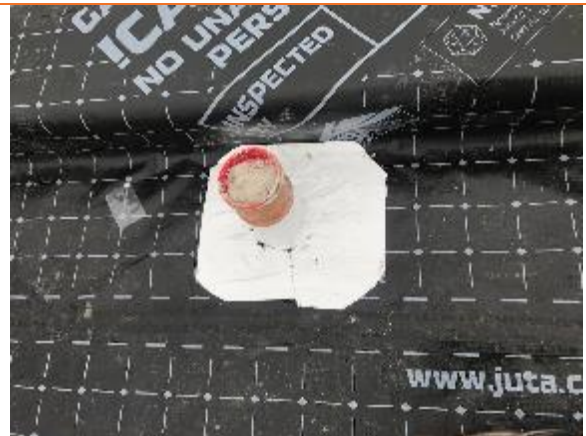
**Verification of Service Penetrations-Good Condition**

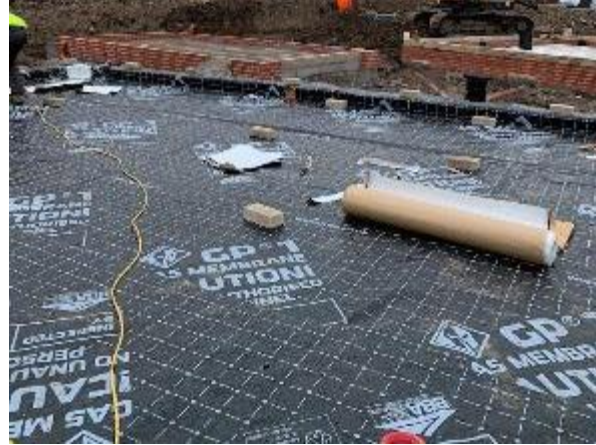
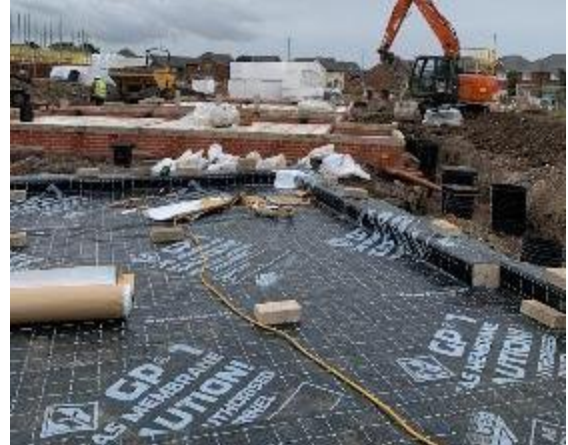
**Plot - 38**

**General Condition of Membrane-Good Condition**

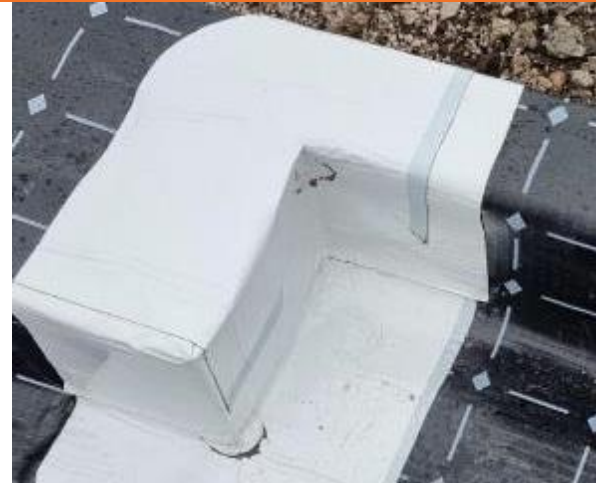
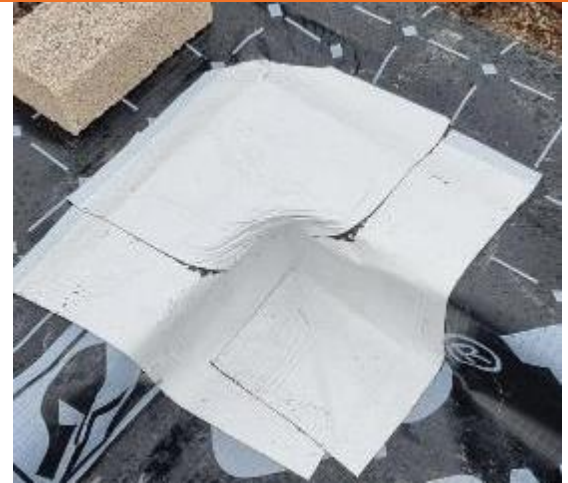
**Verification of Joints and Seals-Good Condition**

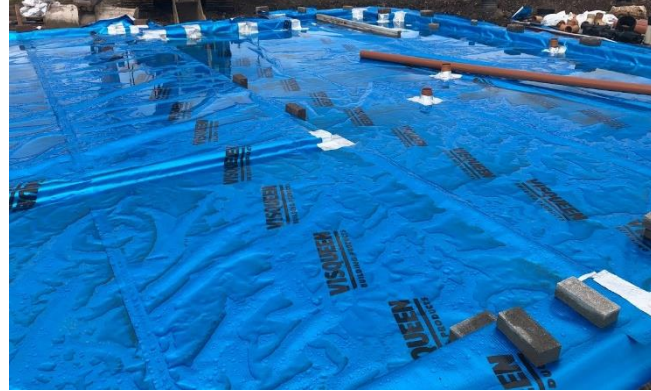
**Plot - 49**

**General Condition of Membrane-Good Condition**

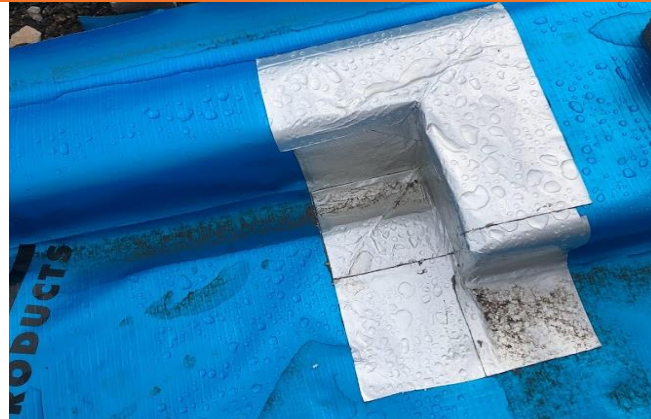
**Verification of Joints and Seals-Good Condition**

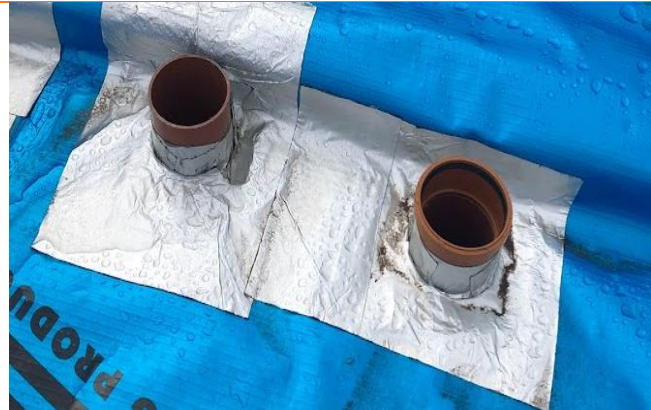
**Verification of Service Penetrations-Good Condition**

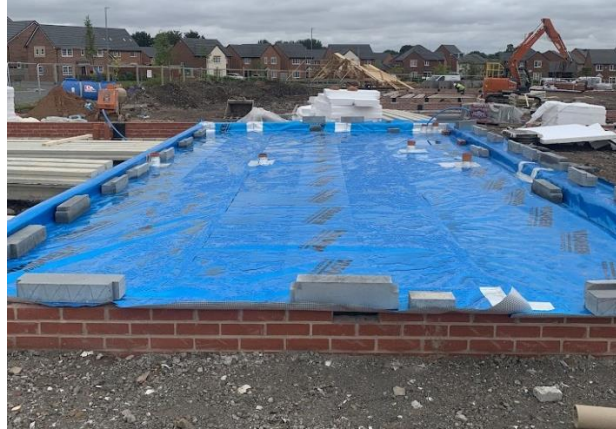
**Plot - 23**

**General Condition of Membrane-Good Condition**

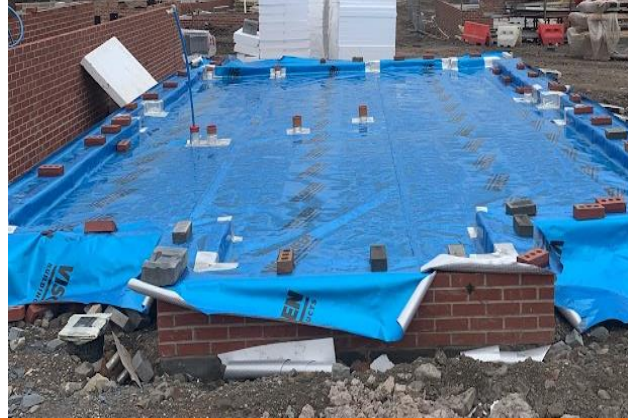
**Plot – 25**

**General Condition of Membrane-Good Condition**

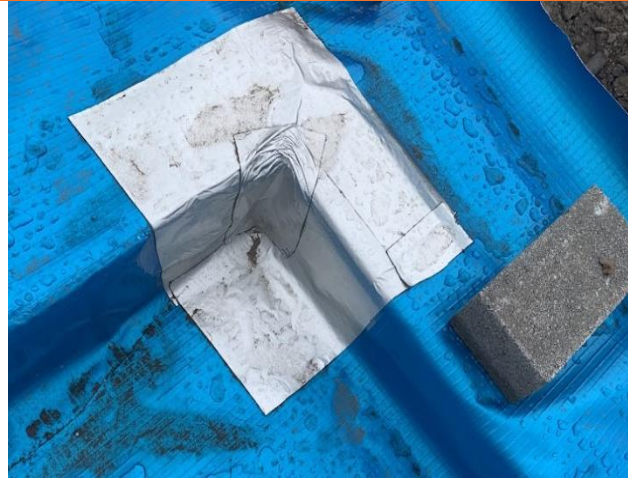
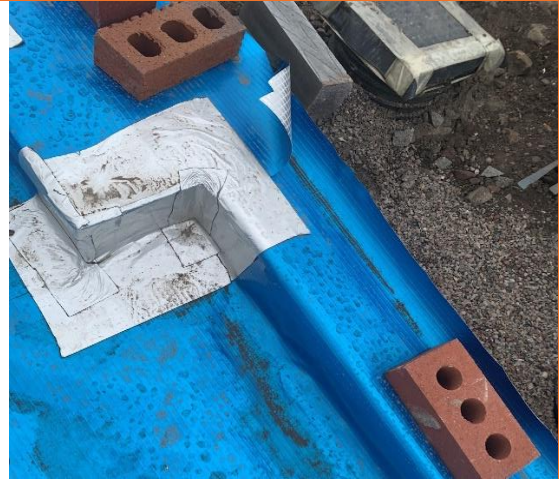
**Verification of Joints and Seals-Good Condition**

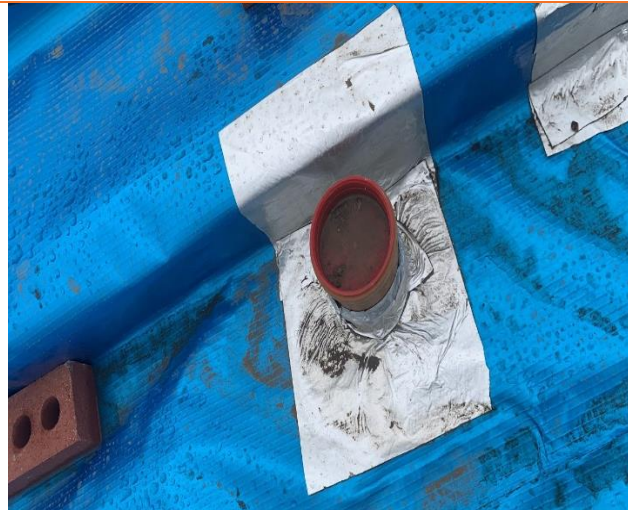
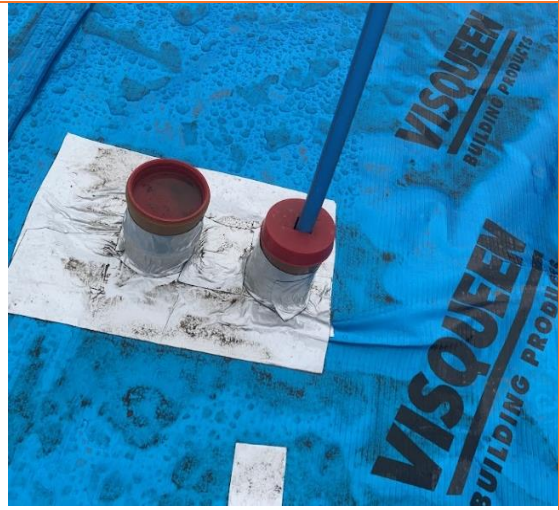
**Verification of Service Penetrations-Good Condition**

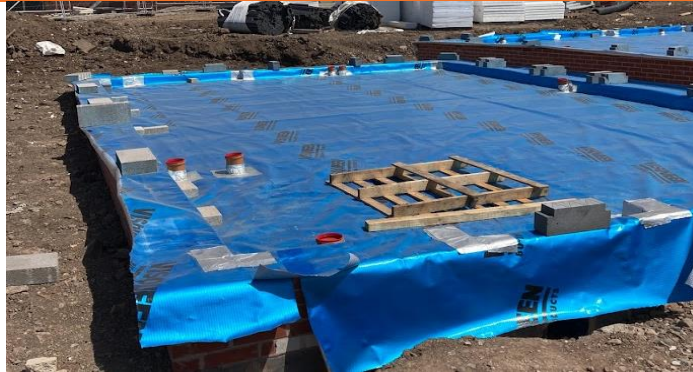
**Plot – 45**

**General Condition of Membrane-Good Condition**
