**e3p** Gas Protection Validation Site Record

## GAS MEMBRANE VALIDATION

| <b>Site Name:</b> Parcel C, Prescott | <b>Project Number:</b> 15-292 |
| <b>Company:</b> Miller Homes | <b>Date:</b> 21-07-2022 |

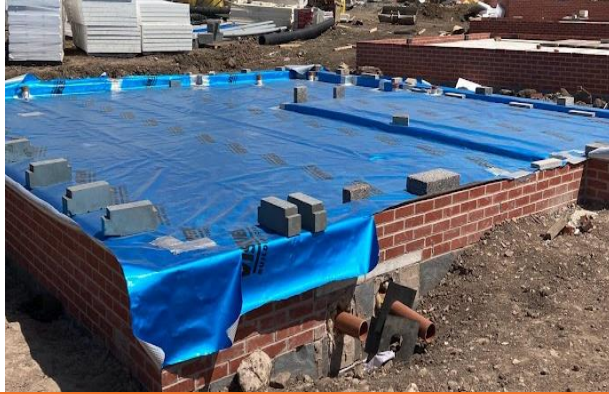
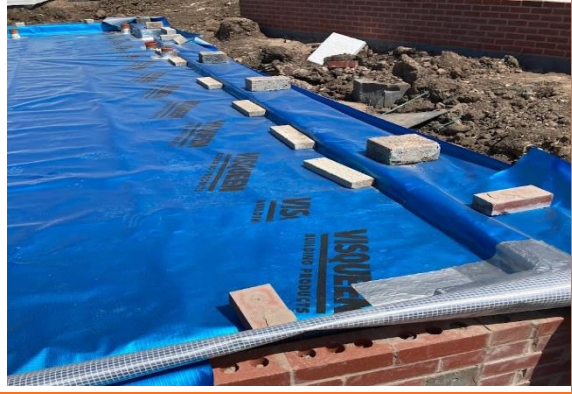
**Plot - 46**

**General Condition of Membrane-Good Condition**

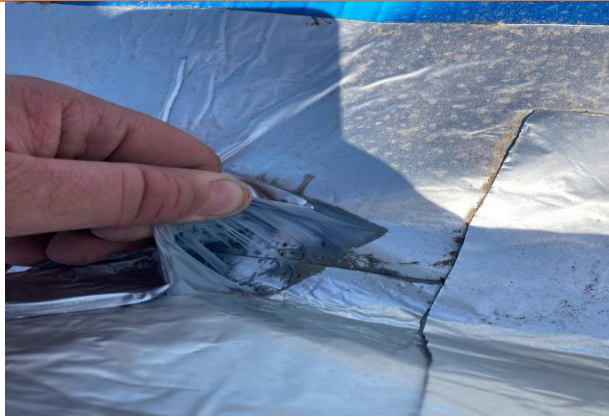
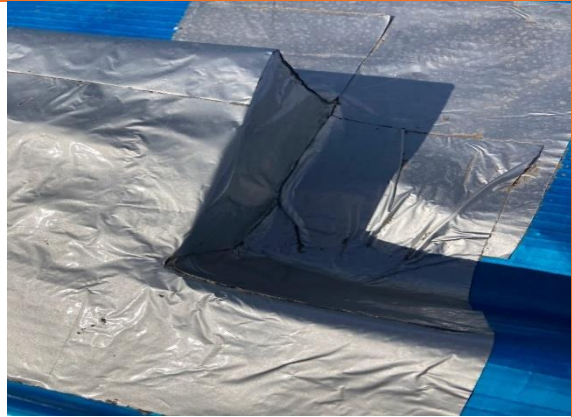
**Verification of Joints and Seals-Good Condition**

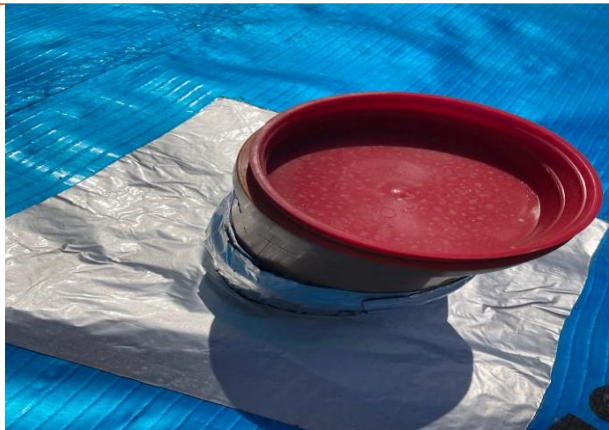
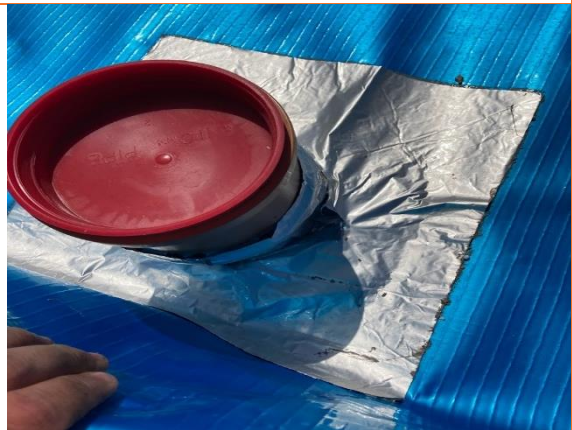
**Verification of Service Penetrations-Good Condition**

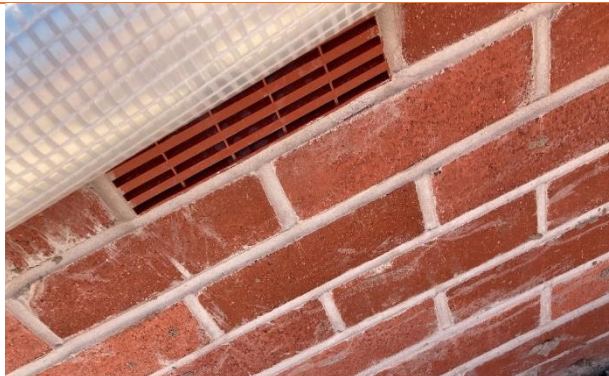
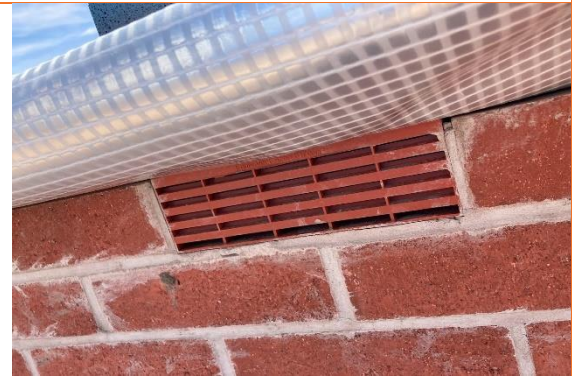
**Verification of Service Penetrations-Good Condition**

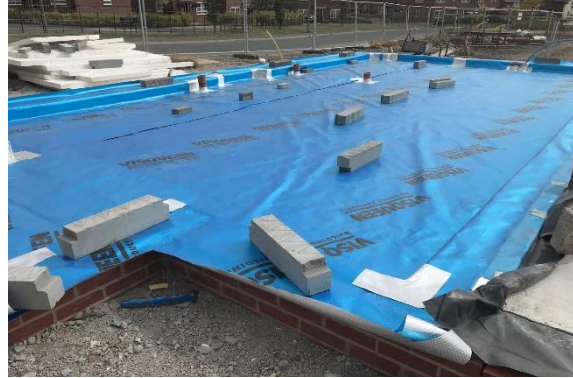
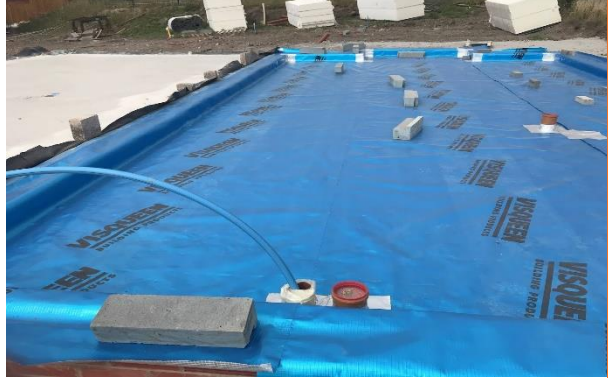
**Plot - 22**

**General Condition of Membrane-Good Condition**

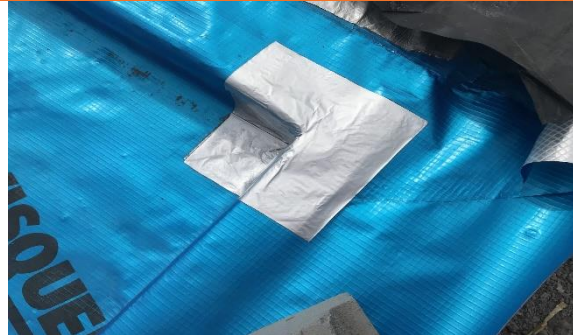
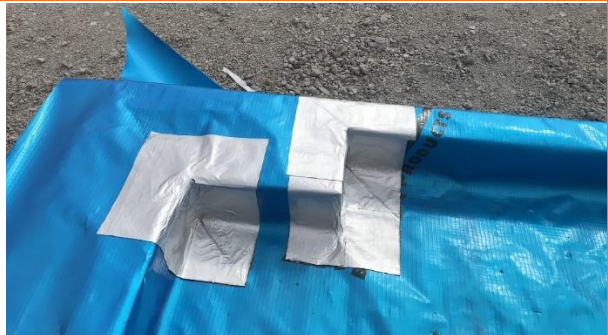
**Verification of Joints and Seals-Good Condition**

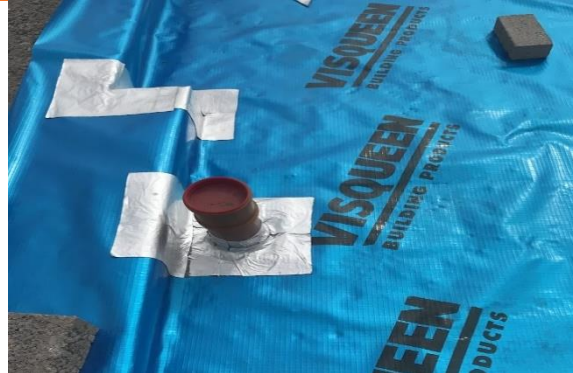
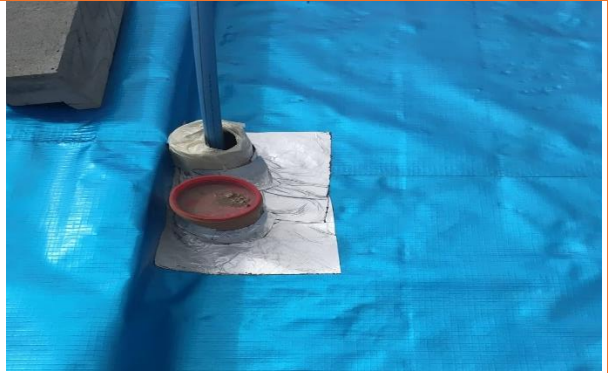
**Verification of Service Penetrations-Good Condition**

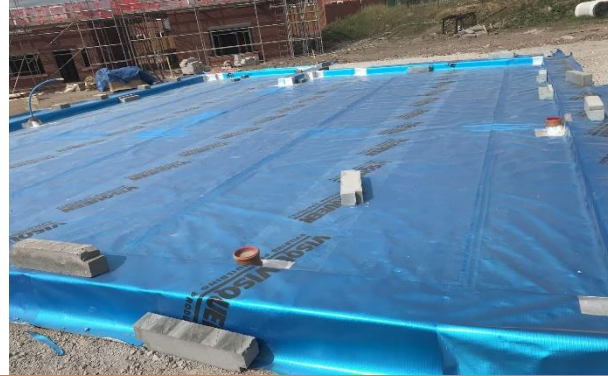
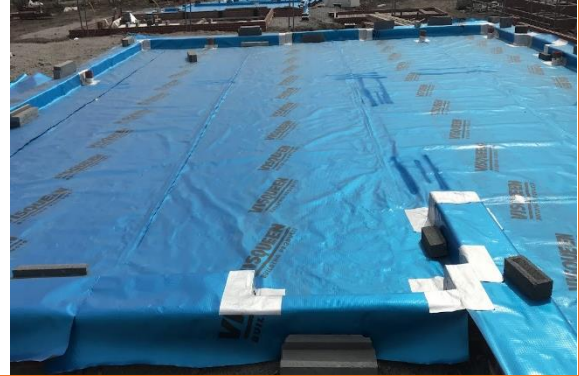
**Plot – 24**

**General Condition of Membrane-Good Condition**

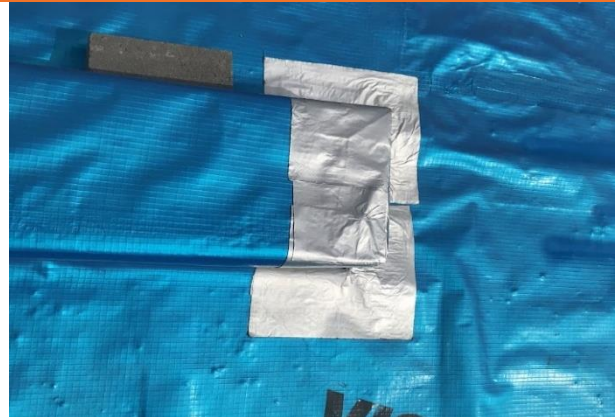
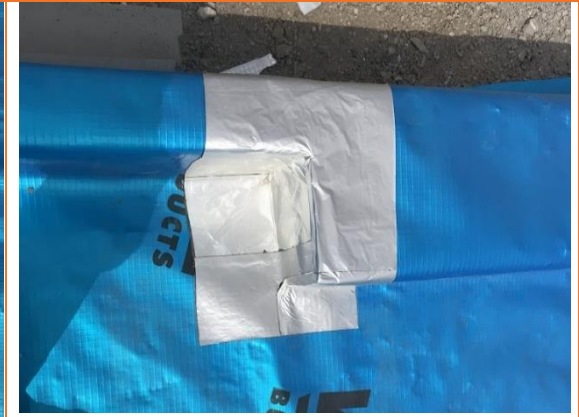
**Verification of Joints and Seals-Good Condition**

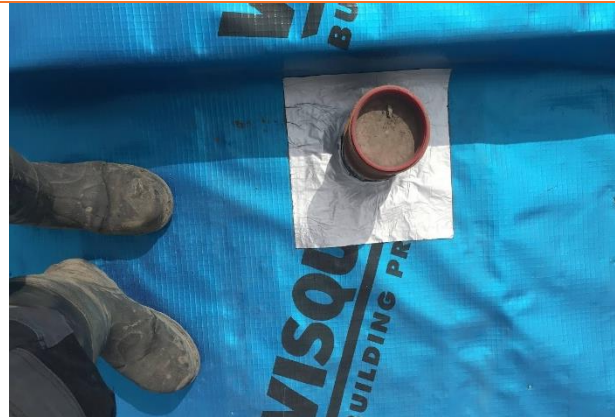
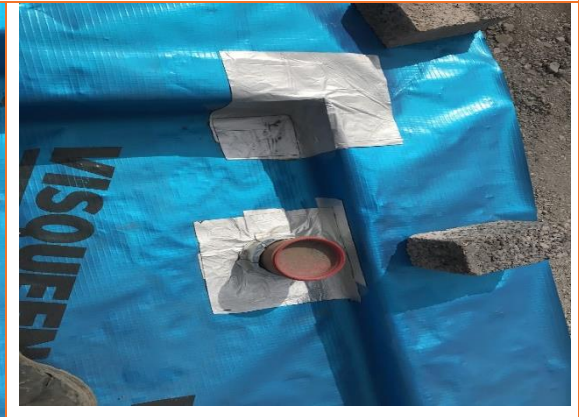
**Verification of Service Penetrations-Good Condition**

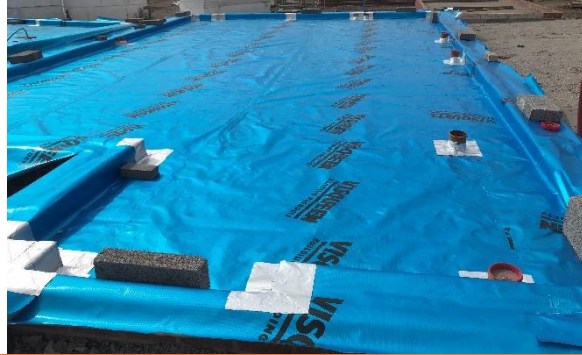
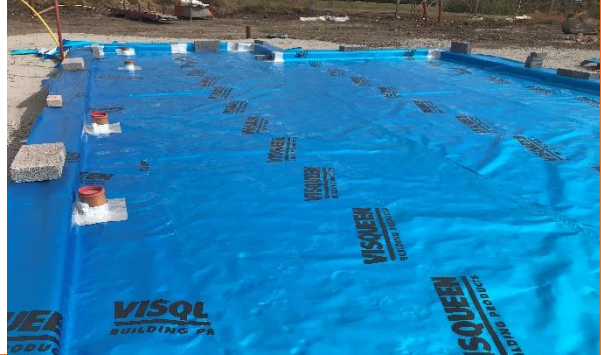
**Plot - 50**

**General Condition of Membrane-Good Condition**

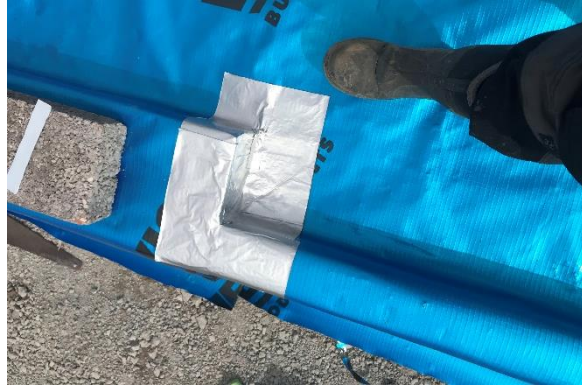
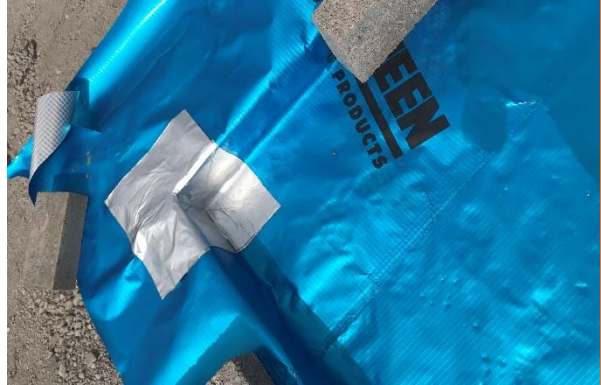
**Verification of Joints and Seals-Good Condition**

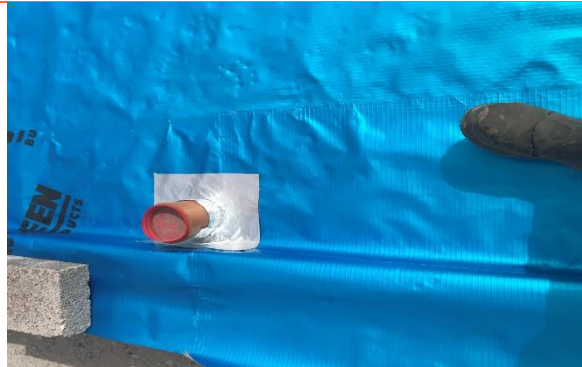
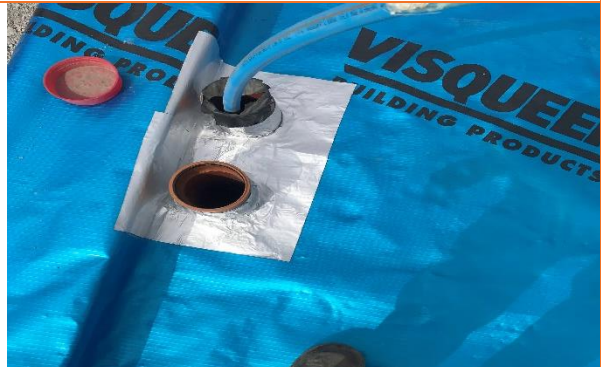
**Verification of Service Penetrations-Good Condition**

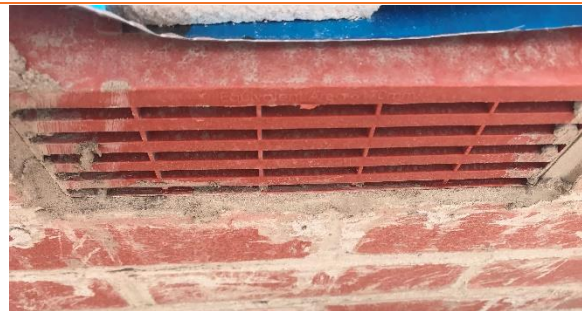
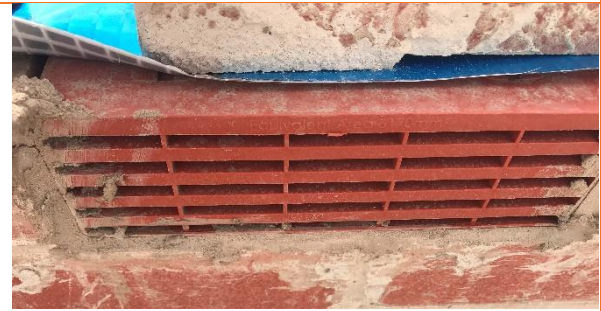
**Verification of Service Penetrations-Good Condition**

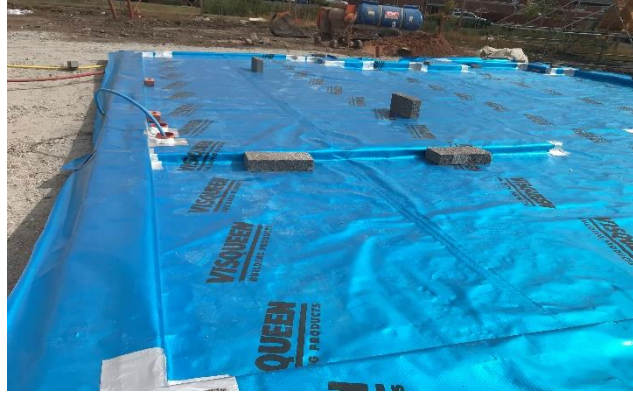
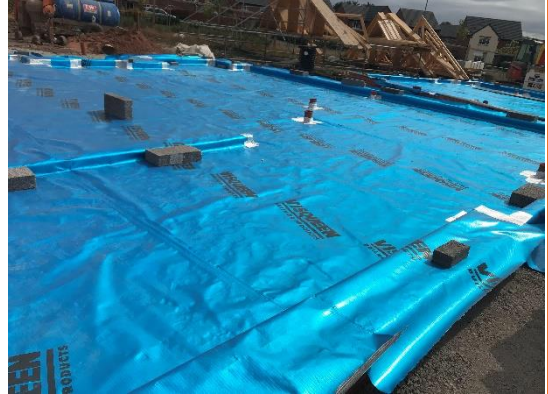
**Plot - 51**

**General Condition of Membrane-Good Condition**

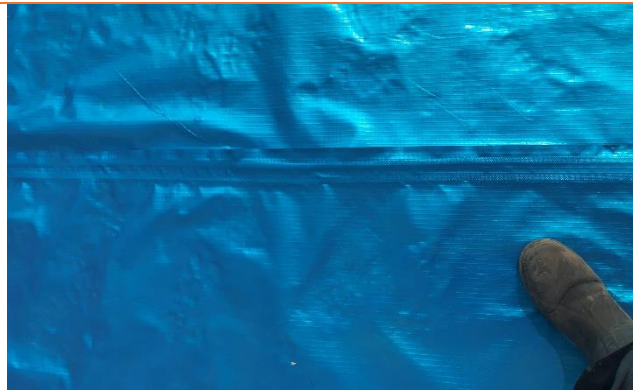
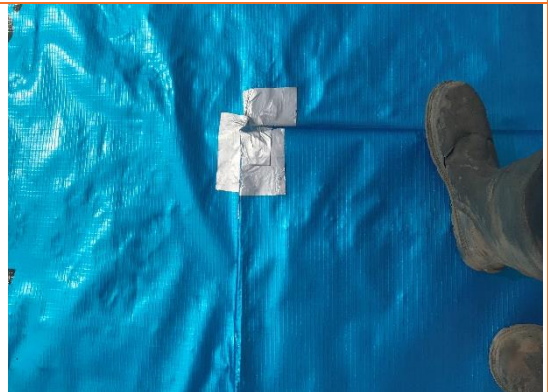
**Verification of Joints and Seals-Good Condition**

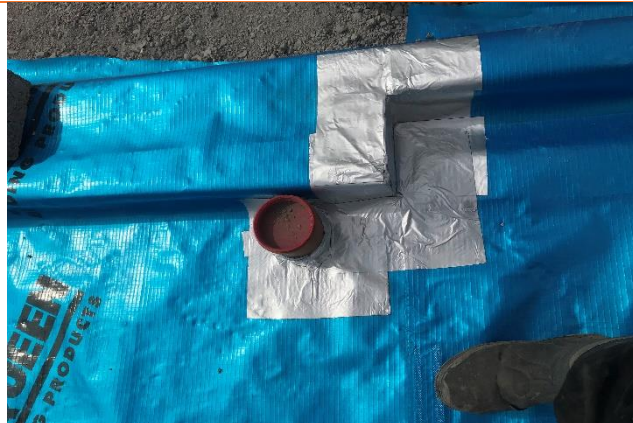
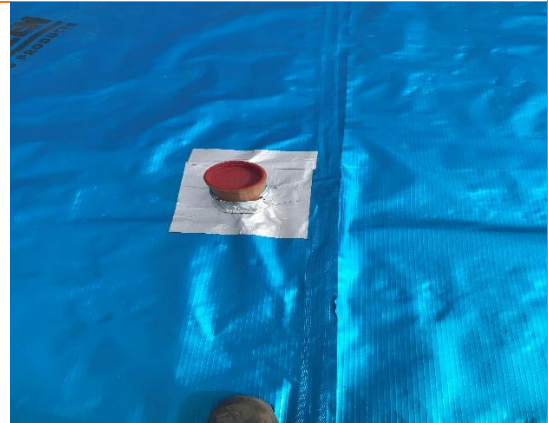
**Verification of Service Penetrations-Good Condition**

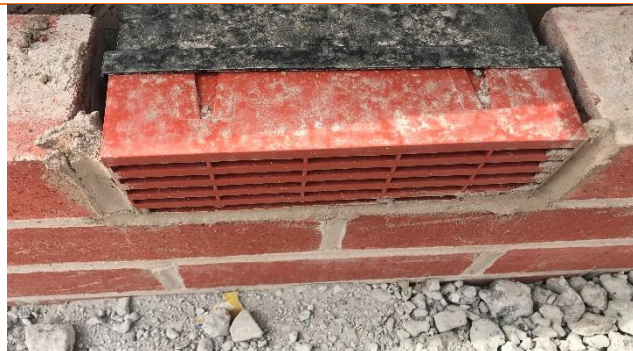
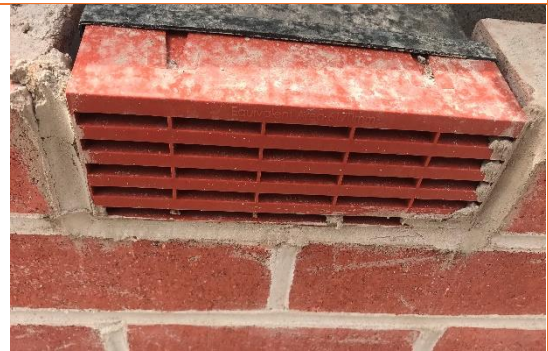
**Verification of Service Penetrations-Good Condition**

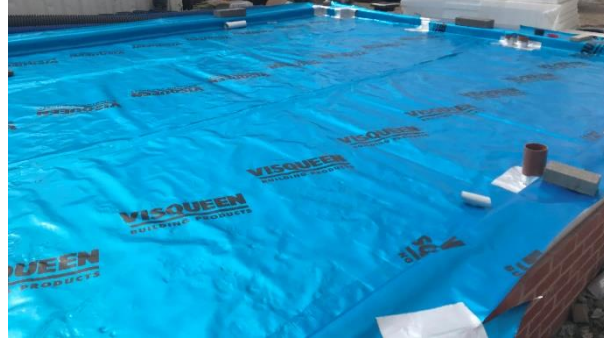
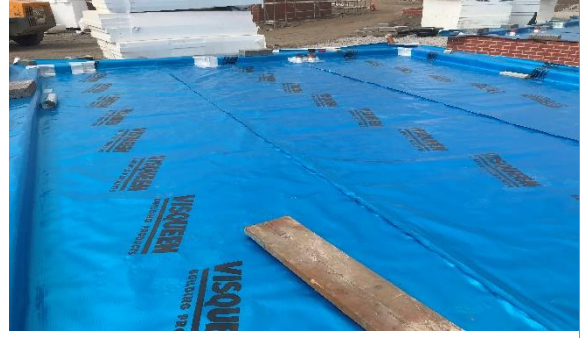
**Plot - 52**

**General Condition of Membrane-Good Condition**

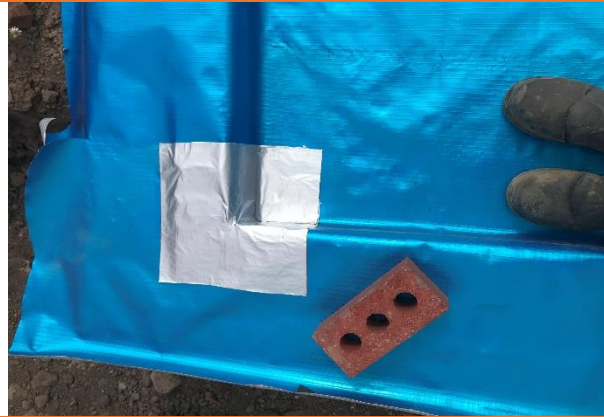
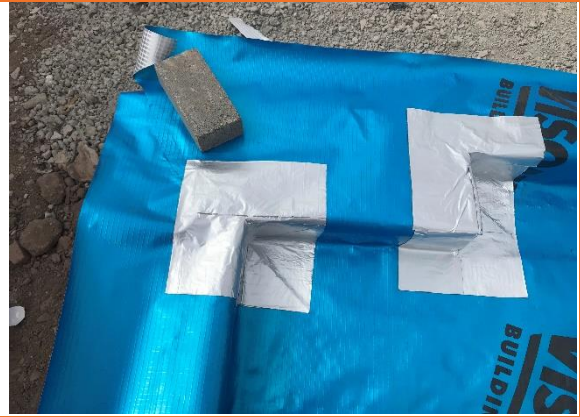
**Verification of Joints and Seals-Good Condition**

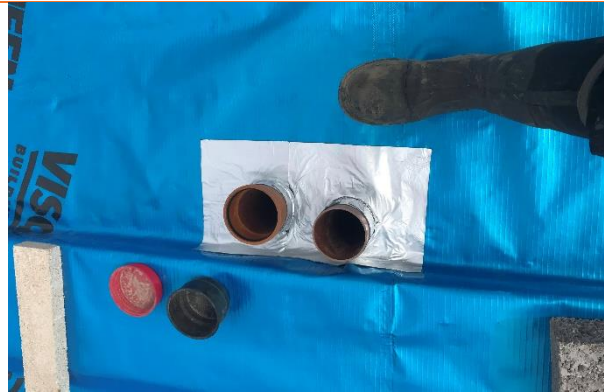
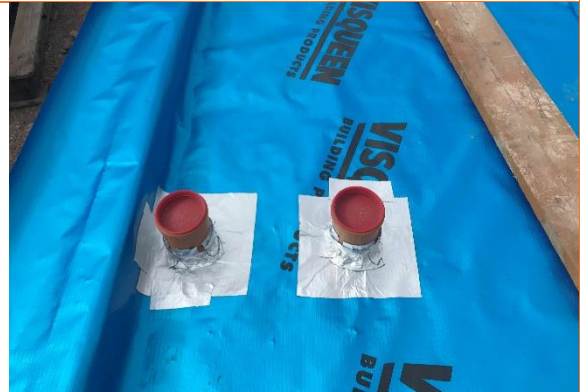
**Verification of Service Penetrations-Good Condition**

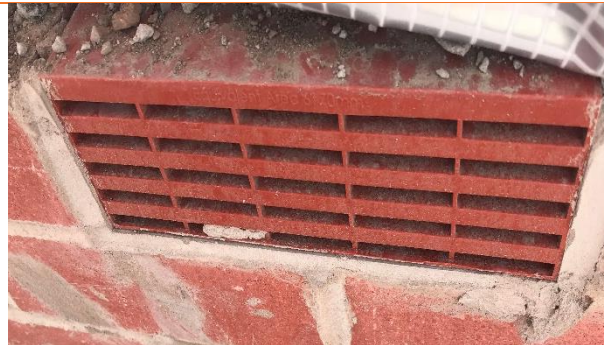
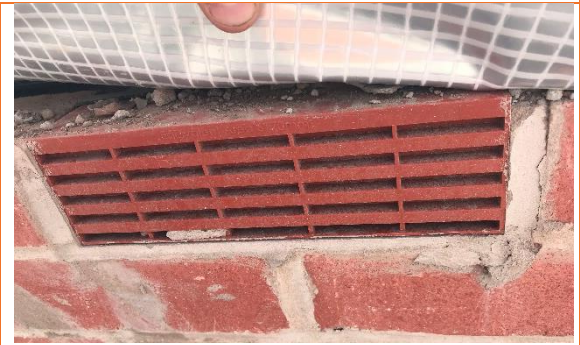
**Verification of Service Penetrations-Good Condition**

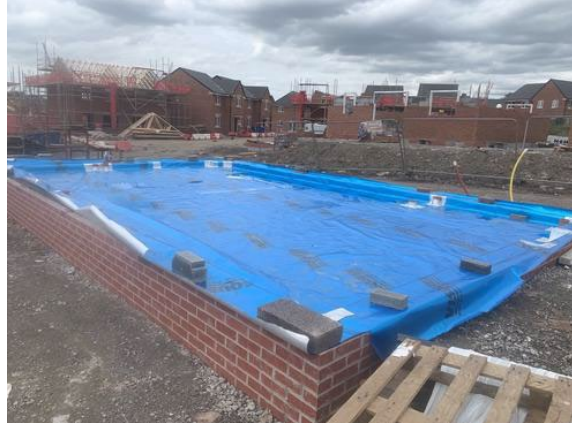
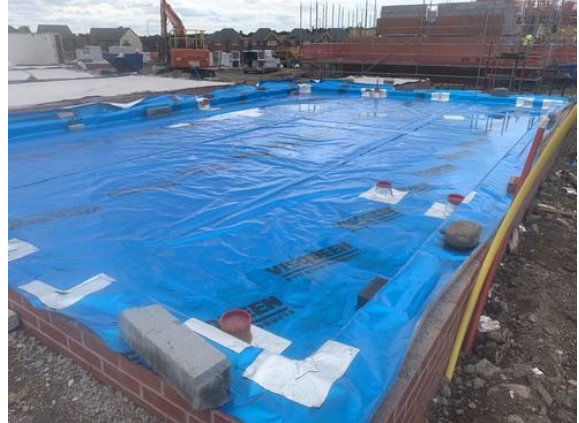
**Plot - 53**

**General Condition of Membrane-Good Condition**

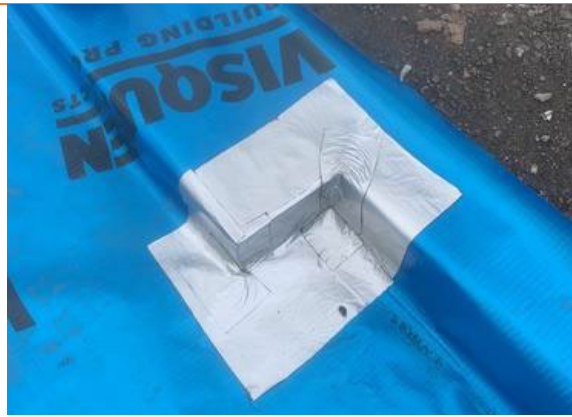
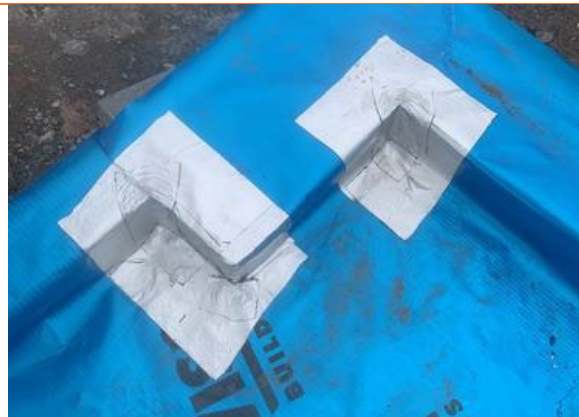
**Verification of Joints and Seals-Good Condition**

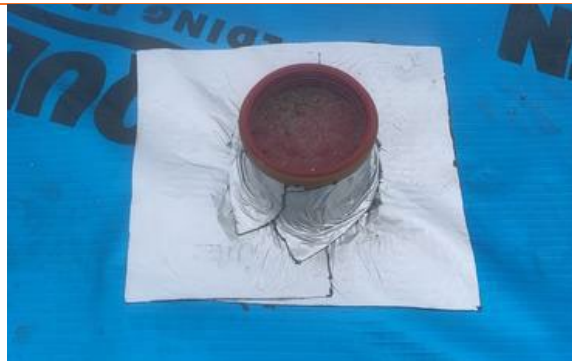
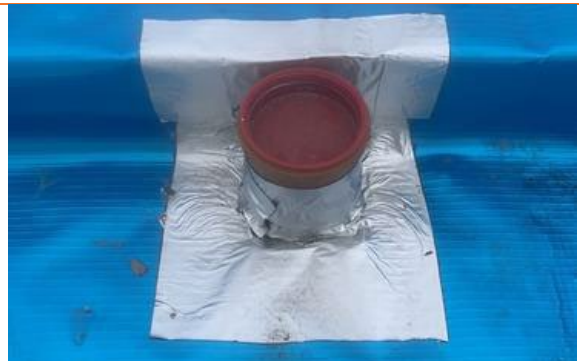
**Verification of Service Penetrations-Good Condition**

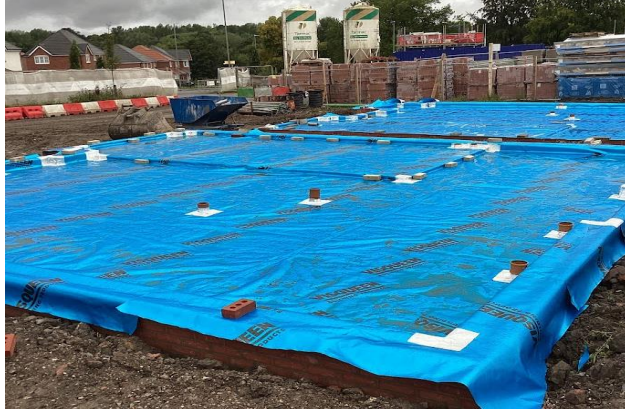
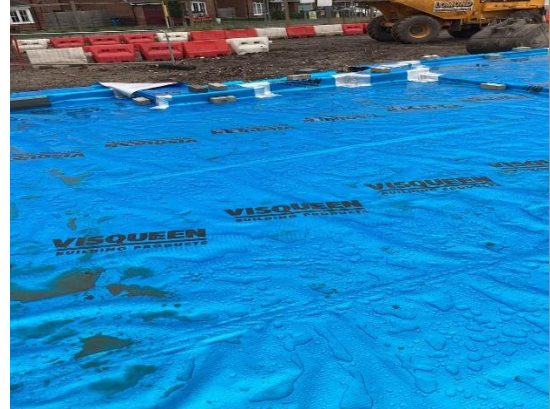
**Plot - 14**

**General Condition of Membrane-Good Condition**

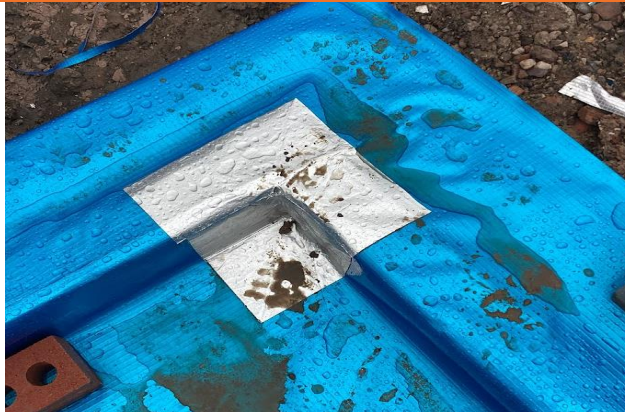
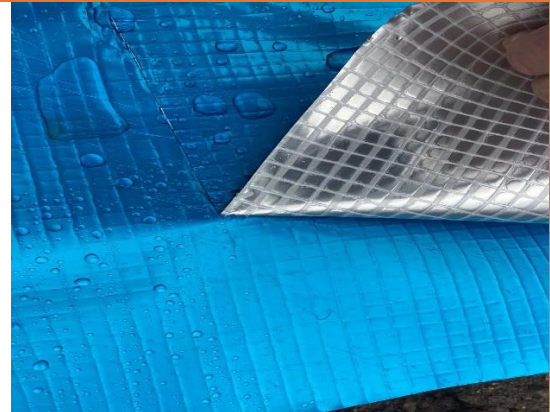
**Verification of Joints and Seals-Good Condition**

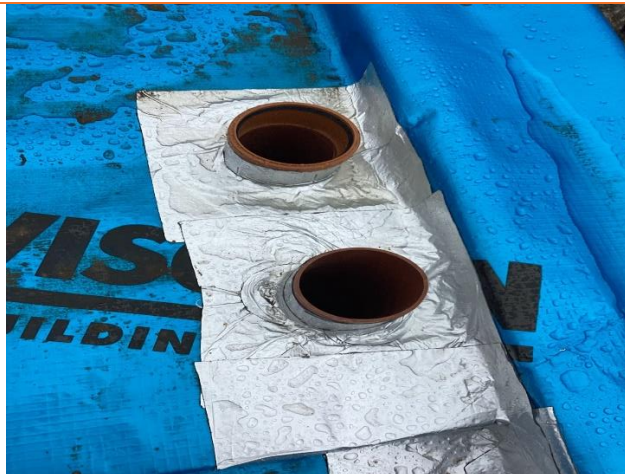
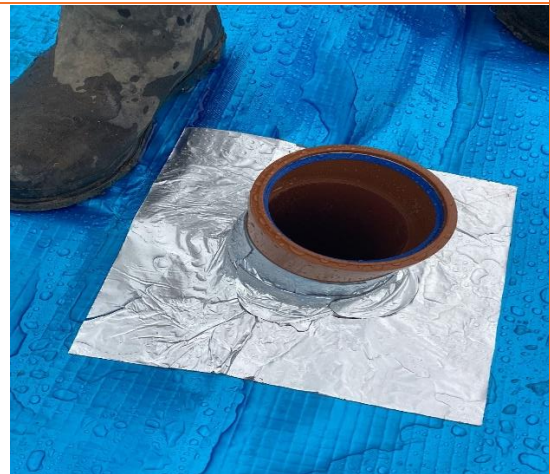
**Verification of Service Penetrations-Good Condition**

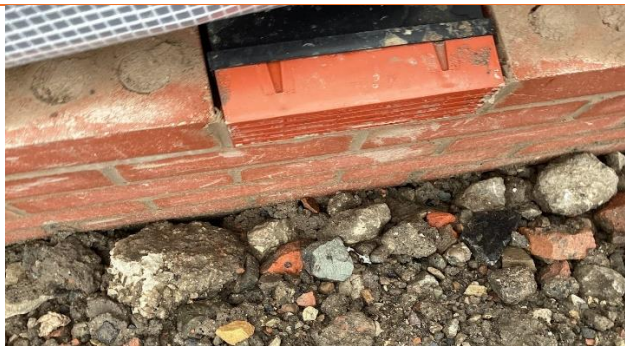
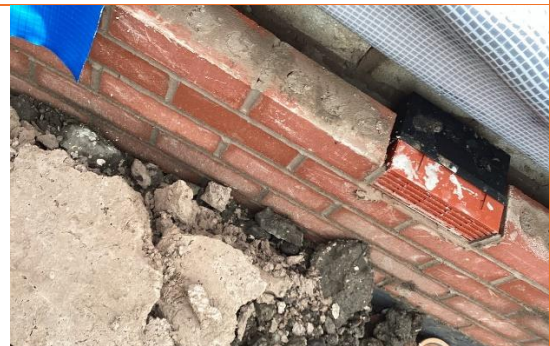
**Verification of Service Penetrations-Good Condition**

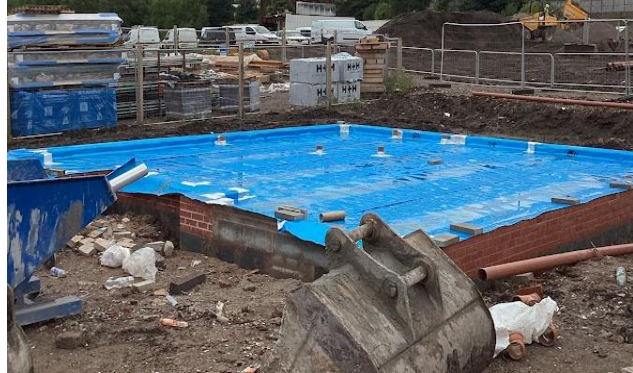
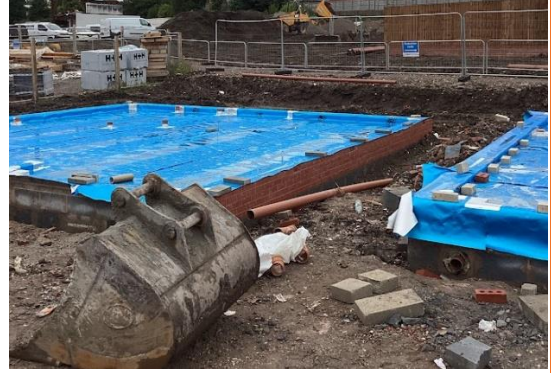
**Plot - 15**

**General Condition of Membrane-Good Condition**

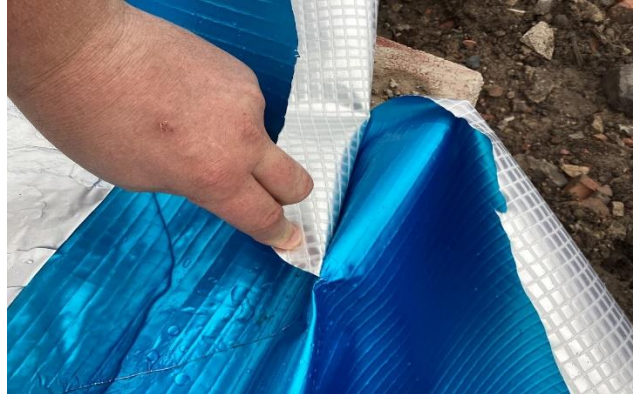
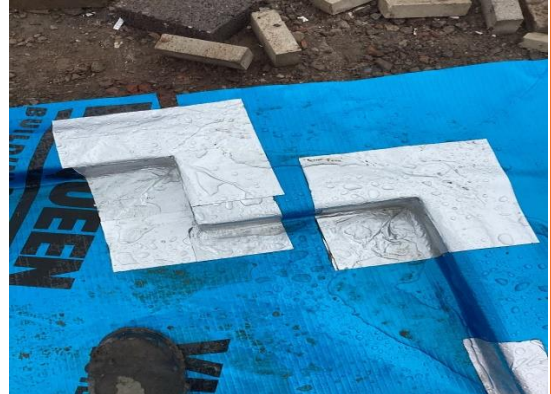
**Verification of Joints and Seals-Good Condition**

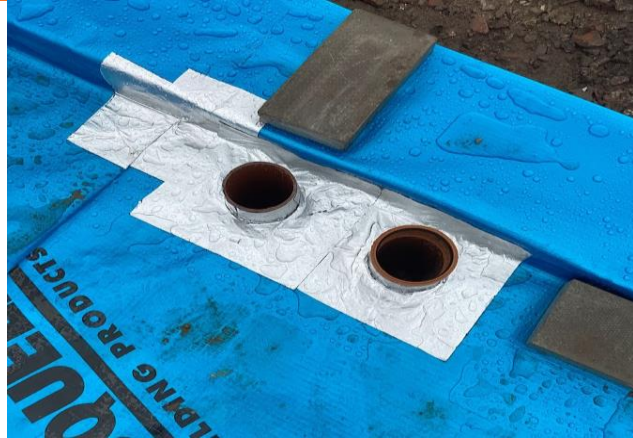
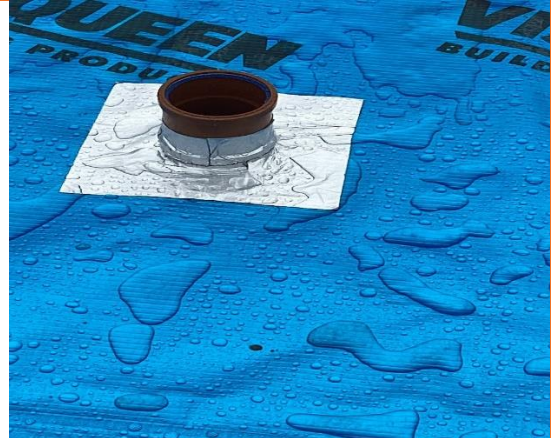
**Verification of Service Penetrations-Good Condition**

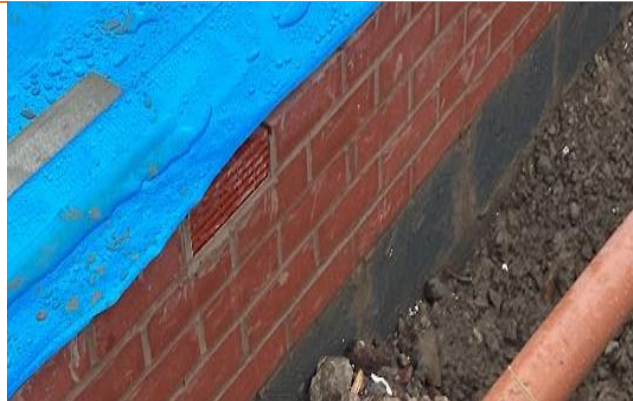
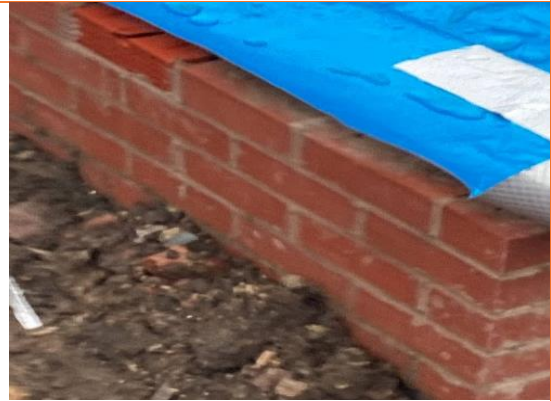
**Verification of Service Penetrations-Good Condition**
