## GAS MEMBRANE VALIDATION

| <b>Site Name:</b> Parcel C, Prescott | <b>Project Number:</b> 15-292 |
| Company: Miller Homes | Date: 19-05-2023 |

### Overview:

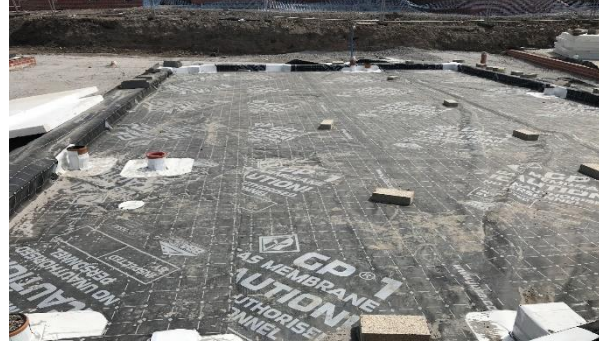
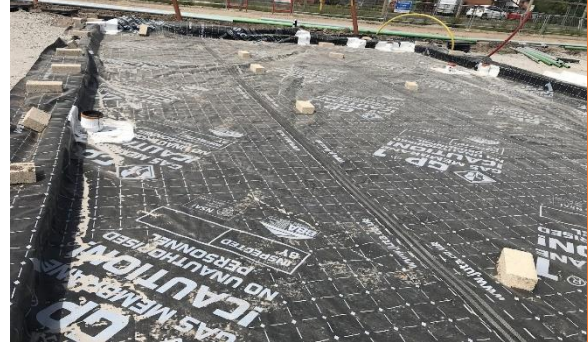
Plot - 38

General Condition of Membrane-Good Condition

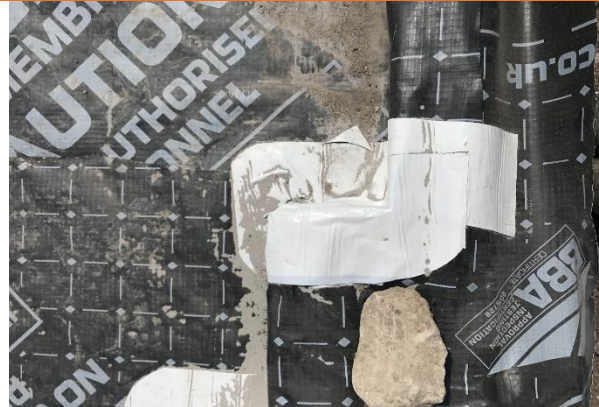
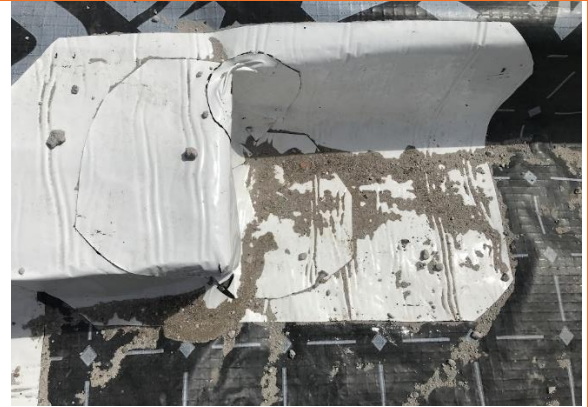
Verification of Joints and Seals-Good Condition

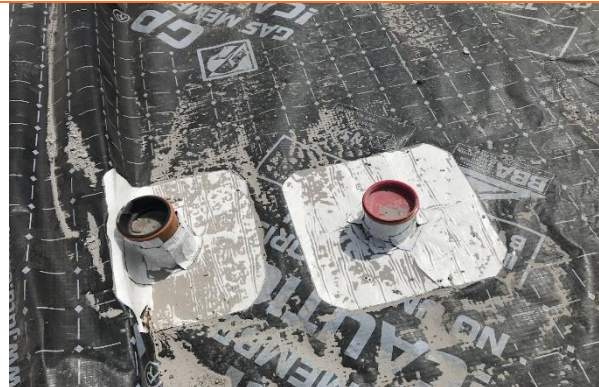
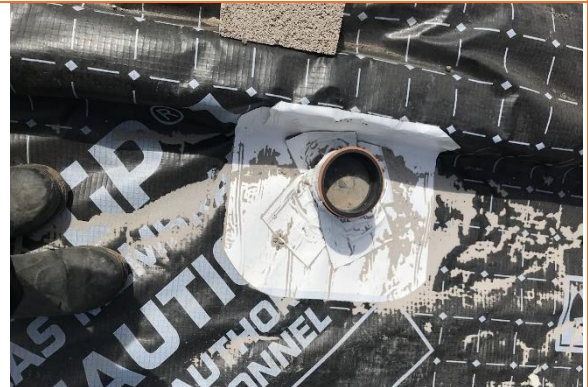
Verification of Service Penetrations-Good Condition

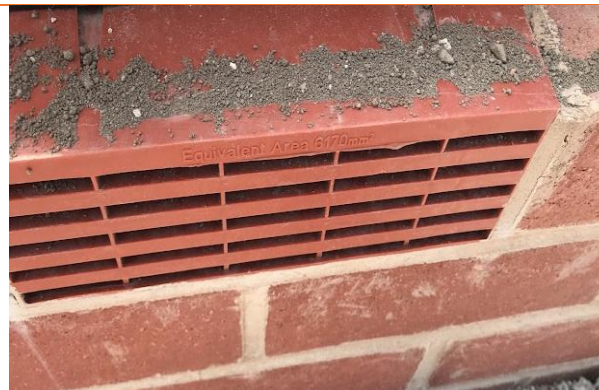
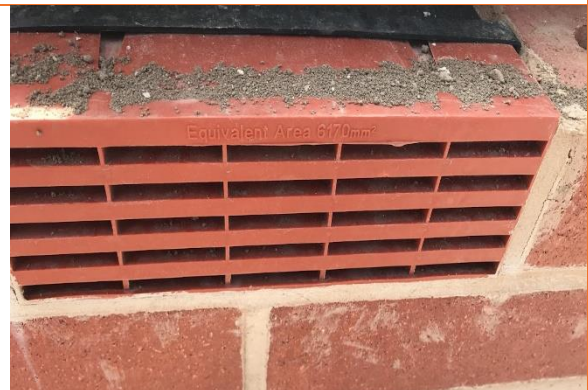
Verification of Service Penetrations-Good Condition

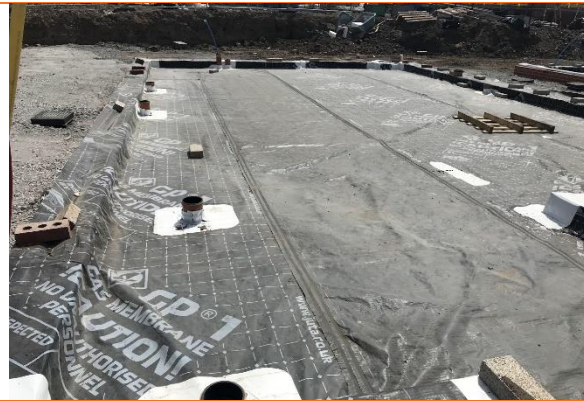
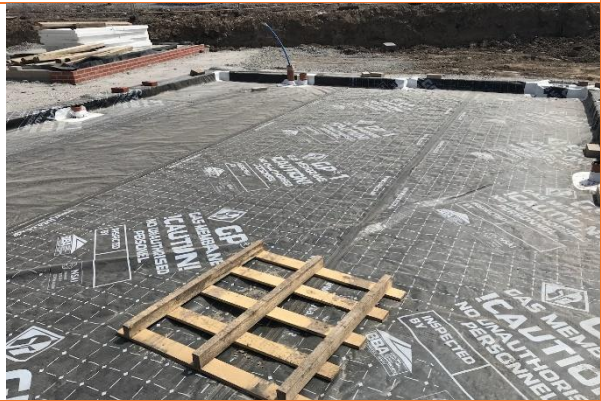
Plot – 39

General Condition of Membrane-Good Condition

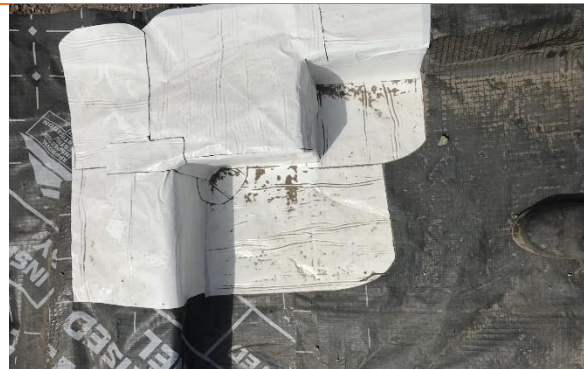
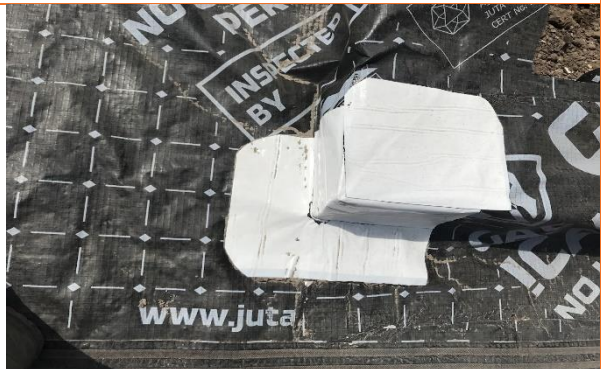
Verification of Joints and Seals-Good Condition

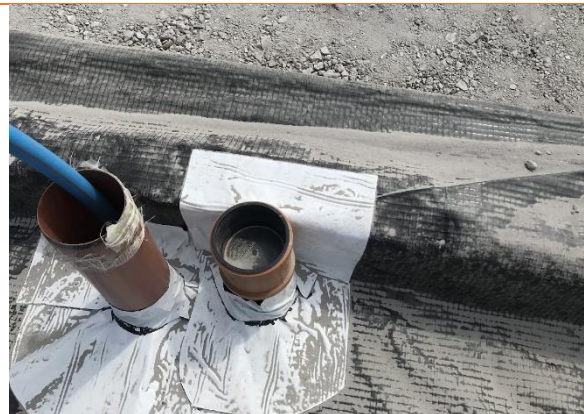
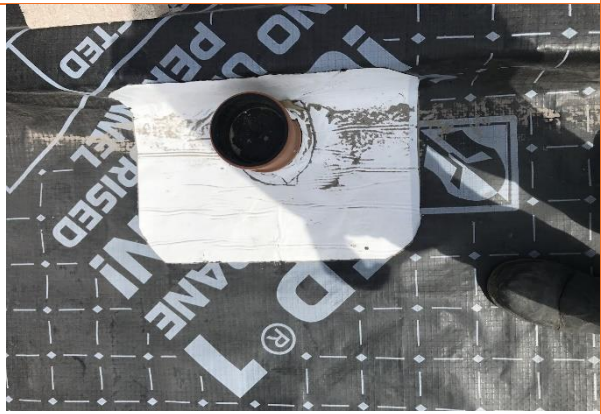
Verification of Service Penetrations-Good Condition

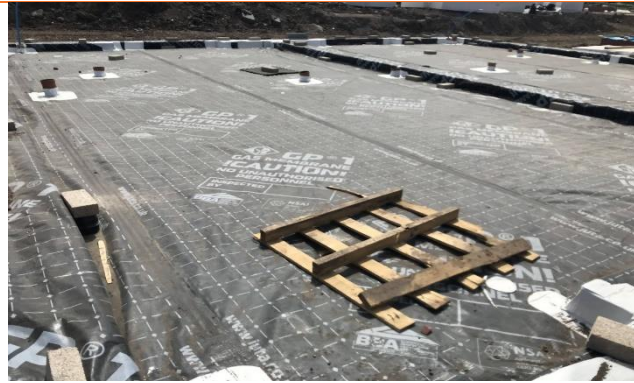
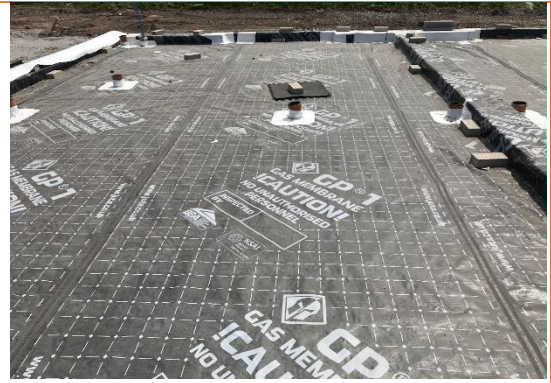
Plot - 40

General Condition of Membrane-Good Condition

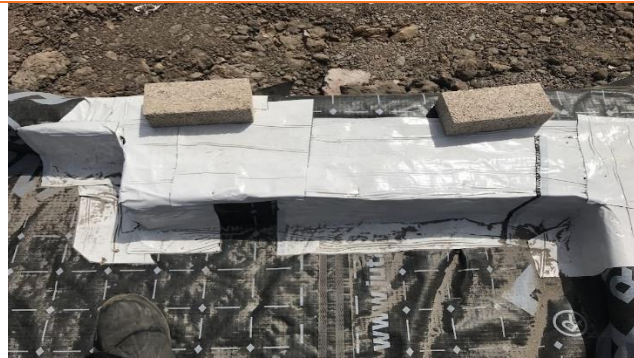
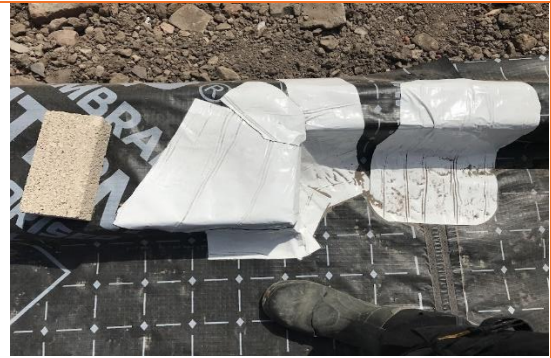
Verification of Joints and Seals-Good Condition

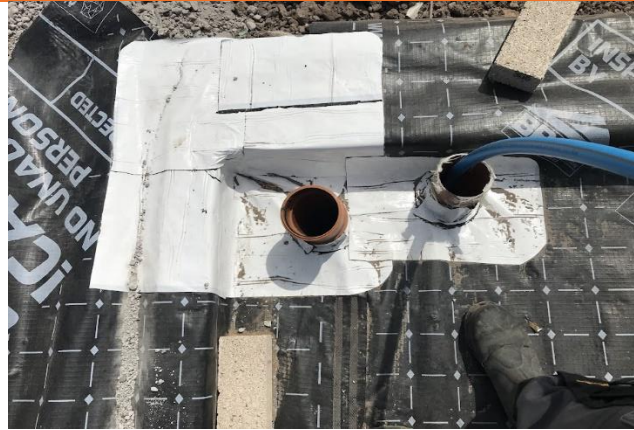
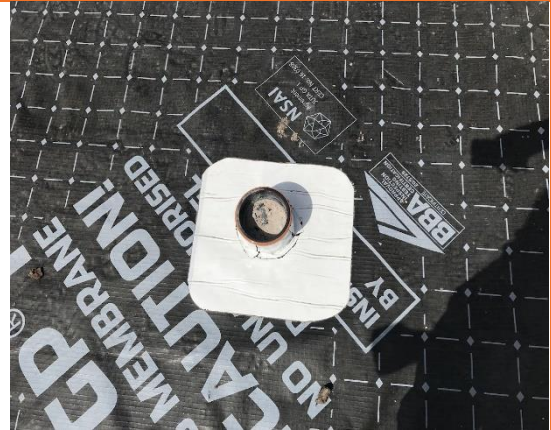
Verification of Service Penetrations-Good Condition

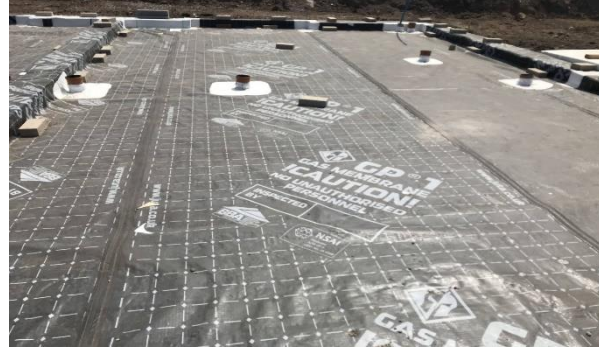
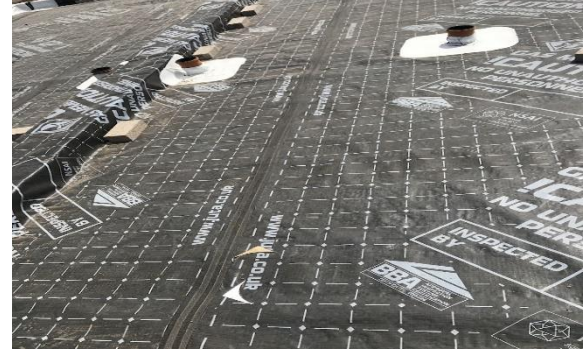
**Plot - 41**

**General Condition of Membrane-Good Condition**

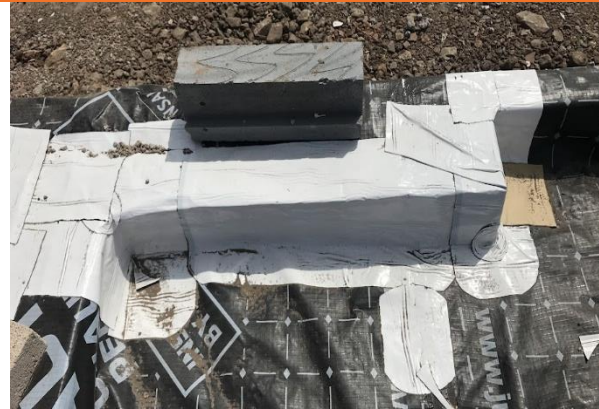
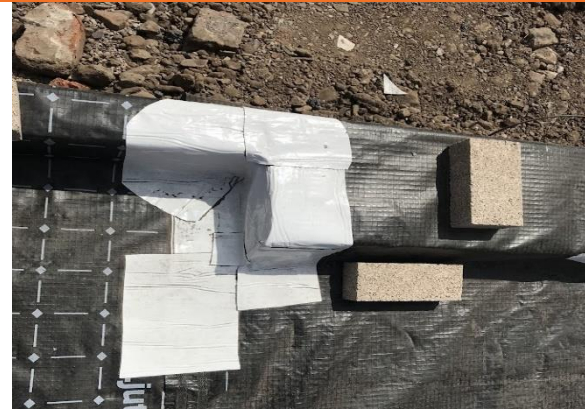
**Verification of Joints and Seals-Good Condition**

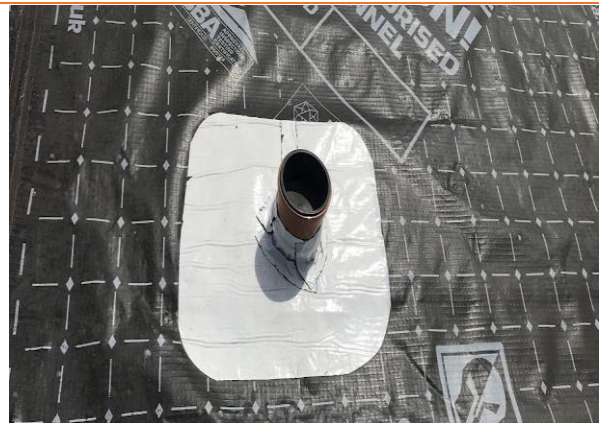
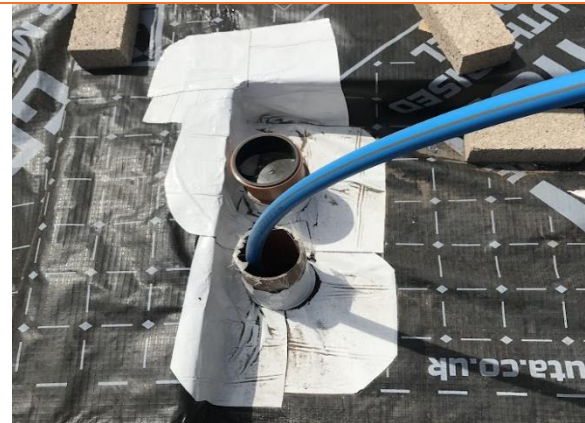
**Verification of Service Penetrations-Good Condition**

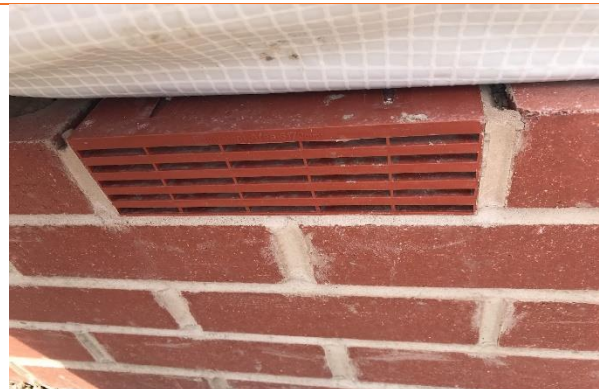
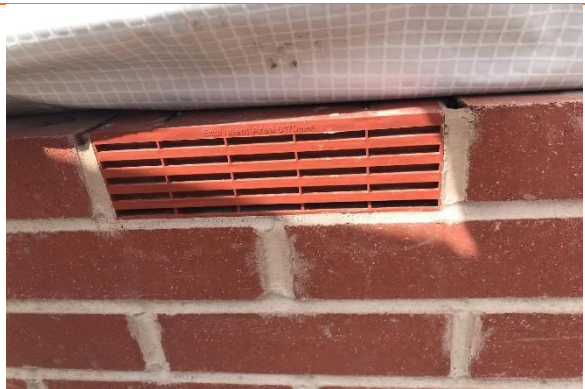
**Verification of Service Penetrations-Good Condition**

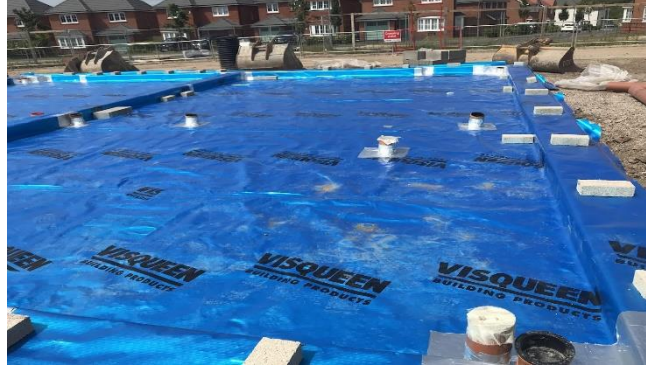
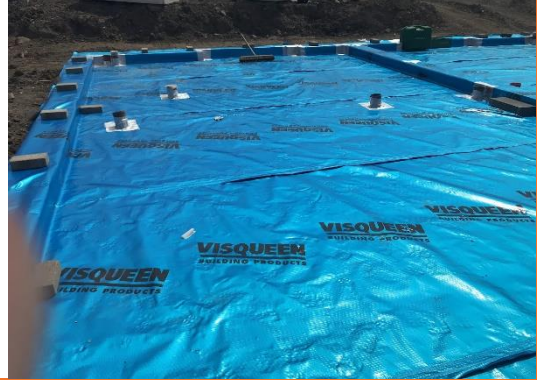
Plot - 42

General Condition of Membrane-Good Condition

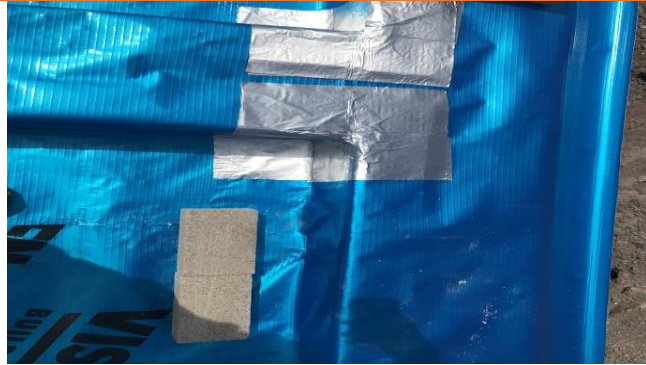
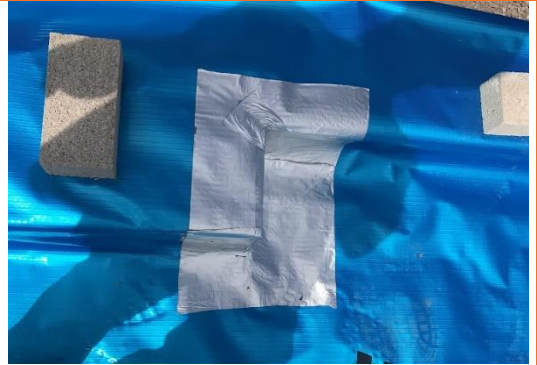
Verification of Joints and Seals-Good Condition

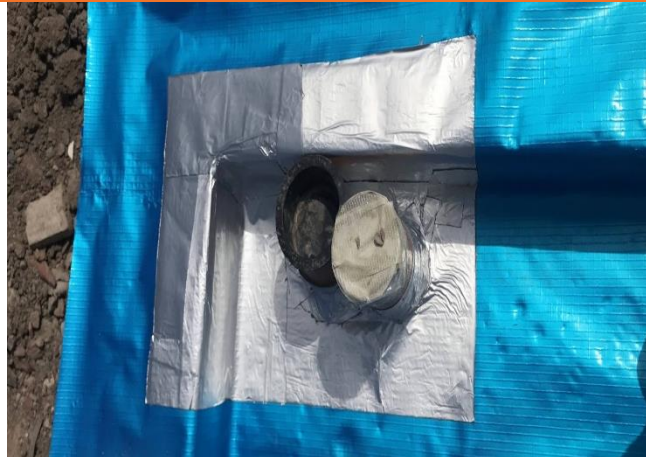
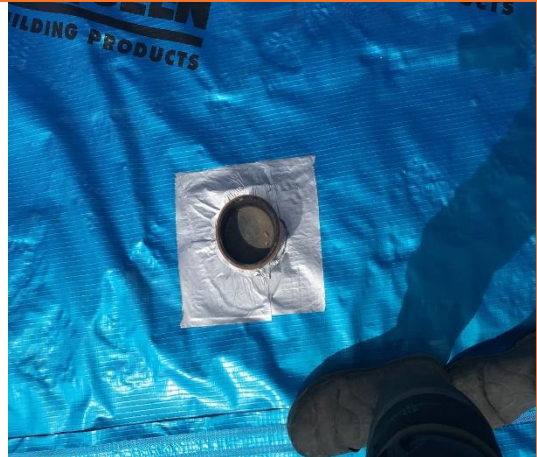
Verification of Service Penetrations-Good Condition

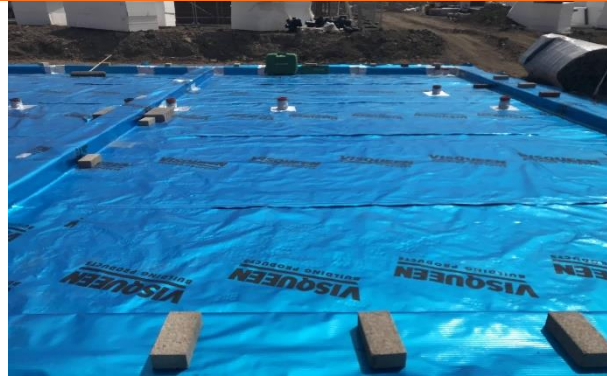
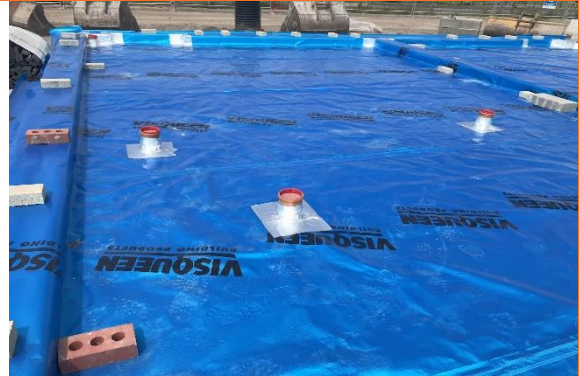
**Plot - 43**

**General Condition of Membrane-Good Condition**

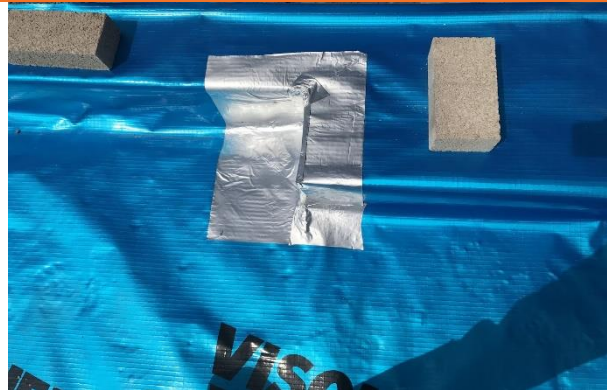
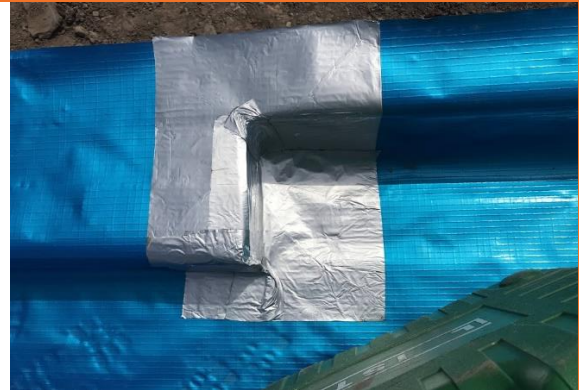
**Verification of Joints and Seals-Good Condition**

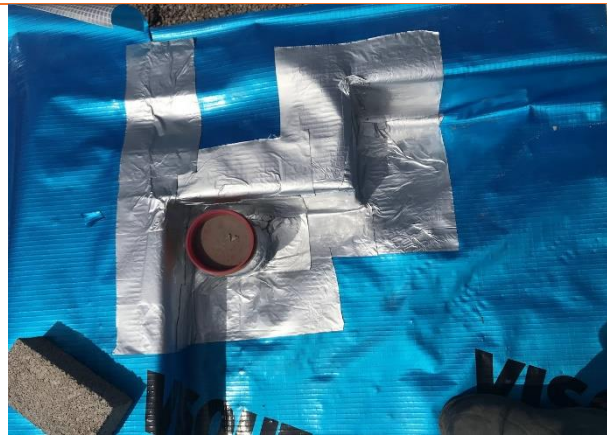
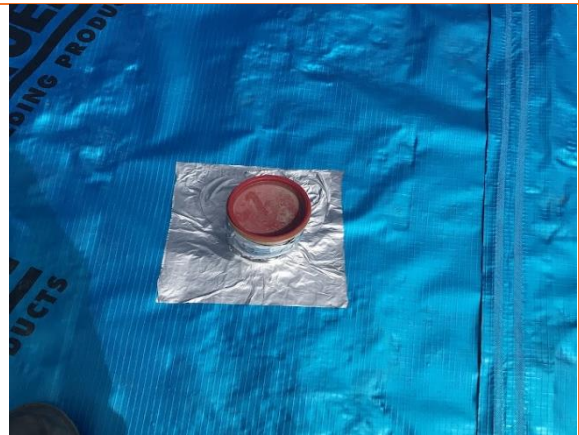
**Verification of Service Penetrations-Good Condition**
