**Appendix B**

### Photographic Record BH105 Trial Trench

### Photographic Record Cell One

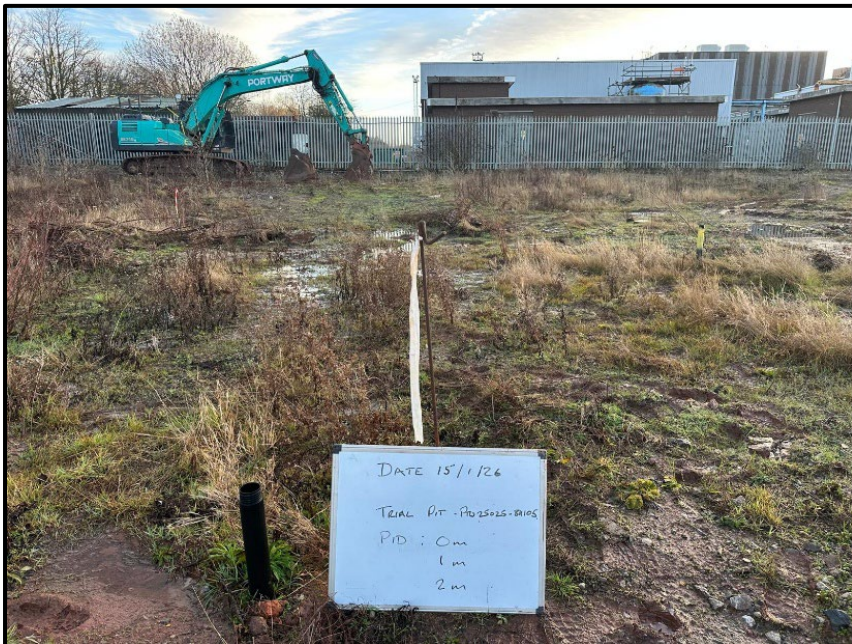
Borehole BH105 had recorded 512mg/kg of 1,2, dichlorobenzene within a previous ground investigation. During the trial pitting exercise across the site within the 20m grid squares no elevated levels of 1,2, dichlorobenzene was discovered.

The trial trench was excavated between BH105 (shown next to the white board) and WS110 (yellow pipe to the centre right).

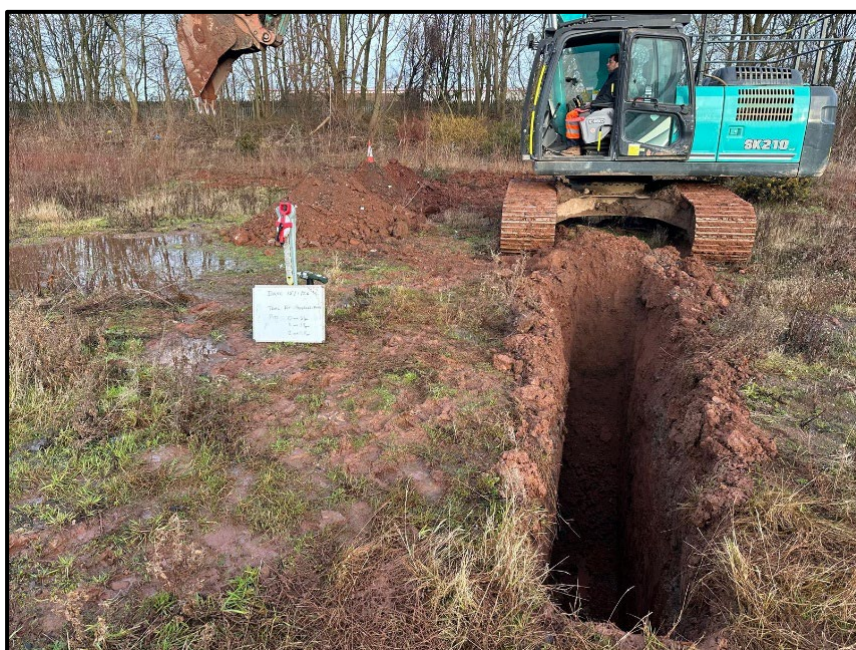
A trial trench was excavated next to BH105, no odour detected with a human nose and readings on a PID meter were encountered at 3.1ppm near the surface.

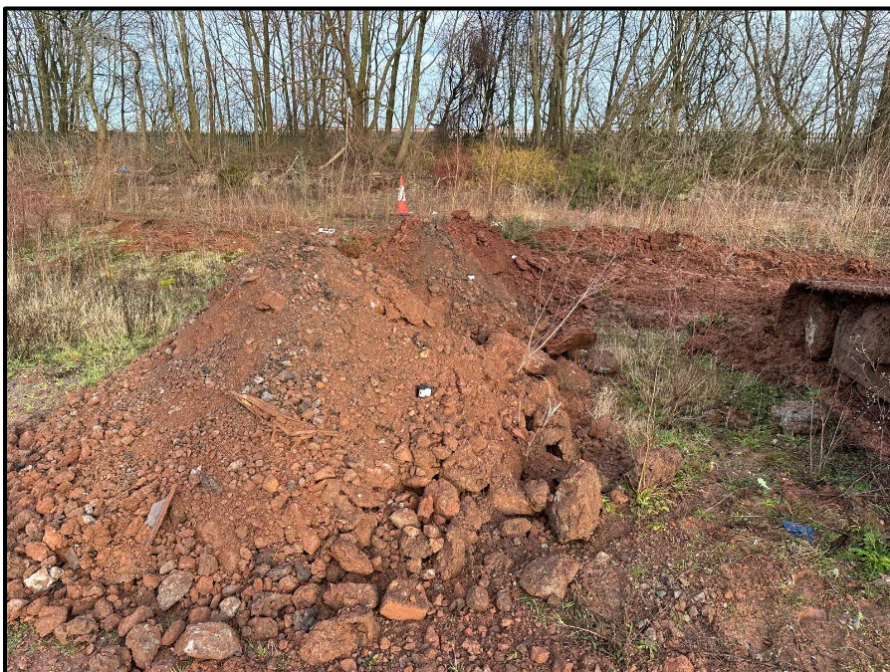
Samples were taken for VOC testing and the results confirmed that no elevated levels of 1,2, dichlorobenzene were present. The material excavated did not exhibit any signs of contamination (strong odour or discolouration). Our only explanation for this is likely to be an error during the historic sampling, test and reporting.

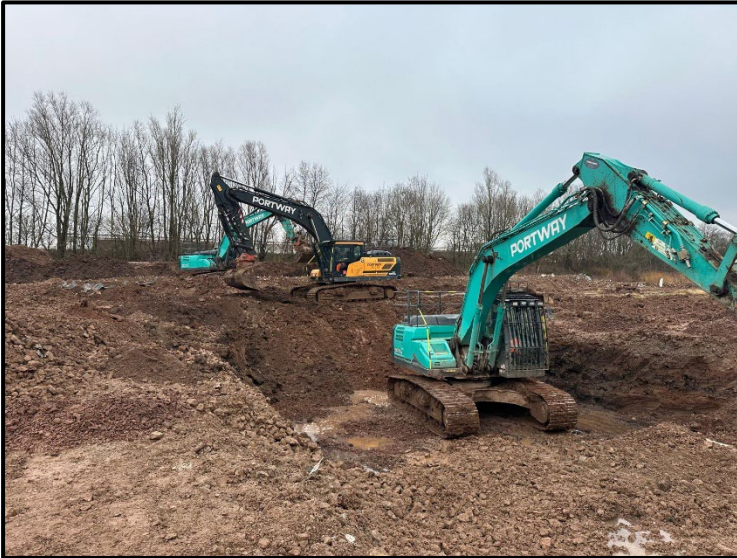
Excavation process showing the groundwater interface encountered at the base of the void within cell two.

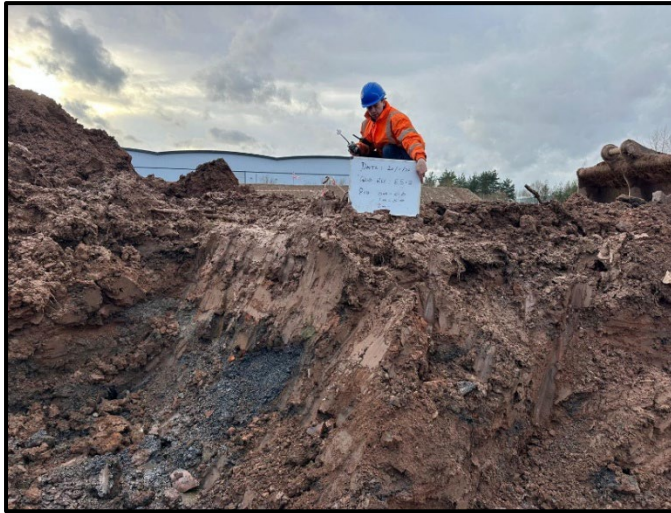
The images displayed here show the black bands of contamination next to GJR03 within cell two. As the material was contaminated, this was excavated and removed to the treatment area, which resulted in the removal of borehole GJR03.

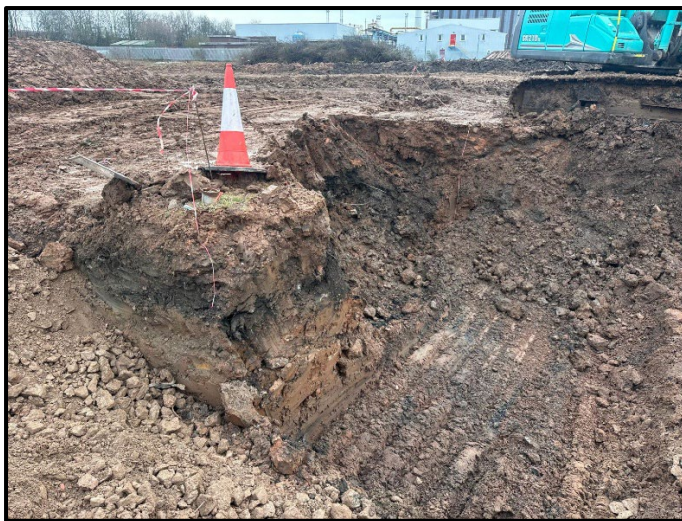
This image shows where contamination is present in black bands above and below the clay material. The cone is placed over borehole GJR03 as a marker.

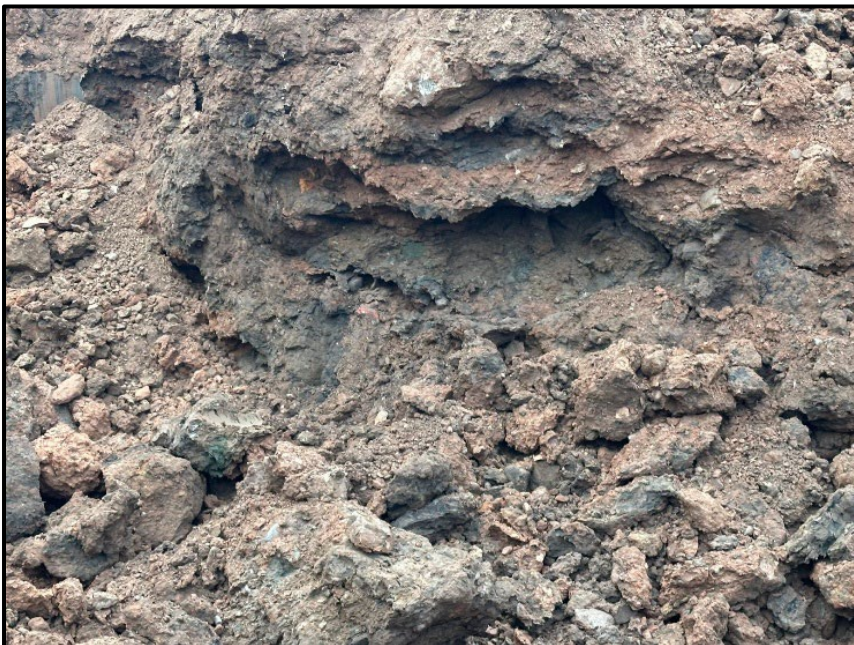
This image shows the type of material that was impacted and the visual effect it had on the material leading of

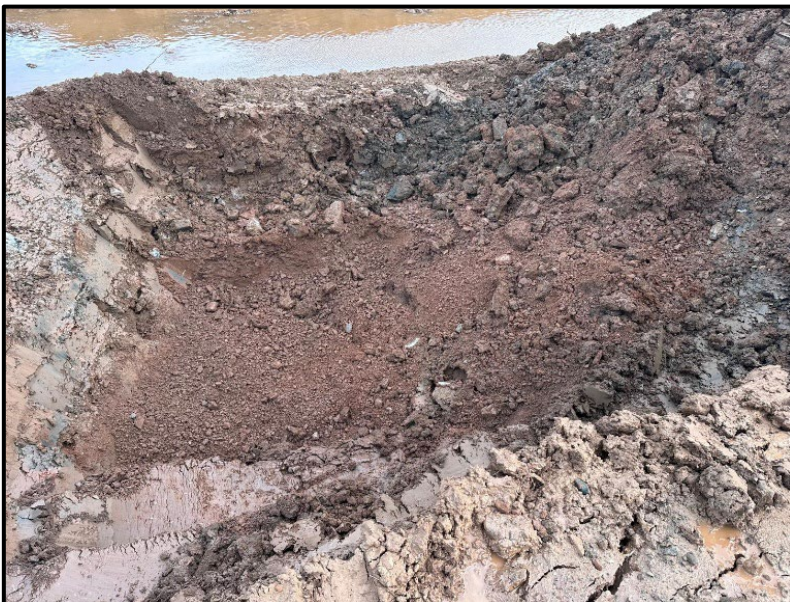
Cell three after completion had a failure on two of the faces resulting in the further excavation of material to ensure that only soil below the site derived RTV's remained. An earth bund was used to prevent water ingress until the suspected impacted material was fully excavated.

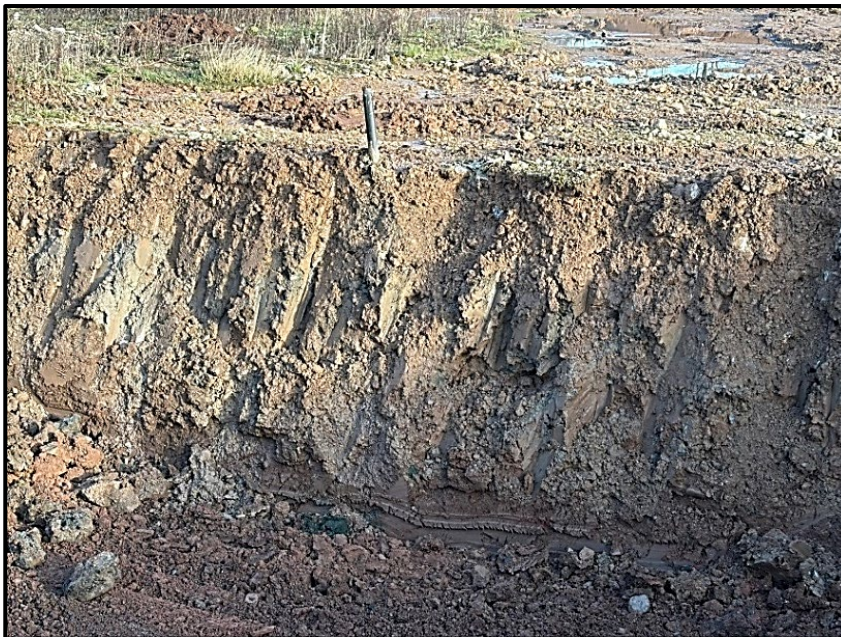
Impacted material identified in the vicinity of BH104 is shown. The soils were observed to exhibit visual and olfactory indicators of contamination, including discolouration and staining, consistent with previously identified ground conditions in this area.

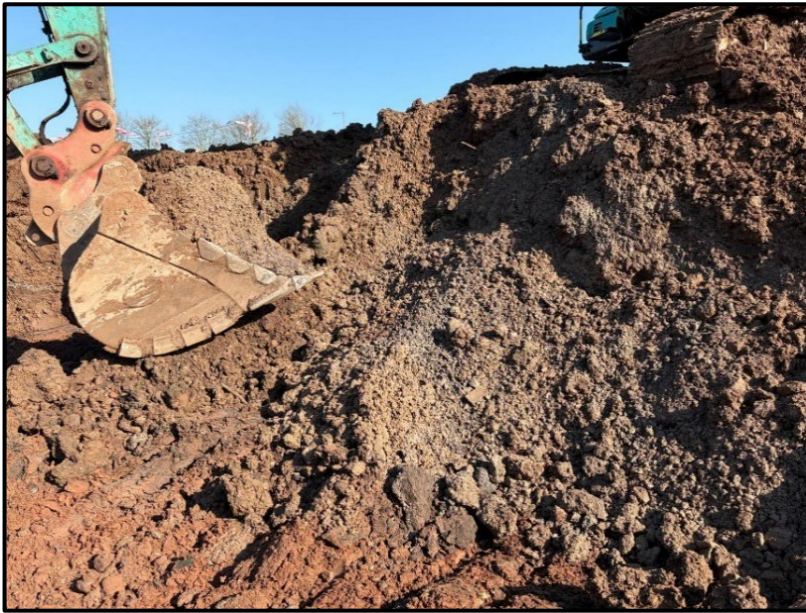
Material being removed from cell four showing the impacted material (lighter/grey in colour) above clean base (orange/brown natural material).

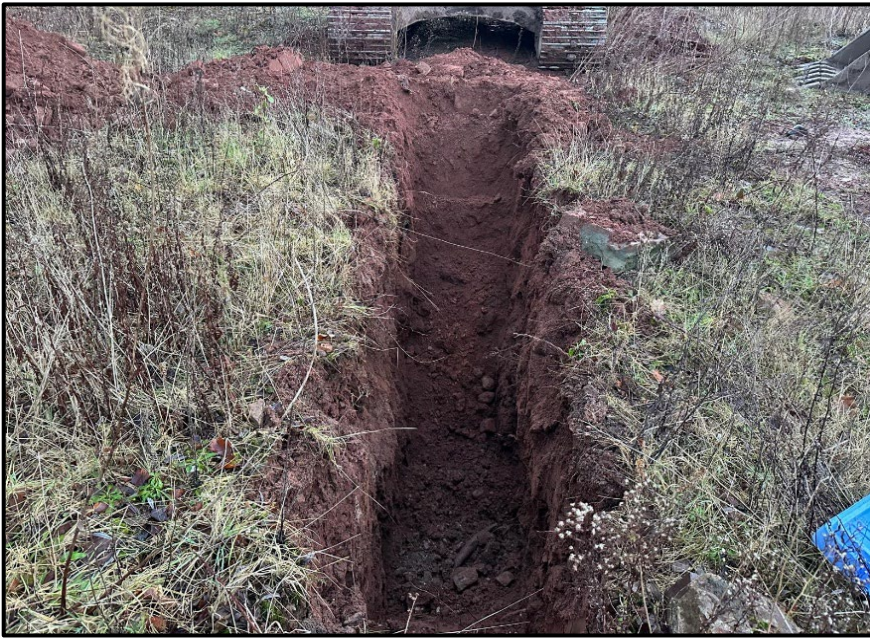
This image shows the ground conditions encountered within the vicinity of WS103, mostly natural undisturbed soils.

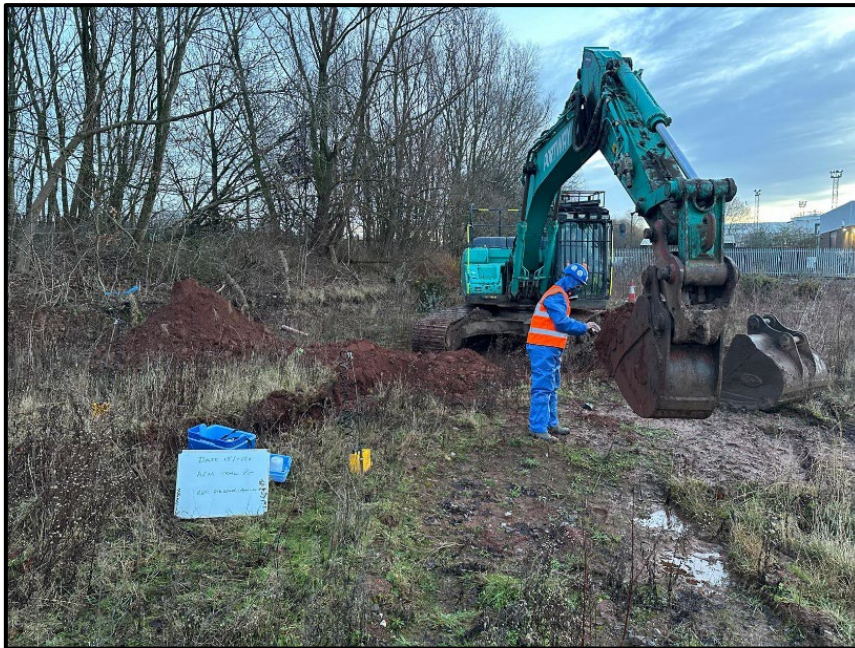
An inspection of the ground was undertaken, and no visible fragments were encountered. Soil samples were obtained for asbestos screen and quantification testing. During these site works full PPE and RPE was used.
