# Drainage Report

**Jubilee Park**  
**Jubilee Park, Dinas Lane**  
**Liverpool**  
**L36 2NW**

## 102678 Jubilee Park - CCTV Survey Report : 09/11/23

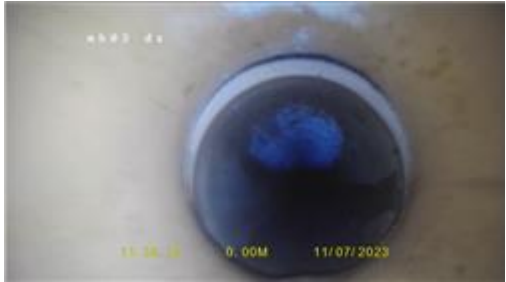
| Position | Code | Description | CD | Pic | Video Ref |
|---|---|---|---|---|---|
| 00.3 | JDM | Joint displaced medium | | 2_2 | 0:00:01 |

| Pos | Video Ref | Code | Cont. | Description | Image |
|---|---|---|---|---|---|
| 00.3m | 0:00:01 | JDM | | Joint displaced medium - Severity 2 | Image Provided - Ref: 2_2<br> |

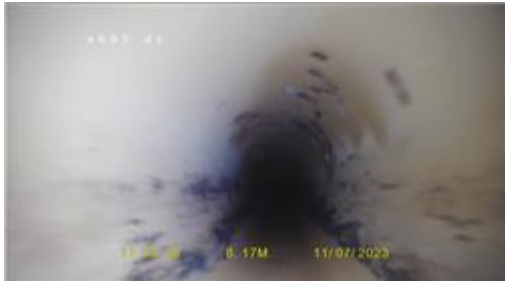
| Pos | Video Ref | Code | Cont. | Description | Image |
|---|---|---|---|---|---|
| 08.2m | | SA | | Survey abandoned<br>Survey Abandoned - Unable to Push Camera Further | Image Provided - Ref: 2_9999<br> |

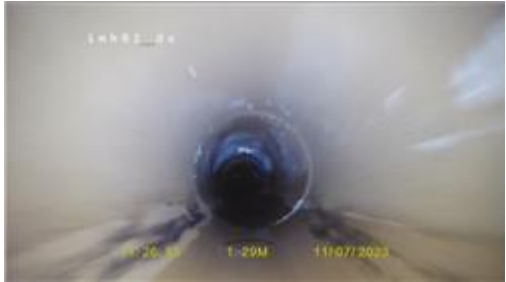
| Pos | Video Ref | Code | Cont. | Description | Image |
|---|---|---|---|---|---|
| 01.5m | 0:00:05 | LL | | Line of drain/sewer deviates left | Image Provided - Ref: 7_2<br> |

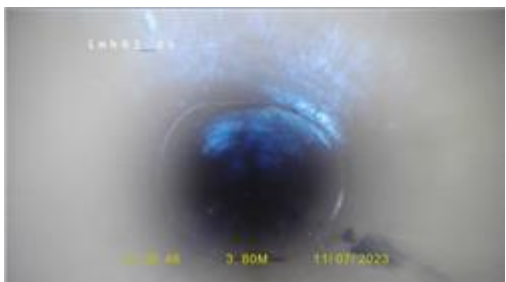
| Position | Code | Description | CD | Pic | Video Ref | |
|---|---|---|---|---|---|--|
| 04.0 | FC | Fracture circumferential 12-12 | | 7_5 | 0:00:18 | |

| Pos | Video Ref | Code | Cont. | Description | Image |
|---|---|---|---|---|---|
| 04.0m | 0:00:18 | FC | | Fracture circumferential from 12 o'clock to 12 o'clock - Severity 3 | Image Provided - Ref: 7_5<br> |

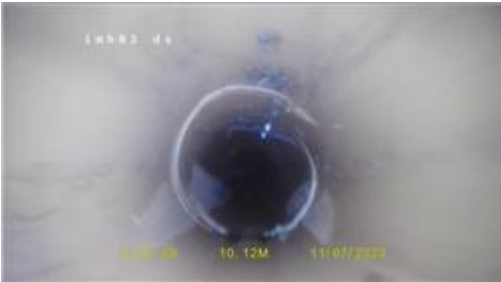
| Position | Code | Description | CD | Pic | Video Ref | |
|---|---|---|---|---|---|--|
| 10.3 | FC | Fracture circumferential 12-12 | | 7_6 | 0:00:41 | |

| Pos | Video Ref | Code | Cont. | Description | Image |
|---|---|---|---|---|---|
| 10.3m | 0:00:41 | FC | | Fracture circumferential from 12 o'clock to 12 o'clock - Severity 3 | <div>Image Provided - Ref: 7_6</div> |

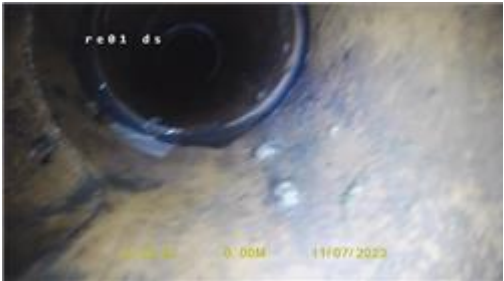
| Position | Code | Description | CD | Pic | Video Ref |
|---|---|---|---|---|---|
| 00.2 | OJM | Open joint medium | | 8_2 | 0:00:01 |

| Pos | Video Ref | Code | Cont. | Description | Image |
|---|---|---|---|---|---|
| 00.2m | 0:00:01 | OJM | | Open joint medium - Severity 2 | Image Provided - Ref: 8_2<br> |

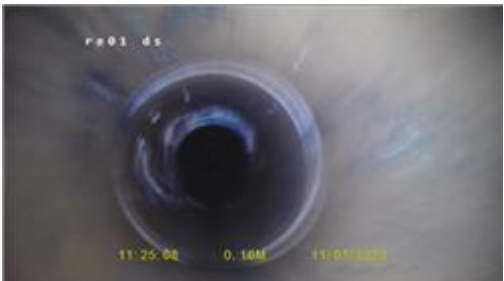
| Position | Code | Description | CD | Pic | Video Ref |
|---|---|---|---|---|---|
| 00.5 | FC | Fracture circumferential 12-12 | | 8_3 | 0:00:02 |

| Pos | Video Ref | Code | Cont. | Description | Image |
|---|---|---|---|---|---|
| 00.5m | 0:00:02 | FC | | Fracture circumferential from 12 o'clock to 12 o'clock - Severity 3 | Image Provided - Ref: 8_3<br> |

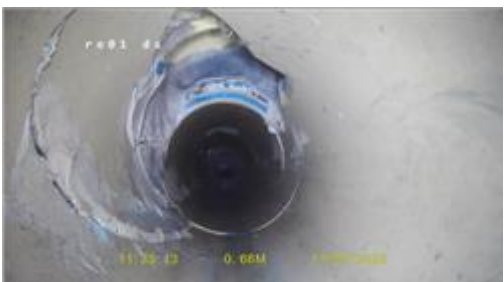
| Position | Code | Description | CD | Pic | Video Ref |
|---|---|---|---|---|---|
| 00.7 | FC | Fracture circumferential 03-12 | | 8_4 | 0:00:06 |

| Pos | Video Ref | Code | Cont. | Description | Image |
|---|---|---|---|---|---|
| 00.7m | 0:00:06 | FC | | Fracture circumferential from 03 o'clock to 12 o'clock - Severity 3 | Image Provided - Ref: 8_4<br> |

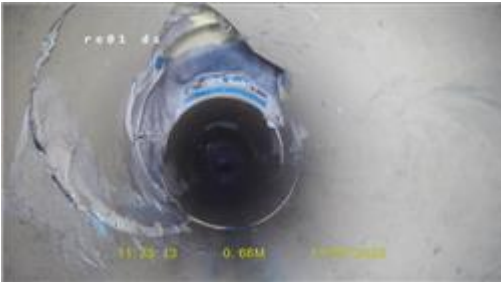
| Pos | Video Ref | Code | Cont. | Description | Image |
|---|---|---|---|---|---|
| 00.8m | 0:00:06 | CN | | Connection other than junction at 12 o'clock: 100mm Diameter | Image Provided - Ref: 8_5<br> |
