Cockpit House, Prescot  
for Purcell

Elevation B

Drawing No: X54/106    Rev: -    Scale: 1:100 @ A3    Date: October 2021

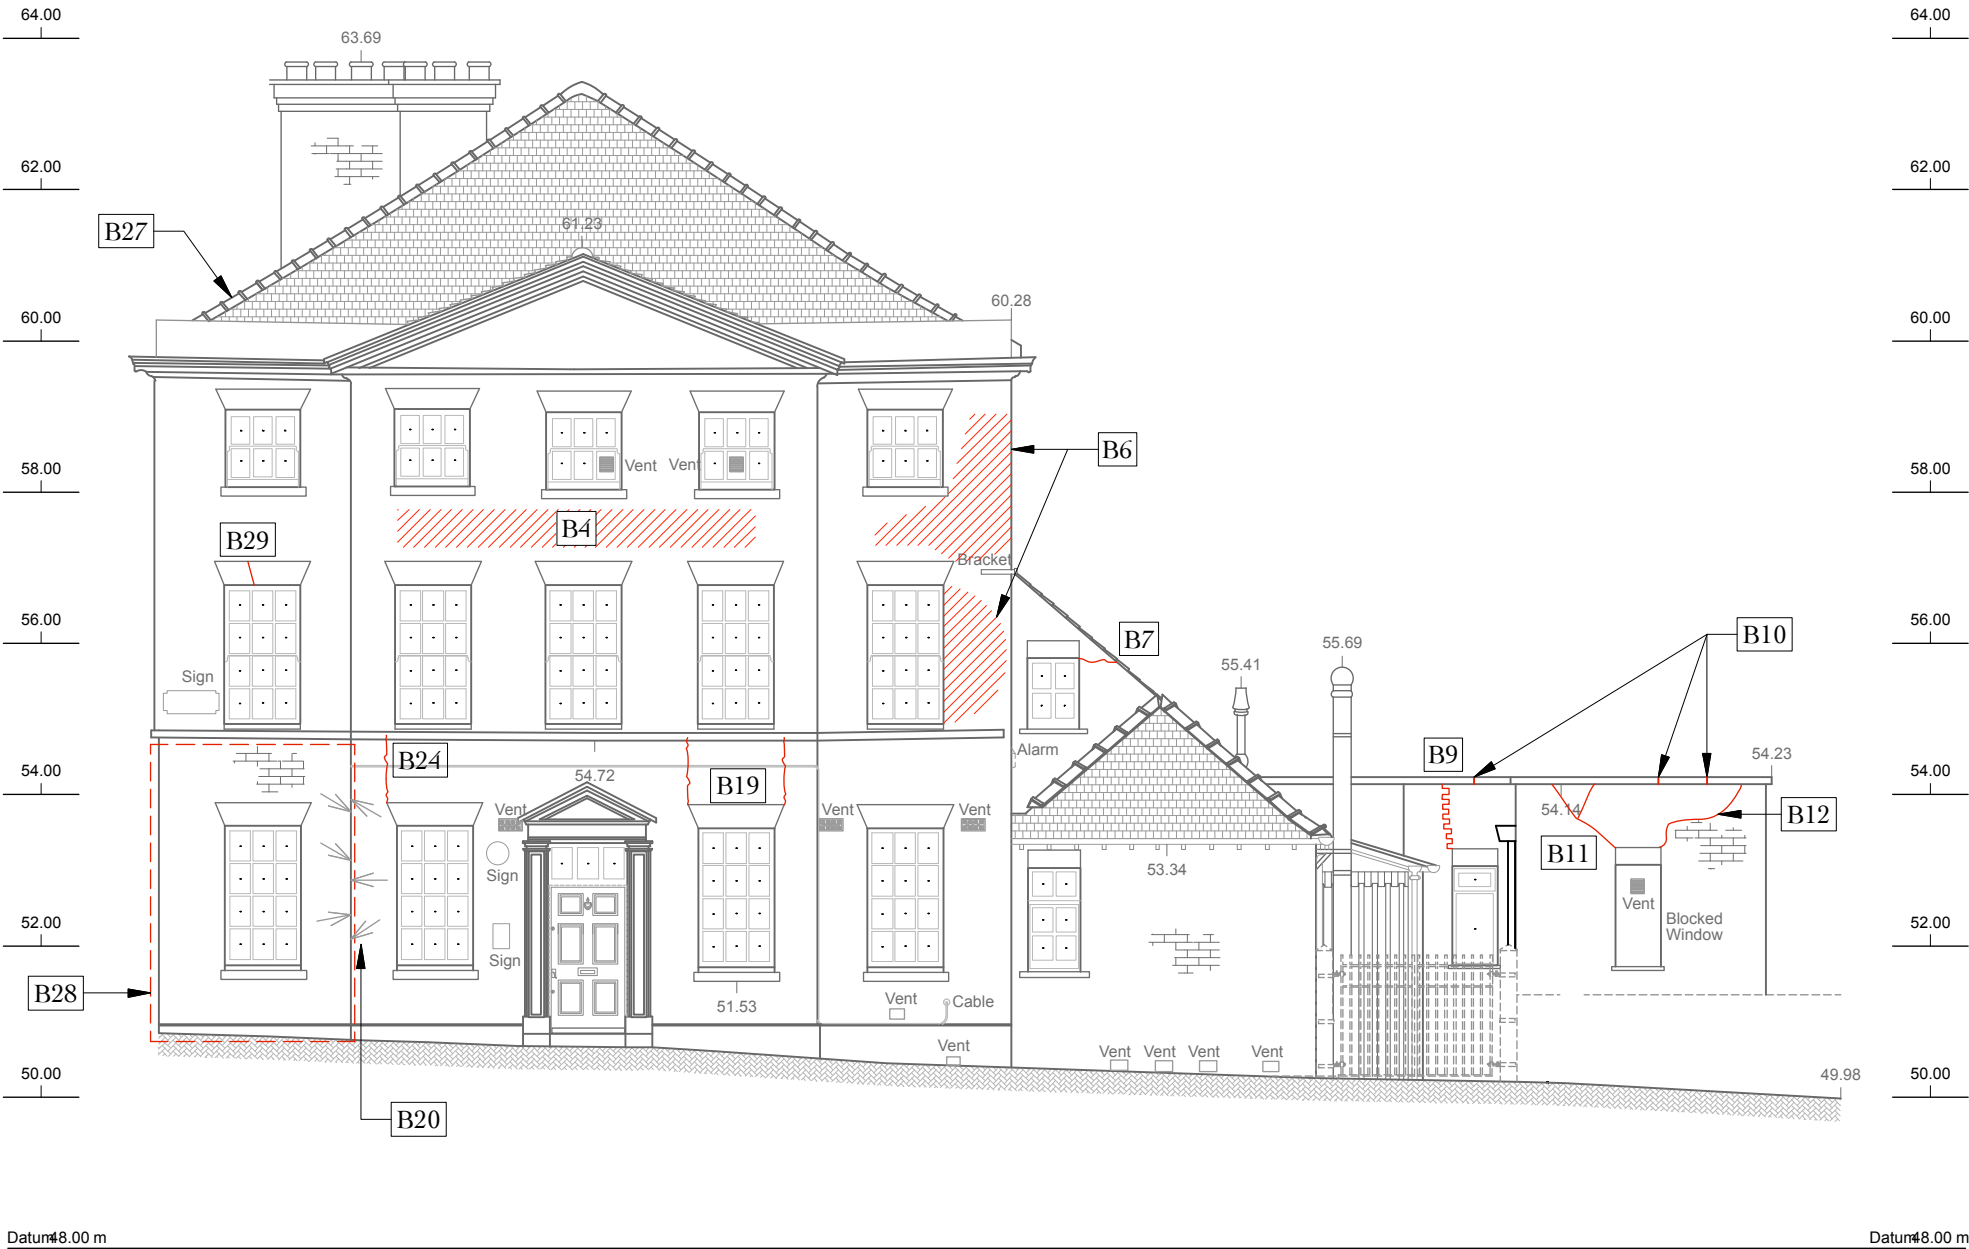
| Ref. | STRUCTURAL DEFECT |
|---|---|
| B4 | Severe mortar decay in this area, deep pack repoint and some indent repairs required. |
| B6 | Severely decayed masonry fabric, indent repair required |
| B7 | 10mm crack below flat arch |
| B9 | Crack increasing with height to 10mm at coping |
| B10 | Open perpend joint in coping, ca. 10-50mm |
| B11 | 20mm diagonal crack up to coping, bricks locally displaced in this location |
| B12 | 10mm diagonal crack |
| B19 | Vertical hairline cracks from either side of flat arch |
| B20 | Bed joints in this section tend in different directions and bricks appear to have been displaced |
| B24 | Vertical hairline crack |
| B27 | Refer to Elevation A – A24. Brickwork moved outwards. |
| B28 | Refer to Elevation A – A23. Wall rebuilt when bank use ended. |
| B29 | Crack through voussoir requires packing and pointing |
