Our ref: 6115/HTL/D&A

## **DESIGN & ACCESS STATEMENT**

**THE RESTORATION  
AND EXTENSION**

**19 ATHERTON STREET  
PRESCOT  
KNOWSLEY  
L34 5QN**

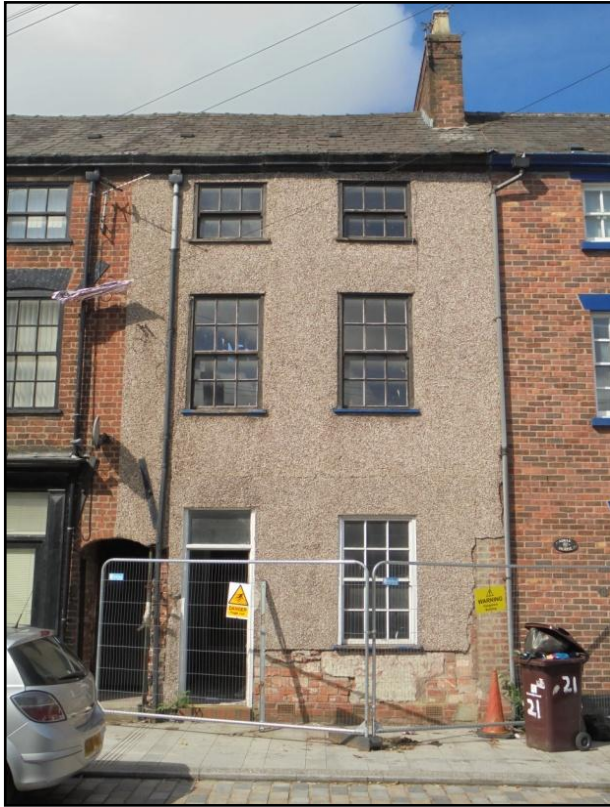
### Front Elevation

Image depicts the front elevation of No.19 at the time of the survey.

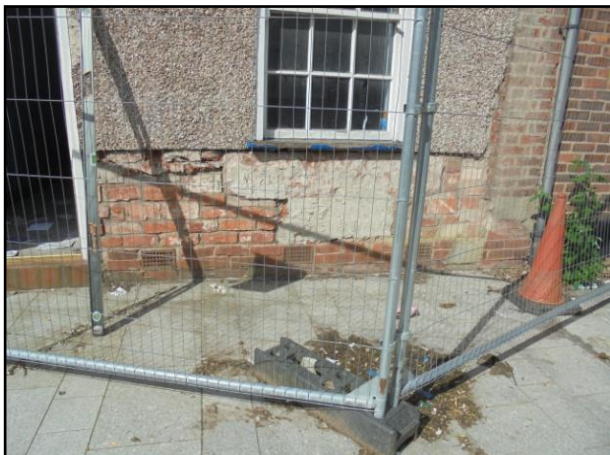
The existing frontage has a number of structural defects which require immediate action, including:

- The front wall bulging,
- Vertical cracking,
- Missing Brickwork.

Defects which are not structural include:

- Flaking render,
- Mish-mash brickwork where render has fallen off,
- Mixed windows.

**Remove the existing pebble dash render to the front and rear elevations and replace with smooth white render.** It has already been established that the brickwork below the render has previously been patch “repaired” and does not match the original render. Therefore it will not be possible to remove the render and make good the brickwork.

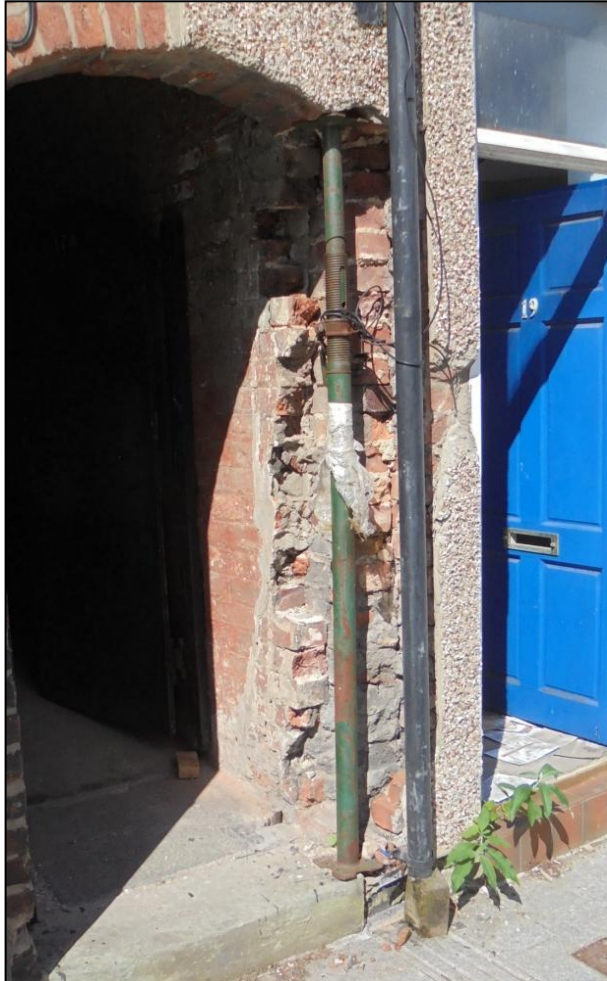
### Unoriginal Brickwork

Collapsed render has revealed a mish-mash, unoriginal brickwork.

The original cellar light has been filled in, and the original lintel may have possibly been removed.

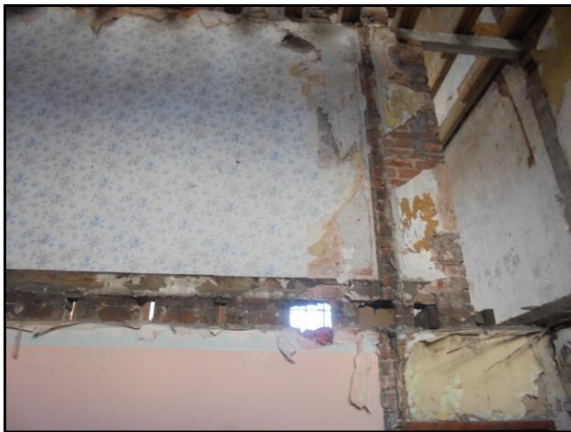
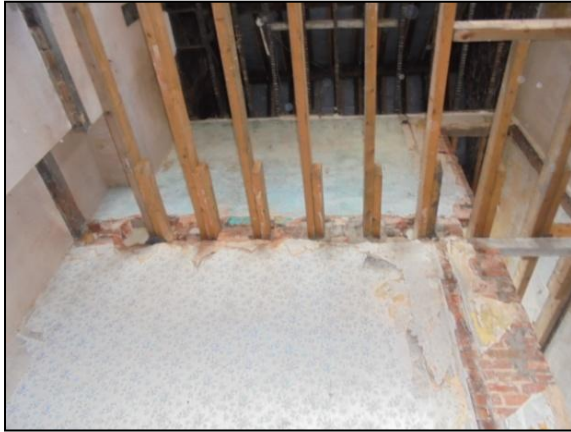
Internally, upon initial inspection the front room appears to be in reasonable structural condition, however, the original chimney breast has been removed at ground floor level and is un-supported above. The rear of the property is in worse condition. The windows are boarded up, the staircase is unsafe and 'leaning' away from the wall, and the building is exceptionally damp.

**Reposition first floor window to rear elevation.** The existing staircase position, etc. does not comply with Building Regulations and is un-safe. The staircase must be re-positioned away from the passage wall towards the middle of the house, which requires the rear first floor bedroom window to be moved to suit.

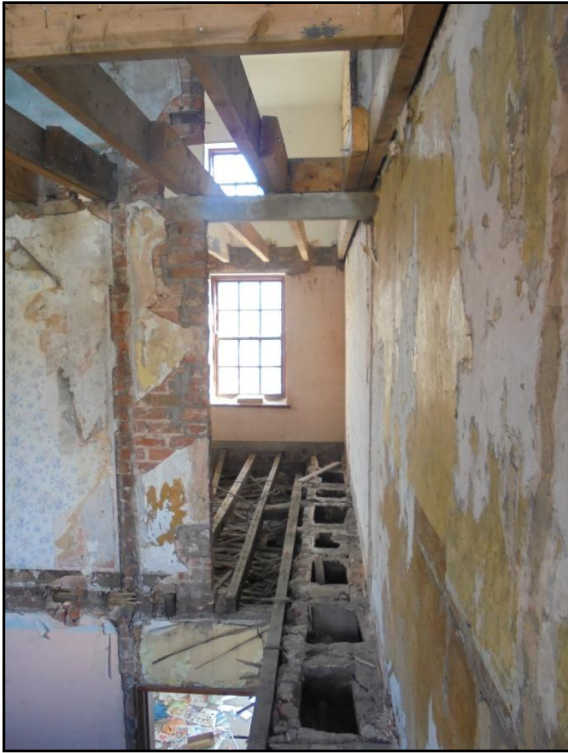
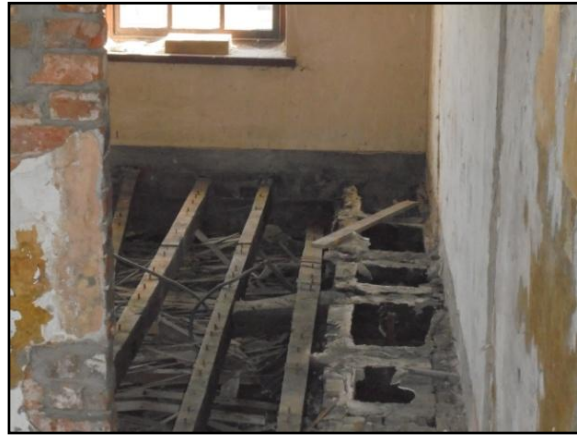
At first floor level, no floor joists remain. At second floor level, newer joists have been installed – however the quality and strength of the joists are unknown. A clear view from ground floor level to roof ridge level can easily be obtained, due to the lack of floors and ceilings.

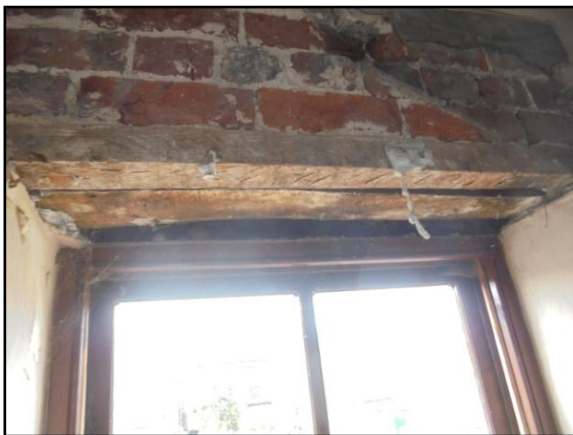
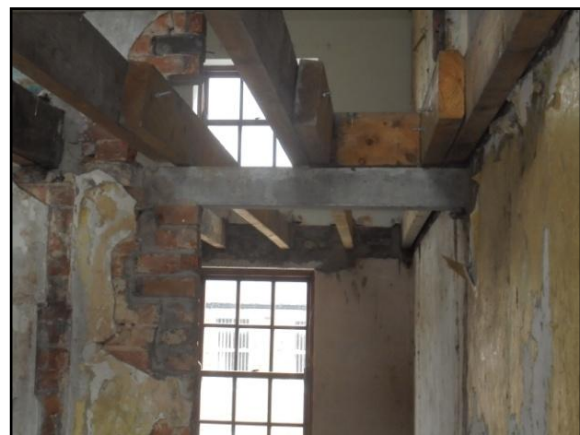
From the top of the staircase, a view can be obtained into the front, first-floor room.

It appears that some floor joists remain, however they have mainly collapsed, and are resting on the false ceiling below.

Joists spanning the shared passageway between No.17 and No.19 appear too weak, and are sagging under the weight of the party wall.
