**A report on trees at 67 Longmeadow Road, Knowsley Village**

**Prepared for Mr A Campbell**

**Paul Hanson – LANTRA Professional Tree Inspector**

**12<sup>th</sup> May 2021**

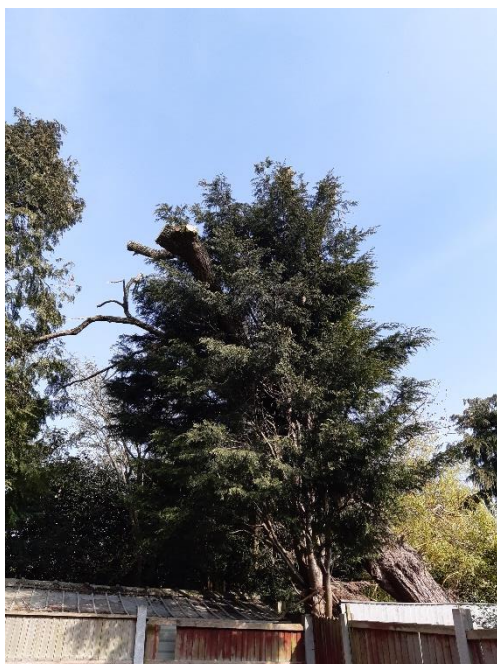
This specimen of Willow (*Salix* spp) has been historically pruned incorrectly on the owners' side of the fence. And after consultation with my client, he informed me that the tree owner, had previously gave him permission, to have the tree pruned which was encroaching his boundaries, and to be pollarded back to boundary as per his legal right (see images) by a fully qualified and insured tree surgeon. The tree has a significant lean towards my clients and no. 65 Longmeadow Road boundary fences. There is a high risk of airborne fungal infection (a list of which will be provided below) and also, damage to the root plate system due to my client undertaking building works, but this will not be wilful destruction as any works will be carried out during the excavation with good current arboricultural practices in mind.

Willow Tree along with Leylandii possibly supporting Willow showing pollard points and heavy lean

I would recommend due the significant factors listed below that the tree is sectionally dismantled and removed and the stump ground out and a tree of a much more appropriate species be planted in its place, i.e. prunus species (flowering cherry).

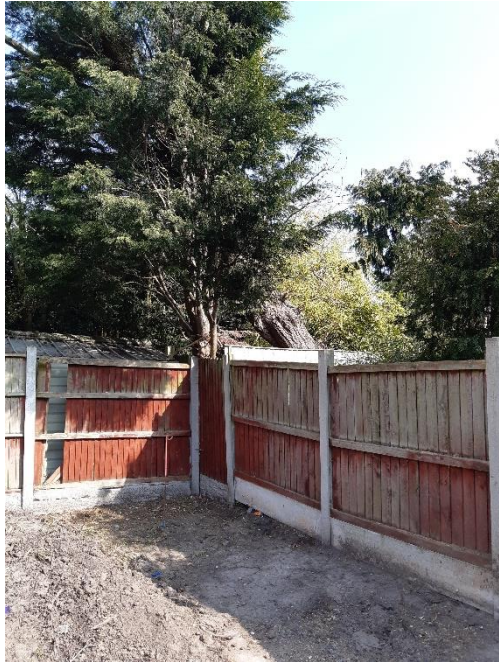
However, my client does have a legal right to prune any root system that encroaches his property boundary. This would further enhance the stability problems of the tree.

Significant lean of Willow Tree

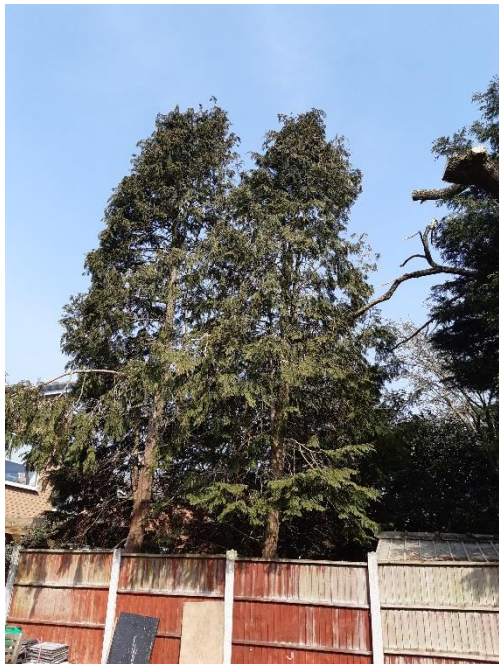
Times Two Thuja Plicata in no. 65 Longmeadow Rd garden

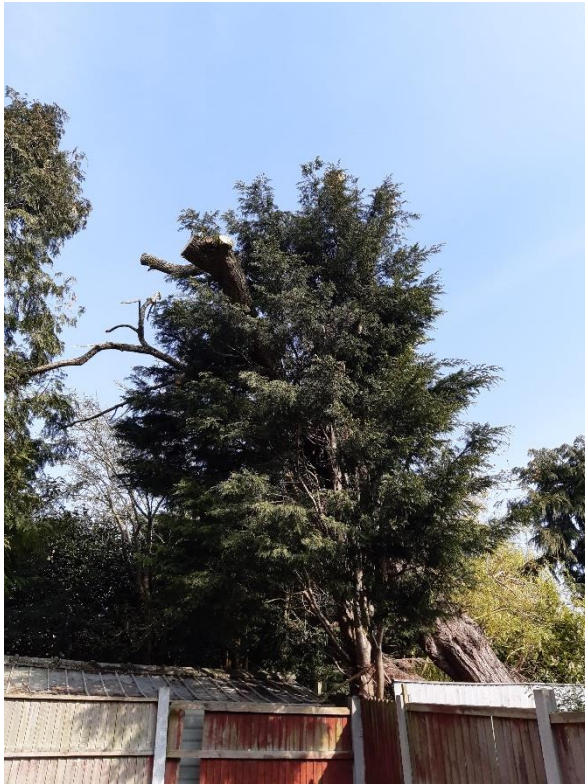
There is also a very poor specimen of Leyland Cypress (*Cupressocyparis Leylandii*) below the Willow Tree which has significant evidence of rubbing upon it. I would recommend removal of this.

## Overall view of Willow emerging from Leylandii
