# ARBORICULTURAL IMPACT ASSESSMENT (AIA)

**PROPOSED DEVELOPMENT AT**

**LYNEHAM,**

**PLA/0422/L35**

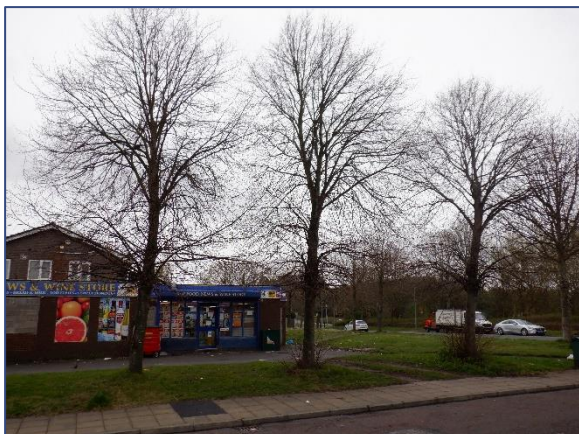
The Lime trees T16, T17 and T18 do form an Arboricultural feature and whilst not in perfect condition they are clearly Category B.

Lime trees T16, T17 & T18

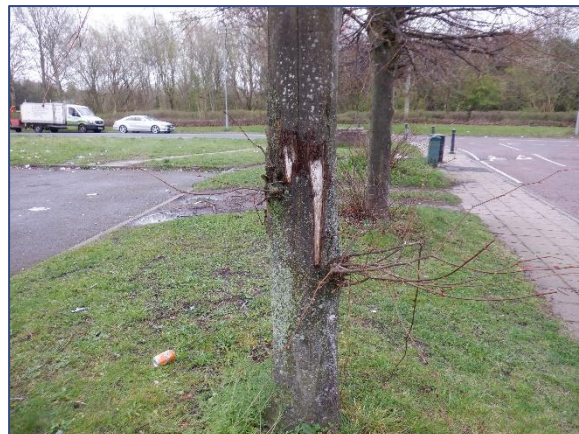
| Ref | Species | Height<br>(m) | Stem<br>Diam<br>(mm) | Radial<br>Crown<br>Spread<br>(m) | | Crown<br>Height<br>(m) | Age | Comments | Recommendations | ERC | Cat | RPA<br>Radius<br>(m) | RPA<br>Area<br>(m <sup>2</sup> ) |
|---|---|---|---|---|---|---|---|---|---|---|---|---|---|
| T16 | Lime<br>( <i>Tilia x europaea</i> ) | 10.1 | 310 | N | 3.8 | 1.9 | EM | Single stemmed with crown starting at circa 4m. Poor historic pruning to lower crown (stubs). Some minor deadwood and crossing branches. Bark stripping (vandalism) from circa 1.0-1.5m (incomplete so survivable). Epicormic growth to base (typical for species).<br><br>No significant visible defects | Remove to facilitate development | 20-40 | B2 | 3.7 | 43 |

Bark damage to Lime tree T16

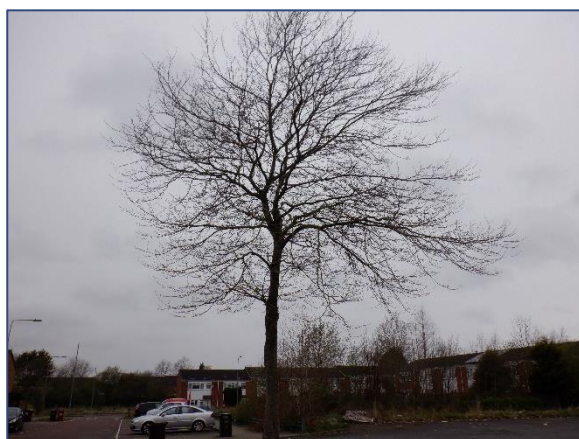
Plan tree (T15)

| Ref | Species | Height<br>(m) | Stem<br>Diam<br>(mm) | Radial<br>Crown<br>Spread<br>(m) | | Crown<br>Height<br>(m) | Age | Comments | Recommendations | ERC | Cat | RPA<br>Radius<br>(m) | RPA<br>Area<br>(m <sup>2</sup> ) |
|---|---|---|---|---|---|---|---|---|---|---|---|---|---|
| T15 | London Plane<br>( <i>Platanus<br/>x hispanica</i> ) | 11.6 | 320 | N | 3.0 | 2.2 | EM | Single stemmed. Historic pruning wounds (3) from 2.0m to 2.6m now occluded. Evidence of stem swelling (thickening) in the area probably caused by the deposition of wound wood surrounding the coalescing decay pockets caused by the multiple pruning wounds. Slight curve to stem. | Remove to facilitate development | 20+ | C1 | 3.8 | 46 |

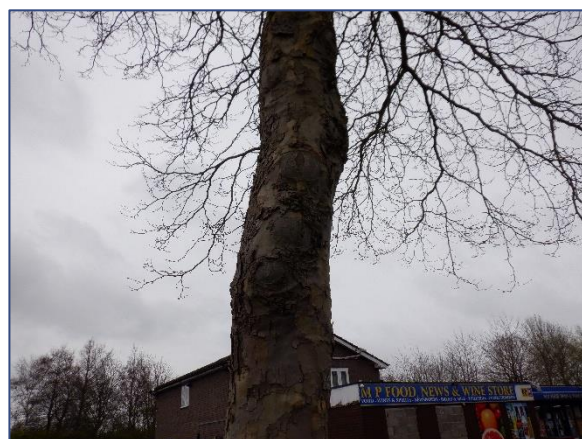
Multiple pruning wounds (T15)

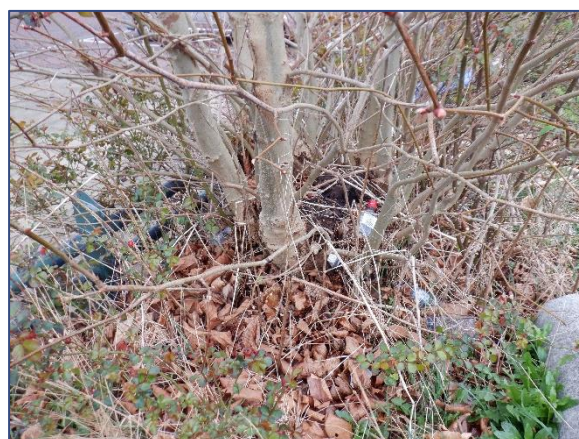
| Category | Definition | Retention | Colour Code | Tree Numbers | Total |
|---|---|---|---|---|---|
| <b>U</b> | Trees in such a condition that they cannot realistically be retained as living trees in the context of the current land use for longer than 10 years | Unfeasible | Dark Red | T14 | 1 |

Plane (T14) Regrowth from old stump

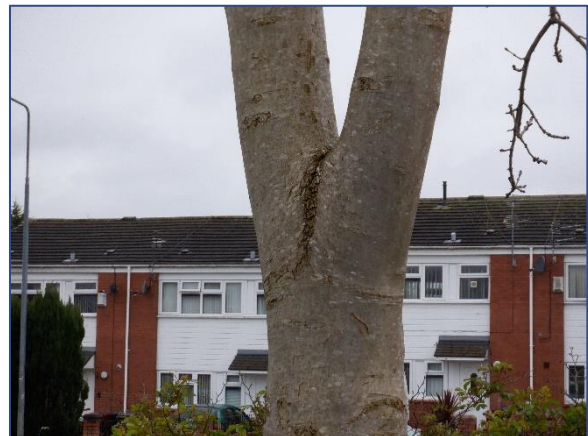
| Ref | Species | Height<br>(m) | Stem<br>Diam<br>(mm) | Radial<br>Crown<br>Spread<br>(m) | | Crown<br>Height<br>(m) | Age | Comments | Recommendations | ERC | Cat | RPA<br>Radius<br>(m) | RPA<br>Area<br>(m <sup>2</sup> ) |
|---|---|---|---|---|---|---|---|---|---|---|---|---|---|
| T13 | Ash<br>( <i>Fraxinus excelsior</i> ) | 11.9 | 275 | N | 3.5 | 2.0<br>(2.5 N) | EM | Probably self-set. Twin stemmed (co-dominant stems) from 1.9m (unions appears sound).<br><br>No significant visible defects | Remove to facilitate development | 20-40 | C1 | 3.3 | 34 |

Ash tree (T13) scaffold union

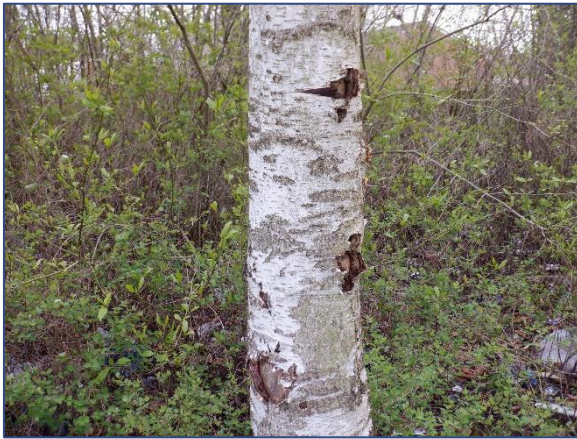
| Ref | Species | Height<br>(m) | Stem<br>Diam<br>(mm) | Radial<br>Crown<br>Spread<br>(m) | | Crown<br>Height<br>(m) | Age | Comments | Recommendations | ERC | Cat | RPA<br>Radius<br>(m) | RPA<br>Area<br>(m <sup>2</sup> ) |
|---|---|---|---|---|---|---|---|---|---|---|---|---|---|
| T12 | Silver Birch<br>( <i>Betula pendula</i> ) | 12.3 | 240 | N | 2.7* | 2.0<br>(2 W) | EM | Nice specimen tree. Minor impact damage (in four areas from 0.5-1.6m) to stem (probably vandalism).<br><br>No significant visible defects | Remove to facilitate development | 20-40 | B1 | 2.9 | 26 |

**Stem damage to Birch (T12)**

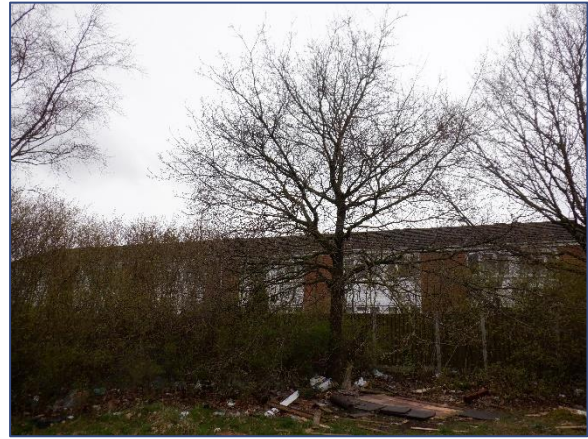
**Oak (T11)**

| Ref | Species | Height<br>(m) | Stem<br>Diam<br>(mm) | Radial<br>Crown<br>Spread<br>(m) | | Crown<br>Height<br>(m) | Age | Comments | Recommendations | ERC | Cat | RPA<br>Radius<br>(m) | RPA<br>Area<br>(m <sup>2</sup> ) |
|---|---|---|---|---|---|---|---|---|---|---|---|---|---|
| T11 | Oak<br>( <i>Quercus sp.</i> ) | 9.3 | 270 | N | 5.0* | 1.0<br>(2 W) | EM | Nice specimen tree. Minor damage to lower scaffold (probably vandalism). Low crown which could be easily crown lifted to provide clearance if necessary.<br><br>No significant visible defects | Retain and protect.<br><br>Crown lift to 3m.<br><br>(Given its proximity to the proposed development their may be undue pressure to prune this tree in the long term. As it is a young tree removal and replacement may be an alternative. | 40+ | A1 | 3.2 | 33 |

Airspade decompaction, tilling and soil enrichment (with activated Biochar) is proposed in the areas surrounding the Oaks (T10 & T11) and the Willow (T7).

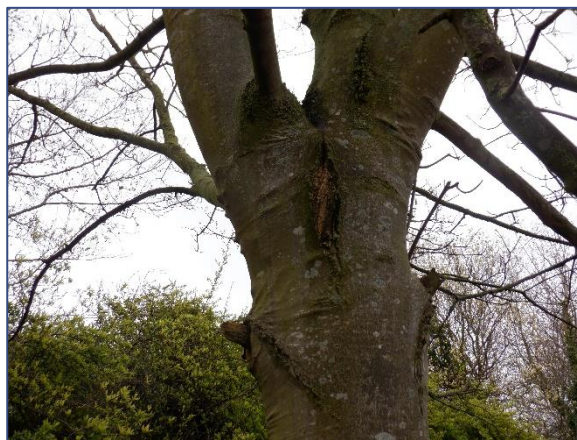
**Included union (T8)**

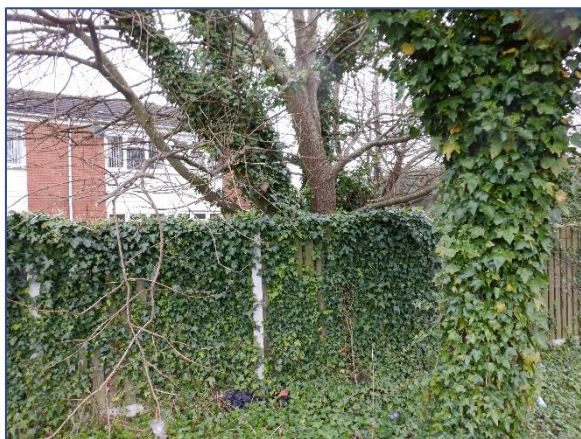
The foundations of the apartment block to the northeast of the site extend into the RPA of the third party Willow tree (T7).

The foundations for the apartment block to the northeast of the site extend c 3.3m in to the RPA of the third party Willow (T7) and typical strip foundations would effectively compromise 20.26 m<sup>2</sup> (or 16.61%) of the 122 m<sup>2</sup> (100%) calculated RPA.

While demonstrating the likelihood of an asymmetric RPA biased away from the site it would be prudent to assume that there may still be roots proximal to the proposed foundations.

Willow (T7) with Cherry (T6) in foreground

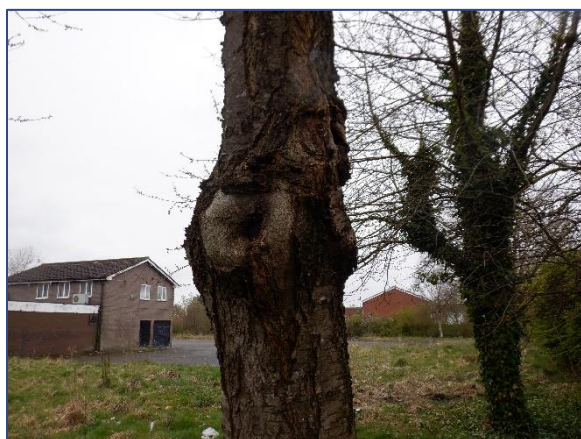
| Ref | Species | Height<br>(m) | Stem<br>Diam<br>(mm) | Radial<br>Crown<br>Spread<br>(m) | | Crown<br>Height<br>(m) | Age | Comments | Recommendations | ERC | Cat | RPA<br>Radius<br>(m) | RPA<br>Area<br>(m <sup>2</sup> ) |
|---|---|---|---|---|---|---|---|---|---|---|---|---|---|
| T1 | Cherry<br>( <i>Prunus spp.</i> ) | 13.8 | 335 | N | 3.4 | 2.0 | EM | High pruned (alongside road and pavement). Multiple pruning wound encircling the stem at approximately 2m. Pruning wounds partially occluded although there is some evidence of stem swelling (thickening) in the area probably caused by the deposition of wound wood surrounding the coalescing decay pockets caused by the multiple pruning wounds. | Remove to facilitate development | 20-40 | B2 | 4.0 | 51 |

The Cherries (T1, T2, T3, T4, T5) and the Sycamore (T19) have all been categorised as B. While they do fulfil the 'Landscape' criterion of Category 'A' trees in the BS:5837 Cascade Chart they do have defects arising from poor historic pruning (significant pruning wounds encircling the stem at the same level creating a coalesced decay pocket) which whilst manageable, reduces the SULE (Safe Useful Life Expectancy) of the trees to 20-40 years. The group would thus be categorised B/C. As the extent of decay and its impact on the future structural integrity of the trees has not been accurately determined (invasively or non-invasively), I have given the trees the higher categorisation.

Typical pruning wounds to Cherries (T1 shown)

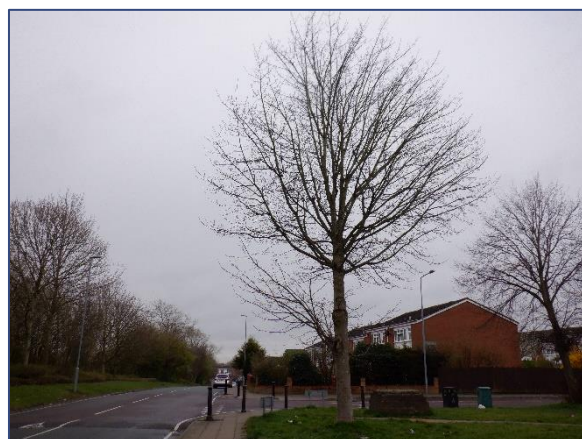
Sycamore (T19)

| Ref | Species | Height<br>(m) | Stem<br>Diam<br>(mm) | Radial<br>Crown<br>Spread<br>(m) | | Crown<br>Height<br>(m) | Age | Comments | Recommendations | ERC | Cat | RPA<br>Radius<br>(m) | RPA<br>Area<br>(m <sup>2</sup> ) |
|---|---|---|---|---|---|---|---|---|---|---|---|---|---|
| T19 | Sycamore<br>( <i>Acer<br/>pseudoplatanus</i> ) | 13.9 | 395 | N | 4.5 | 1.7 | EM | Single stemmed with crown starting at circa 4.5m. Multiple historic pruning wounds from 2.0-3.0m with regrowth from the partially occluded wounds.<br><br>No significant visible defects | Retain and protect. | 20-40 | B2 | 4.7 | 71 |

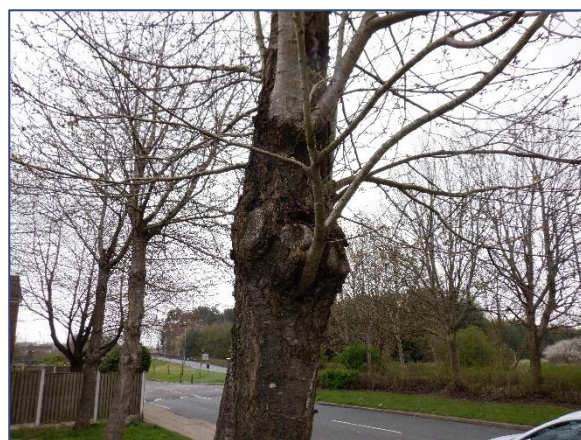
| Ref | Species | Height<br>(m) | Stem<br>Diam<br>(mm) | Radial<br>Crown<br>Spread<br>(m) | | Crown<br>Height<br>(m) | Age | Comments | Recommendations | ERC | Cat | RPA<br>Radius<br>(m) | RPA<br>Area<br>(m <sup>2</sup> ) |
|---|---|---|---|---|---|---|---|---|---|---|---|---|---|
| T3 | Cherry<br>( <i>Prunus spp.</i> ) | 12.0 | 345 | N | 3.0 | 2.0 | EM | High pruned (alongside road and pavement). Multiple pruning wound encircling the stem at approximately 2m. Some epicormic growth surrounding the pruning points which creates a lower crown clearance. Pruning wounds partially occluded although there is some evidence of stem swelling (thickening) in the area probably caused by the deposition of wound wood surrounding the coalescing decay pockets caused by the multiple pruning wounds. | Remove to facilitate development | 20-40 | B2 | 4.1 | 54 |

Pruning wounds to Cherry (T3)

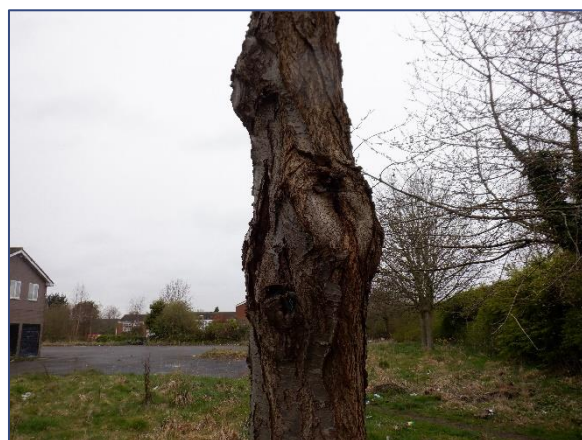
Typical Cherry pruning wounds.
