**Project:** 11a High Street, Prescot

**Project Reference:** 4044

**Structural Report**

S-Mech Ltd were appointed to undertake a structural condition survey of the boundary wall to the North and North East at 11a High Street, Prescot, L34 3LD. As such our investigations were limited to this structure only; adjacent structures and/or neighboring buildings were not inspected except where specifically referenced.

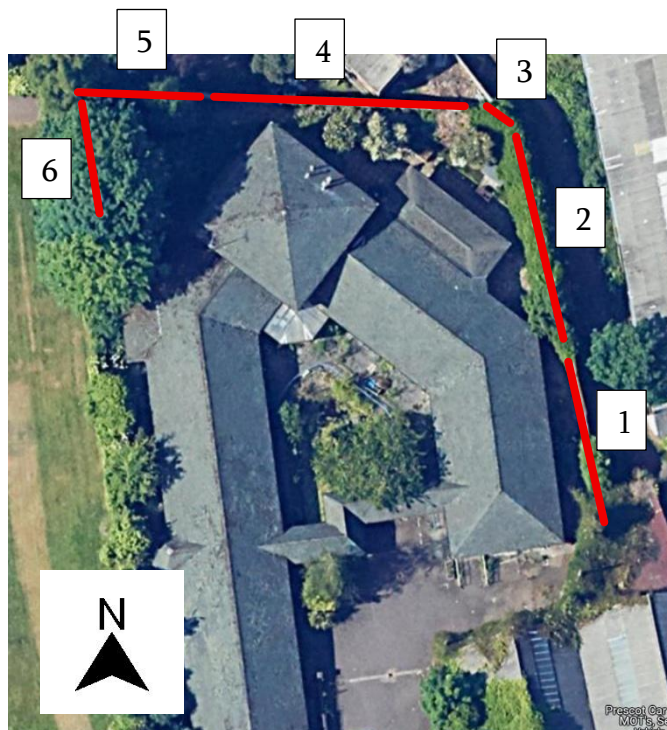
**Figure 1 Surveyed Wall**

For reporting, six distinction sections of wall are considered as noted in the key below.

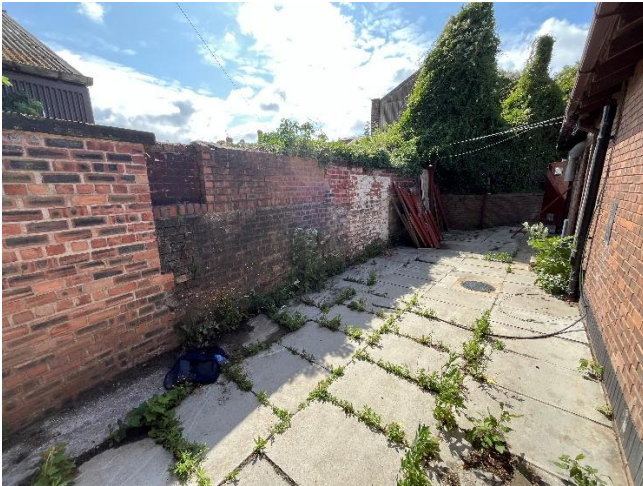
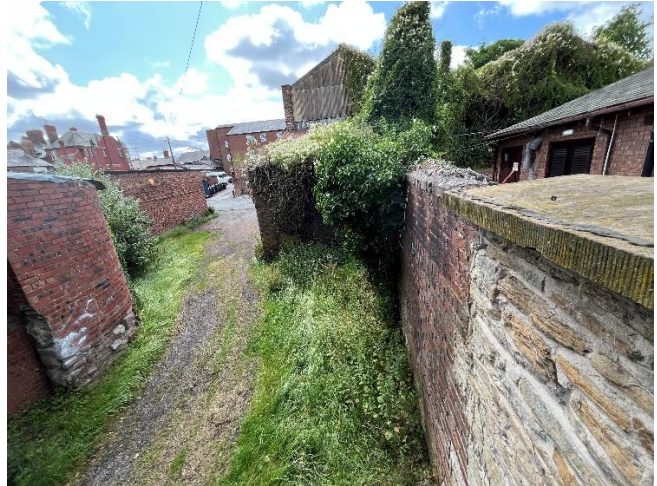
### Section 1

| Vertical Alignment | Leans out 50/900 toward South end, out 25/900 towards North end. |
| Comments | Vegetation growth on top and rear. Embedded glass in mortar coping. |

| Wall | Thickness | Middle third –<br>max<br>eccentricity | Maximum lean for<br>height | Maximum recorded lean (in, UNO) | Stable |
|---|---|---|---|---|---|
| 1 | 327mm | 55mm | 23/900 at 2200mm | Out 50/900 at South, Out 25/900 at North | Partial |

The majority of the copings throughout the full length of the wall have been disturbed by vegetation (and are missing throughout Section 4) and will need removing, the mortar cleaning out and the coping resetting in place. In addition, the wall requires repointing in all Sections.

The requirement for the boundary is to erect a fence to achieve greater privacy. It is recommended that unless noted below the walls are taken down to an appropriate height where stability is considered to be acceptable and the fence erected independently of the wall. Assuming a client-side height of 1.1m for the wall, allowable leans become 60/900 for the 440mm construction and 45/900 for the 327mm construction. Referring to the previous stability analysis, it can be seen that this would reduce the amount of rebuild work required considerably.

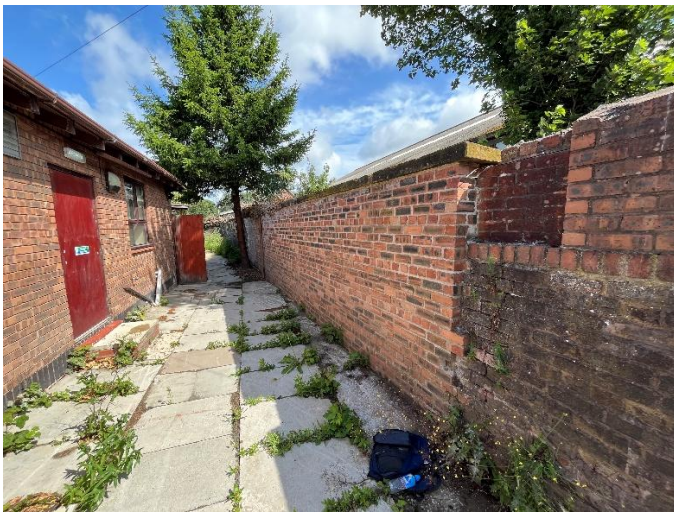
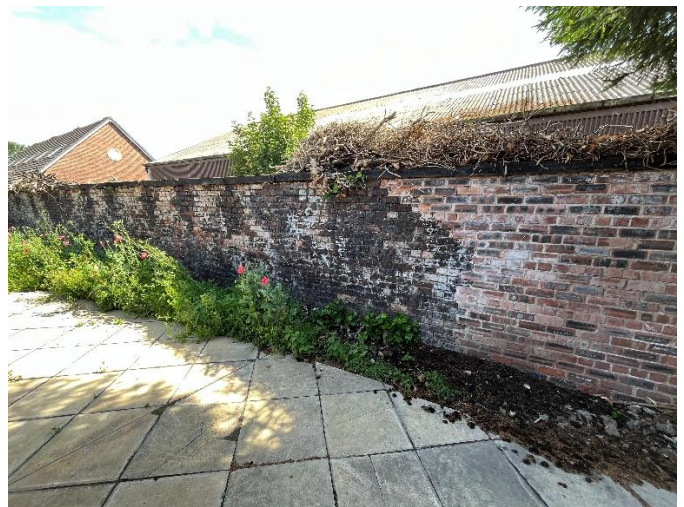
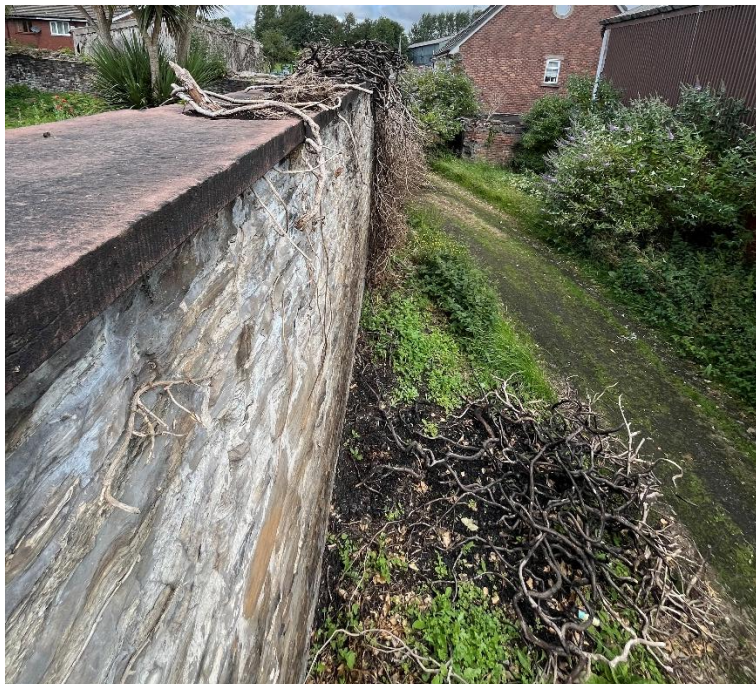
## Section 2

| Vertical Alignment | Generally plumb at recently refaced/rebuilt section, becoming in 10/900 at joint with original. Original leans in 25/900 to a maximum of 45/900 |
| Comments | Vegetation growth on top and rear, now died off. Coping stones disturbed by growth into mortar gap. |

Rebuilt section adjacent Section 1. Junction of original and rebuilt.

| Wall | Thickness | Middle third –<br>max<br>eccentricity | Maximum lean for<br>height | Maximum recorded lean (in, UNO) | Stable |
|---|---|---|---|---|---|
| 2 | 440mm | 75mm | 34/900 at 2000mm | 25 to 45/900 | Partial |

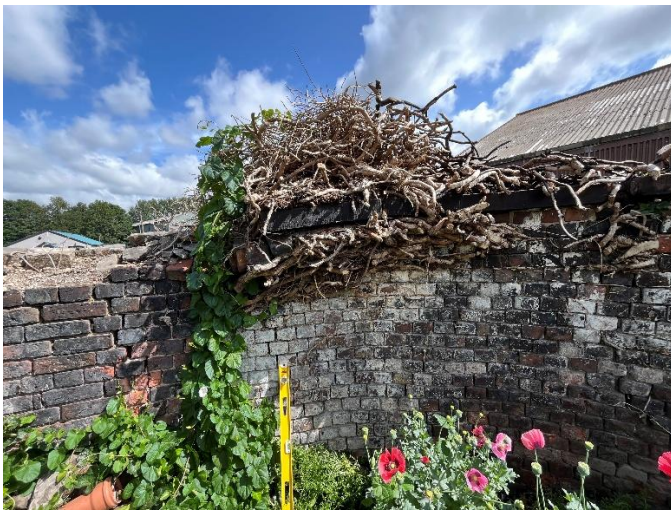
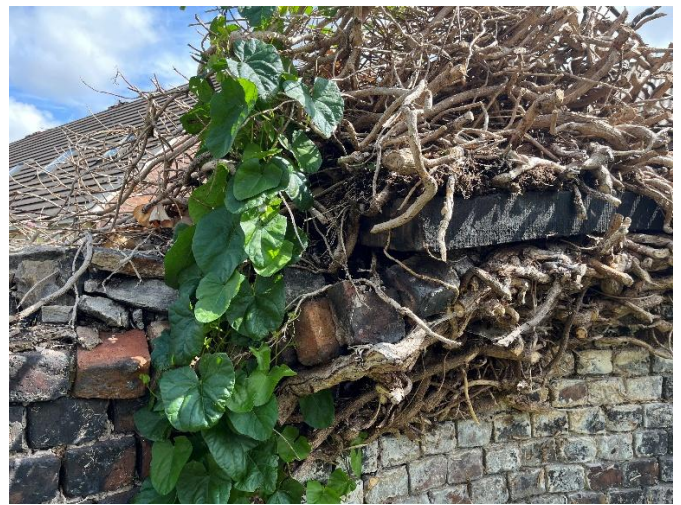
### Section 3

| Vertical Alignment | Leans in 90/100 |
| Comments | Short section at change in direction. Heavy vegetation growth on top and beneath coping stones. Partial collapse at top of wall appears to be held in place by vegetation. |

| Wall | Thickness | Middle third –<br>max<br>eccentricity | Maximum lean for<br>height | Maximum recorded lean (in, UNO) | Stable |
|---|---|---|---|---|---|
| 3 | 440mm | 75mm | 34/900 at 2000mm | 90/100 | No |

Section 3 should be taken down to client-side ground level and rebuilt.

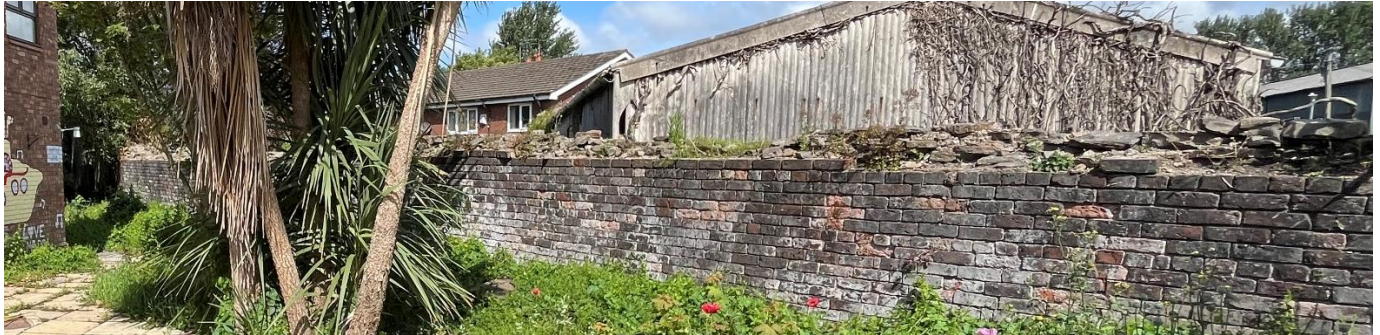
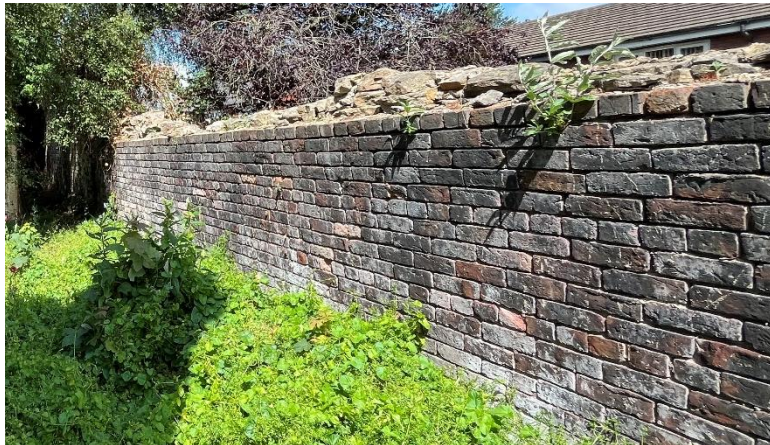
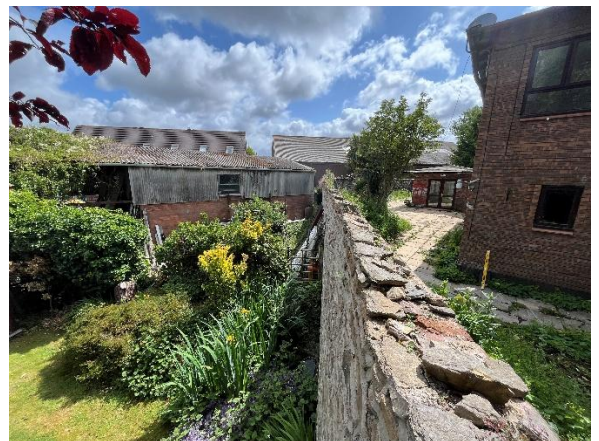
## Section 4

| <b>Vertical Alignment</b> | Short length adjacent Section 3 leans out 25/900, becoming plumb towards the centre of the length. Inward lean from centre to Section 5 is generally 75/900 with areas of 90/900. A lateral bow into the client side is visible along this length. |
| <b>Comments</b> | All copings along this length are lost along with some masonry from the top of the wall. Some copings are visible on the clients side on the ground, buried in the vegetation. |

| Wall | Thickness | Middle third –<br>max<br>eccentricity | Maximum lean for<br>height | Maximum recorded lean (in, UNO) | Stable |
|---|---|---|---|---|---|
| 4 | 440mm | 75mm | 38/900 at 1800mm<br>34/900 at 2000mm<br>31/900 at 2200mm | Western end exceeds this. Centre and<br>towards section 3 within limits. | Partial |

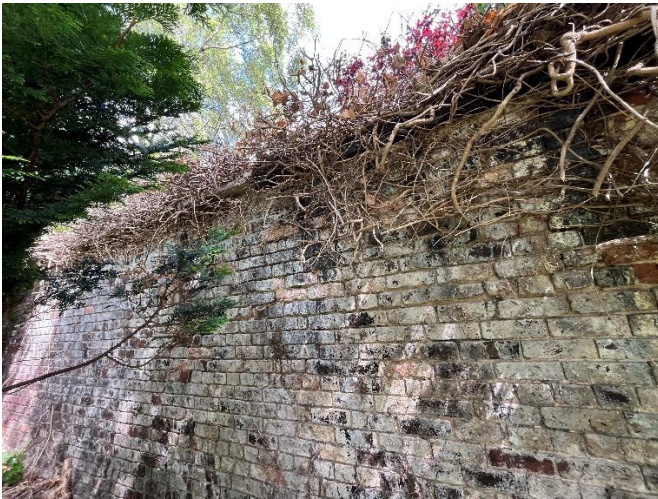
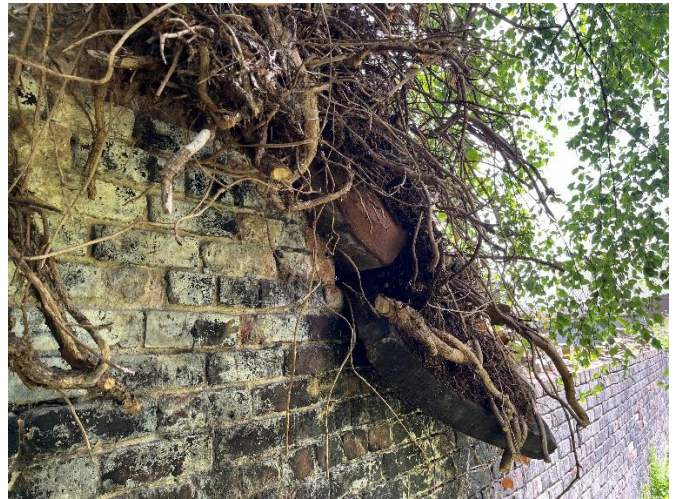
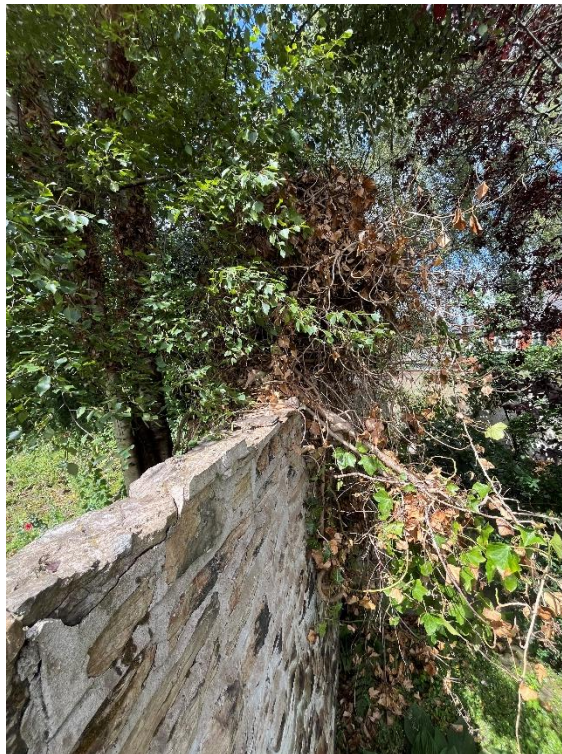
## Section 5

| <b>Vertical Alignment</b> | Leans in 75/900 adjacent Section 4. In centre leans in 65/900 at top and 15/900 at base. At corner with Section 6 leans in 30/900 at top and is plumb at base. |
| <b>Comments</b> | Short section at change in direction. Heavy vegetation growth on top and beneath coping stones. Partial collapse at top of wall adjacent to Section 4 appears to be held in place by vegetation. |

| Wall | Thickness | Middle third –<br>max<br>eccentricity | Maximum lean for<br>height | Maximum recorded lean (in, UNO) | Stable |
|---|---|---|---|---|---|
| 5 | 440mm | 75mm | 25/900 at 2700mm<br>29/900 at 2300mm | Upper section of wall exceeds limits<br>throughout. | No |

Section 6 may be left as existing if required, with the corner at Section 5 left full height. The top of Section 5 should then be stepped down to 1.1m within 2.0m of the corner.

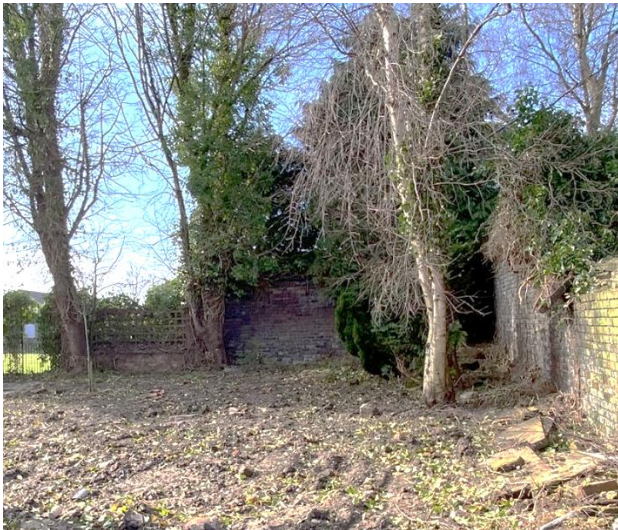
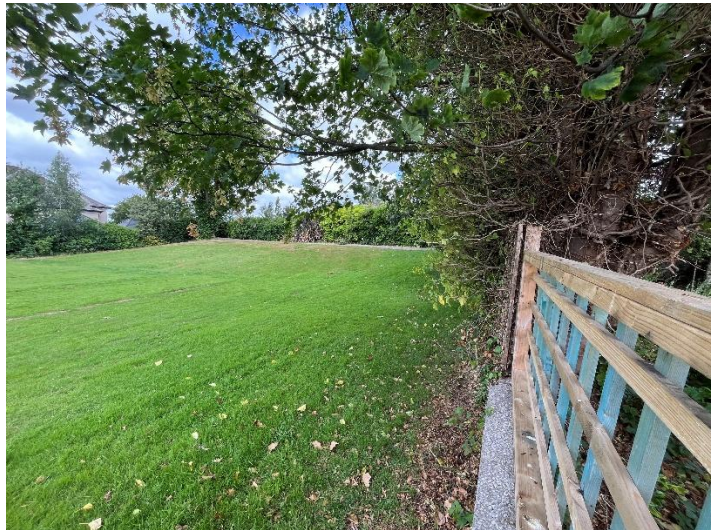
| Height (Opposite side) | Unknown. Ground levels appear to rise on land behind therefore wall is expected to retain the ground behind. |

Section 6 (Image AWA Building Consultancy) and land behind showing level increase.

| Wall | Thickness | Middle third –<br>max<br>eccentricity | Maximum lean for<br>height | Maximum recorded lean (in, UNO) | Stable |
|---|---|---|---|---|---|
| 6 | 440mm | 75mm | 28/900 at 2400mm | Acceptable throughout. | Yes |
