**WJ SHIRLEY**

Mon 25th, Tues  
26th & Wed 27th  
February  
2019

# DRAINAGE REPORT

**UNIT 6, WILSON ROAD  
HUYTON BUSINESS PARK  
LIVERPOOL  
L36 6JF**

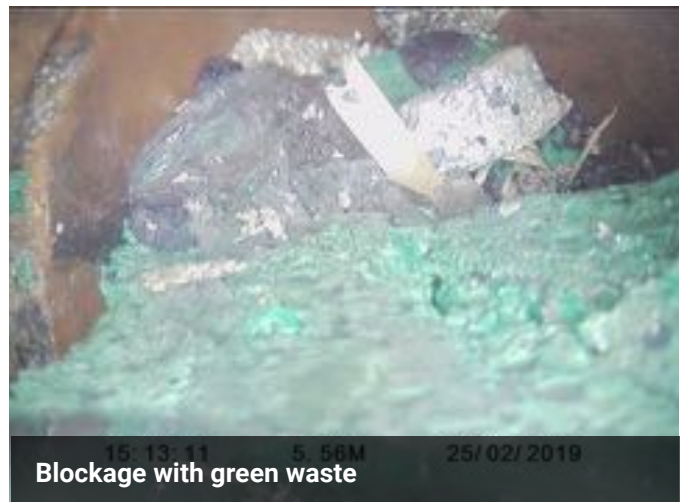
There is silt and debris in the surface-water system causing blockages and reduced flow. Some of this has probably occurred through a natural build-up and lack of maintenance, but some of this is green, probably from green ink or dye. This has formed hard deposits on the inside of the drain pipes but then dissolves when subject to high pressure jetting. This is in the surface-water drains so has probably been washed down though

surface gullies. This needs to be removed but cannot simply be jetted through as it would leave the site and pass untreated to a river or stream and cause environmental pollution which is a criminal offence. We recommend that de-scaling and de-silting works are carried out with high pressure water jetting and a suction tanker with the surface-water system temporarily sealed off and all wash-waters removed from site and disposed of as Hazardous Waste. We have made a provisional allowance for this in the budget costs but it may be necessary to analyse a sample of the green waste to determine its precise content before it can be disposed of.

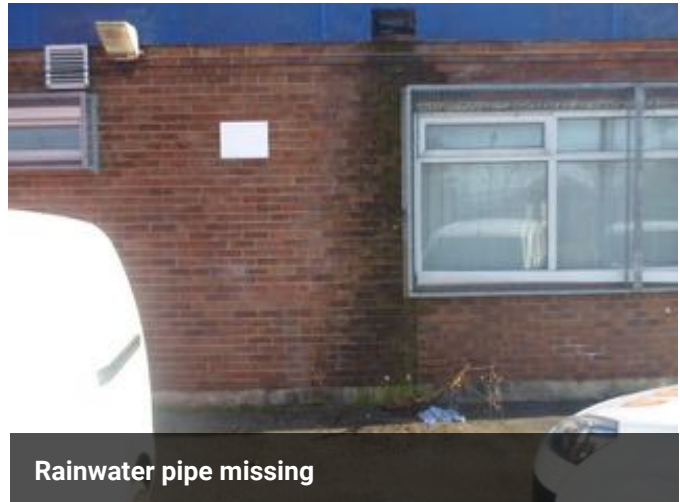
There are a number of rainwater pipes which are missing and thus do not connect to the below-ground section of the pipe. We recommend these are replaced to ensure the rainwater pipes are connected to the below-ground system. Although strictly outside the scope of our inspection as they are above-ground, we have made an allowance for this in the budget costs.

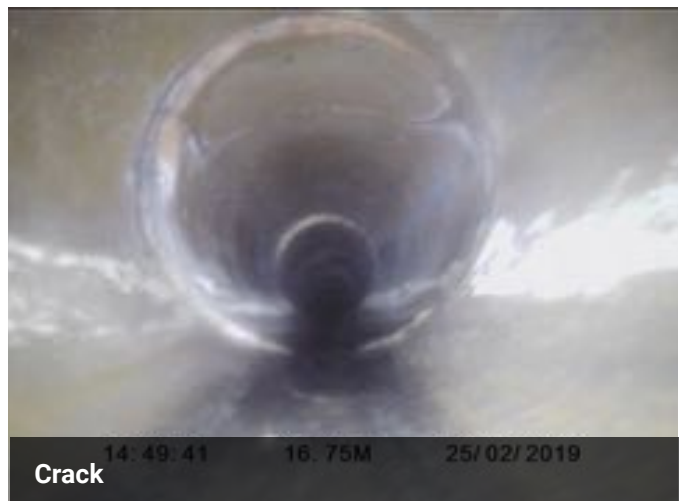
We noted a crack in a section of below-ground surface-water drain at MH2. We recommend this is repaired to prevent further deterioration and possible collapse. This can currently be repaired in-situ by patch lining.

| ASSET | DEFECT | RECOMMENDATION | URGENCY | BY | COST | |
|---|---|---|---|---|---|---|
| MH 2 | D 4 | Crack, moderate | Repair by patch lining | Moderate | Aug 2020 | £600 |
