Mon 25th, Tues  
26th & Wed 27th  
February  
2019

# DRAINAGE REPORT

**UNIT 1, WILSON ROAD  
HUYTON BUSINESS PARK  
LIVERPOOL**

**L36 6JF**

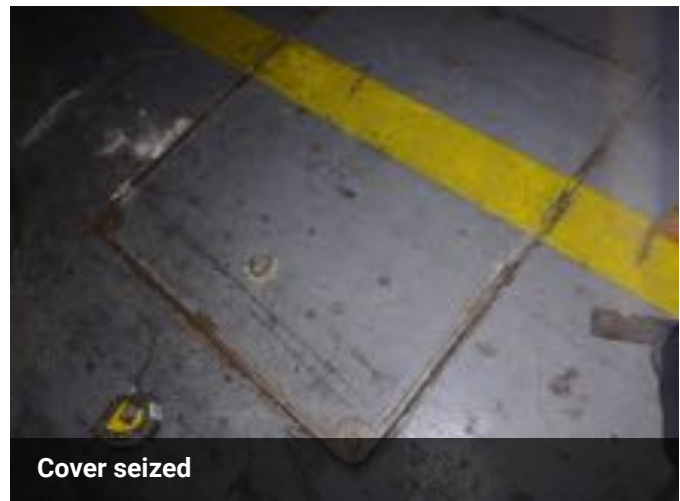
There are ten seized inspection covers, mostly inside the unit. The covers have rusted into their frames and effectively fused to make a single piece of metal. These covers would need to be broken out and renewed to allow maintenance or inspection access. There is one inspection cover under carpet, and to gain access the carpet would need to be cut. One internal inspection chamber is without a cover and has accumulated a build up of debris and rubbish. This would need to be cleared and a new inspection cover fitted.

Cover seized

There is adequate general maintenance access to the drainage systems, however the seized inspection covers should be broken out and renewed to allow full maintenance access.

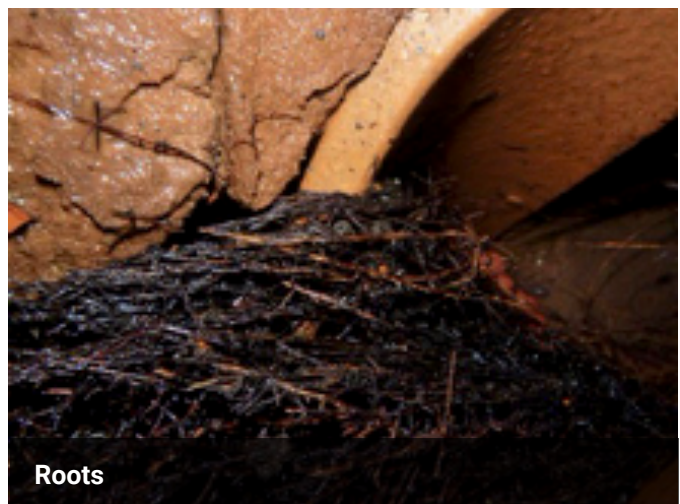
Roots

There is evidence of root ingress in the surface water system. Roots usually grow through existing, often minor defects in search of water and can cause repeat blockages. We recommend that the roots are cut and the pipe sections repaired by patch lining to prevent re-growth.

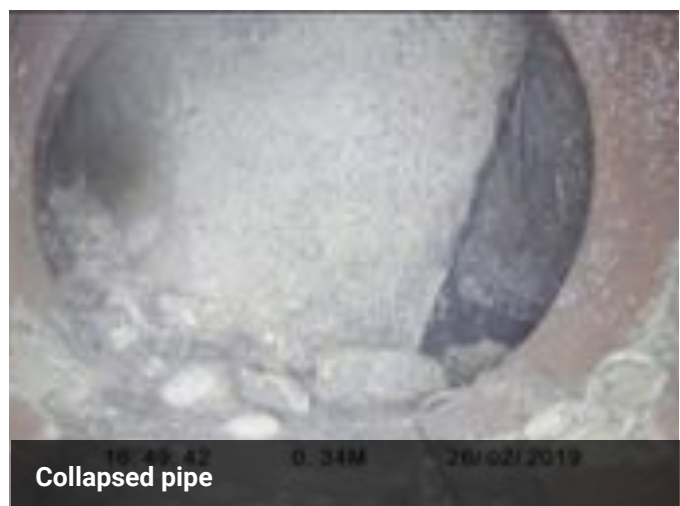
There appears to be a collapsed pipe D15 (MH17) which will need excavation and renewal to repair. It can sometimes be difficult to determine if a pipe has been intentionally blocked off and not properly sealed or has in fact collapsed. There are also cracked pipes D4 and D5 which we recommend are repaired to prevent further deterioration and possible collapse. These can currently be repaired relatively easily and cheaply in-situ by patch lining.

| ASSET | DEFECT | RECOMMENDATION | URGENCY | BY | COST |
|---|---|---|---|---|---|
| MH 17 | D 15 Collapse, moderate | Excavate and renew pipe | Moderate | Mar 2020 | £7,500 |

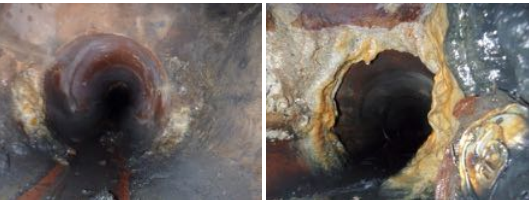
Section SW 2

Silt

| Asset | Defect | Recommendation | Urgency | Cost |
|---|---|---|---|---|
| MH 1 | Silt | Clear out chamber with suction tanker | Moderate | £0 |

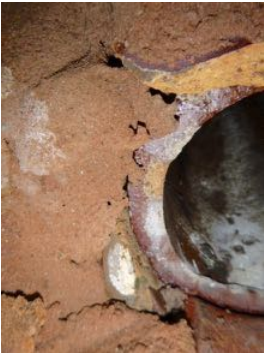
Section FW 2

Crack

| Asset | Defect | Recommendation | Urgency | Cost |
|---|---|---|---|---|
| MH 4 | Crack | Repair by patch lining | Moderate | £600 |

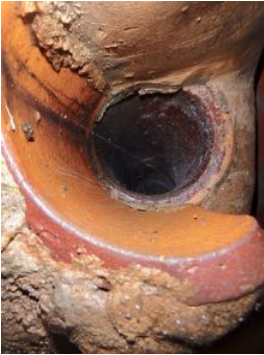
Section SW 57

Silt

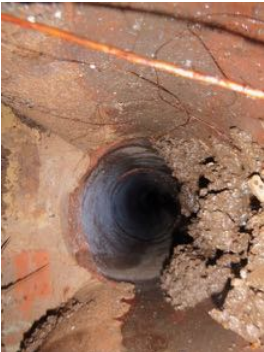
Section FW 35

Roots

| Asset | Defect | Recommendation | Urgency | Cost |
|---|---|---|---|---|
| MH 19 | Roots | Cut roots and repair by patch lining | Moderate | £800 |

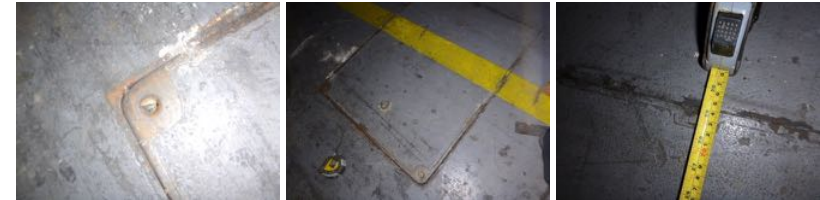
MH 28 chamber  
Defects

Bolts to cover seized  
None

| <b>MH 28</b> | <b>D 12</b> | Bolts to cover seized, | Will probably need break-out and renewal at next maintenance access | Low | Mar 2022 | £800 |

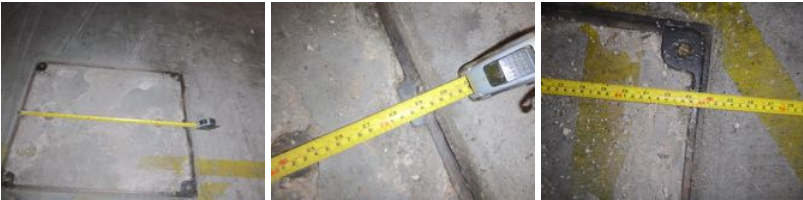
MH 34 chamber  
Defects

Bolts to cover seized  
Section FW 35

| ASSET | DEFECT | RECOMMENDATION | URGENCY | BY | COST |
|---|---|---|---|---|---|
| MH 34 | D 17 Bolts to cover seized, | Will probably need break-out and renewal at next maintenance access | Moderate | Mar 2020 | £800 |

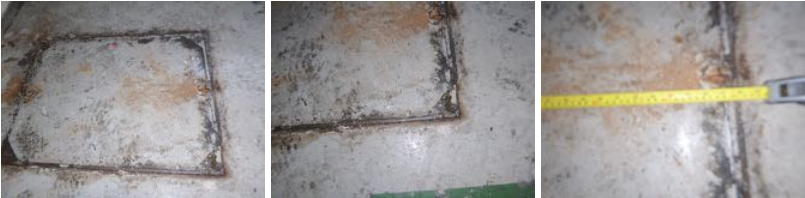
Cover seized in frame
