# CCTV Drainage Inspection Report.

Produced on behalf of - McCarthy and Stone

Site location - Huyton Liverpool

Survey reference – **108648**

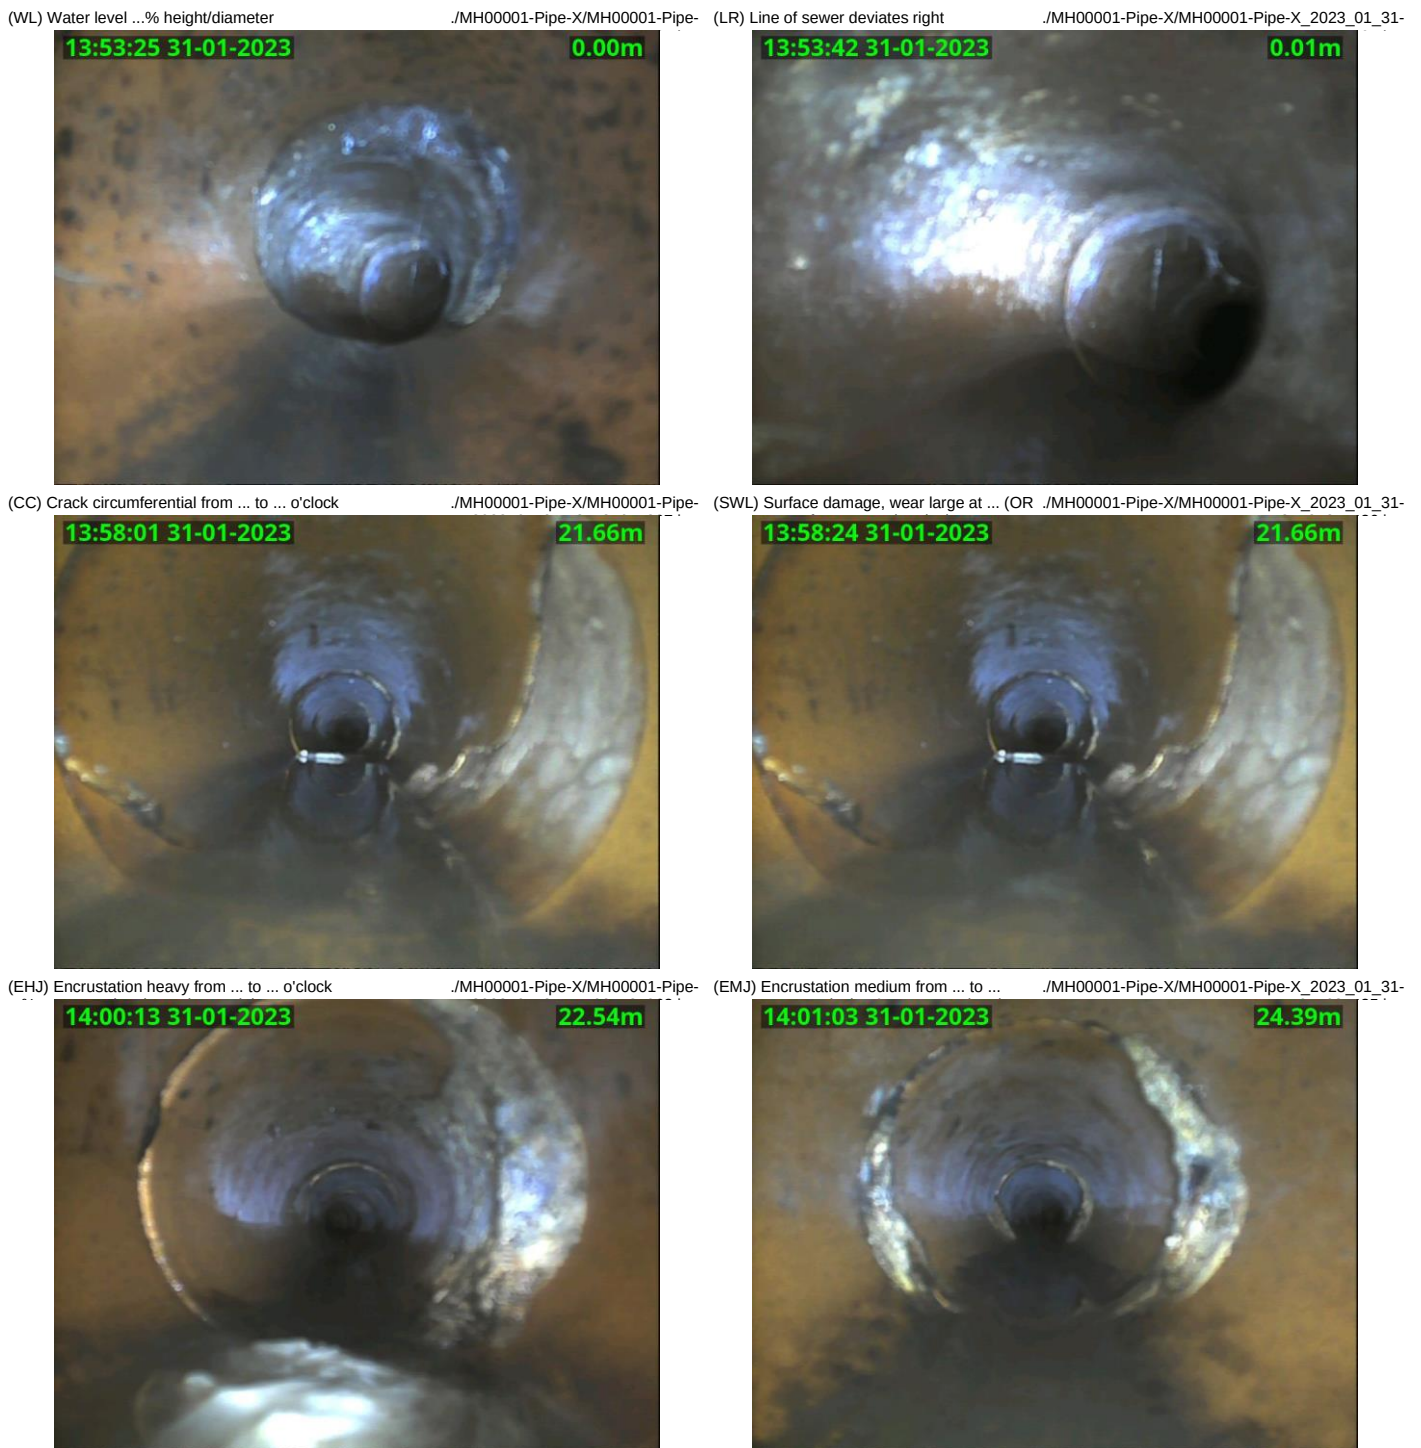
| Distance | Condition code and attributes | Photo Ref |
|---|---|---|
| 21.7 | (CC) Crack circumferential from ... to ... o'clock<br>Clock At/From: 01<br>Clock To: 09 | ./MH00001-Pipe-X/MH00001-Pipe-X_2023_01_31-13_58_01_207.jpg<br> |
| 21.7 | (SWL) Surface damage, wear large at ... (OR from ... to ...) o'clock<br>Clock At/From: 01<br>Clock To: 04 | ./MH00001-Pipe-X/MH00001-Pipe-X_2023_01_31-13_58_24_426.jpg<br> |
| 22.5 | (EHJ) Encrustation heavy from ... to ... o'clock ...% cross-sectional area loss at joint<br>Clock At/From: 01<br>Clock To: 04<br>Percentage: 20% | ./MH00001-Pipe-X/MH00001-Pipe-X_2023_01_31-14_00_13_063.jpg<br> |
| 24.4 | (EMJ) Encrustation medium from ... to ... o'clock ...% cross-sectional area loss at joint<br>Clock At/From: 01<br>Clock To: 04<br>Percentage: 10% | ./MH00001-Pipe-X/MH00001-Pipe-X_2023_01_31-14_01_03_425.jpg<br> |

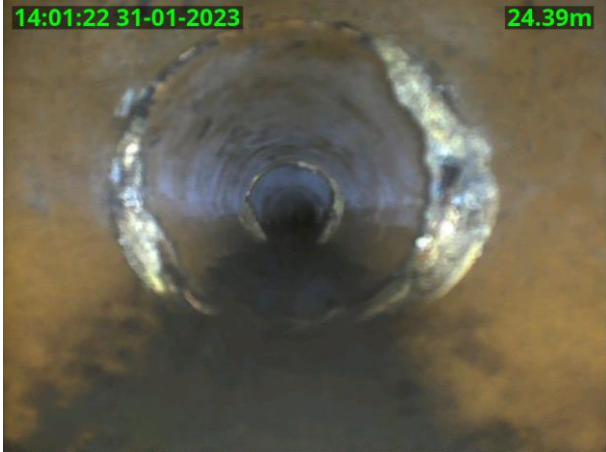
| Distance | Condition code and attributes | Photo Ref |
|---|---|---|
| 24.4 | (EMJ) Encrustation medium from ... to ... o'clock ...% cross-sectional area loss at joint | ./MH00001-Pipe-X/MH00001-Pipe-X_2023_01_31-14_01_22_751.jpg |

(EMJ) Encrustation medium from ... to ... /MH00001-Pipe-X/MH00001-Pipe- (EMJ) Encrustation medium from ... to ... /MH00001-Pipe-X/MH00001-Pipe-X\_2023\_01\_31-

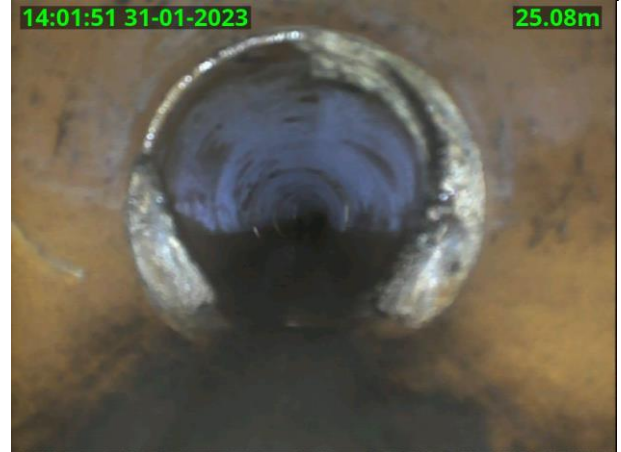
| Distance | Condition code and attributes | Photo Ref |
|---|---|---|
| 25.1 | (EMJ) Encrustation medium from ... to ... o'clock ...% cross-sectional area loss at joint | ./MH00001-Pipe-X/MH00001-Pipe-X_2023_01_31-14_01_51_737.jpg |

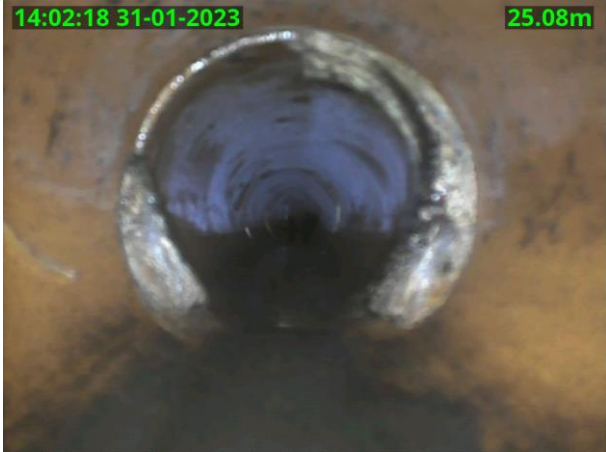
| Distance | Condition code and attributes | Photo Ref |
|---|---|---|
| 25.1 | (EMJ) Encrustation medium from ... to ... o'clock ...% cross-sectional area loss at joint | ./MH00001-Pipe-X/MH00001-Pipe-X_2023_01_31-14_02_18_602.jpg |

(EMJ) Encrustation medium from ... to ... /MH00001-Pipe-X/MH00001-Pipe- (ELJ) Encrustation light from ... to ... o'clock at /MH00001-Pipe-X/MH00001-Pipe-X\_2023\_01\_31-

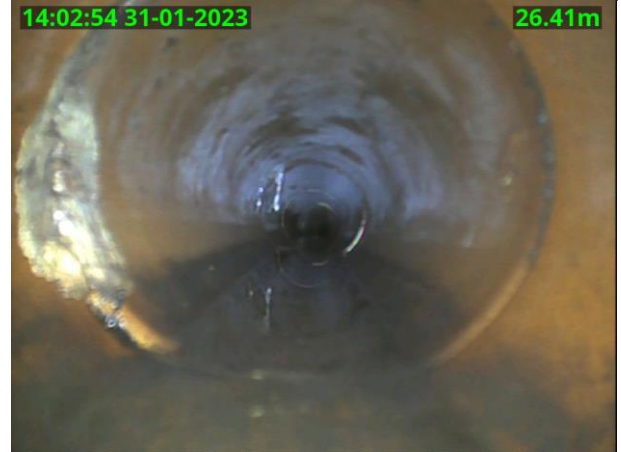
| Distance | Condition code and attributes | Photo Ref |
|---|---|---|
| 26.4 | (ELJ) Encrustation light from ... to ... o'clock at joint | ./MH00001-Pipe-X/MH00001-Pipe-X_2023_01_31-14_02_54_414.jpg |

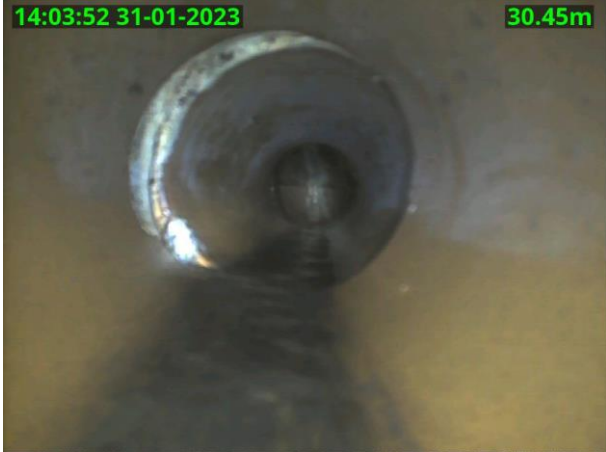
| Distance | Condition code and attributes | Photo Ref |
|---|---|---|
| 30.4 | (ELJ) Encrustation light from ... to ... o'clock at joint | ./MH00001-Pipe-X/MH00001-Pipe-X_2023_01_31-14_03_52_946.jpg |

(ELJ) Encrustation light from ... to ... o'clock at /MH00001-Pipe-X/MH00001-Pipe- (MH) Manhole/node /MH00001-Pipe-X/MH00001-Pipe-X\_2023\_01\_31-
