## **FPCR Response to Merseyside Environmental Advisory Service Consultation response (26/00006/OUT)**

### **Bellway Homes.**

**Cronton Road, Cronton**

**6<sup>th</sup> July 2026**

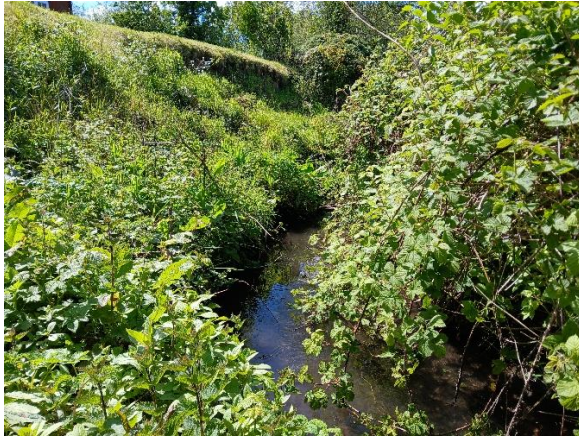
- 2.14 The first survey section (D) was located upstream to the east. Here the watercourse had a relatively wide channel (1-2m) containing shallow (<0.50cm) moderate flowing water. The substrate comprised predominantly silt, mud and stones. The banks were steep (~45°), comprised of earth with small stones and vegetated on the northern bank by ruderal vegetation and to the south by bankside trees and scrub. Further west, in section C where the watercourse is recorded adjacent the dog walking field, bank side trees and scrub are present along both banks.

**Photograph 1: Watercourse R1 – Section D**

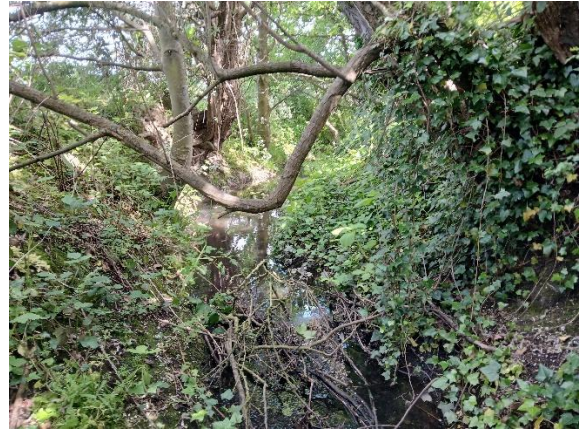
**Photograph 2: Watercourse R1 – Section C**

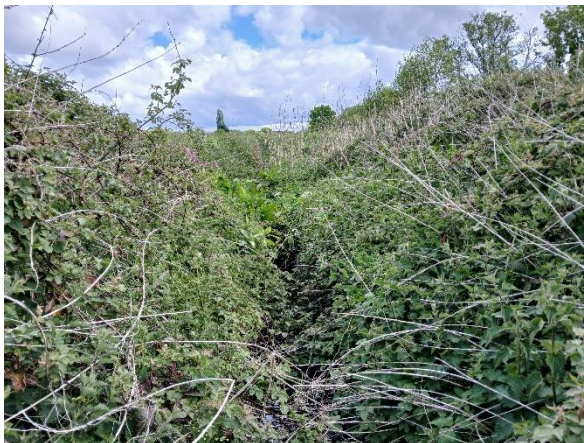
- 2.15 As the watercourse borders the Site, within section B the channel meanders gently and the bankside woody vegetation significantly reduces, replaced by areas of rough grassland, bramble scrub and individual trees directly adjacent to the watercourse. The banks remain steep with the channel width in this section narrowing slightly. The section continues to the west of the Site where the channel runs straighter.
- 2.16 In the final survey section (section A), the watercourse runs along the northern edge of Georges Wood LWS
- 2.17 R1 was considered to offer 'suitable but poor' value habitat for water vole due to relatively low water levels and poor in channel vegetation structure. The watercourse did however offer burrowing opportunities along the length of the watercourse and structural vegetation cover for shelter and foraging purposes.

**Photograph 1: Watercourse R1 – Section B**

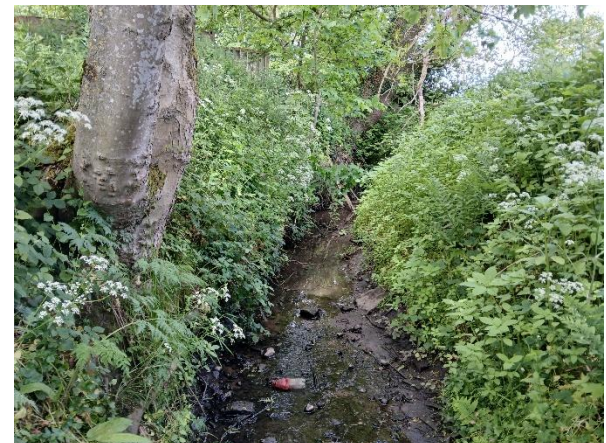
**Photograph 4: Watercourse R1 – Section A**

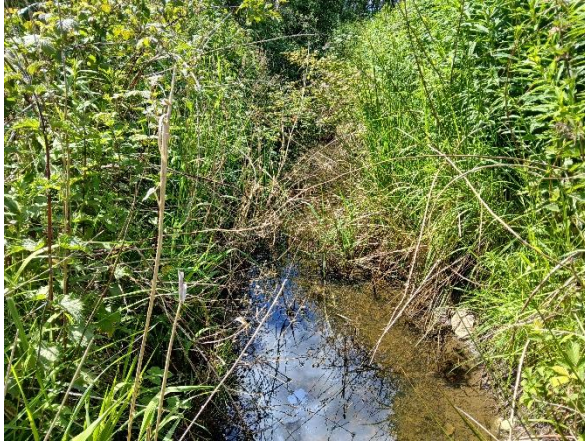
- 2.18 Ditch D1 runs westwards from the south extent of hedgerow H1 and featured a wet channel approximately 1.5m wide with shallow still water. The banks were steep, but only 0.5m high. No aquatic vegetation was noted but reed canary-grass and rosebay willowherb characterised the tall bankside vegetation. D1 was considered to offer 'suitable but poor' habitat for water vole due to relatively low water levels.

**Photograph 5: Watercourse D1**

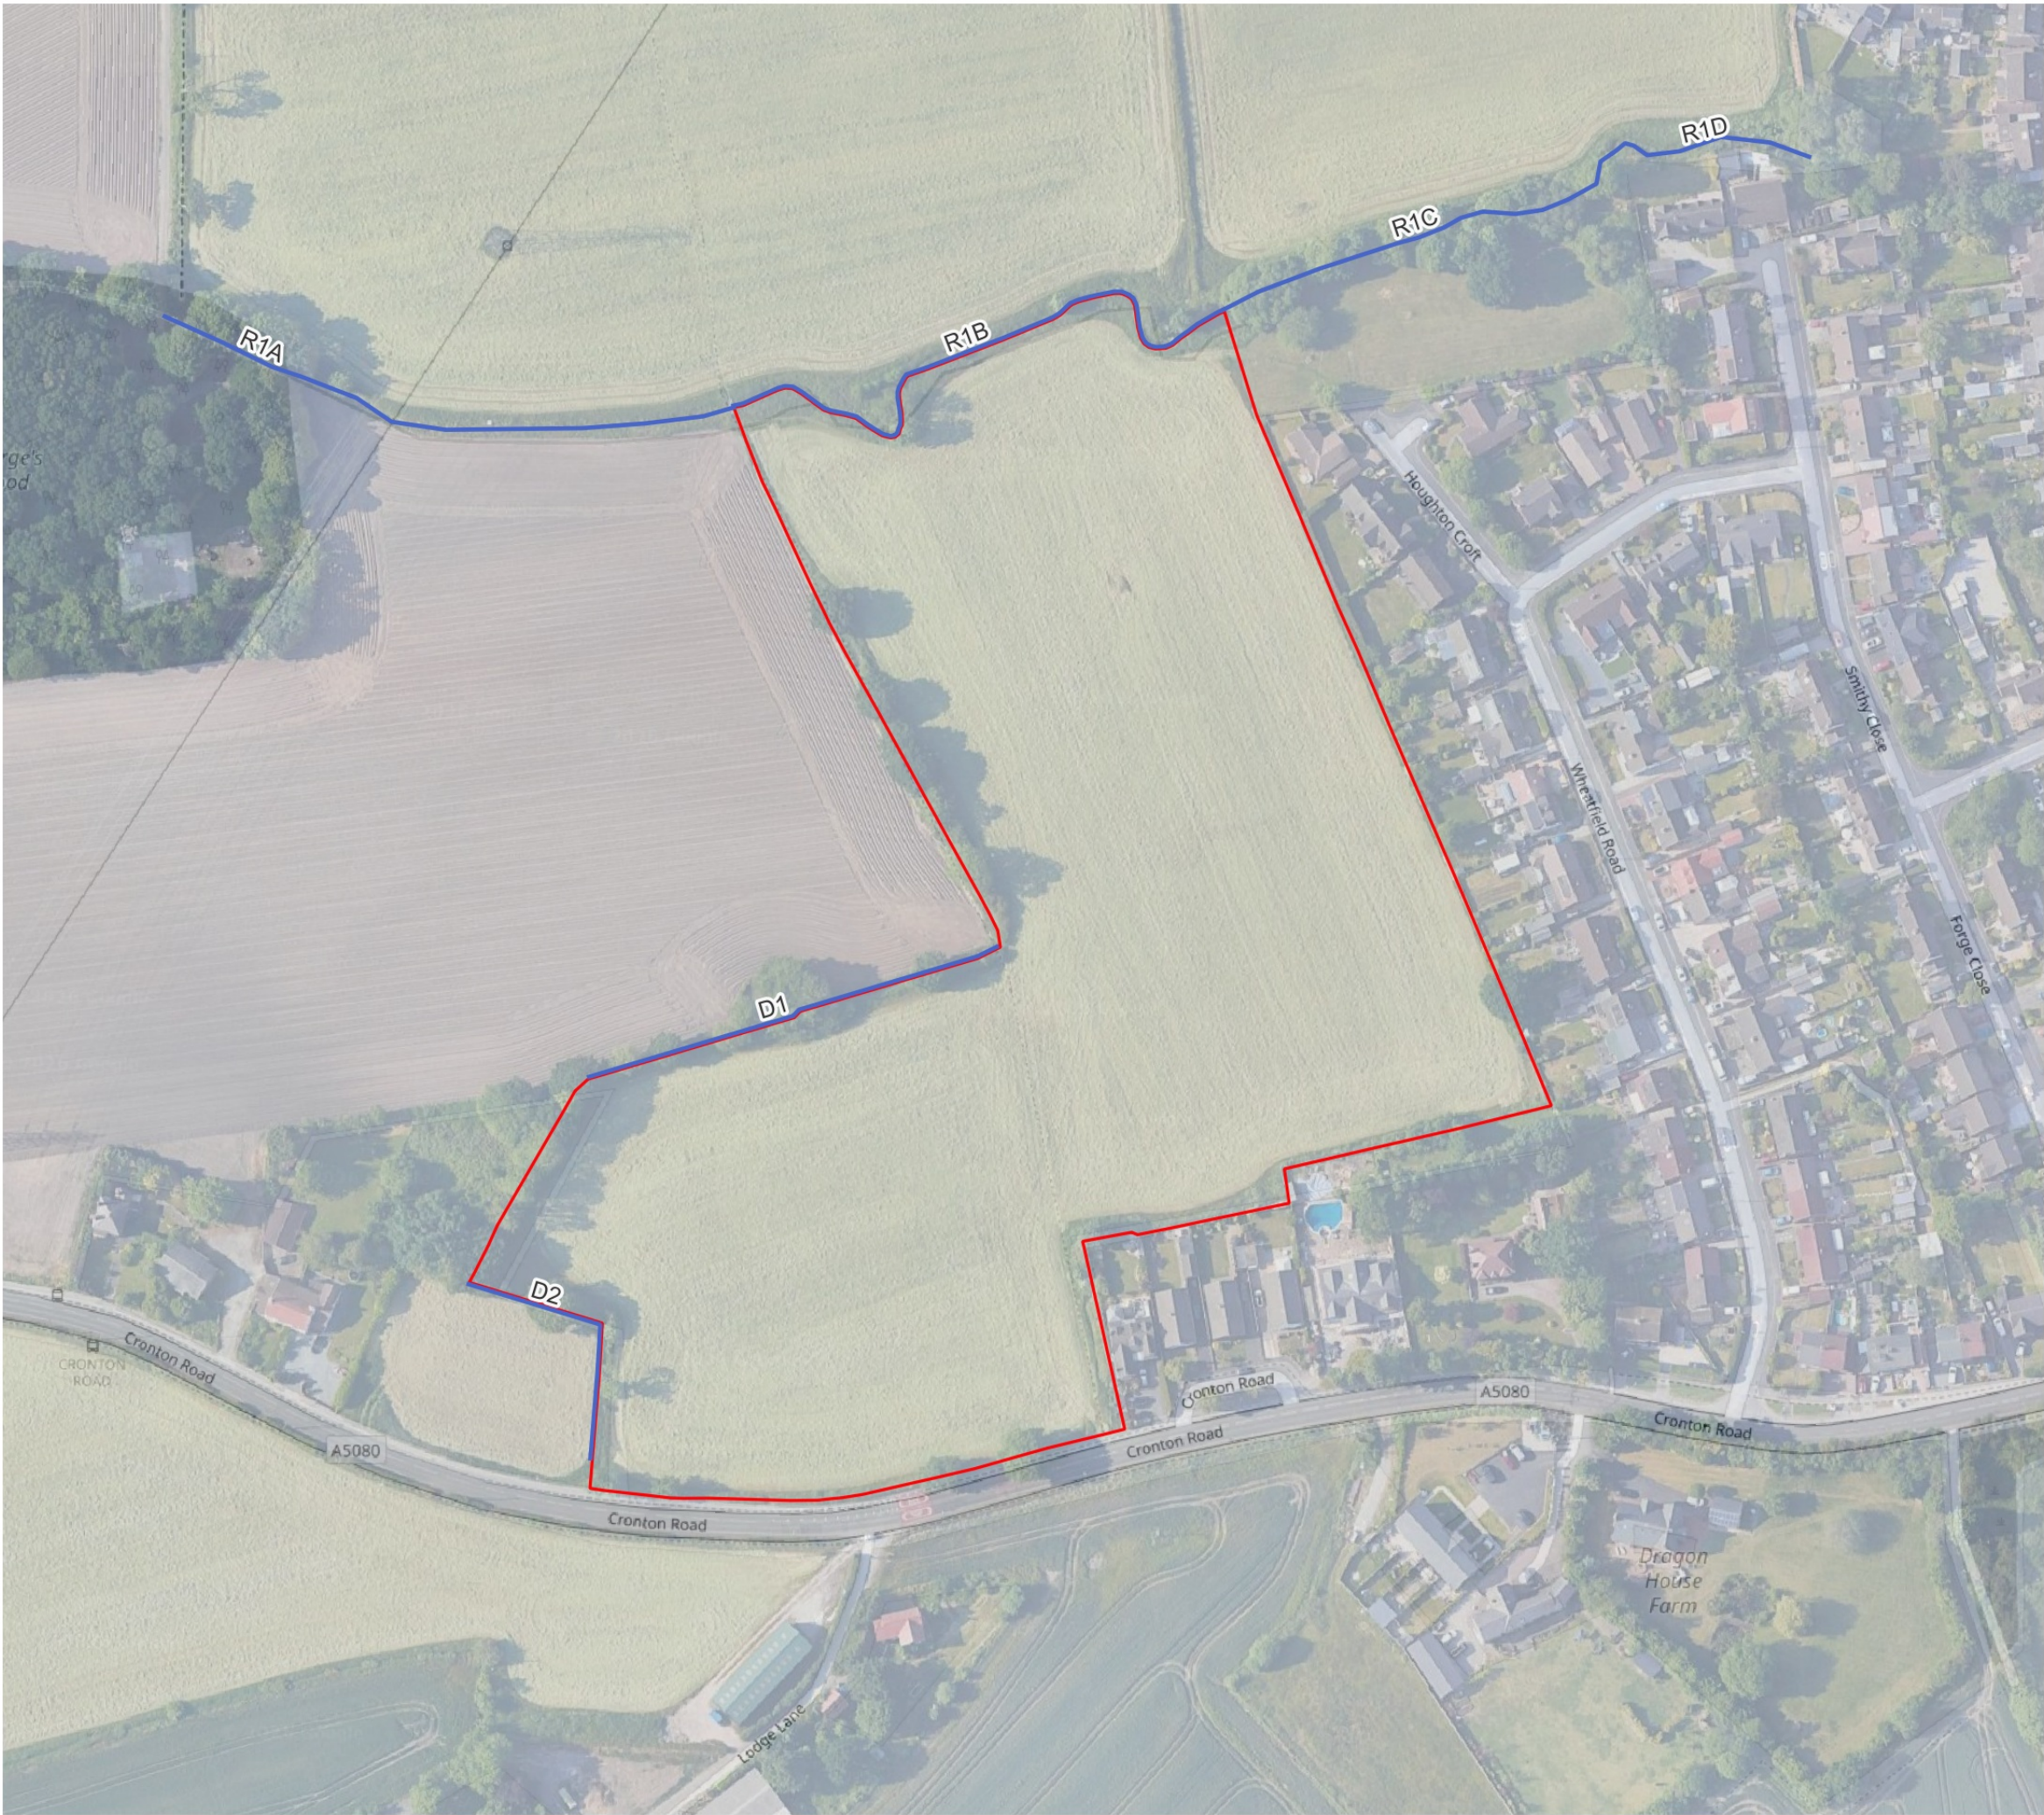
number  
**FIGURE 1**

- 2.13 Figure 1 illustrates the location of waterbodies across the Site and adjacent areas. One stream and two ditches were present adjacent the Site boundary (R1 & D1 – D2). R1, known as Dog Clog Brook, starts west of Norland's Lane to the northeast of the site, continues for several kilometres before it joins Ochre Brook. The watercourse eventually joins the River Mersey. Dog Clog Brook passes along the northern boundary of the Site, entering from the east and flowing out to the west.

- 2.20 Three watercourses bordering the Site, were considered to offer 'suitable but poor' habitat value for water vole. While all the watercourses were predominantly wet throughout the survey season, holding shallow static / flowing water, the water levels were insufficient to support water vole populations. However, other factors such as vegetation providing structural cover and/or banks suitable for burrowing offer sheltering and foraging opportunities for water vole.
- 2.21 No field signs indicating presence of water vole or otter were recorded within the waterbodies and adjacent areas on Site.

- 2.23 Impacts to water vole are considered to be unlikely, however this species can rapidly recolonise sites, so it is recommended that a pre-works survey is undertaken to confirm continued absence (or presence).
