# LAND AT HALSNEAD PARK WHISTON ARBORICULTURAL IMPACT ASSESSMENT MARCH 2022

| Document Title | Arboricultural Impact Assessment |
| Prepared for | Taylor Wimpey |
| Document Ref | 7137.001 |

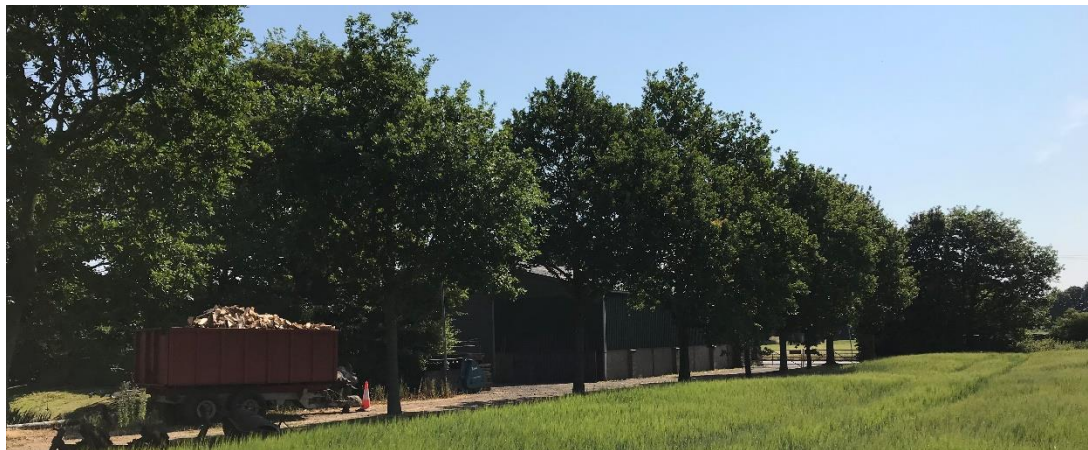
- 4.6 Immediately adjacent to the existing access track is a linear group of trees (G8) comprising 8 middle-aged English oak. All trees have been crown lifted over the access track with pruning wounds evident however, no other management is evident. These trees are in good condition and provide good amenity and landscape value.

*Figure 5 Linear group of English oak (G8) adjacent to existing access track.*

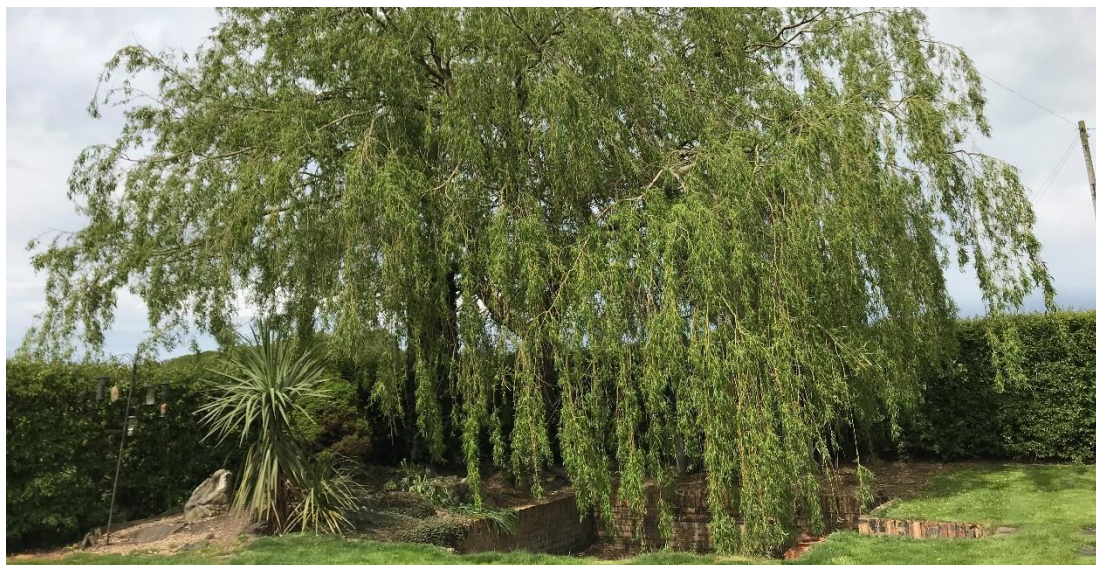
- 4.7 Located to the north-west of the farmhouse garden is a middle-aged weeping willow tree (T27). It is situated in close proximity to a sunken patio area surrounded by retaining walls which will likely have influenced the root growth of the tree. It has good form typical of the species and there is no evidence of previous management.

*Figure 6 Weeping willow (T27) adjacent to sunken patio area with retaining walls.*
