## Former Laboratory, Lower Road Halewood, Liverpool

### Bat Scoping Survey

8<sup>th</sup> February 2022

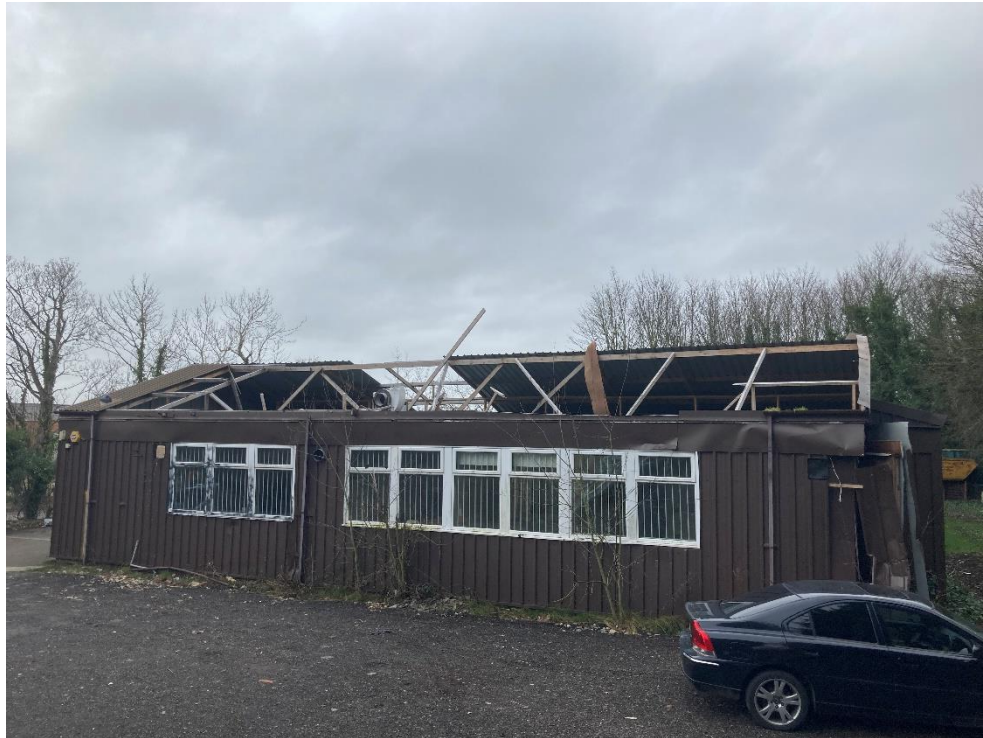
Building 1 is constructed of rendered chipboard which has also been partially clad in corrugated metal panels. The west facing pitch of the roof of the building has mostly blown off fully exposing the internal roof space. The building does not support any obvious external features suitable for roosting bats.

The roof void could be observed from the exterior owing to the missing roof panels. The internal face of the roof is unlined and the void space has been previously insulated with fibrous felt. The roof is supported on softwood timber trusses. The interior of the building is considered to be unsuitable for roosting bats.

*Photograph 1- Building 1*

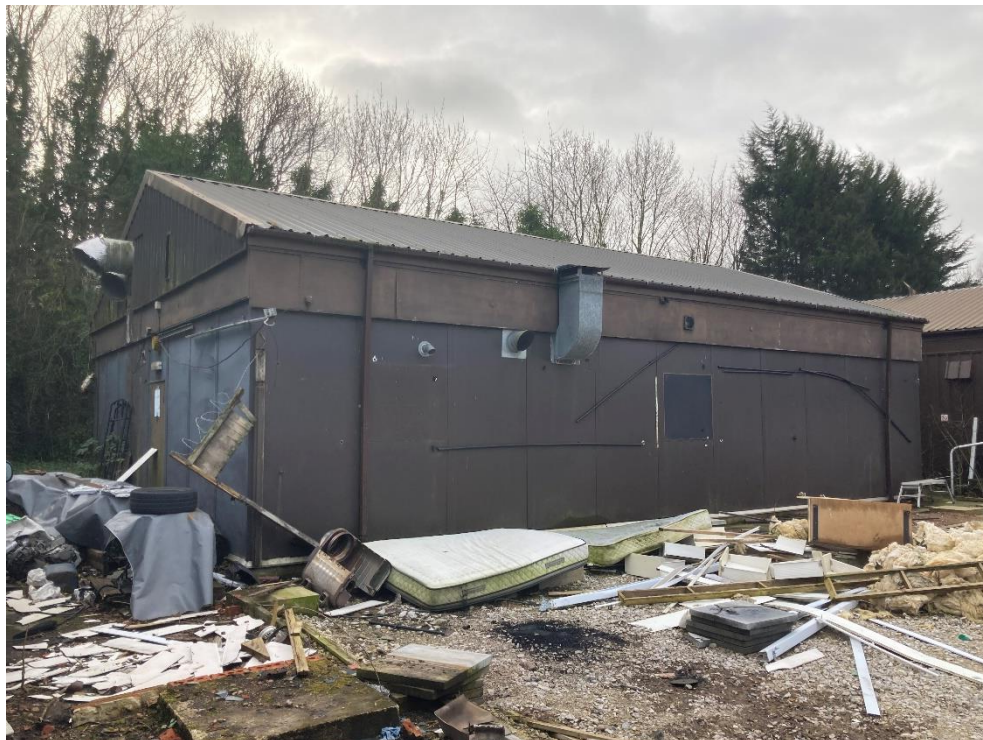
Building 2 is of a similar construction to Building 1. Building 2 was previously used as a laboratory. The building is constructed from coated plasterboard with corrugated metal panels at the gables. The building has protruding extractor fan pipework at its east facing gable and a rectangular hole measuring approximately 30cm x by 20cm which goes through to the roof void space.

*Photograph 2- Building 2*

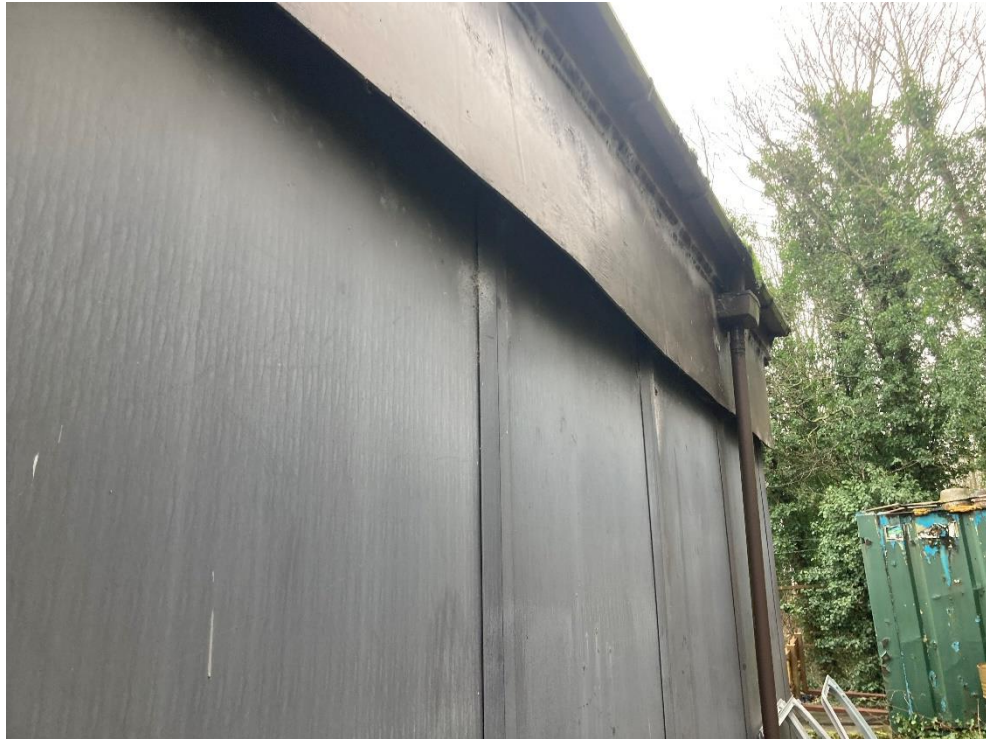
There is a length of chipboard fascia running beneath the roof eaves at a height of approximately 2.5 m. There is a 5 cm wide gap between the chipboard and the outer walls of the building. This leads back to a blind ending space which is approximately 15cm deep. The space could be fully viewed and explored during survey; it was observed to be partially cobwebbed over for much of its length. The space is not considered to offer suboptimal bat roosting habitat as it is very exposed.

Building 1 was found to be entirely unsuitable for bats, whilst Building 2 supports a wide and shallow crevice behind fascia boarding below the building's eaves. The crevice was observed to be mostly cobwebbed over and the full extent of the crevice could be easily viewed with a torch. Whilst a bat could hypothetically roost in such a location, such usage is considered to be unlikely owing to the low height, broad width and exposed nature of the crevice.

*Photograph 3- Fascia boarding beneath eaves of Building 2*

As a precaution, it is recommended that a visual inspection of the crevice behind the fascia boarding is carried out by an appropriately qualified ecologist immediately prior to demolition.

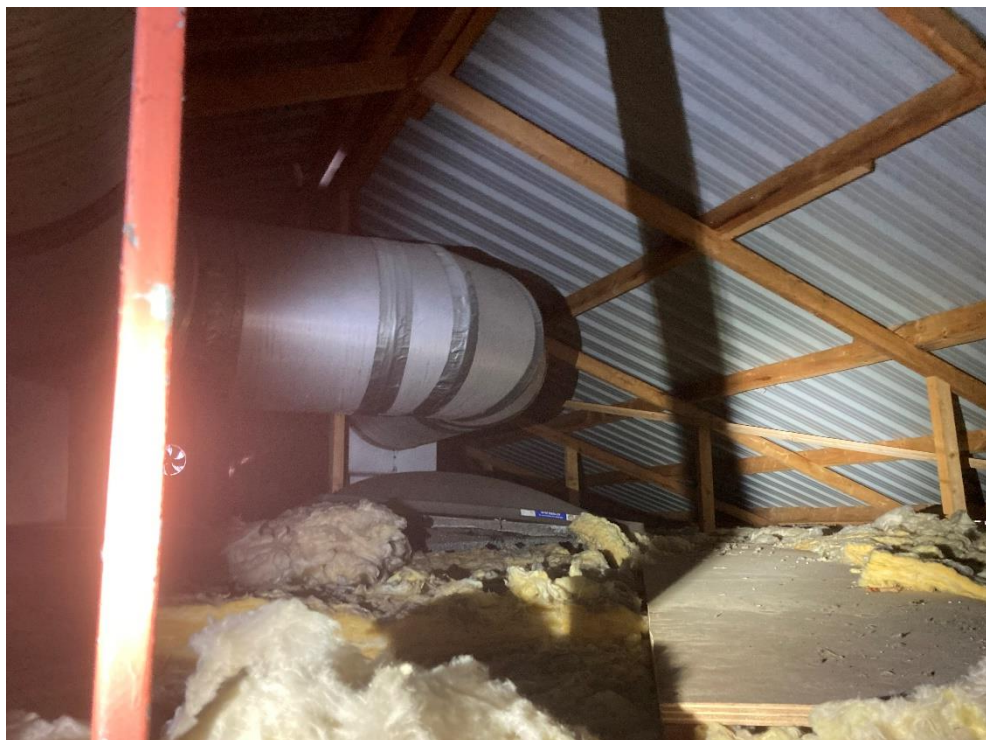
Internally, this building comprises of a series of windowless laboratory rooms with plastered and tiled walls and ceilings. These rooms are considered to be inaccessible to bats. The building does not have a hatch to provide access to the roof space above. However, the interior of the loft space could be viewed from the exterior through the hole at its east facing gable. The loft space houses ventilation ducts and is unlined. The void space has been insulated with fibrous felt. The roof is supported on softwood timber trusses.

The building loft space and interior do not support any obvious suitable features for roosting bats.

*Photograph 4- Loft space of Building 2*

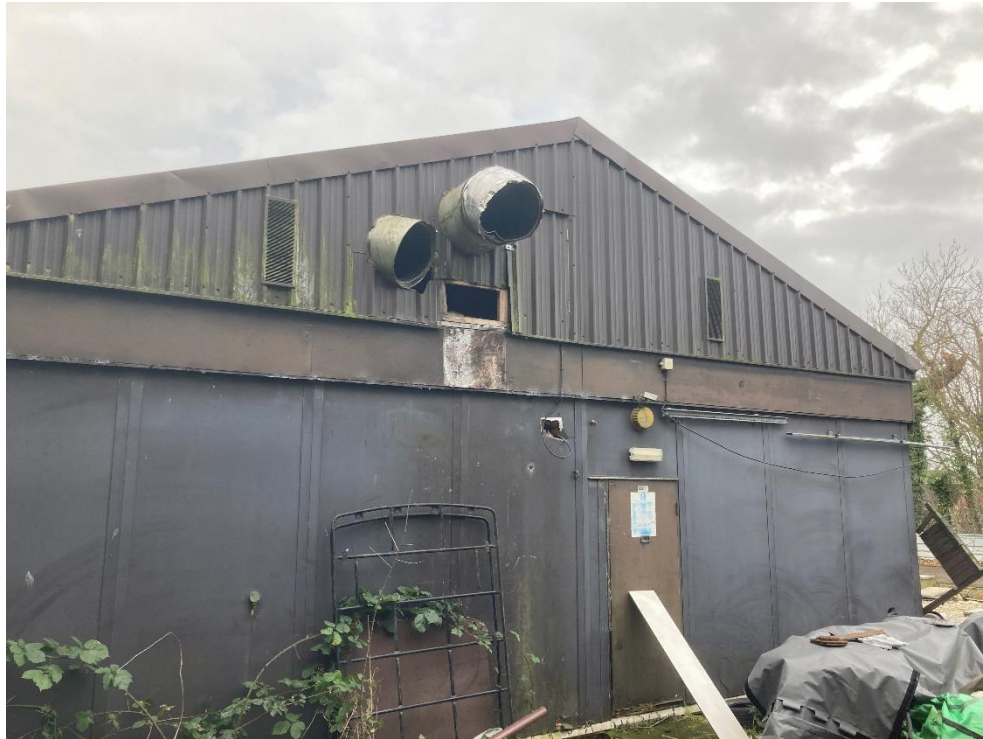
*Photograph 5- East facing gable of Building 2*

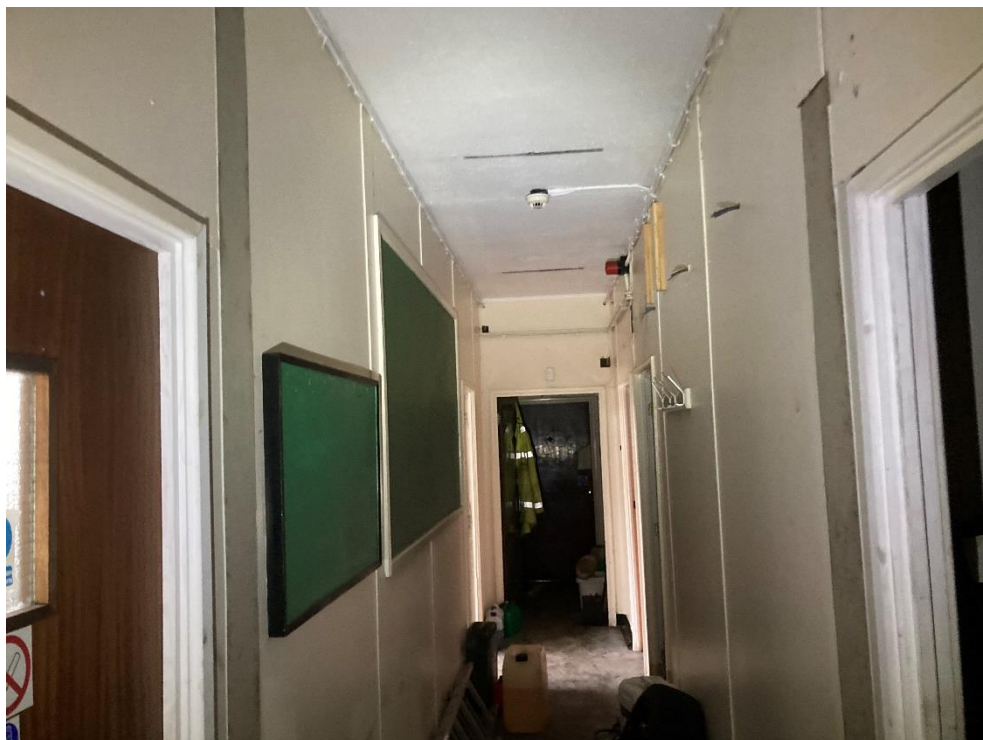
Internally, this building was previously used as an office. It comprises of several interlinked rooms with glazed windows and plastered walls and ceilings. Some parts of the ceiling have partially collapsed due to rain damage.

*Photograph 6- Interior of Building 1*
