## **ARBORICULTURAL IMPACT ASSESSMENT REPORT**

**The Construction of an Extension to an  
Existing Dwelling House**

41 Longview Drive,  
Huyton L36 6EA

**Report Ref:**  
DTCL.310.AIA.2023

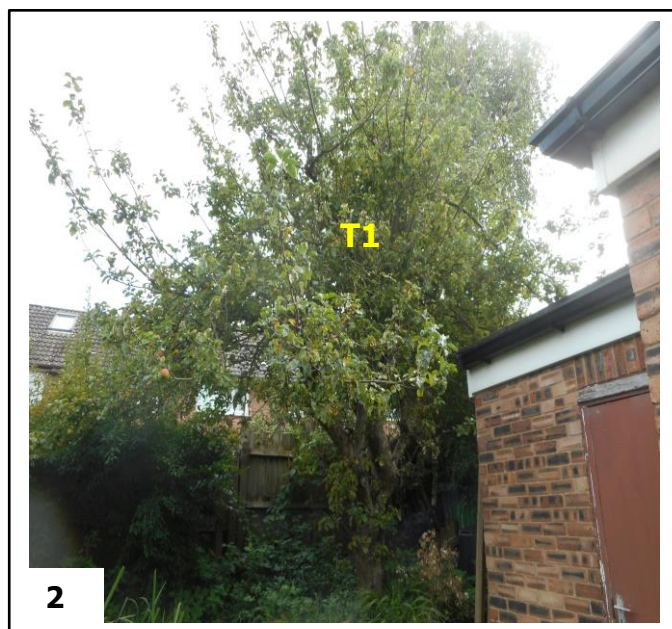
- 3.1 There is a single tree on the site, **T1**, which is a mature apple tree, (*Malus* spp), located in the rear garden close to the gable wall of the existing garage, (Photograph 2). It has a stem diameter of 310 mm and is approximately 7 m in height with a crown diameter of 7 m.

**Photo 2:** A view of the apple tree (**T1**) looking north from the existing house. Note that it needs pruning to reshape and balance the crown.

The apple tree, **T1**, has been categorised as '**B1**', '*trees that might be included in category A, but are downgraded because of impaired condition, e.g., the presence of significant though rectifiable defects, including unsympathetic past management or storm damage, such that they are unlikely to be suitable for retention beyond 40 years; or trees lacking the special quality necessary to merit the category A designation*'.

- 3.3 It is proposed to reduce the crown of the tree by 2 m all around to reshape and balance the crown. This can be achieved by directional pruning to prevent regrowth towards the garage.

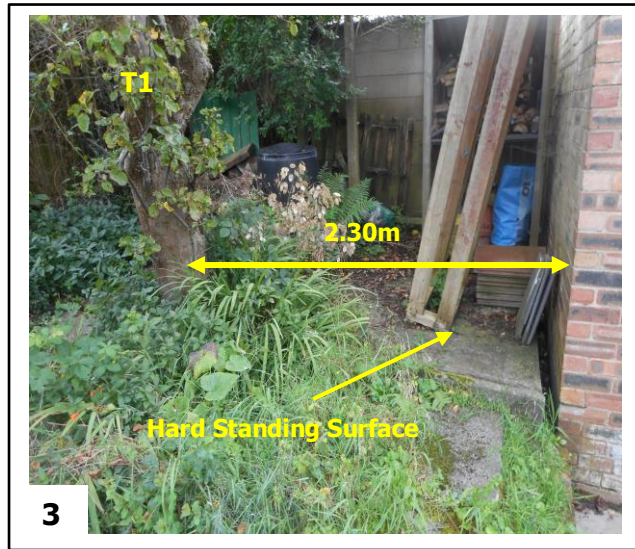
- 3.4 With a stem diameter of 310 mm would dictate that the root protection area with a nominal circle radius of 3.60 m and a total RPA of 41 m<sup>2</sup>. The tree is located at 2.30 m from the existing structure and 4.76 m from the closest part of the proposed extension. In addition, the area between the apple tree and the gable of the existing garage is a hard surface, (Photograph 3).

**Photo 3:** A view of the proximity of the apple tree (**T1**) to the gable of the existing garage. Note the existing hard standing between the tree and the garage.

- 3.5 The apple (**T1**) is 4.76 m from the closest point of the proposed extension; therefore, the proposed extension is outside the RPA of the tree and construction works would not impact on the tree root zone. However, the tree needs to be protected during the construction phase.
