# ARBORICULTURAL REPORT (BS 5837:2012)

PROPOSED DEVELOPMENT

ROSEWOOD FARM  
CHAPEL LANE  
CRONTON  
WIDNES  
WA8 5QF

May 2021

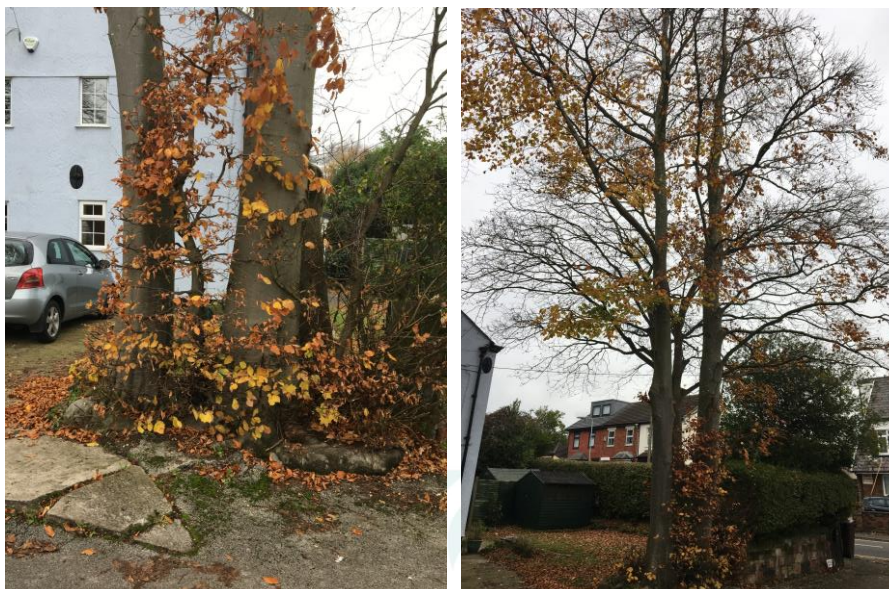
G3 – 3 Beech stems

- 5.1.1 The loss of any tree due to development is always regrettable but, in this instance, G3 (Beech) to be removed has limited long term viability due to the existing root activity and their proximity to the existing development. They appear to be old hedging plants that have been allowed to mature.
- 5.1.2 Special surfacing was considered but due to the vigorous surface roots that are visible it would be too difficult and potentially damaging.

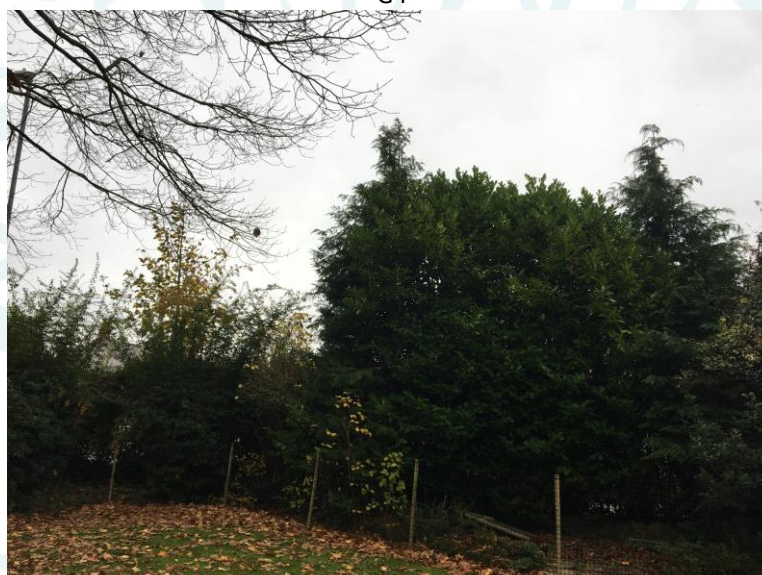
- 5.1.3 The partial removal of G4 will involve removing Laurel and Cypress as the picture illustrates below. These are considered to be minor trees of low quality.
