# Site Inspection Note – Updated Bat Roost Assessment

| <b>Project Reference:</b><br>BOW17_1486 Carr Lane,<br>Prescot. | <b>Date of Inspection:</b> 24/07/2024 | <b>Surveyor/s:</b> Paula Hollings, Senior Ecologist & Class 1 Bat Licence Holder (reg no. 2015-16053-CLS-CLS) & Lucy Wilde, Ecologist. |

Document Title: BOW17\_1486 Carr Lane, Prescot. Bat Roost Assessment \_24.07.24

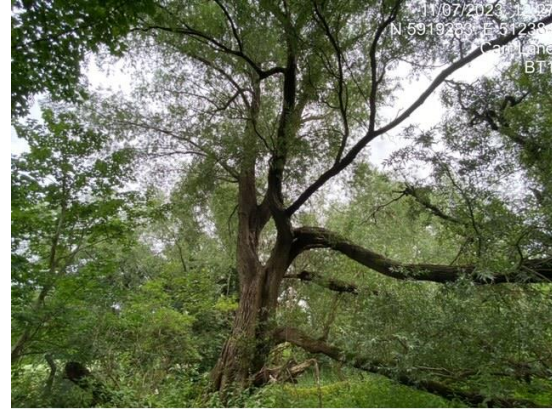
This tree has been significantly damaged by the 2024 excavation work. Two limbs have been removed, the larger of which possessed several linear cracks, up to 4cm in width, in the form of splits, transverse snaps, hazard beams and frost cracks. These limbs have been placed on the ground next to the tree. Based on a close inspection of accessible potential roosting features on the felled limbs, it was considered that these features could have potentially supported low numbers of bats. Based on the size of PRFs present, it is unlikely that the limbs had the potential to support a maternity roost. No evidence of previous bat usage was recorded, however the stems have been on the ground for several weeks, with many features upward facing and exposed to rain which may have removed any field evidence.

Photo 1: T3 in 2023, showing horizontal stems extending out to right which have been removed.

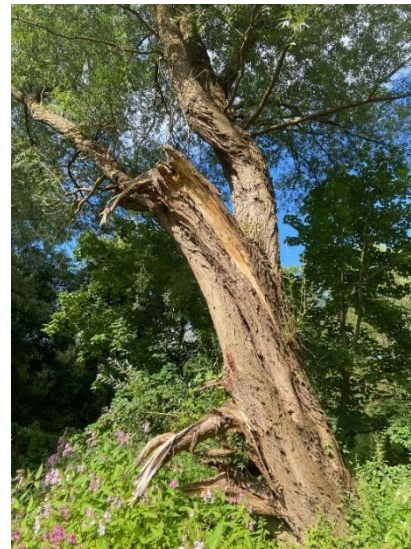
Photo 2: T3 in 2024

Aside from the removed horizontal limbs, the upright section of this tree has been retained as standing and continues to possess a number of potential roosting features for roosting bats such as longitudinal gaps into stem cavities, and deep bark fissures. Owing to height and accessibility, these cannot be subject to internal inspections from ground level, however it was noted that at least one gap penetrated into a larger internal cavity within the main stem.

The removal of a main limb, and surrounding scrub vegetation has resulted in a less sheltered environment for the tree and retained PRFs.

It is also of note that ground close to the tree base has been subject to excavation work, potentially causing root damage to the tree.

2024 potential roosting value: **High**, however with a reduced number of PRFs in a more exposed location/environment.

| <p><b>Actions required:</b></p> <p><u>Trees T3, T4 &amp; T5</u></p> <ul style="list-style-type: none"><li>• Despite damage, the trees with moderate/high bat roost potential should be <b>retained in situ</b> if possible, to form part of the proposed woodland belt along the western site boundary. The AIA recommends Tree T3 for removal, however also states that retention may be possible.</li><li>• The open, disturbed area adjacent to Trees T3, T4 and T5 created by excavation work should be planted with native trees and shrub to restore sheltered conditions within the wooded belt.</li><li>• The lighting strategy of the proposed development should ensure this woodland belt remains unlit by artificial light, to prevent loss or fragmentation of foraging / commuting habitat for bats.</li><li>• As compensation for the loss of potential roosting features on Tree T3, bat boxes should be erected on suitable trees throughout the woodland:<ul style="list-style-type: none"><li>○ Six boxes are suggested as compensation, based on the nature and number of PRFs that have been lost within the limb that was removed.</li><li>○ Suggested locations of boxes are plotted on the appended plan, close to T3 with the aim of creating roosting habitat within the same locality from which it has been lost.</li><li>○ The woodland contains trees that are large enough to support bat boxes and possess direct connectivity with adjacent park and lake habitats with high potential value foraging habitat.</li><li>○ Boxes will be installed on three trees which are not at high risk of any tree diseases, do not overhang any proposed roads, will not be affected by artificial light spill, and with flightlines that are not cluttered by epicormic growth or other adjacent features. The exact positions will be decided on</li></ul></li></ul> | |

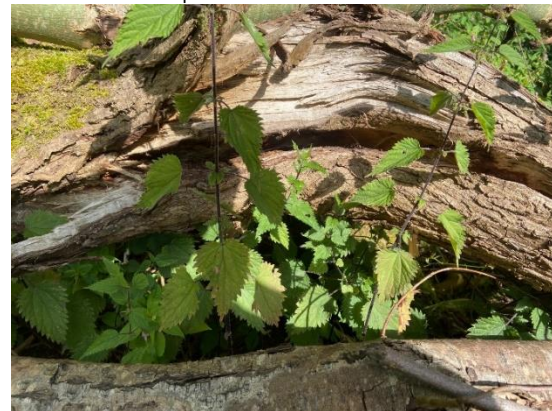
Photo 3: Example of PRF within removed limb

- The felled tree limbs should be left in situ as a deadwood resource for invertebrates.
  - If Trees T3, T4 and/or T5 must be removed or pruned for safety reasons, further survey work will be required prior to any disturbance, to establish the current presence or likely absence of bat roosts. This further survey work will involve tree climbing inspections of the trees, where safe to do so, or two to three dusk/dawn bat surveys between May and August, in line with current best practice guidance. If a bat roost is identified by this survey work, a licence will be required for any removal/pruning work to ensure compliance with wildlife legislation and planning policy.

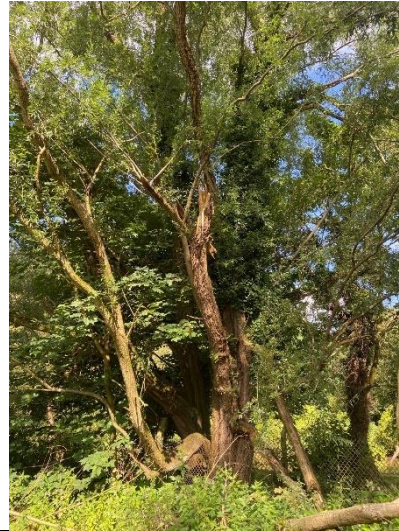
Photo 4: T4 in 2024

Numerous failed and snapped branches, and longitudinal cracks in back and heartwood.

No direct damage to PRFs from excavation work.

The removal of surrounding scrub vegetation has resulted in a less sheltered environment for the tree and retained PRFs.

Ground close to the tree base has been subject to excavation work, potentially causing root damage.

2024 potential roosting value: **Moderate**

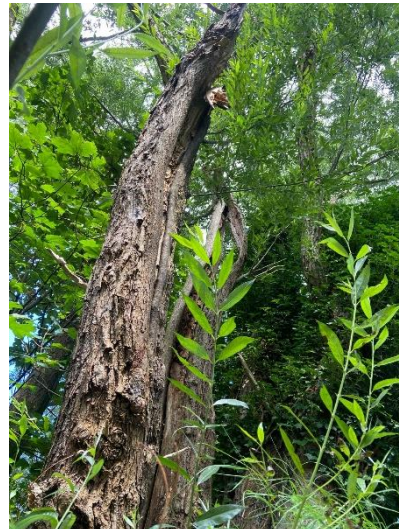
Photo 5: T5 (2024)

Rotten heartwood exposed for full height of tree on northern aspect, and in places heartwood is completely absent. PRFs comprise gaps behind partially occluded bark, splits in heartwood and deep fissures in bark.

No direct damage to PRFs from excavation work.

The removal of surrounding scrub vegetation has resulted in a less sheltered environment for the tree and retained PRFs.

Ground close to the tree base has been subject to excavation

2024 potential roosting value: **Moderate**

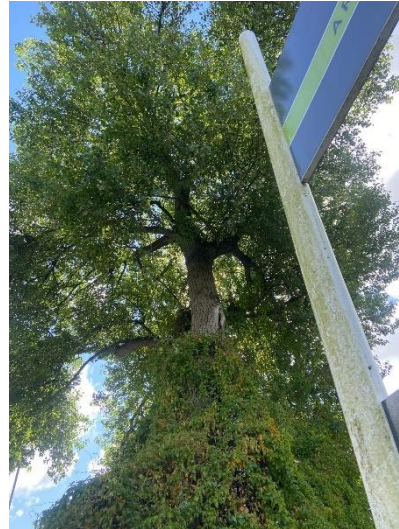
Photo 6: T7 (2024)

Mature hybrid poplar, located away from areas of damage from excavation works. Stem forks at approximately 3m height. A tear out feature is present on the north-western aspect of the tree at approximately 5 m high. This appears upward facing with shards of heartwood still present within, implying an absence of an open internal cavity. A smaller second tear out was noted however this appears exposed to the elements and is wet.

No change or damage has occurred to this tree since July 2023.

2024 potential roosting value: **Low**

- If either of the trees with low bat roost potential are due to be removed or disturbed, these should be subject to an inspection for roosting bats immediately prior to any felling/pruning works. This would likely take the form of a tree climbing survey to allow for the close inspection of features. If tree-climbing is not possible (e.g. for safety reasons), the tree should either be subject to a dusk/dawn bat survey, or be soft-felled under the supervision of a suitably experienced ecologist. Soft felling would involve safely lowering any sections of the tree containing potential roosting features to ground after removal, which must be maintained in an upright position until an ecologist is satisfied no bats are present within any suitable roosting features.

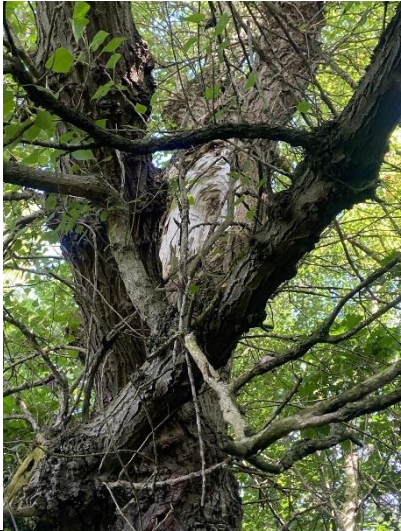
| <p><u>Tree G15a</u></p> <p>Mature poplar, located away from areas of damage from excavation works.</p> <p>A main limb has snapped off the tree – potentially as a result of fire damage based on bark colouration. No gaps were noted behind partially occluded bark, however direct access to the feature was not possible.</p> <p>No damage has occurred to this tree from the 2024 excavation works.</p> <p>2023 potential roosting value: <b>Negligible</b></p> <p>2024 potential roosting value: <b>Low</b></p> | <p>Photo 7: Tree G15a (2024)</p> |
