**Barn at Brook House Farm,  
Lower Road,  
Halewood,  
L26 3UB**

**On behalf of T&O Harrison**

**Bat Scoping Survey Report**

**Report number:** HALEW/2022

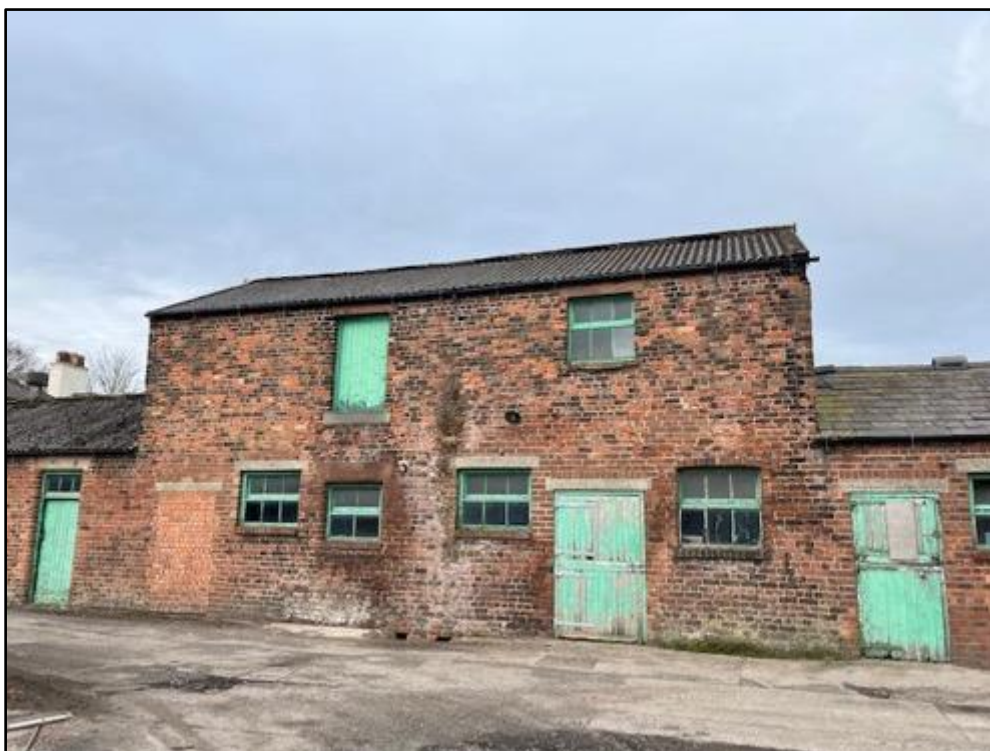
**Fig 4:** A view of the subject building. The middle section of the building is in a two-storey configuration, with a corrugated asbestos roof atop.

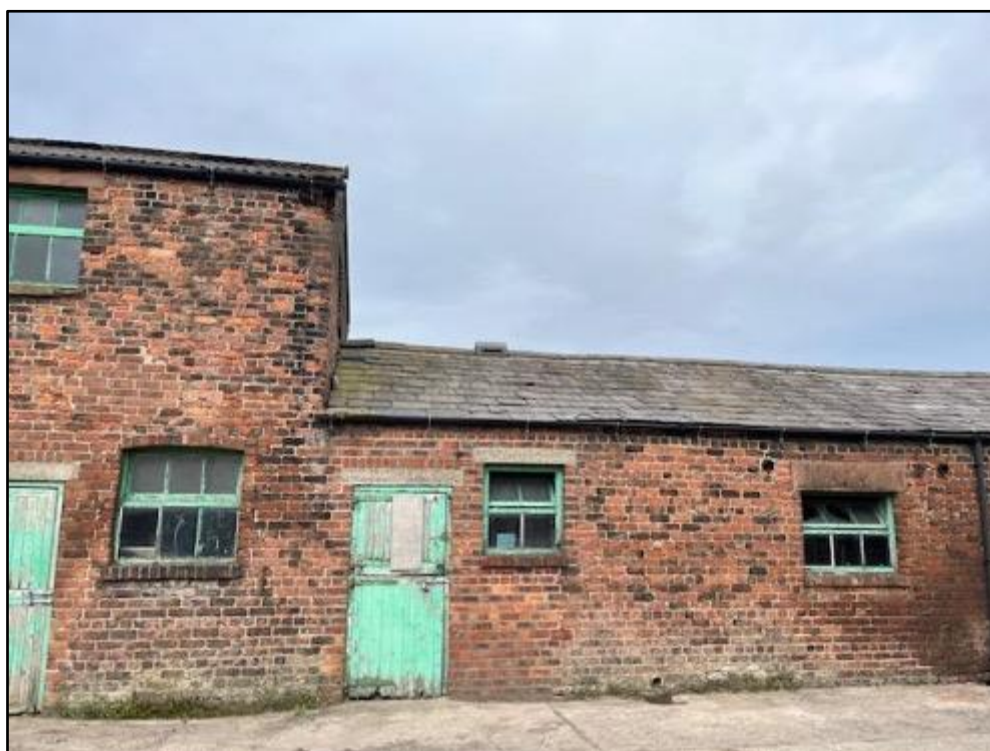
**Fig 5:** A view of the slate roof section of the building.

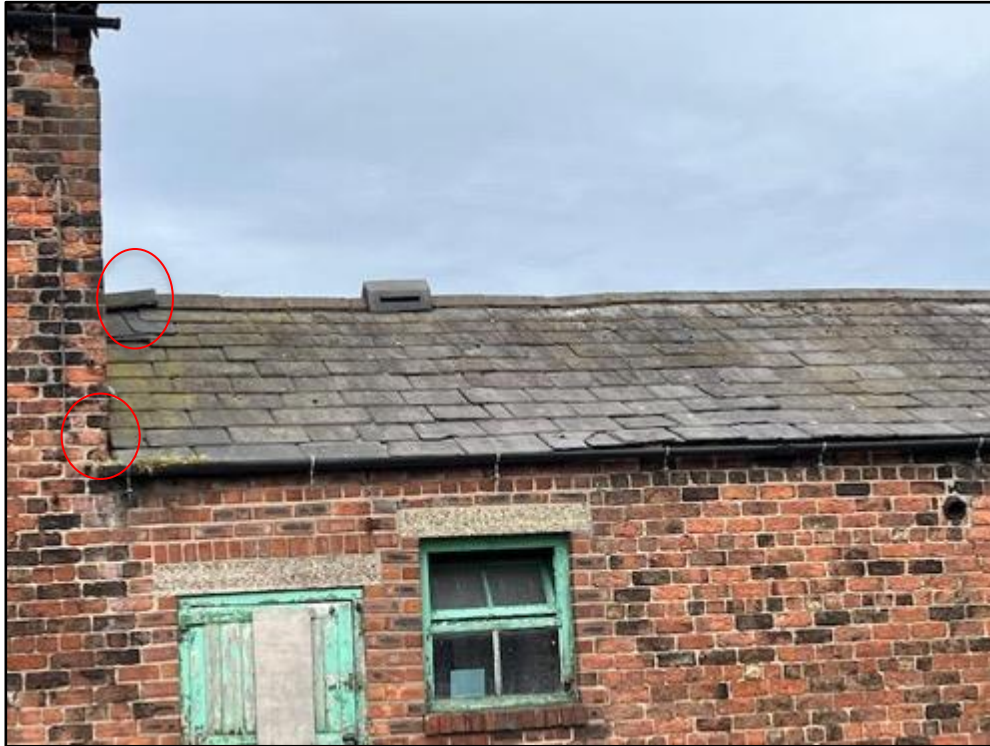
- 1.1.4 The building was found to hold moderate bat potential due to its condition, especially the slate tile, single-storey section of the building. The section of the building which features a slate-tiled roof is in poor condition, with several displaced and damaged tiles noted during the survey.

**Fig 6:** A closer view of the slate roof section. Several displaced tiles have been circled.

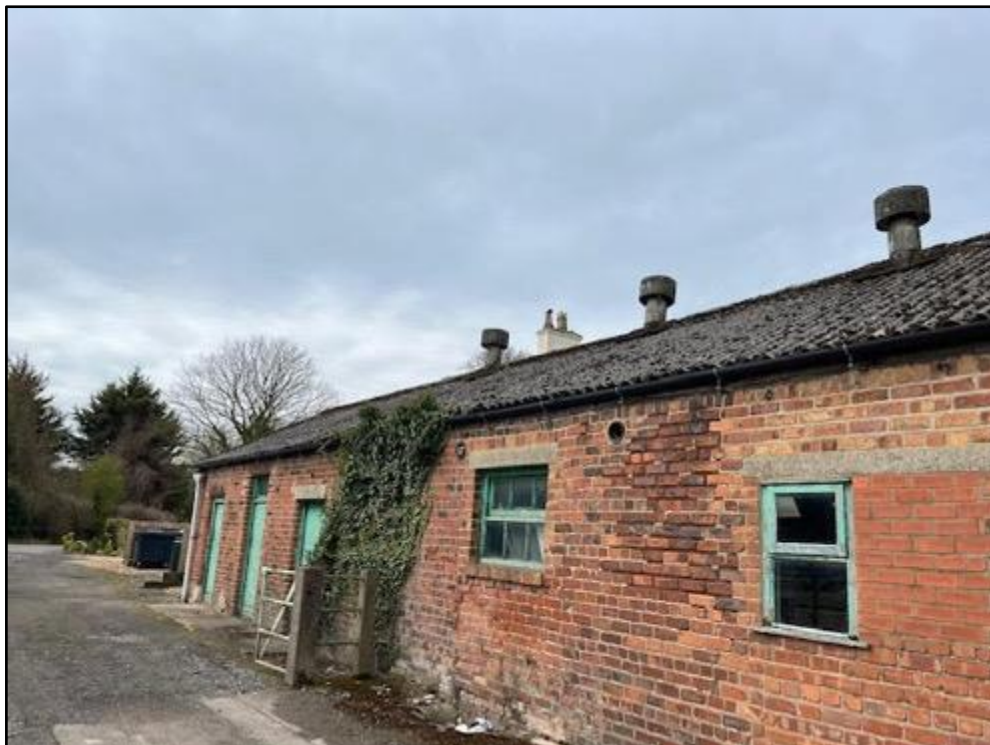
**Fig 7:** A view of the single-storey section with a corrugated asbestos roof. Windows throughout the building are open, creating ideal access points for foraging bats.

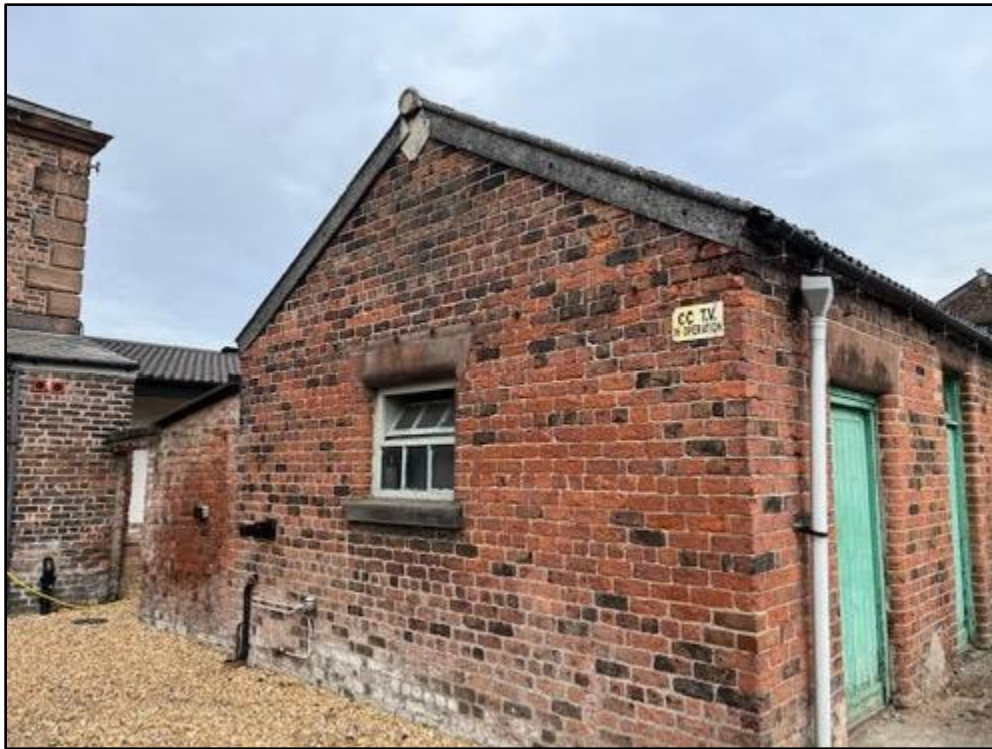
**Fig 8:** View of the southern gable. The gable is in fair condition, but an obvious entry point is seen at the apex.

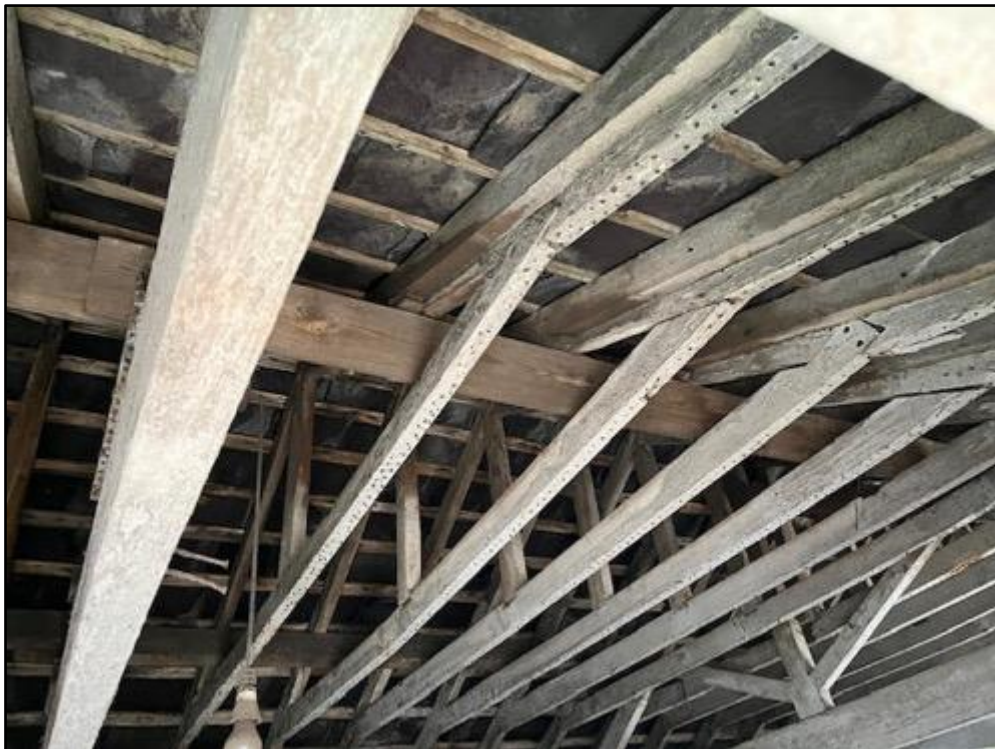
**Fig 9:** A view of the internal roof space within the northern section of the barn. Wooden beams and rafters sit beneath the slate tiles. No deep cavities were noted within the external walls; there is also a lack of obvious crawlspace or areas suitable for roosting bats.

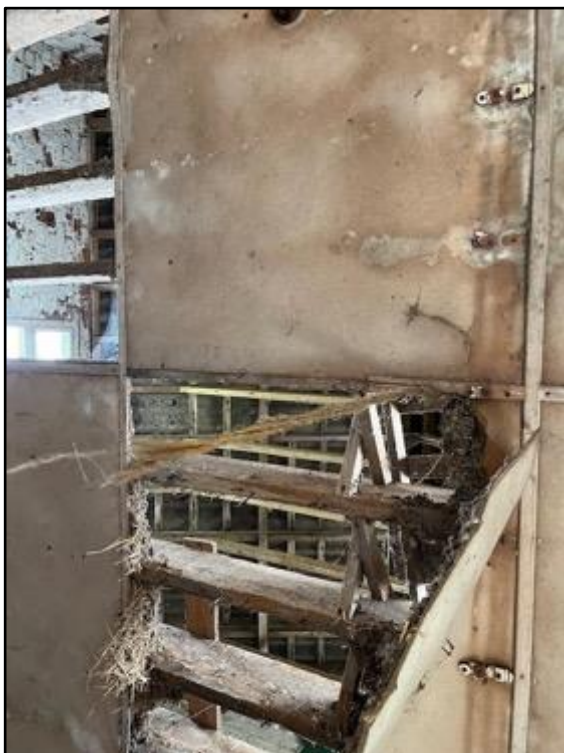
**Fig 10:** The upper floor of the two-storey section could not be accessed due to obvious rotting and damage. The roof space could be clearly seen despite this. Wooden purlins and rafters support the corrugated asbestos roof.

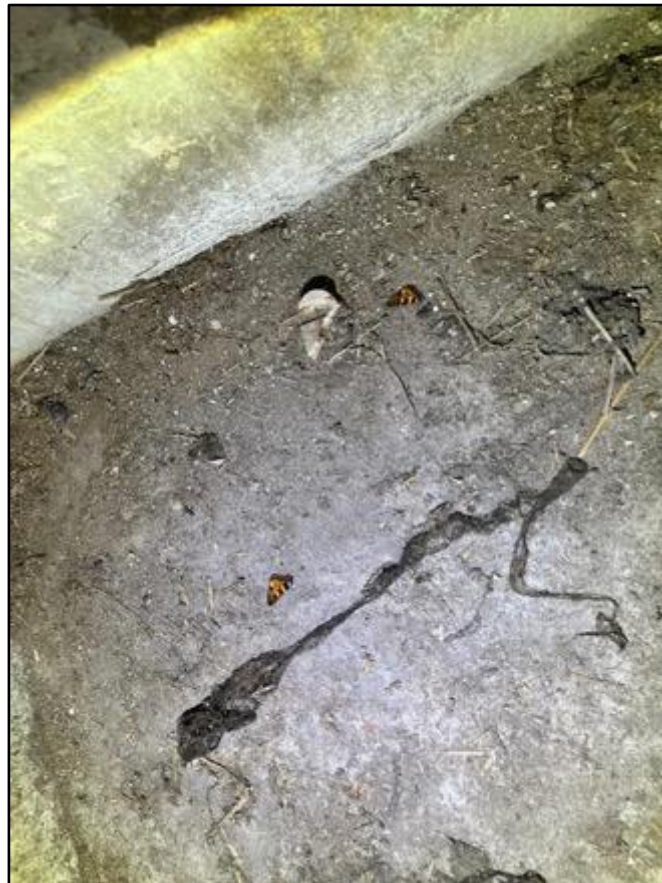
- 4.1.1 The subject building offered moderate bat potential as only one section of the building featured a suitable external roof, but due to the findings of bat feeding remains (seen below), meaning it is likely bats use the building as a foraging space.

**Fig 11:** Feeding remains found within the building.

- 1.1.6 It is suggested that at least one single bat activity survey be undertaken between May and September to decipher the presence of bats within the target building.
