# **Arboricultural Impact Assessment**

in Relation to Proposed 88 Unit  
Residential Development at

**Former United Utilities site,  
Carr Lane, Prescott,  
Merseyside, L34 1AX**

**ARBORICULTURAL IMPACT ASSESSMENT  
FORMER UNITED UTILITIES SITE, CARR LANE, PRESCOT**

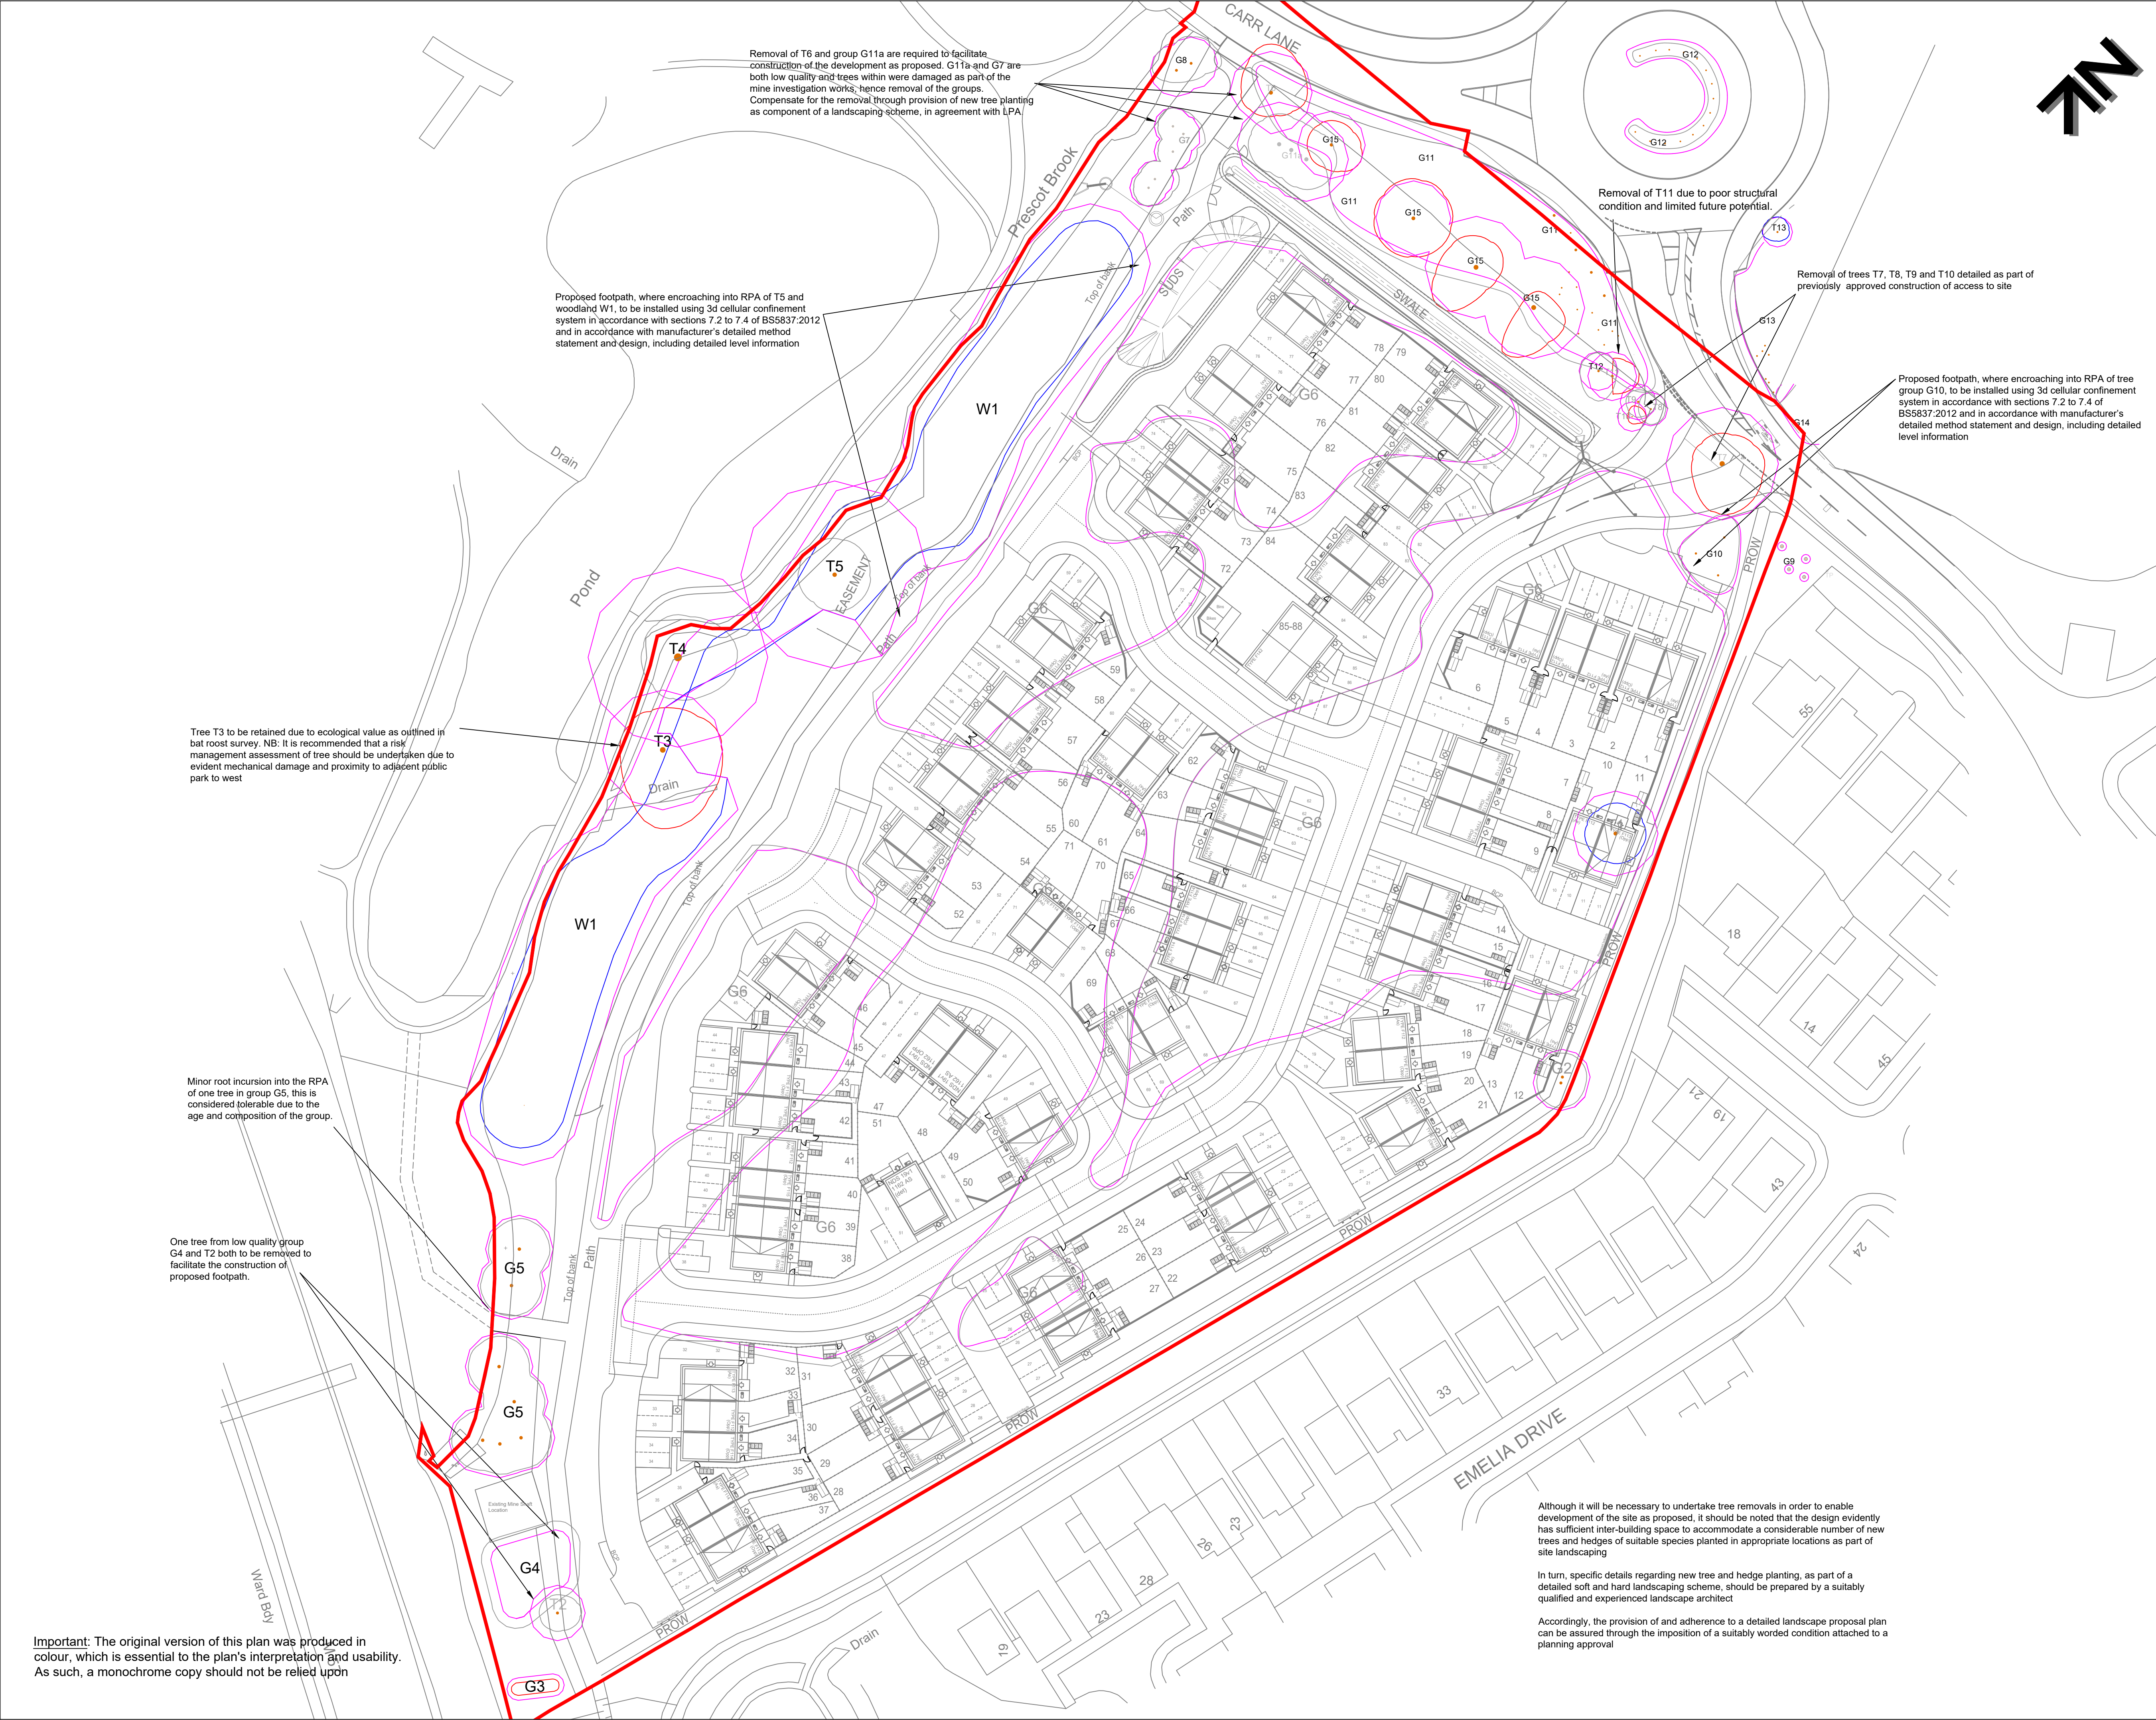
**Title:**  
**TREE IMPACT PLAN**  
in Relation to Proposed 88 Unit Residential Development

Although it will be necessary to undertake tree removals in order to enable development of the site as proposed, it should be noted that the design evidently has sufficient inter-building space to accommodate a considerable number of new trees and hedges of suitable species planted in appropriate locations as part of site landscaping  
In turn, specific details regarding new tree and hedge planting, as part of a detailed soft and hard landscaping scheme, should be prepared by a suitably qualified and experienced landscape architect  
Accordingly, the provision of and adherence to a detailed landscape proposal plan can be assured through the imposition of a suitably worded condition attached to a planning approval
