## Arboricultural Impact Assessment

Land off Marl Road,  
Knowsley L33 7UH

| Quality Management Approved prior to Issue | | | |
|---|---|---|---|
| Report Ref: | SE0952-02_AIA_G01a_DH | | |
| Issue Date: | 15 <sup>th</sup> September 2021 | Revision No: | a |

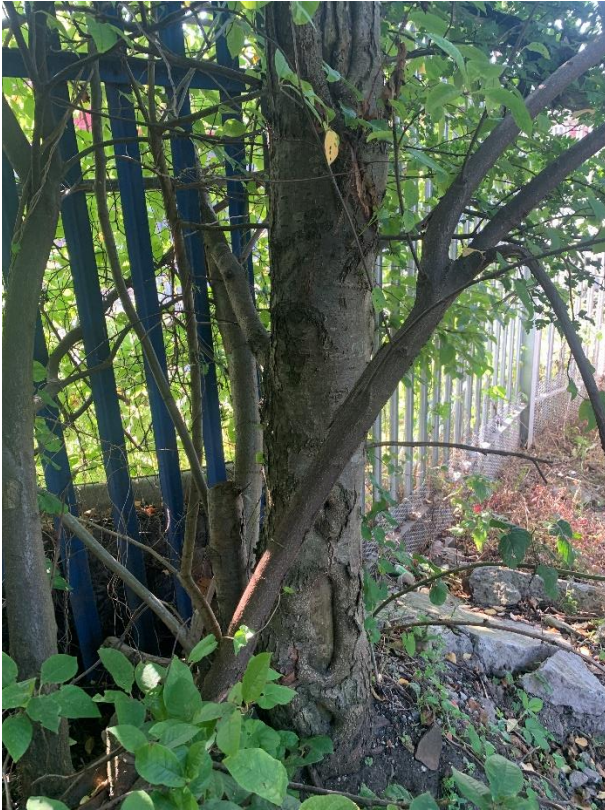
| Tree No. | Species | H (m) | CC (m) | No. of stems | DBH (mm) | Crown Spread (m) | | | | Age | Comments | RPA (m <sup>2</sup> ) | RPR (m) | SULE | Category |
|---|---|---|---|---|---|---|---|---|---|---|---|---|---|---|---|
| T1 | alder<br><i>Alnus glutinosa</i> | 6 | 4 | 1 | 180 | 2 | 2 | 5 | 4 | Y | Roots exposed and damaged by earth movement | 15.2 | 2.2 | <10 | U |

Plate 1: T1 Young alder growing adjacent to boundary fence. Large open wound on stem at 0.5 m

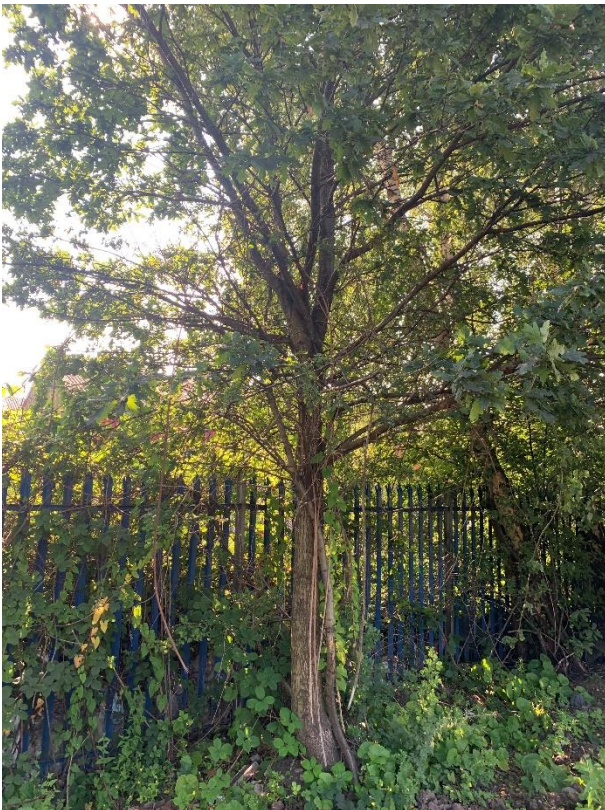
| Tree No. | Species | H (m) | CC (m) | No. of stems | DBH (mm) | Crown Spread (m) | | | | Age | Comments | RPA (m <sup>2</sup> ) | RPR (m) | SULE | Category |
|---|---|---|---|---|---|---|---|---|---|---|---|---|---|---|---|
| T8 | hairy birch<br><i>Betula pubescens</i> | 12 | 4 | 1 | 290 | 6 | 6 | 6 | 6 | EM | Tree growing against fence with partially occluded wound at 2.25 m | 38.5 | 3.5 | >20 | C <sub>1</sub> |

Plate 2: T8 Healthy young alder near boundary fence.

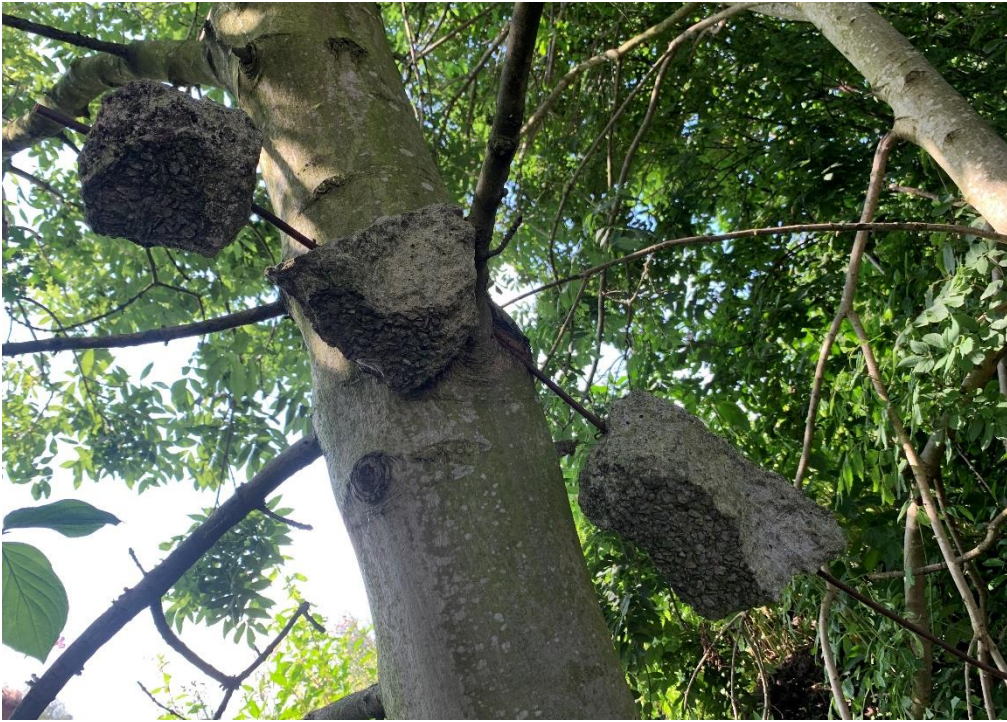
| Tree No. | Species | H (m) | CC (m) | No. of stems | DBH (mm) | Crown Spread (m) | | | | Age | Comments | RPA (m <sup>2</sup> ) | RPR (m) | SULE | Category |
|---|---|---|---|---|---|---|---|---|---|---|---|---|---|---|---|
| T15 | ash<br><i>Fraxinus excelsior</i> | 10 | 7 | 4 | 210 | 5 | 5 | 5 | 5 | SM | Healthy young tree; reinforcing bar embedded in first main branch – damage only superficial. | 19.6 | 2.5 | 20+ | B <sub>2</sub> |

Plate 3: T15, showing reinforcing bar embed in stem at branch junction.

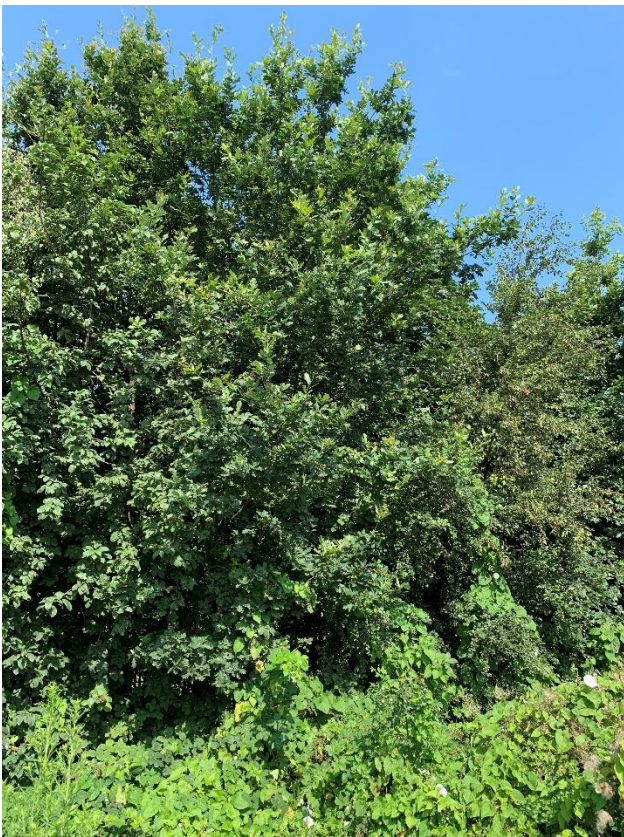
| Tree No. | Species | H (m) | CC (m) | No. of stems | DBH (mm) | Crown Spread (m) | | | | Age | Comments | RPA (m <sup>2</sup> ) | RPR (m) | SULE | Category |
|---|---|---|---|---|---|---|---|---|---|---|---|---|---|---|---|
| G4 | ash, hairy birch, goat willow, sycamore, hazel | 8 - 14 | 7 | | 210 | 5 | 5 | 5 | 5 | SM | All trees growing at lower level than main site (approximately 2 m below). Planted trees (guards and stakes still apparent) starting to develop woodland characteristics; hawthorn understory. Provides screening into the site and visual amenity at prominent location on corner of road. | | | >20 | B <sub>2</sub> |

Plate 4: G4, as viewed from within site.

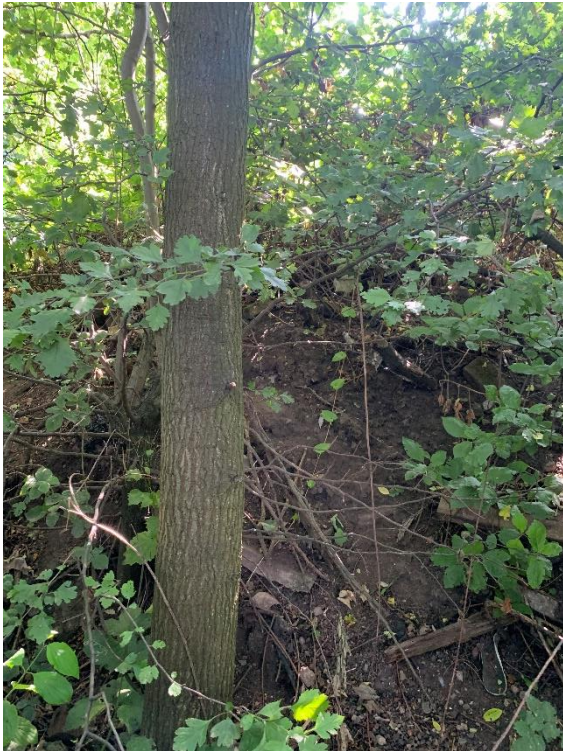
Plate 5: View looking out from G4 at made ground, toward development site.

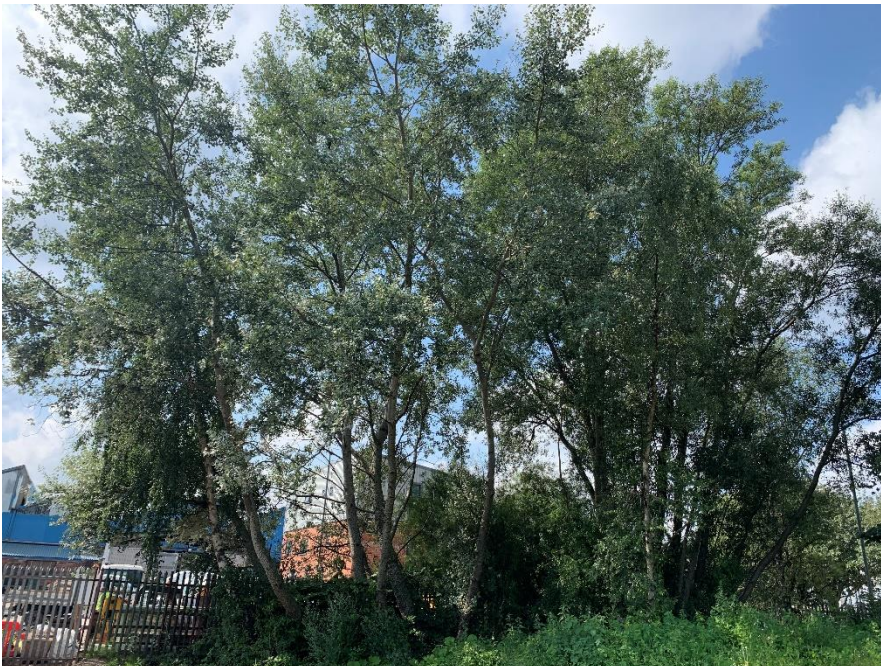
| Tree No. | Species | H (m) | CC (m) | No. of stems | DBH (mm) | Crown Spread (m) | | | | Age | Comments | RPA (m <sup>2</sup> ) | RPR (m) | SULE | Category |
|---|---|---|---|---|---|---|---|---|---|---|---|---|---|---|---|
| T18 | white poplar<br><i>Populus alba</i> | 10 | 6-7 | 7 | 280<br>250<br>230<br>410<br>350<br>220<br>220 | 3 | 7 | 7 | 7 | M | Large, multi-stem white poplar to southern boundary of the site. Lower branches showing large, unoccluded wounds - may lead to structural failure. Where tree is to be retained, tree would benefit from pollarding and removal of damaged stems. | 333.1 | 10.3 | <20 | C <sub>1</sub> |

Plate 6: T18 Large multi-stem white poplar to southern boundary

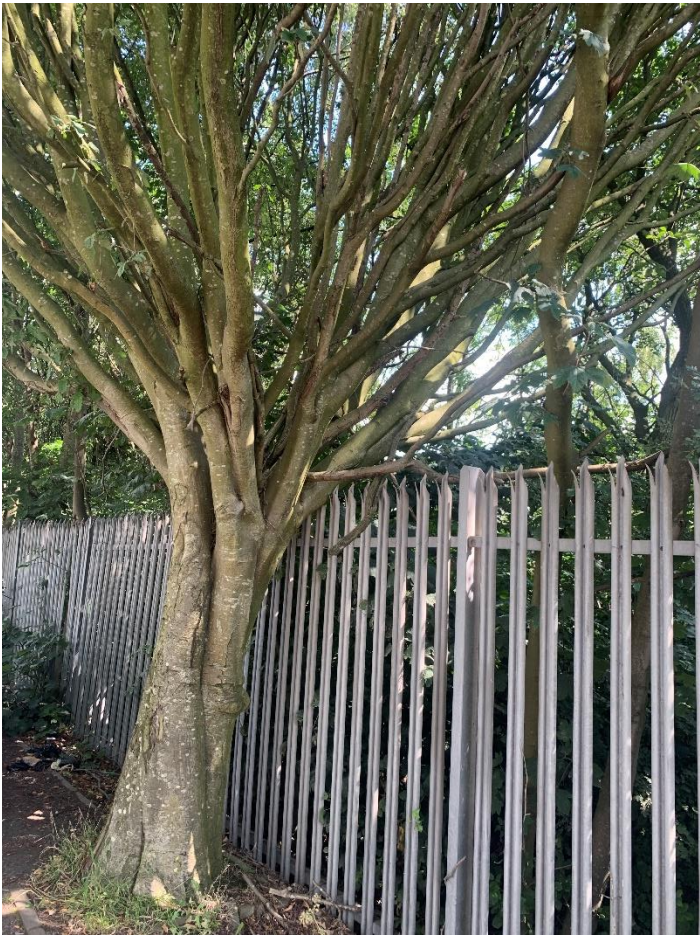
| Tree No. | Species | H (m) | CC (m) | No. of stems | DBH (mm) | Crown Spread (m) | | | | Age | Comments | RPA (m <sup>2</sup> ) | RPR (m) | SULE | Category |
|---|---|---|---|---|---|---|---|---|---|---|---|---|---|---|---|
| T21 | Swedish whitebeam<br><i>Sorbus intermedia</i> | 12 | 4 | 1 | 550 | 5.5 | 5.5 | 5.5 | 5.5 | M | This tree sits adjacent to the site in the footpath immediately west of the site. Branching at 2 m; unoccluded damage and bark inclusions on main stems; structurally unsound and may collapse/shed limbs in strong winds. | 136.8 | 6.6 | <10 | U |

Plate 7: T21, Swedish Whitebeam, showing wounds to main stem and bark inclusions.
