# Contaminated Land Phase One Desk Study for Proposed Residential Dwellings at, Foxhill Farm, Foxhill Lane, Halewood, L26 4XG.

Revised and Updated August 2022

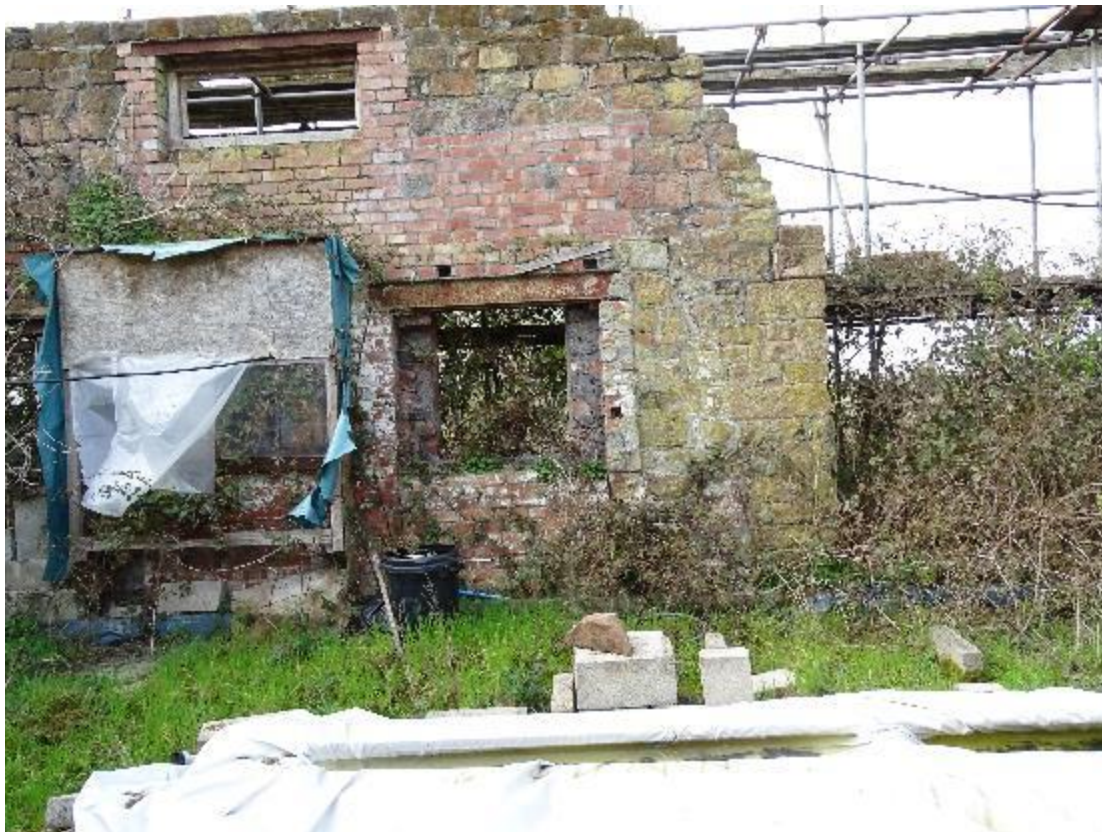
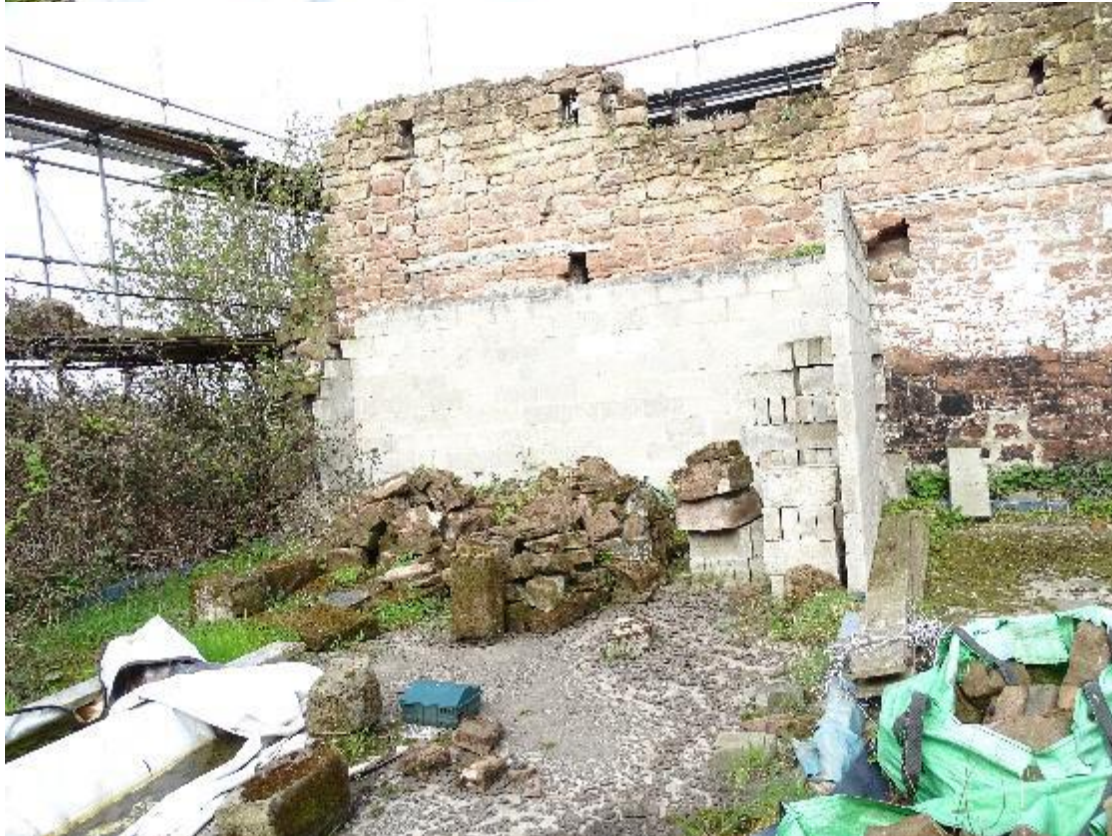
The remains of the barn

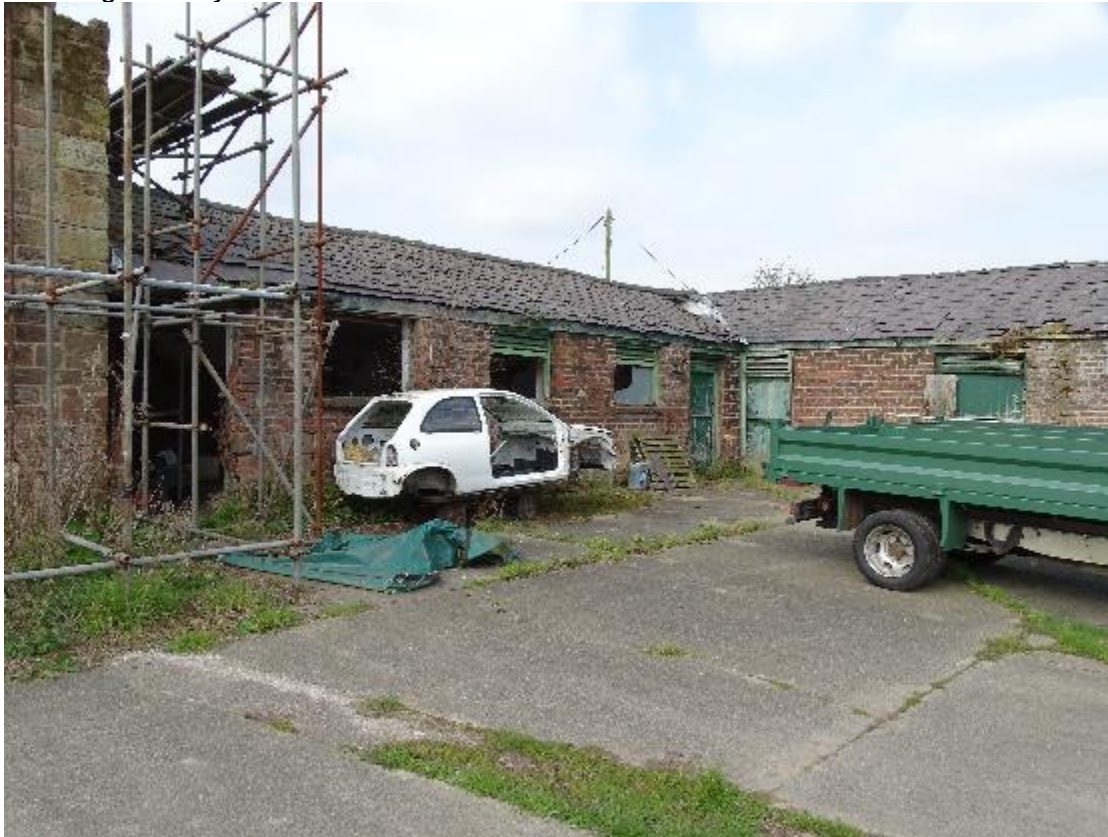
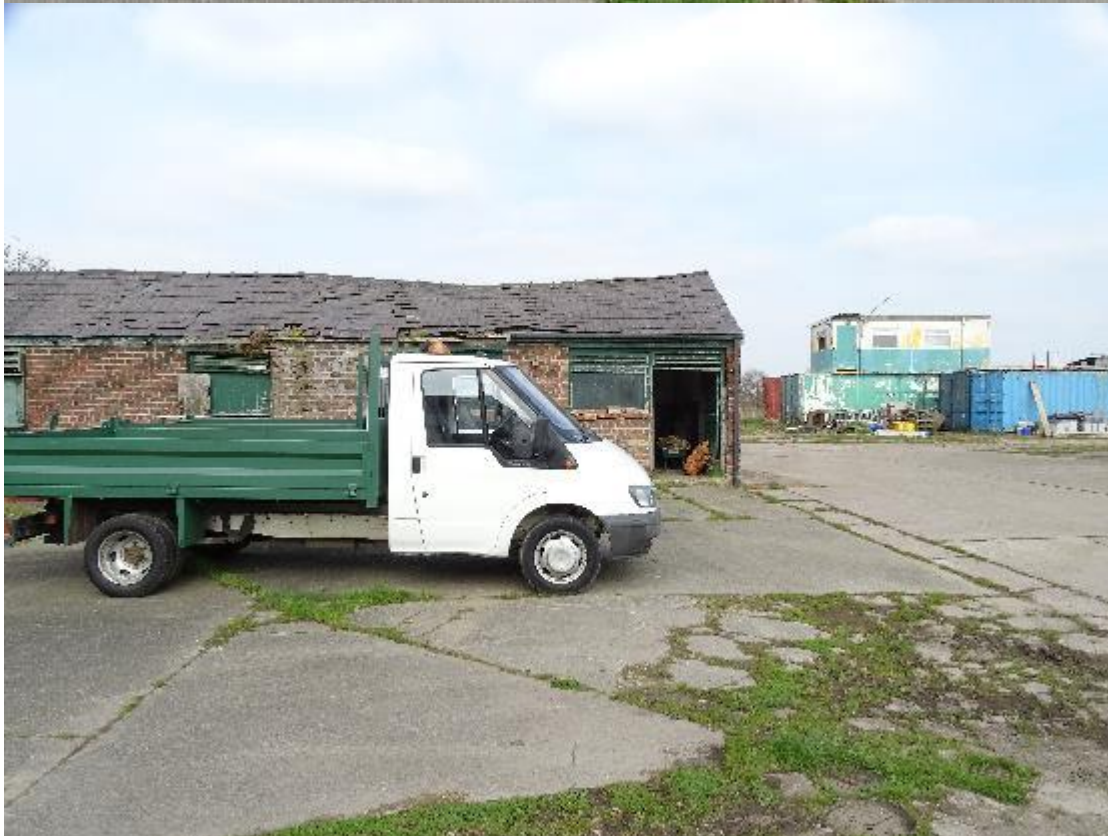
The single storey barns to the rear

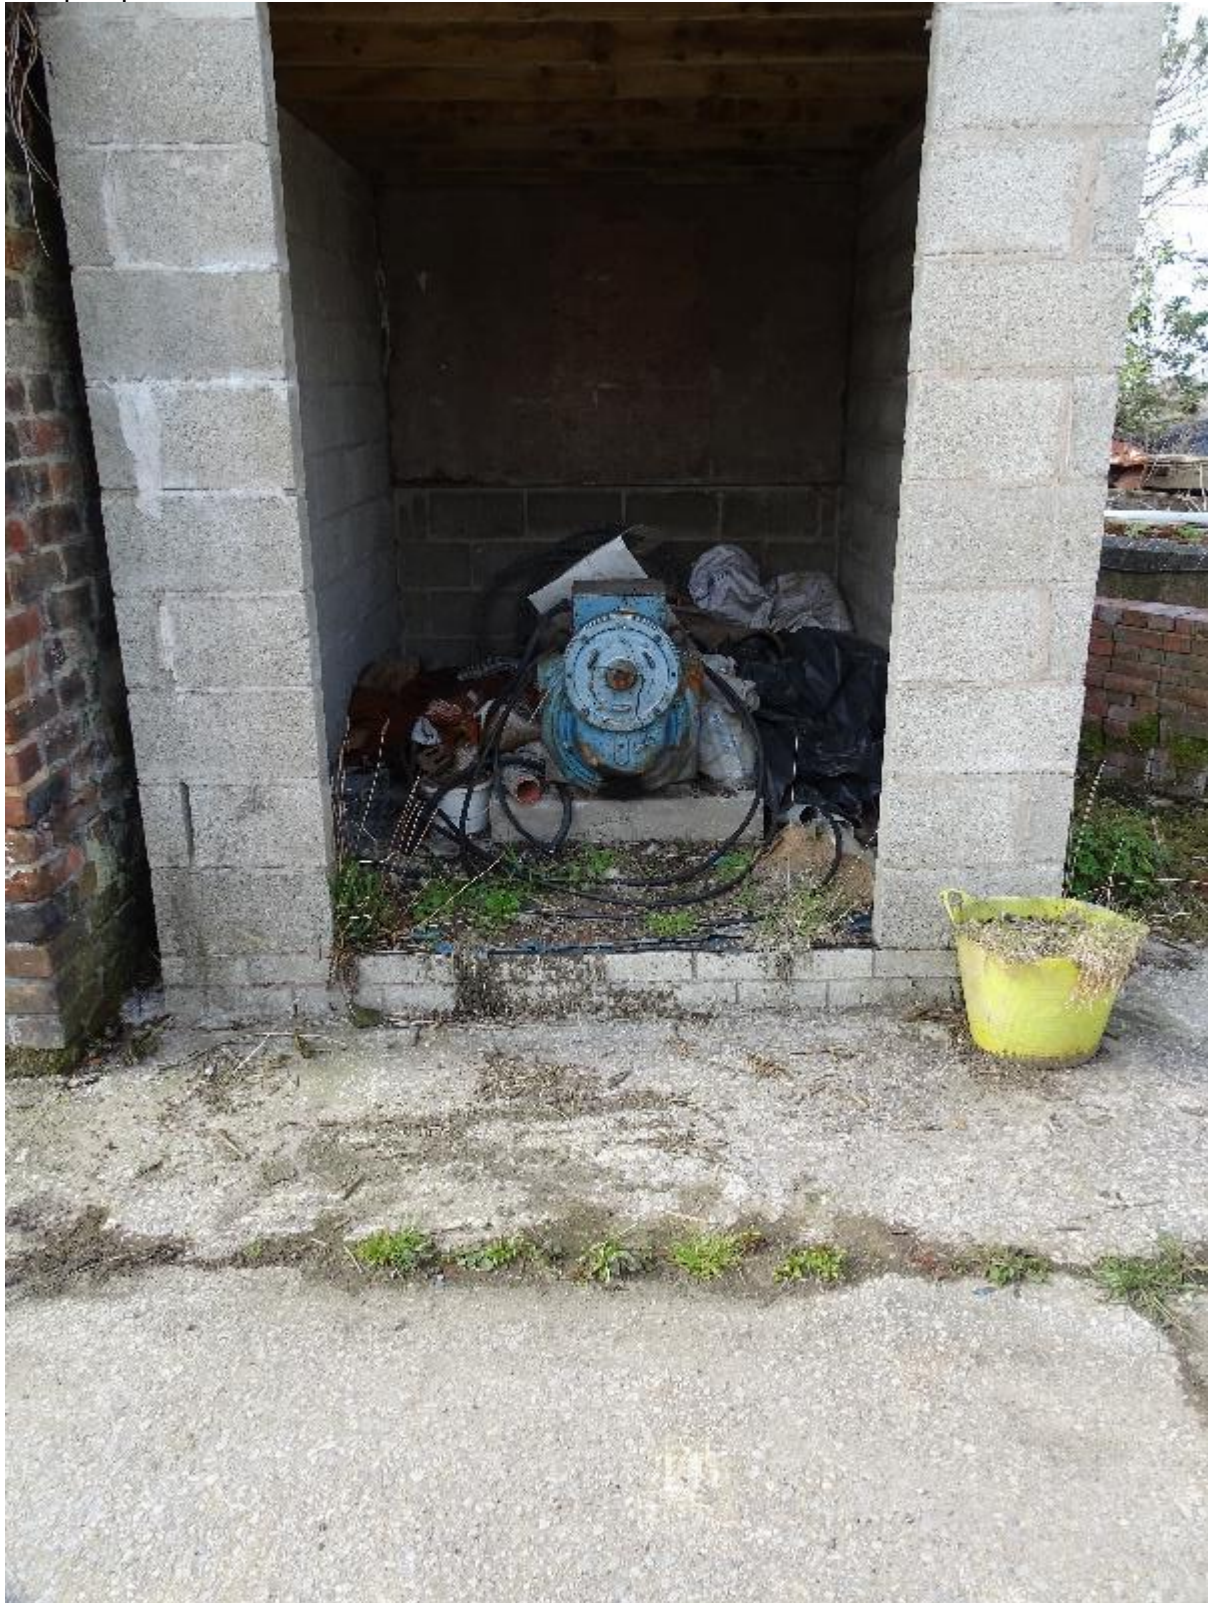
Behind the barns is a small breeze block/concrete floor shed containing a pump/motor. The remains of a concrete above ground slurry tank are located behind this.

The pump tot e rear of the barns

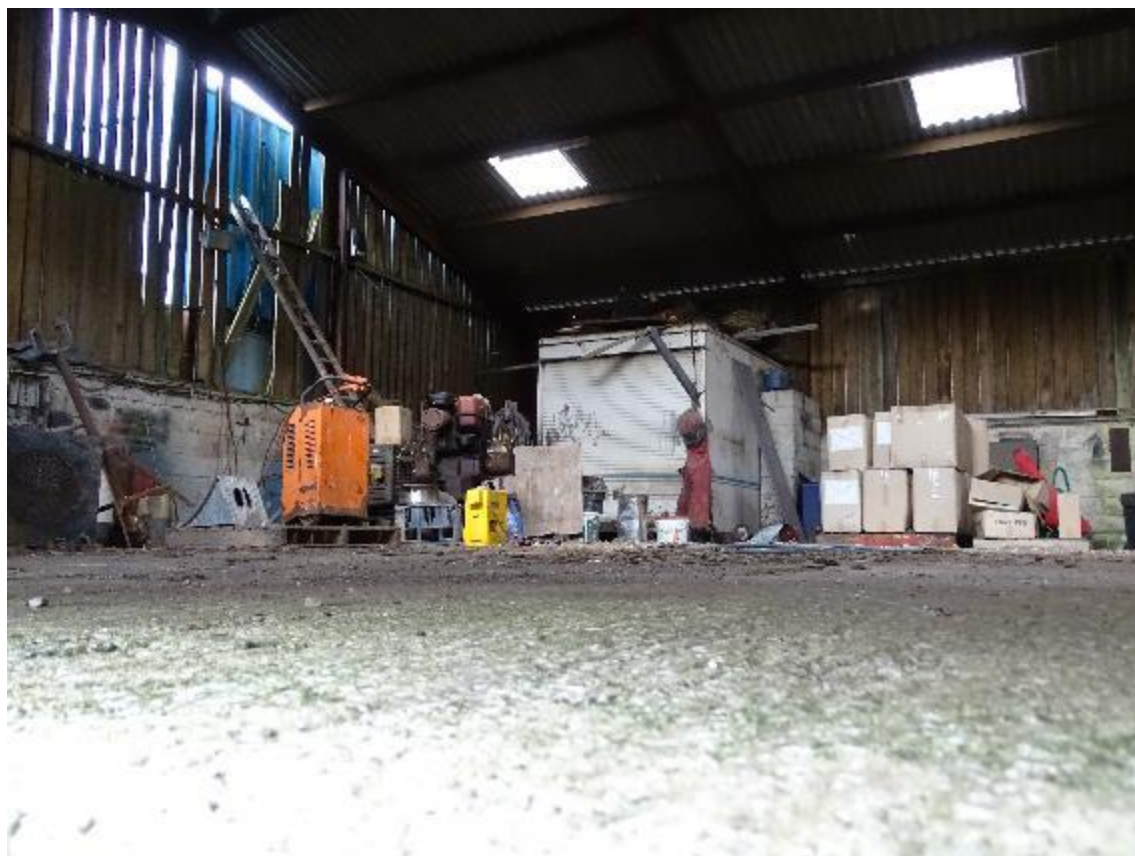
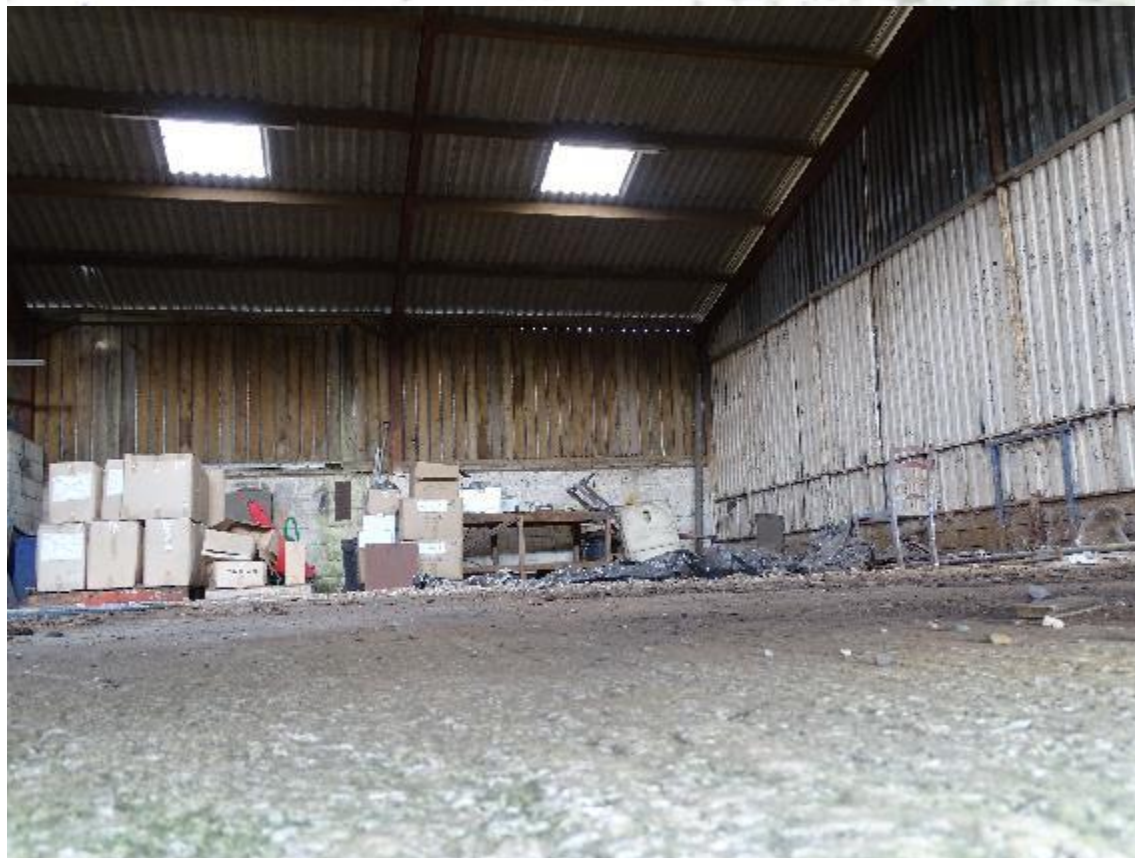
The next barn was split in two, constructed from a metal frame, metal sheeted walls and roof. The rear section had wooden planks for walls. Above breeze block lower section. Evidence that the building had been used for the processing of wood chip remained.

The second barn along the northern boundary

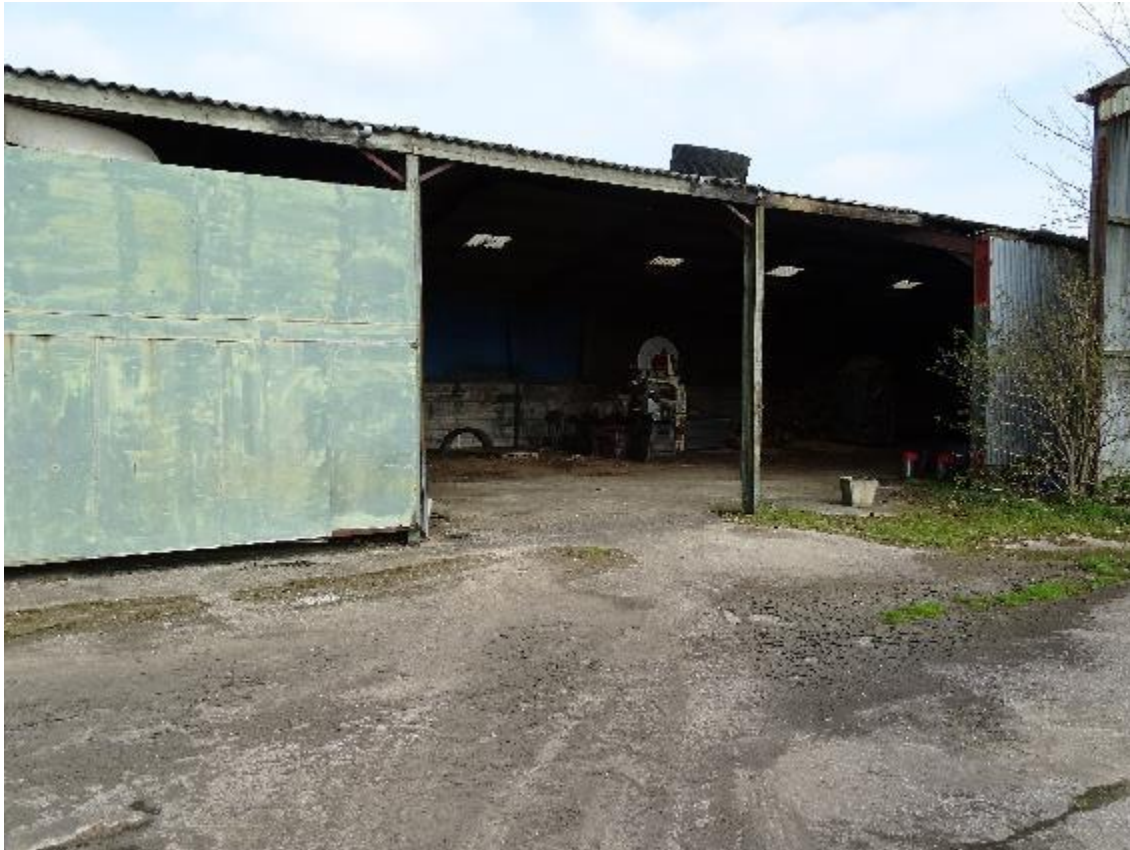
The second section of the barn

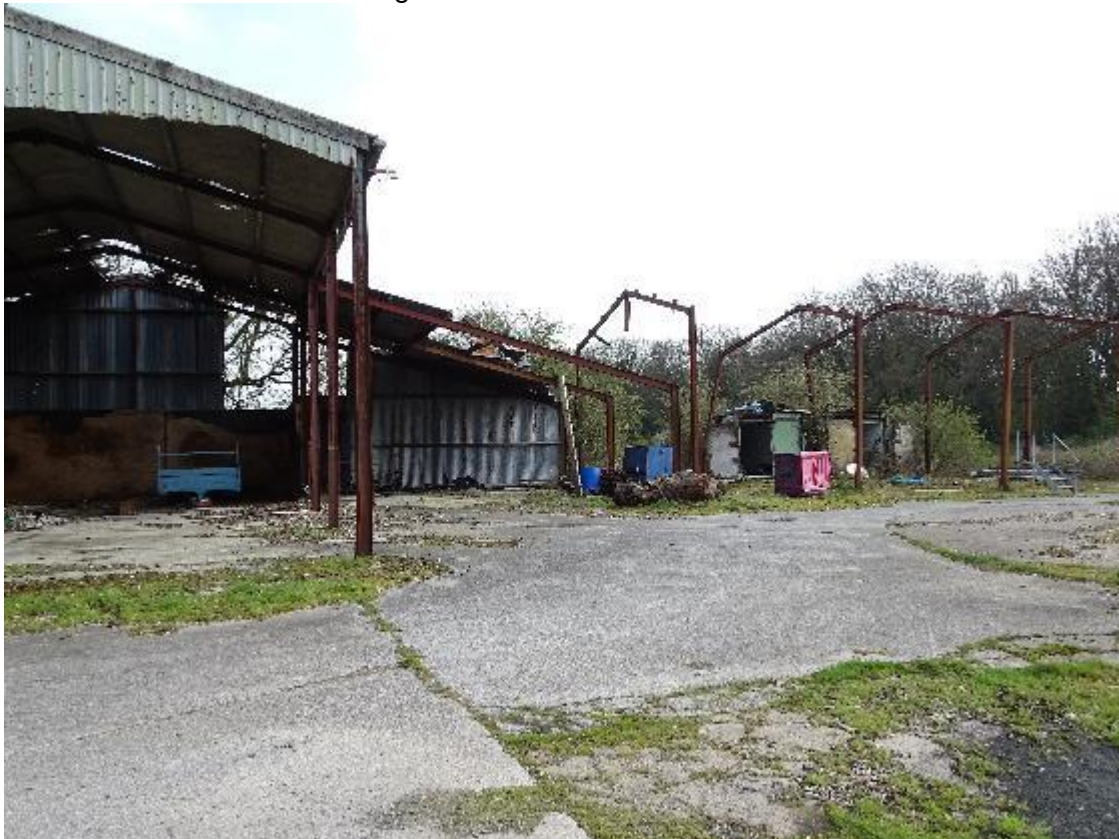
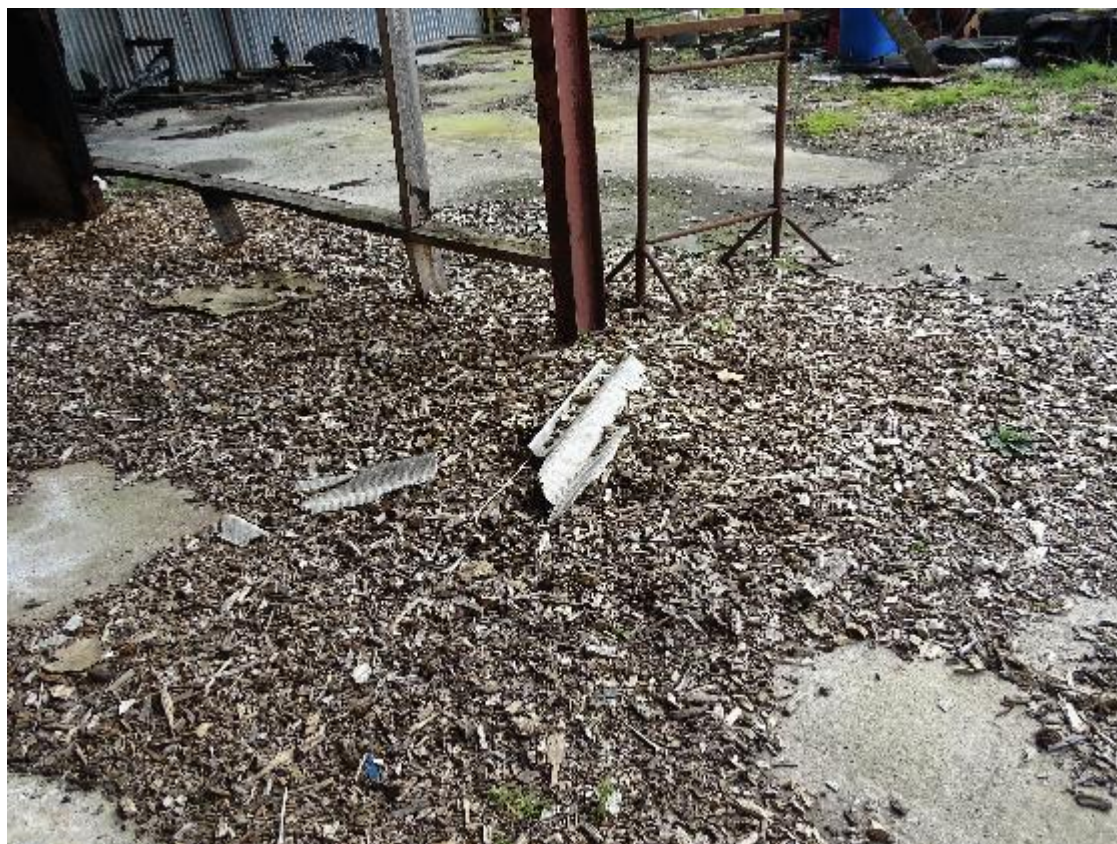
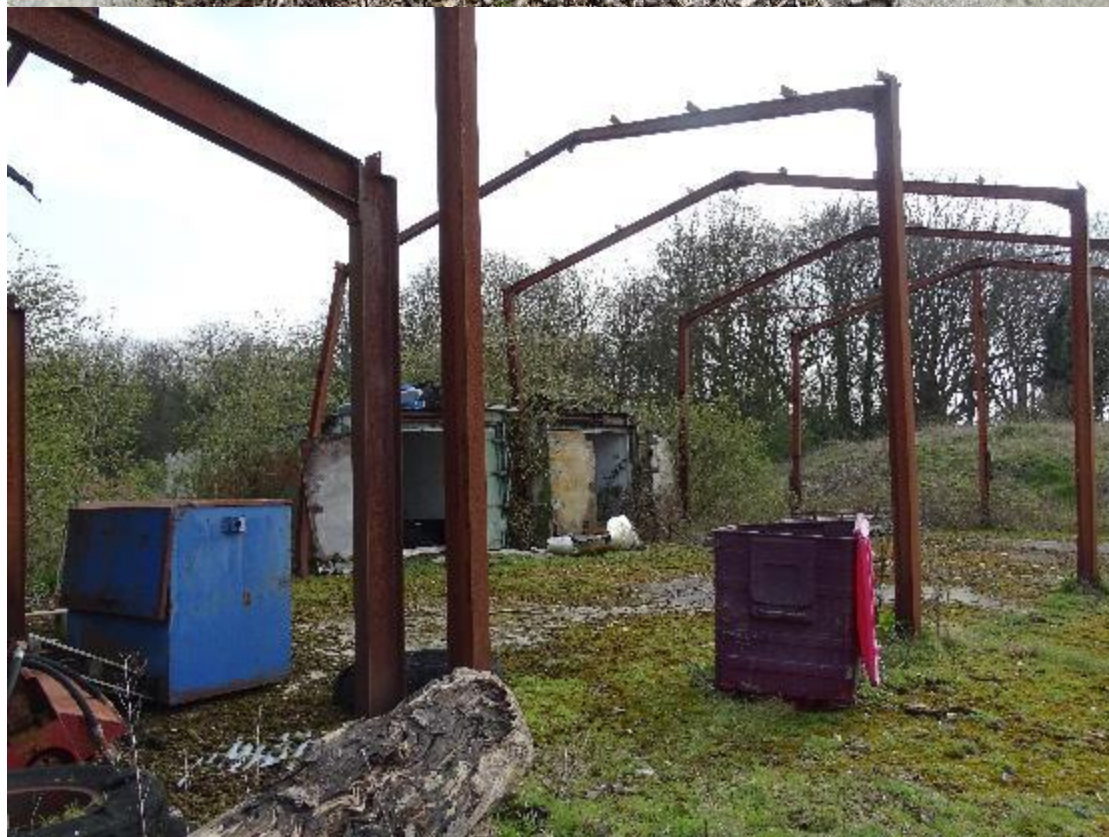
Moving down the eastern boundary the remains of two large barns are present, both following the sites concrete flooring with a mixture of metal and Cementous corrugated walls, the second barn only had the frame remaining. A couple of empty storage containers were located behind it.

The remains of the barns along the eastern section

The site is concreted over and this will need to be removed before any development takes place. As such as part of the site clearance all corrugated Cementous material should be carefully removed from site and the site effectively cleaned prior to the break-up of any concrete base. This will ensure that should asbestos fibres be present that they will be removed prior to exposing the ground beneath the concrete base, thus prevent contamination of the site.

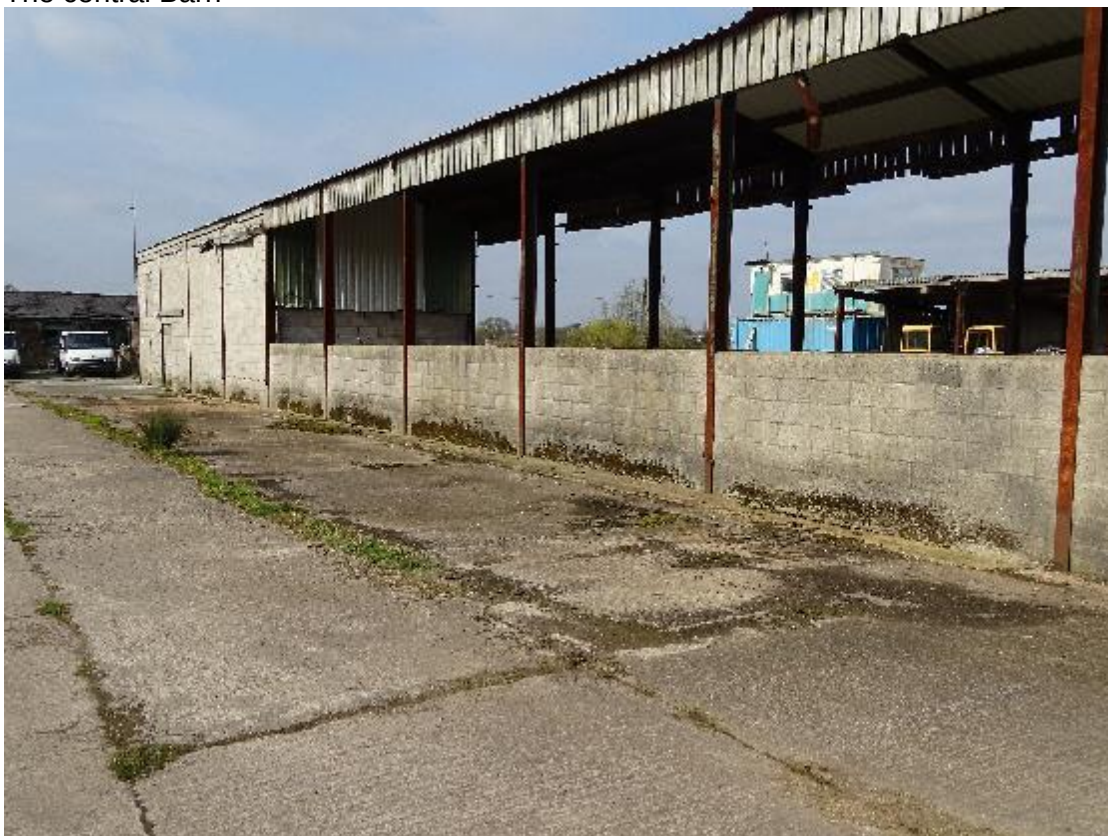
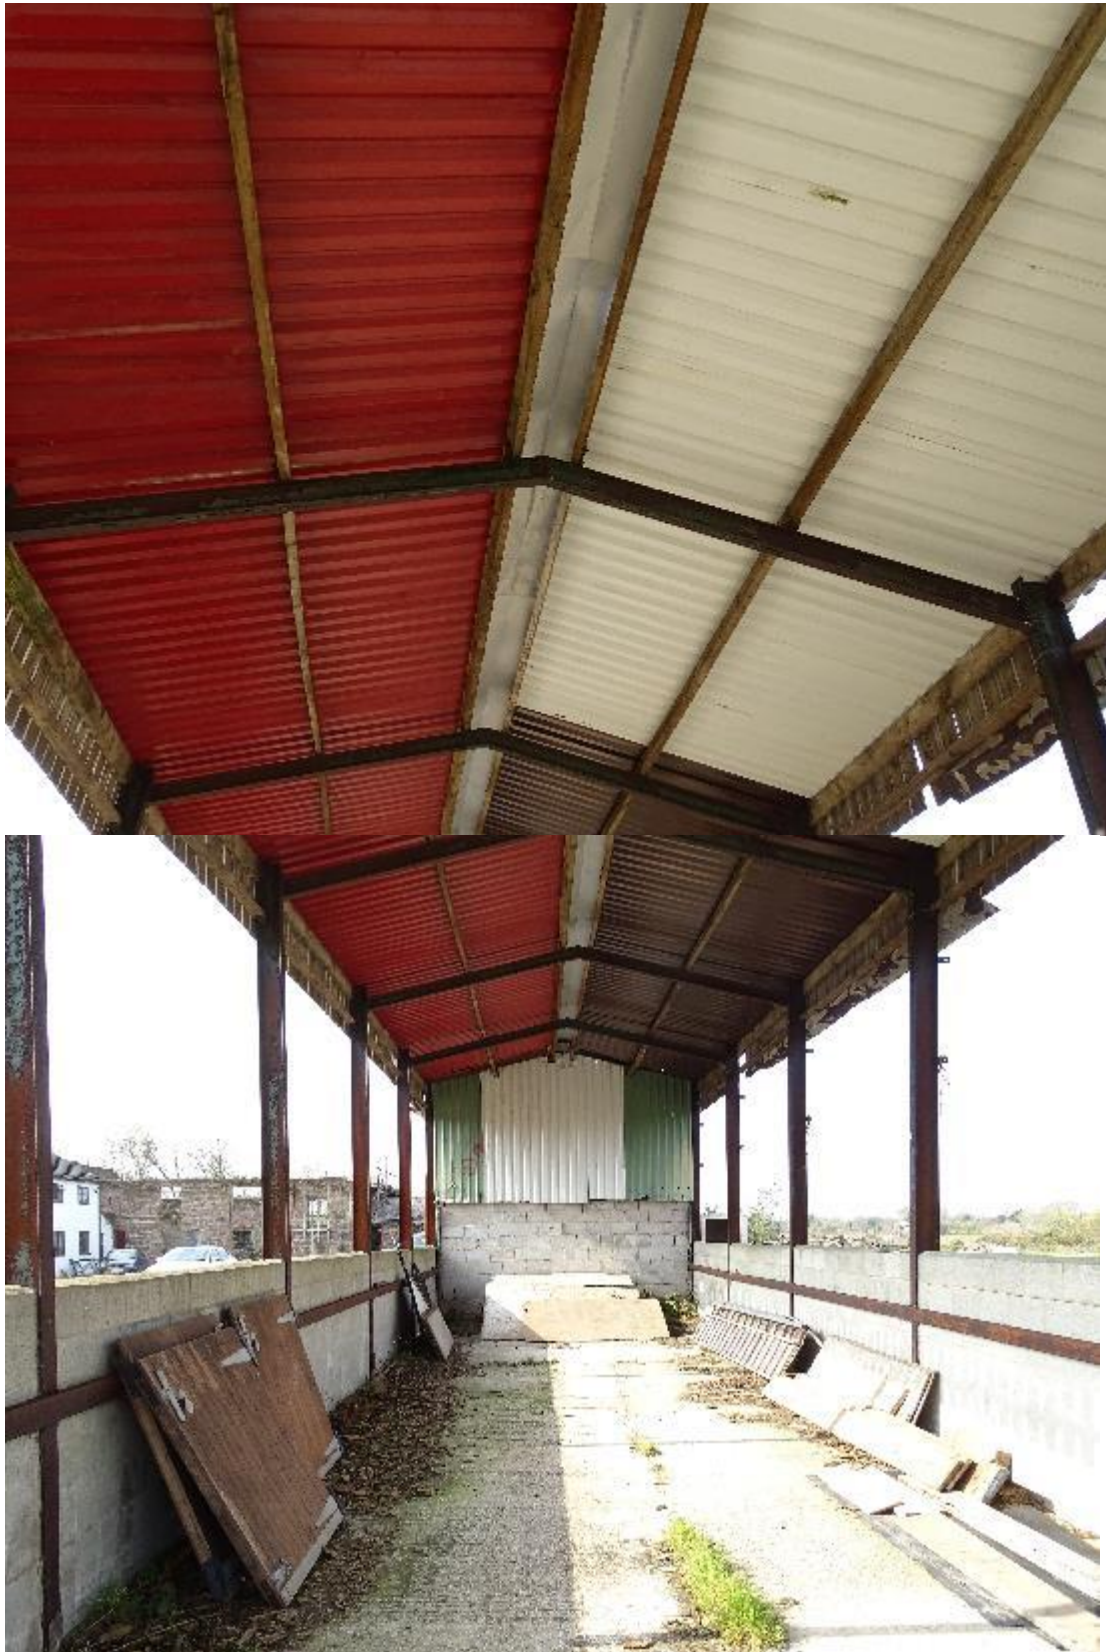
The central barn area was the previous milking parlour and extended across the yard as can be seen on the historical mapping. This was reduced in size, to accommodate the last business on the site a tree surgeon/horticulture business which utilised the barns to produce wood chip. The central area now consists of a concrete base, metal frame and breezeblock walls and a metal roof.

The central Barn

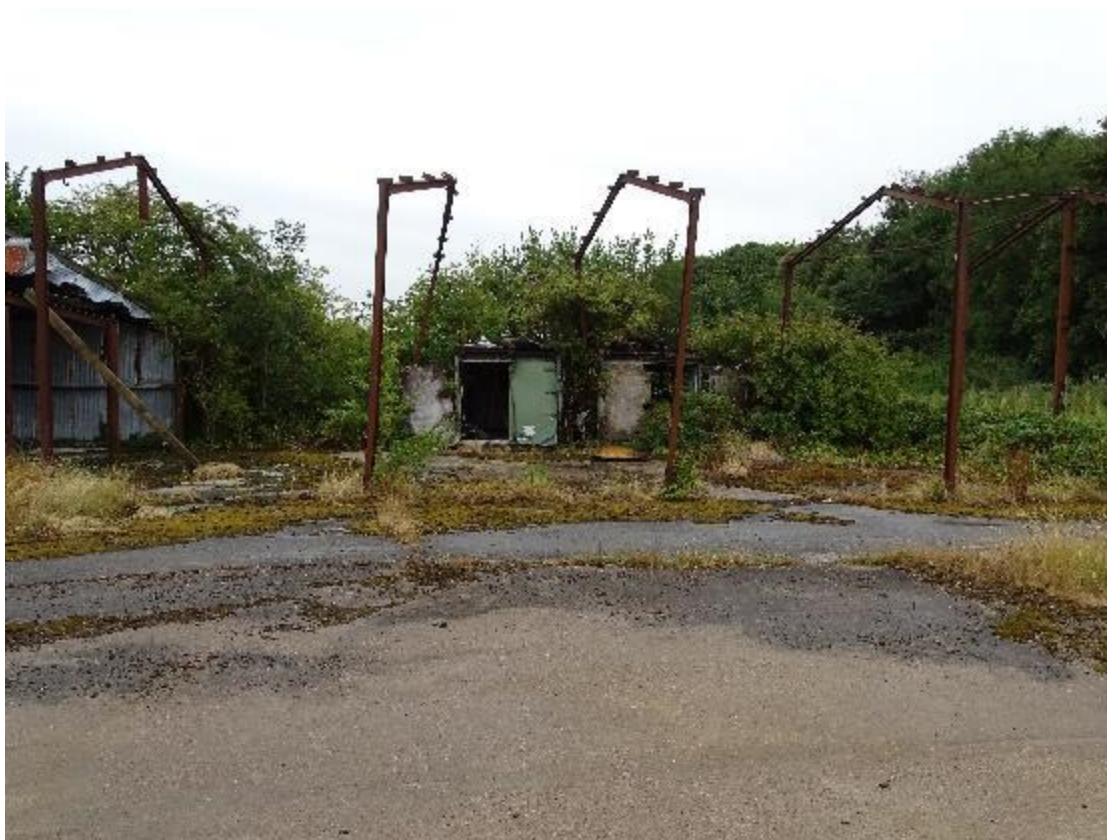
The building to the eastern boundary

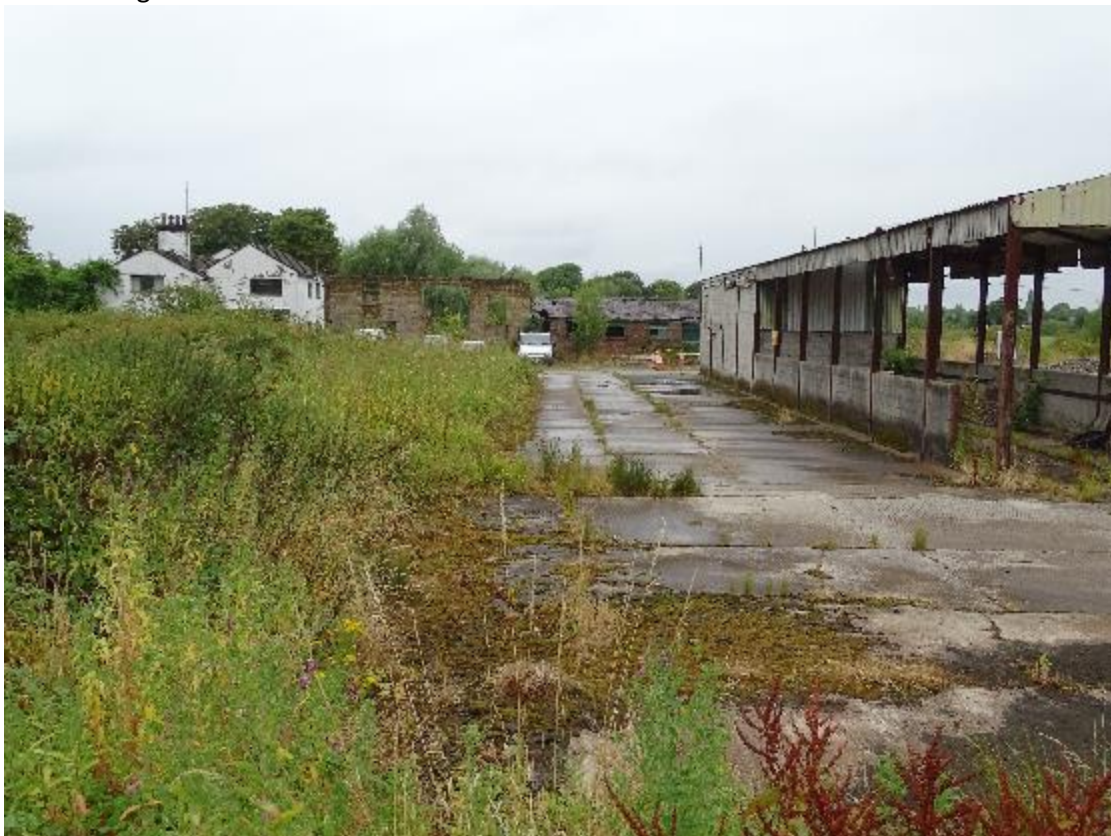
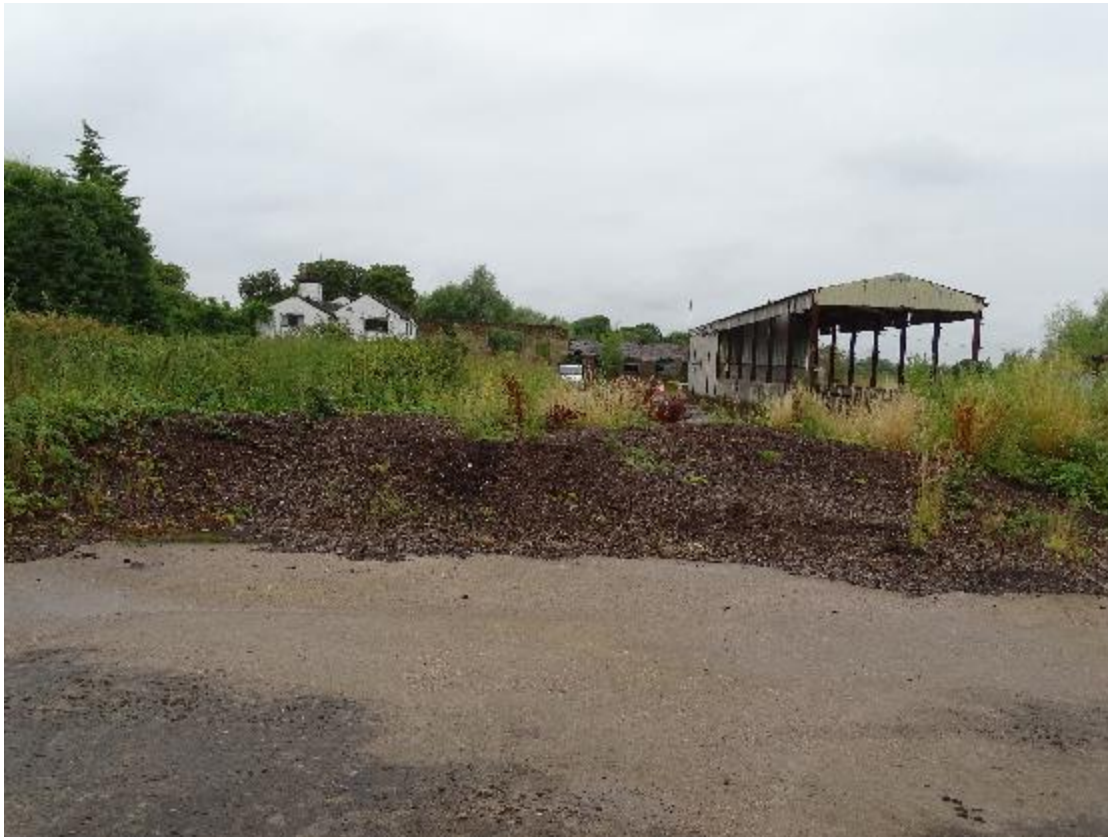
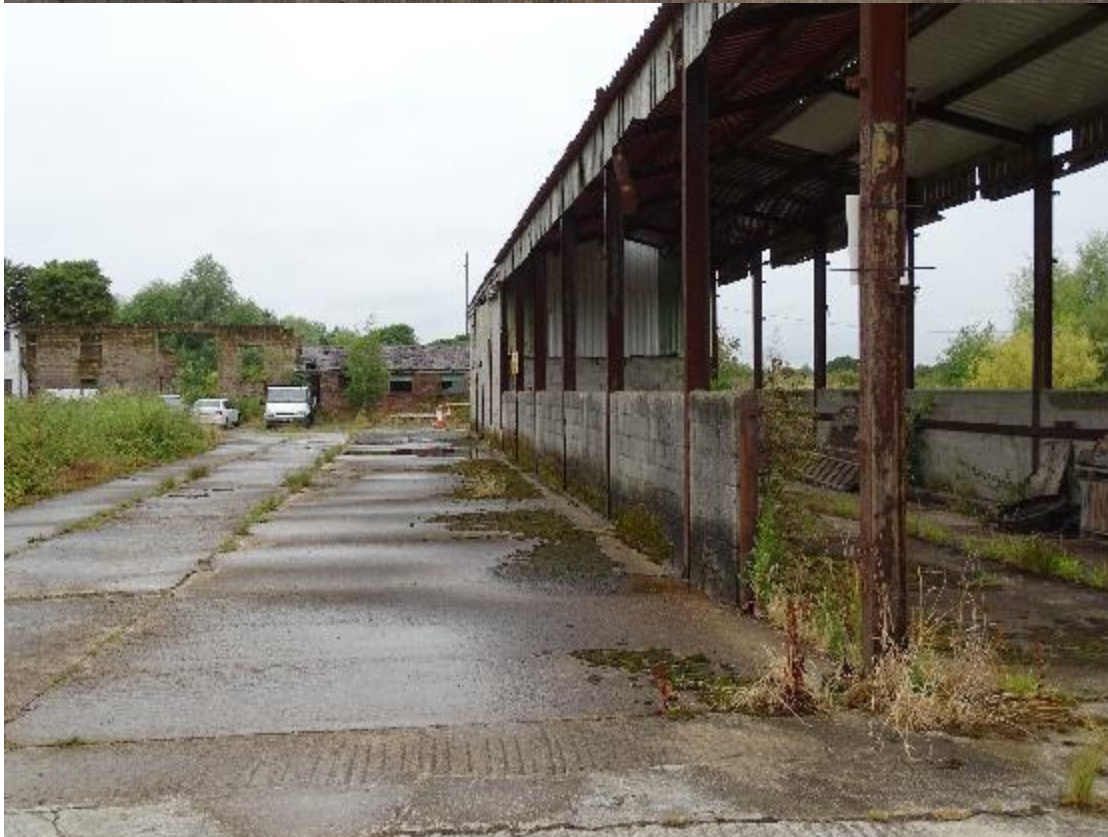
The building in the centre of the site
