## Arboricultural Impact Assessment (AIA)

Halsnead Farm

Report prepared for Starship Hub

| PROJECT No: | 12449 |

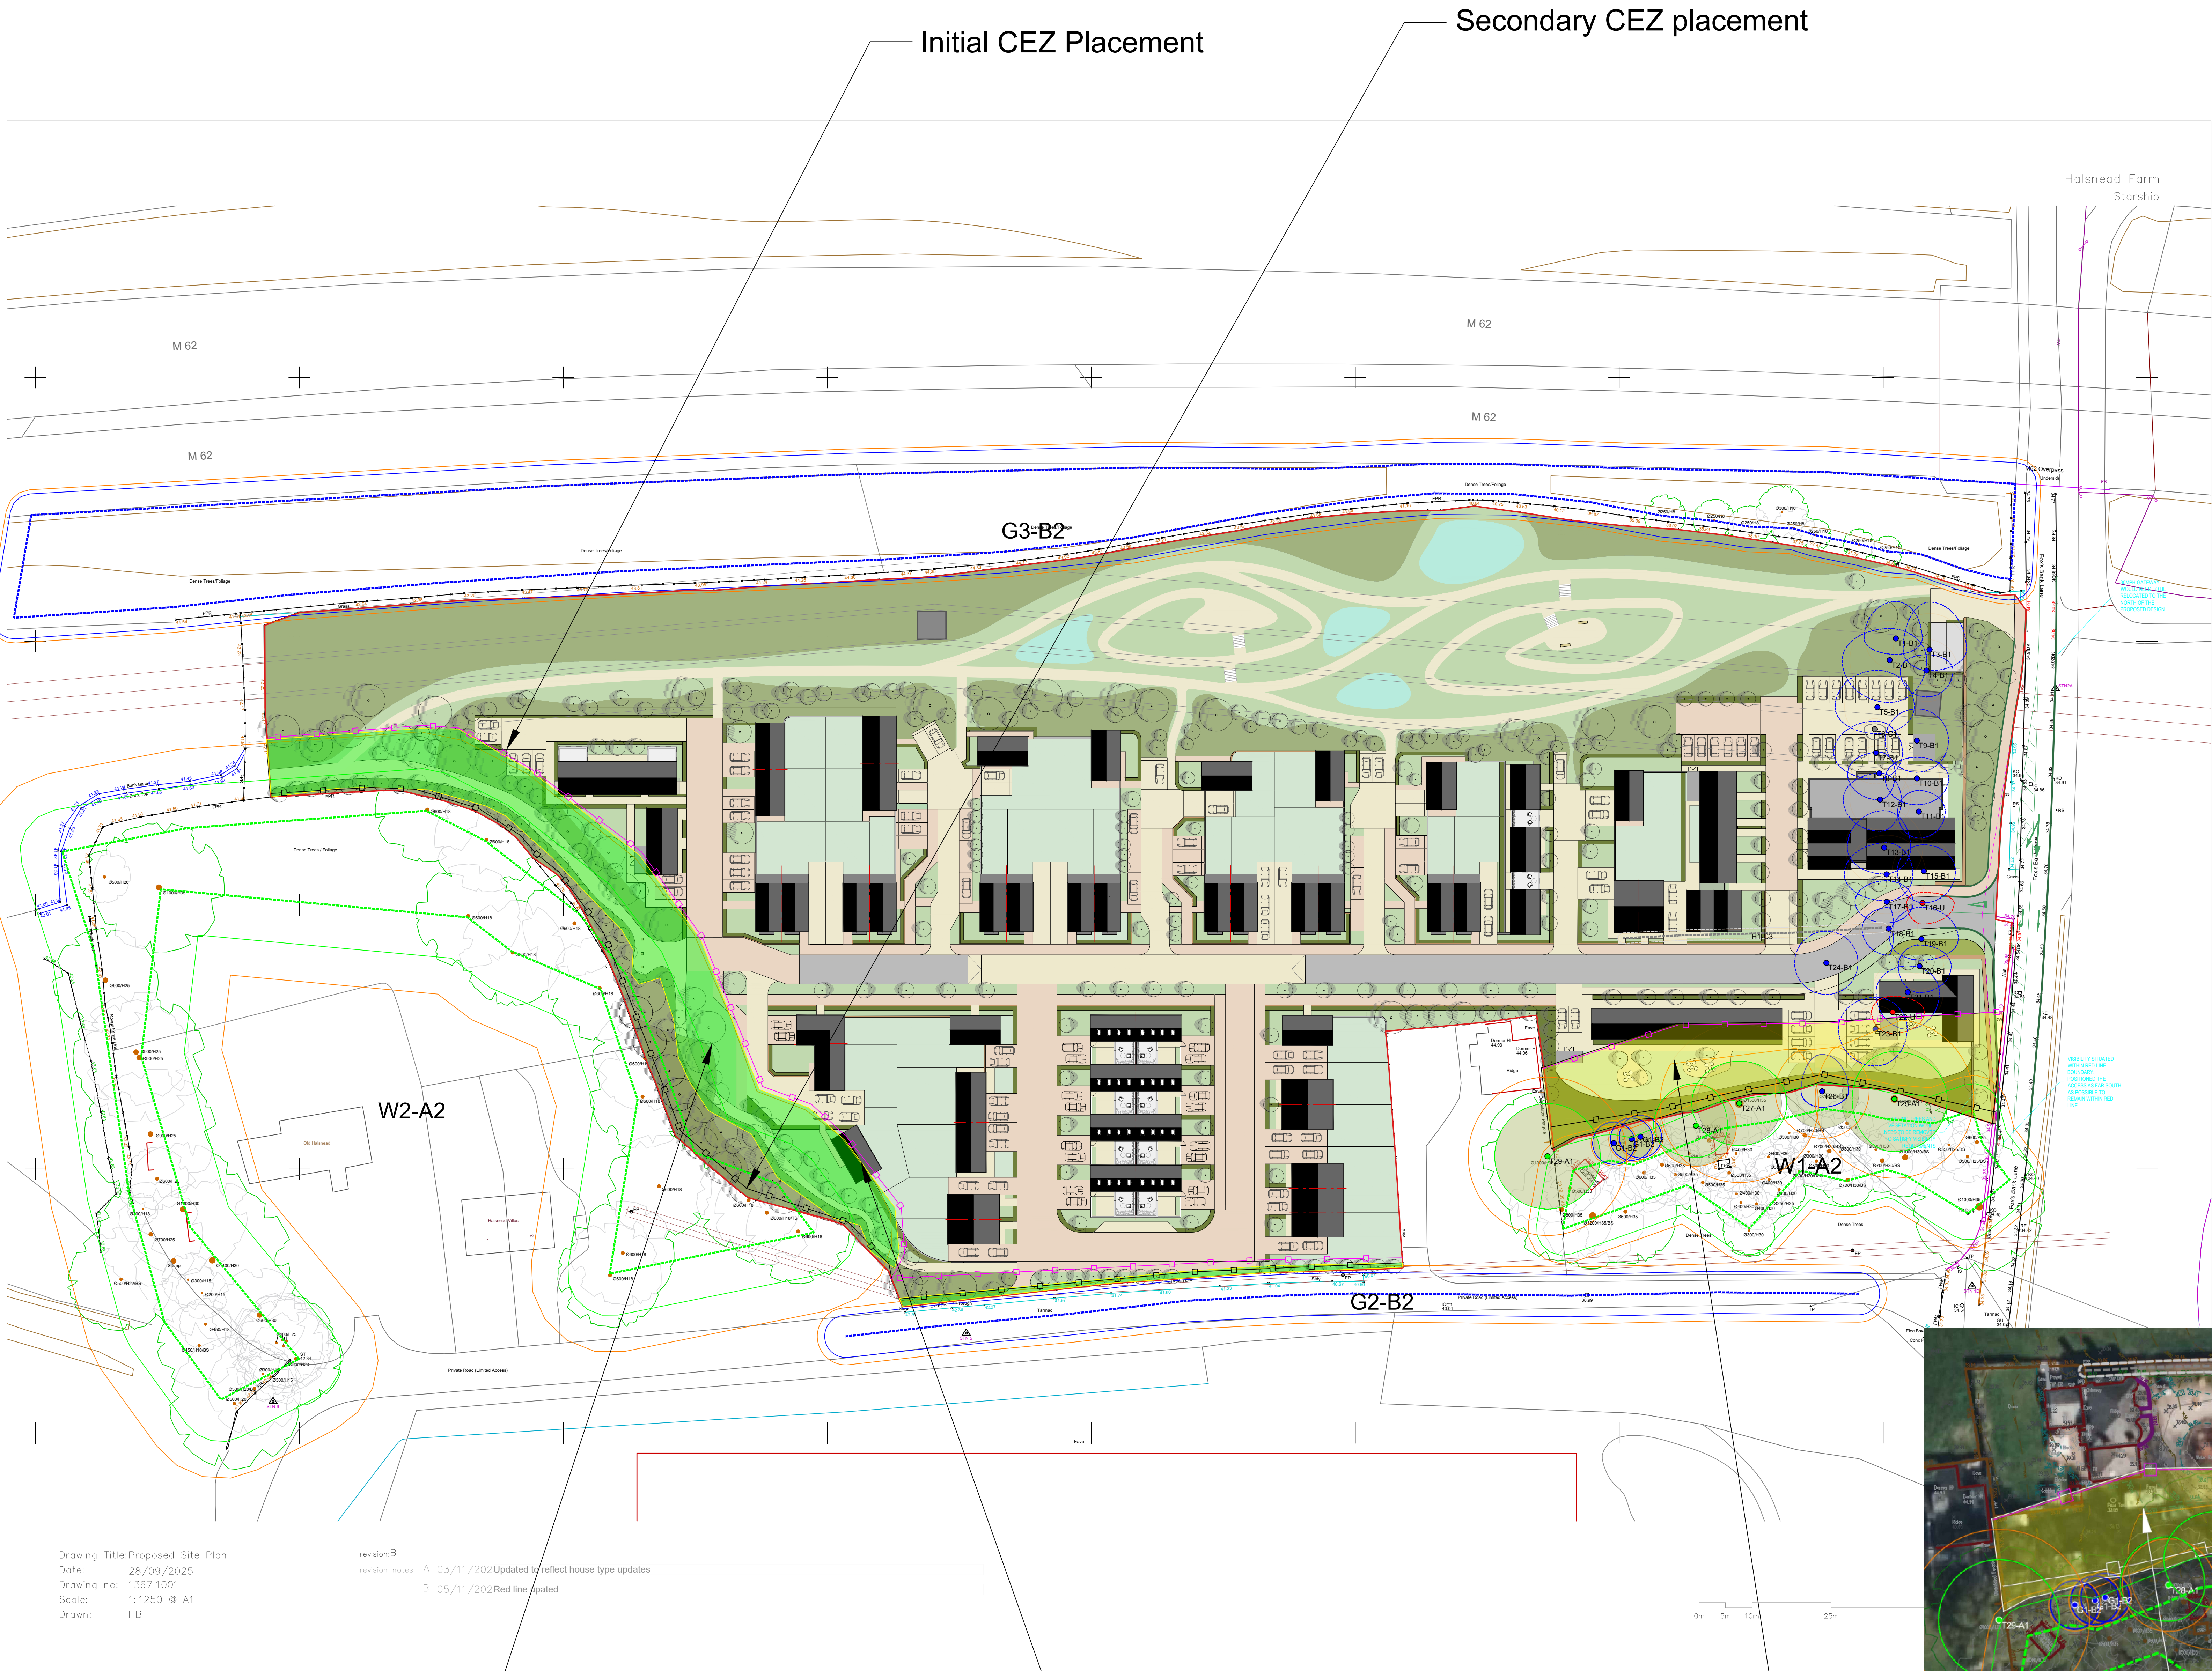
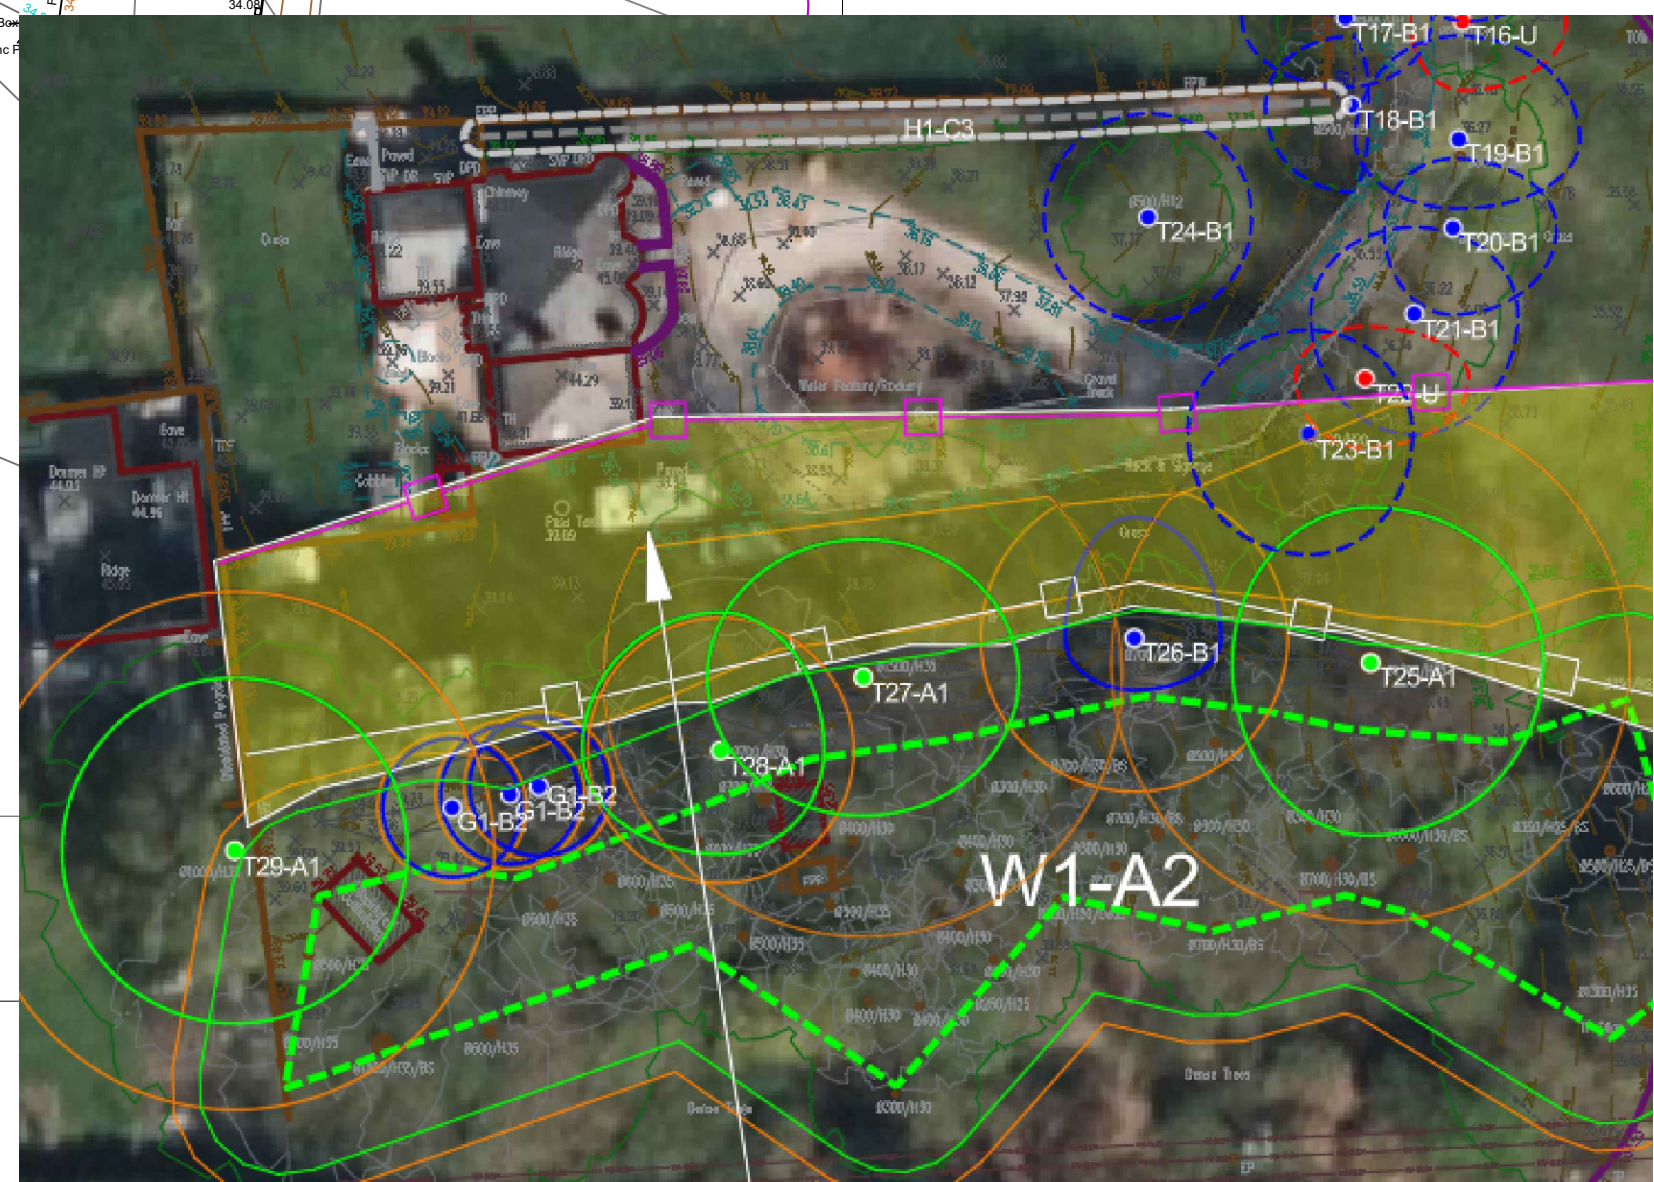
Detail:  
TREE PROTECTION PLAN - Overview

SMA No Dig, Air Spade investigation

Raft and Pile foundations depending on results of Air Spade investigations

SMA for existing surface removal
