## BOW17.7593: Ecological Advice Note

Bowland Ecology Ltd. was commissioned to undertake a Ground Level Tree Assessment (GLTA) for bats at Wilson Road, Huyton. The survey relates to proposed tree felling works required to facilitate development proposals at the site (Appendix A).

BOW17.1593 - Wilson Road, Huyton

Drawing title: Ground Level Tree  
Assessment - Bats

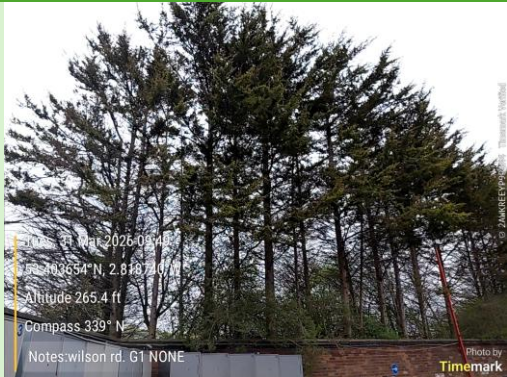
| Tree Reference & NGR | Bat Roost Suitability | Description | Photograph |
|---|---|---|---|
| G1 - SJ 45671 90517 | NONE | Row of mature Cypress ( <i>Cupressus</i> spp.) trees, good condition. | |

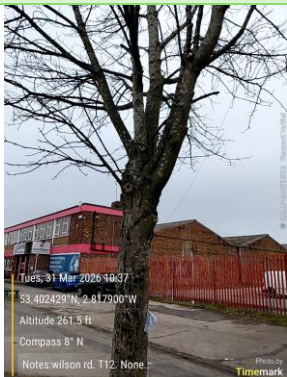
| Tree Reference & NGR | Bat Roost Suitability | Description | Photograph |
|---|---|---|---|
| T12 - SJ 45718 89824 | NONE | Semi-mature sycamore ( <i>Acer pseudoplatanus</i> ) tree with well-healed pruning wounds. | |

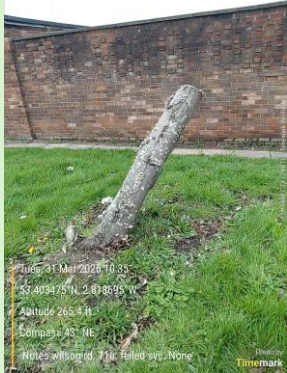
| Tree Reference & NGR | Bat Roost Suitability | Description | Photograph |
|---|---|---|---|
| T16 - SJ 45667 89941 | NONE | Felled whitebeam ( <i>Sorbus aria</i> ) with signs of decay. | |

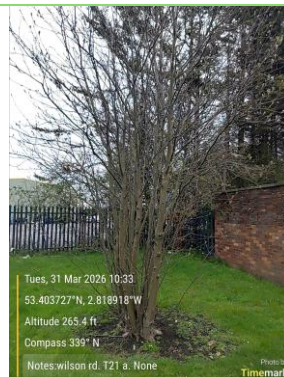
T21a - SJ NONE Young whitebeam in good condition.  
45652 89969

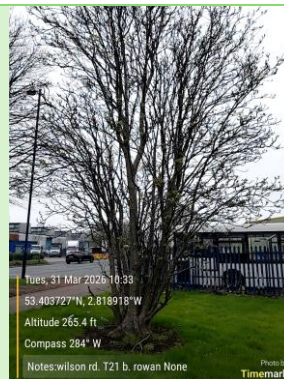
T21b - SJ NONE Young whitebeam in good condition.  
45652 89969

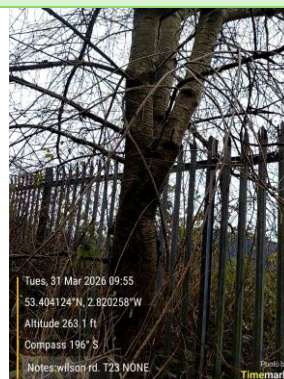
T23 - SJ 45564 NONE Semi-mature wild cherry (*Prunus avium*)  
90014 tree in good condition.

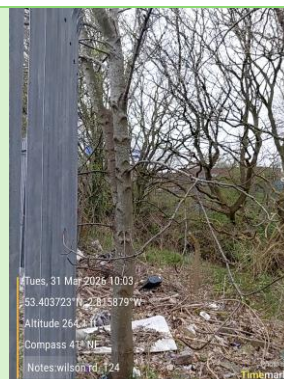
**T24 - SJ 45855 89966** NONE Young ash (*Fraxinus excelsior*) & sycamore trees in good condition.

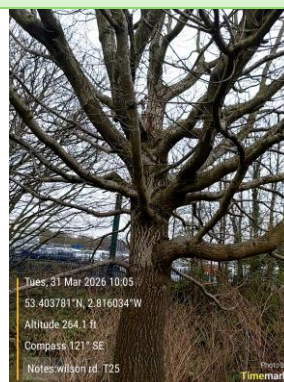
**T25 - SJ 45844 89973** NONE Semi-mature English oak (*Quercus robur*) tree in good condition.

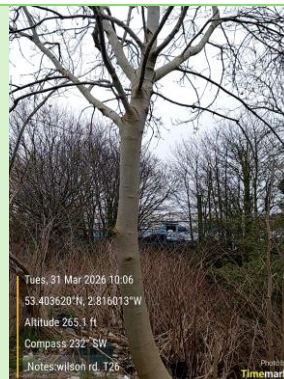
**T26a - SJ 45845 89955** NONE Young ash tree in good condition.

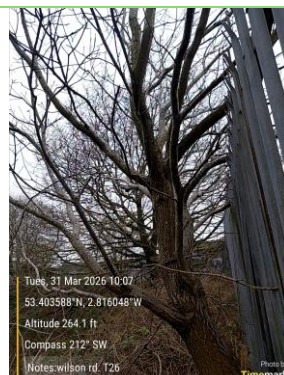
**T26b - SJ** NONE Young English oak tree in good condition.  
**45843 89951**

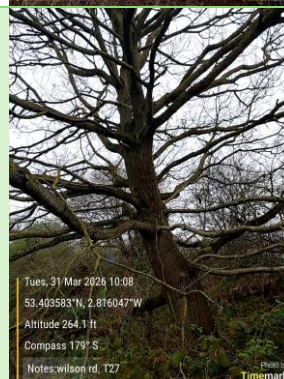
**T27a - SJ** NONE Semi-mature – mature English oak tree in good condition.  
**45843 89951**

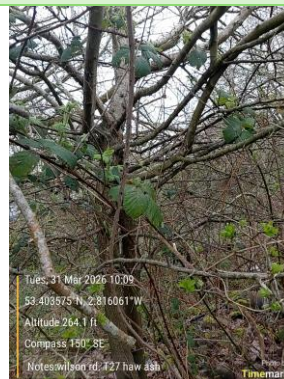
**T27b - SJ** NONE Young hawthorn (*Crataegus monogyna*) in good condition.  
**45853 89905**

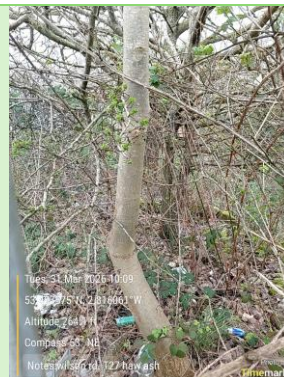
T27c - SJ  
45842 89950

Young ash in good condition.

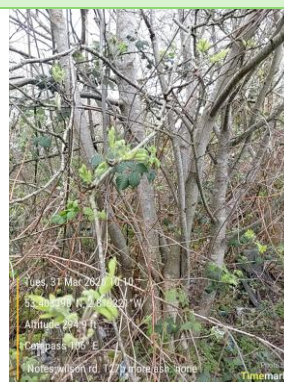
T27d - SJ  
45831 89930

Young multi-stemmed ash in good condition.

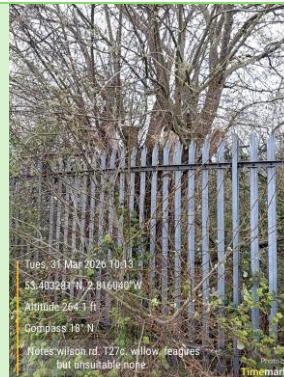
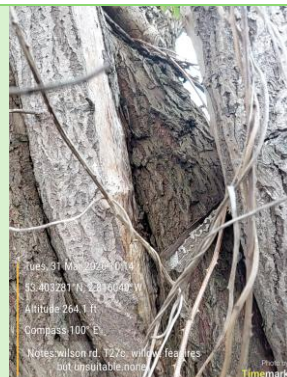
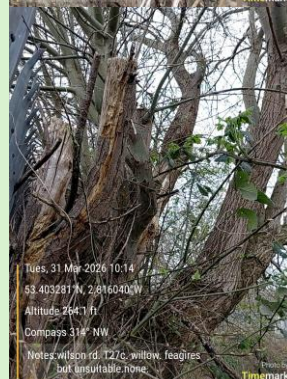
27e - SJ 45843  
89917

A single goat willow (*Salix caprea*) tree (T27e) was noted to have lifting bark and weld features. However, these were deemed unsuitable for roosting bats, due to the relative inaccessibility of the features, in which flight lines are significantly obscured by fencing and brash. Thus, T27e was also assessed as 'NONE'.

Mature goat willow, with poor pruning. Main stem and secondary limbs are growing into the fence and have lifted bark in places, alongside a weld to the main stem.

However, these features are very inaccessible to bats, due to obstructed flight lines.

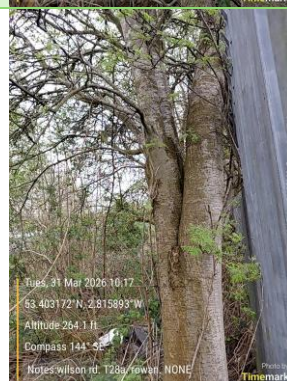
T28a - SJ  
45853 89905

Semi-mature rowan (*Sorbus aucuparia*) in  
good condition.

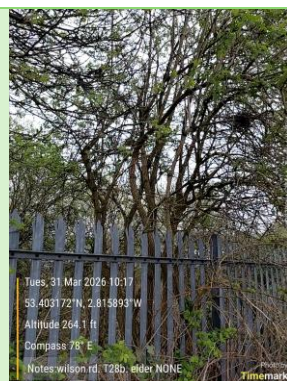
28b - SJ 45853  
89905

Elder (*Sambucus nigra*) shrub, no  
features.

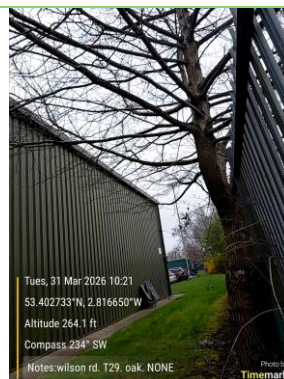
**T29 - SJ 45802 89857** NONE Young – semi-mature English oak tree in good condition.

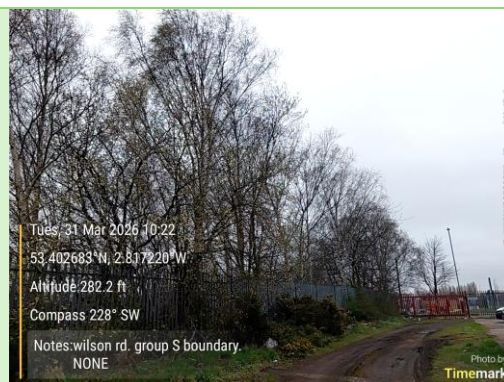
**G5 - SJ 45764 89851** NONE Deciduous tree line comprising oak, silver birch (*Betula pendula*), cherry, and willow with small shrub understory. All trees are in good condition, except for one silver birch at the centre which shows signs of decay. No potential roosting features noted.
