**HALSNEAD GARDEN VILLAGE NORTH,  
KNOWSLEY, MERSEYSIDE -**

**BAT & BARN OWL SURVEY OF  
BUILDINGS & BAT ROOST POTENTIAL  
ASSESSMENT OF TREES**

**2020**

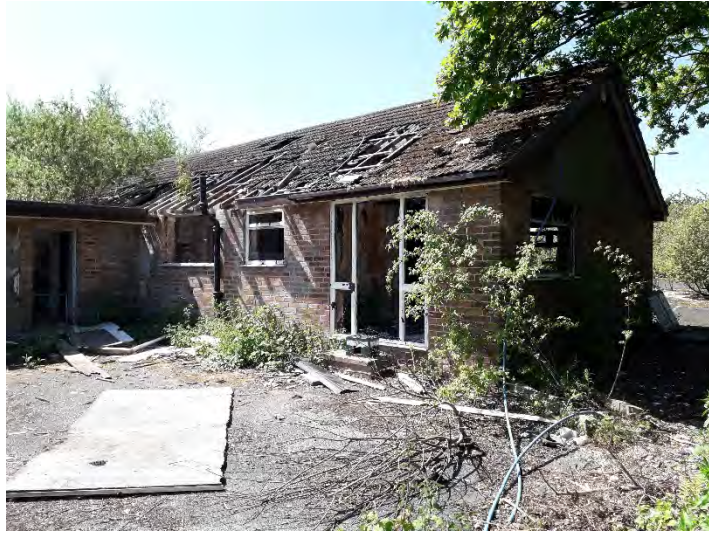
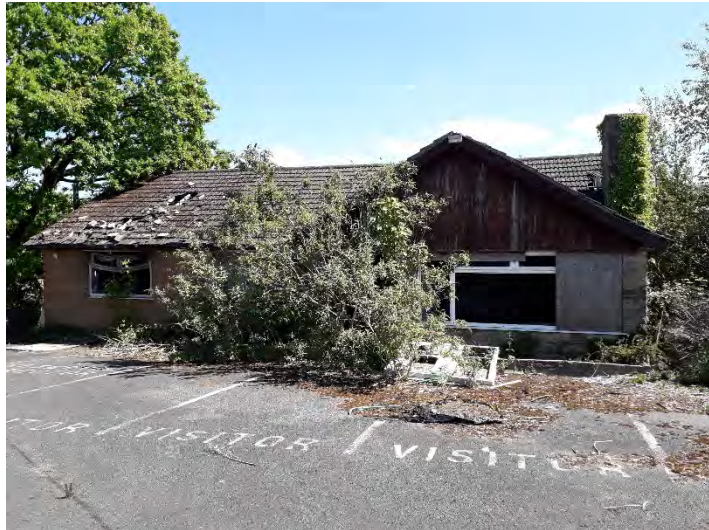
**Plate 1a, 1b: External views of Building 1**

- 5.4 Building 1 was a bungalow which had a pitched roof with roof and ridge tiles. Roof pitches faced north, south, east, and west, gable ends faced north, south, and west. There was a small single storey section with a flat felted roof on the east side.
- 5.5 Gable end walls above eaves height, were wooden clad. There were wooden boxed soffits at the eaves. Walls were brick with an insulated cavity. The building was in a significant state of disrepair, having suffered fire damage and vandalism.
- 5.6 Since the 2017 survey, the state of the building had deteriorated with further wide holes in the roof pitches. The door and most of the windows were without glass and

- 5.7 The roof had a wooden rafter and purlin structure, which was lined with bitumen felt. The holes in the roof could allow direct access. Ceilings were damaged and/or missing, allowing free movement between the roof void, and living areas.

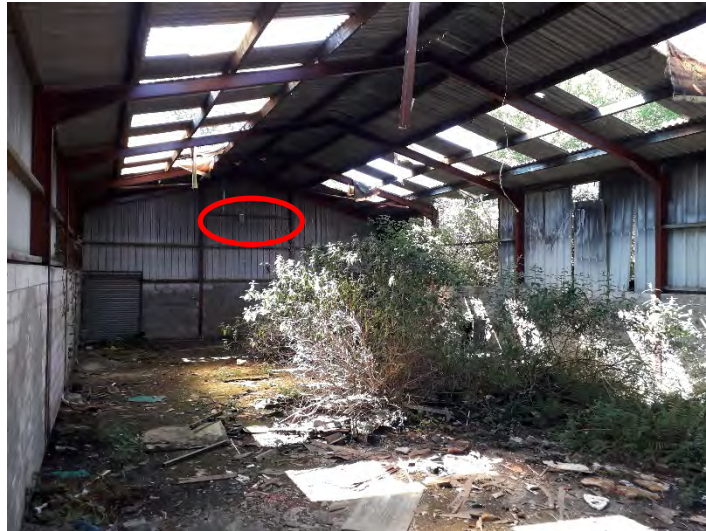
- 5.20 Blue tits (*Cyanistes caeruleus*) were noted as nesting within Building 1, and pigeons (*Columba livia domestica*) within Building 2.

**Plate 4: Internal view of Building 2 (pigeons were nesting on the metal framework at the end)**

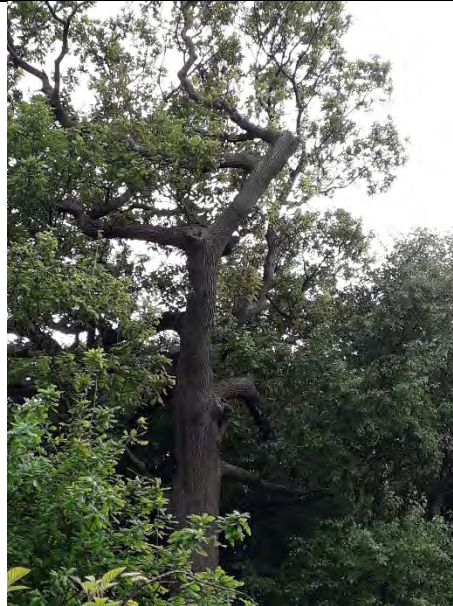
T2 – Sycamore

Semi mature sycamore located just outside site boundary. No features observed, but only the eastern side could be surveyed. Unlikely to be directly impacted by proposals.

Negligible BRP

No further survey work.

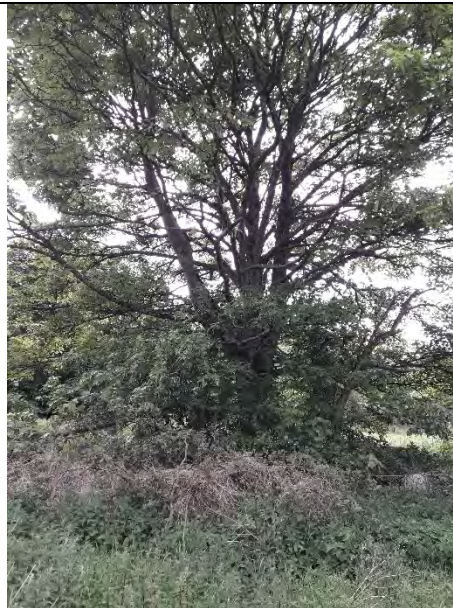
G1 – Sycamore

Multi stemmed sycamore trees with no obvious features suitable for bat roosting.

Negligible BRP

No further survey work.

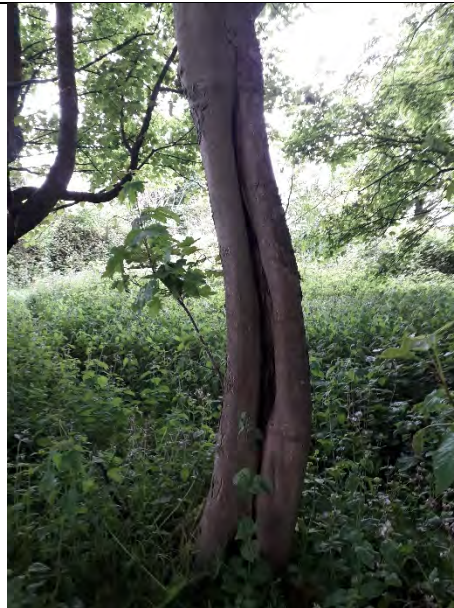
#### W1.2 – Sycamore

Wound with a cavity at the apex at 1m height. 5cm x 5cm entrance hole, approx.. 15cm upwards travel. Dry inside, with woodlice.

BRP – Low

Fell under RAM

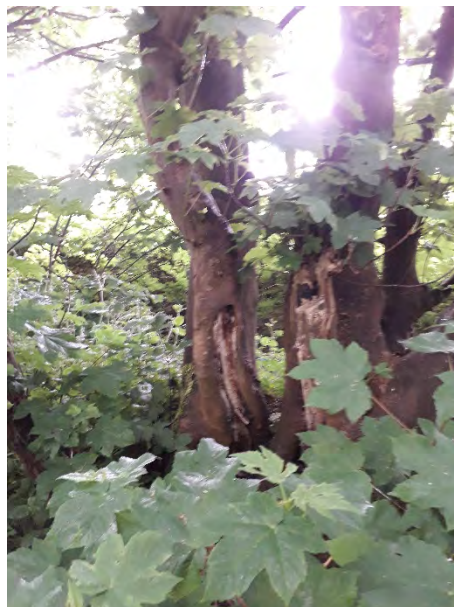
#### W1.3 – Sycamore

Three stemmed tree with wounds on two stems. Frost crack type wound extended 1m up stem from ground. 10 x 20cm entry hole, with 20cm upwards travel. Appeared dry inside but small amount of white mould present indicating some damp.

BRP – Low

Fell under RAM

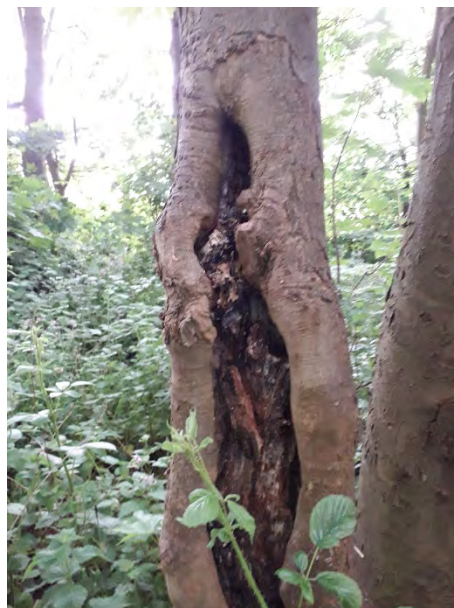
#### W1.4 – Sycamore

Twin stemmed tree with wounds at base of both stems. Butt rot. Small cavities developing at apex of both wounds. 5 x 5cm entry points and 5cm upwards travel in lower of the two wounds. Exposed.

BRP – Low

Fell under RAM

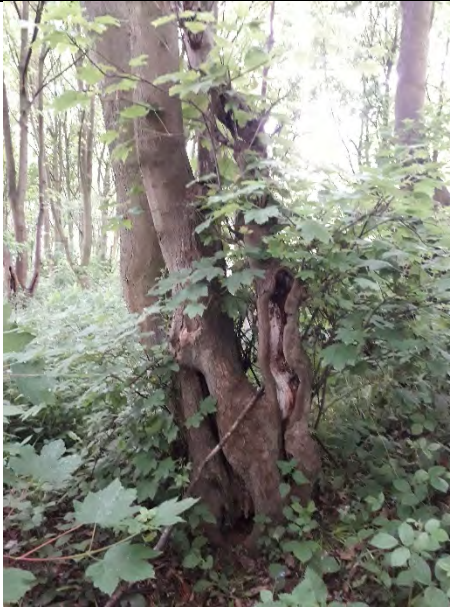
#### W1.5 – Sycamore

Frost crack type wound extended 1m up from the ground. 5 x 10cm entry hole at apex, leading into 10cm upwards travel. Damp lower down but drier at the top.

Low BRP

Fell under RAM

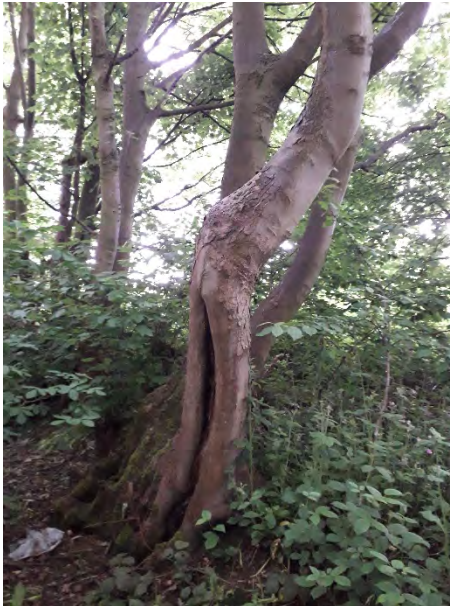
#### W1.6 – Sycamore

Two large frost crack type wounds. The first from the ground, terminating at 2m. Rams horns developing. No apparent access into callus gaps. Cavity at midpoint apex. 5 x 5cm entry hole leading to 20cm upwards travel. Relatively dry and narrow cavity.

A further frost crack type wound above this appeared damp with no suitable cavity.

Low BRP

Fell under RAM

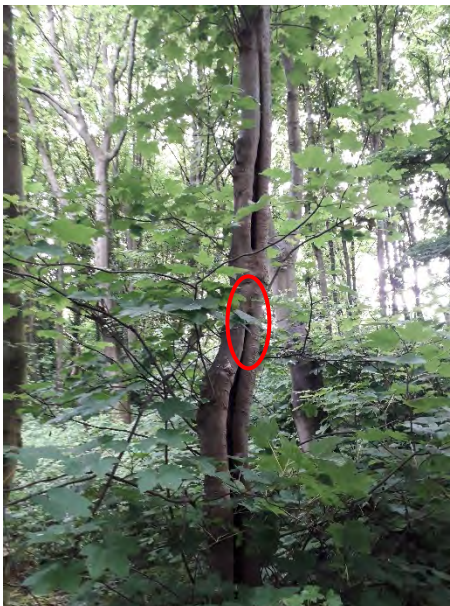
#### W1.7 – Sycamore

Frost crack type wound extending from ground up to 4m with rams horns developing on both sides. Cavity at the apex with an entrance hole of 5cm x 5cm.

Moderate BRP

Climb with ladders and inspect with endoscope

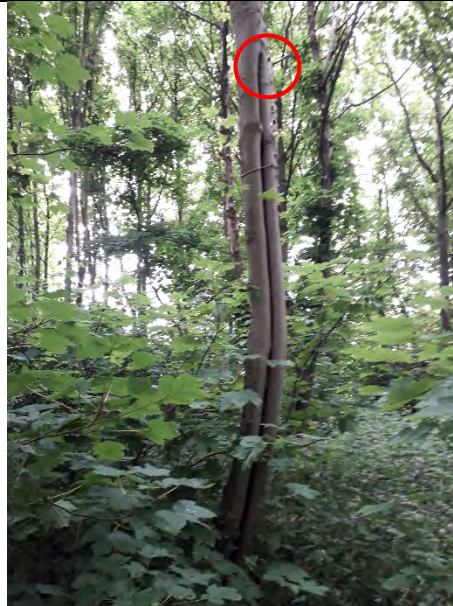
#### W1.8 – Sycamore

Two frost crack type wounds. The first from 0.5m to 1m, with rams horns developing. No apparent access to callus gaps. Cavity at apex with 5cm by 5cm entrance hole. 25cm upwards travel at apex.

Second frost crack wound at 2.5m. This appeared wet and unsuitable.

All features fully inspected.  
Moderate BRP

Check again with endoscope prior to development. If no evidence of bats, fell under RAM.

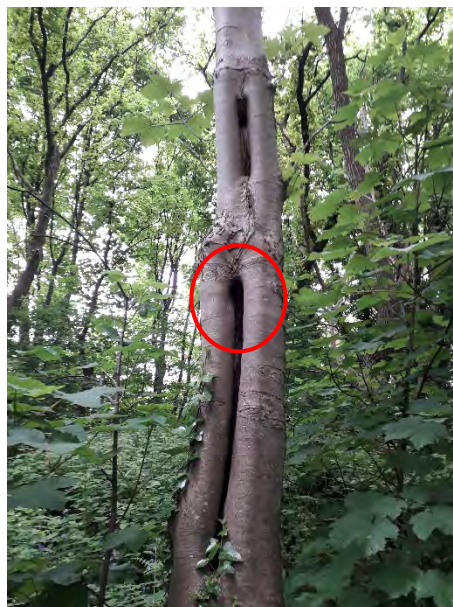
#### W1.9 – Sycamore

Frost crack type wound extending from the ground to 1.5m high. Rams horns developing. No apparent access into callus gaps. Cavity at apex of wound with entrance hole of 3cm x 3cm. 20cm upwards travel offering a dry cavity. Occasional woodlice.

All features fully inspected.  
Moderate BRP

Check again with endoscope prior to development. If no evidence of bats, fell under RAM.

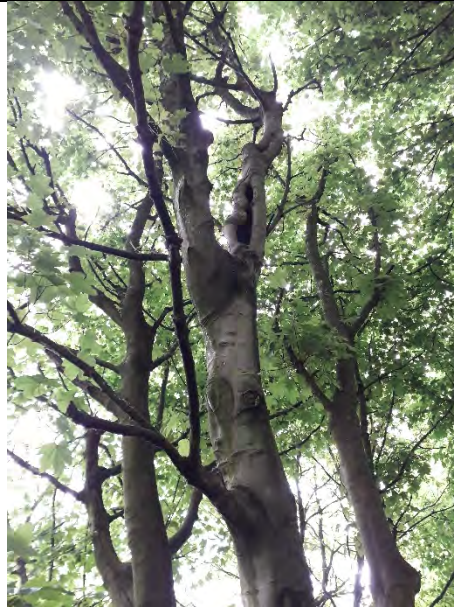
W2.2 – Sycamore

Multi stemmed tree with a dead and damaged branch facing south, at 6m high. Rot hole observed in dead wood, leading into possible cavity with an entrance hole of 5cm x 5cm.

Moderate BRP

Climb with ladders/rope access and inspect with endoscope

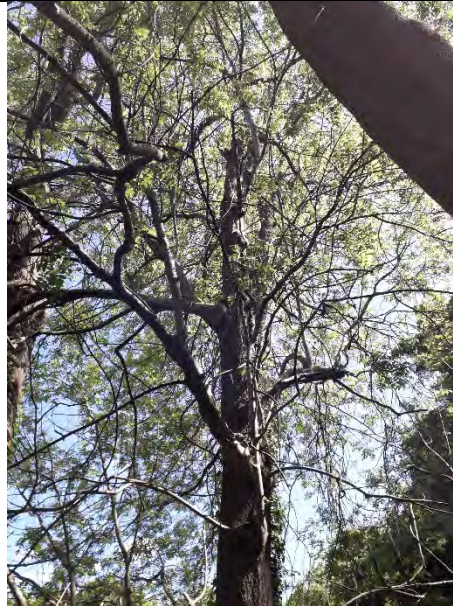
#### G2.3

Semi mature ash tree with a knot hole at 10m high on the southern aspect.

In 2018 this tree was climbed and the knot hole was found to have a cavity feature which was open to the elements and had Low BRP. The feature is considered unlikely to have improved in BRP due to being exposed but may have deteriorated. It is slightly upwards facing and appeared damp. The same classification is given as a precaution.

Low BRP

Fell under RAM

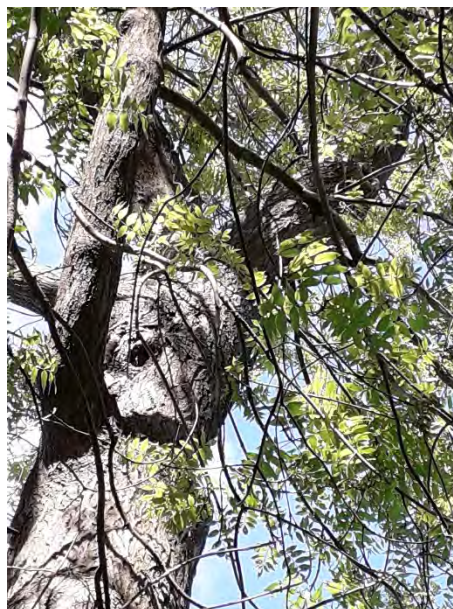
#### G2.4

Semi mature ash with a broken branch on the western aspect at 10m. A tear out type wound is present on the underside of this branch, leading to a possible cavity with an entry hole of 5cm by 5cm.

Moderate BRP

Climb via rope access to inspect features with endoscope,

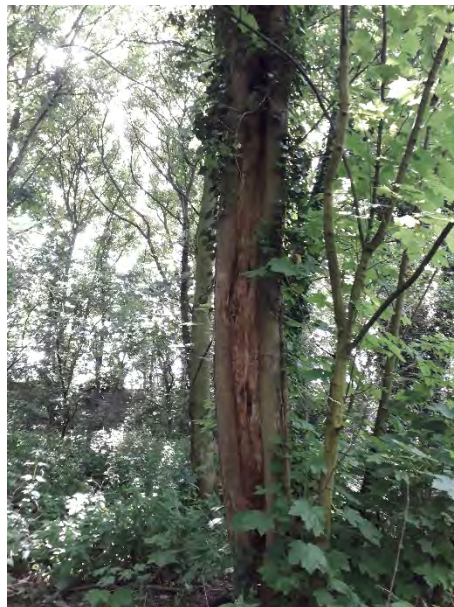
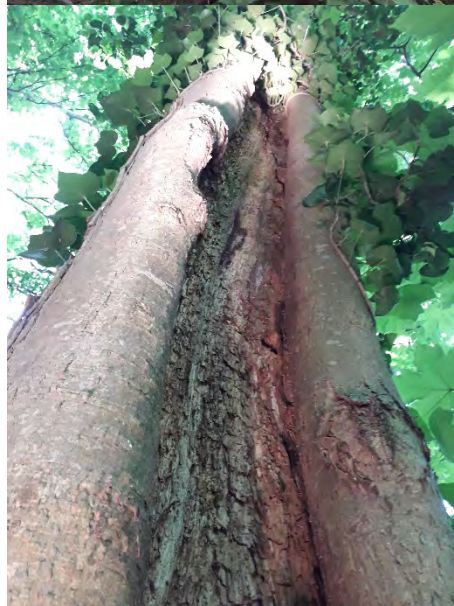
W1.5 – Sycamore

Small twin stemmed sycamore tree, both stems are snapped at approx. 8m high. Significant stem damage with deadwood and a small 2cm x 5cm entry hole into a hollow stem at 3m.

Moderate BRP

Climb with ladders and inspect with endoscope.

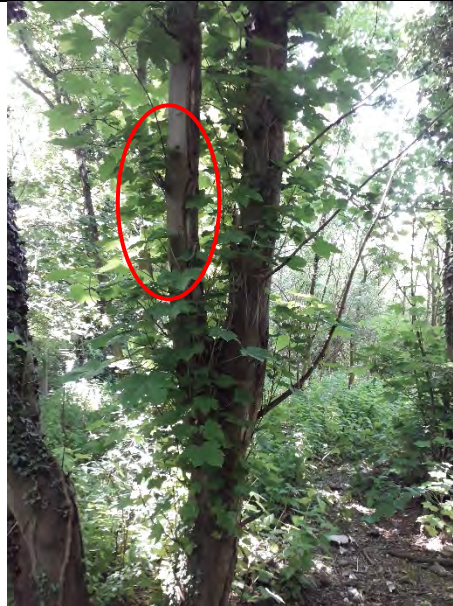
W1.6 – Sycamore

Frost crack type wound from almost ground up to 2.5m high. Cavity in the apex is small and slugs present.

Low BRP

Fell under RAM

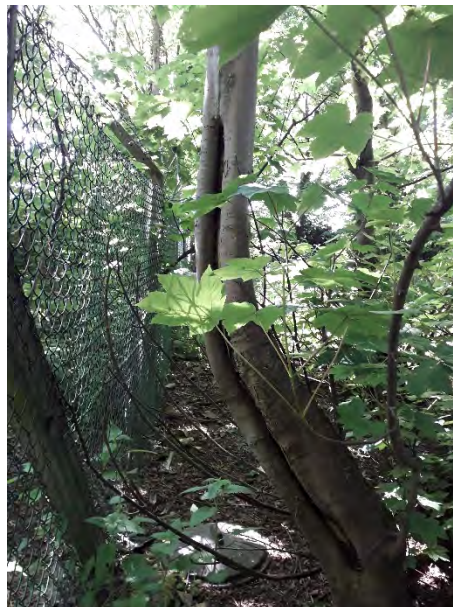
W1.7 – Dead sycamore

Twin stemmed, both with dead wood. Stem on western aspect had 2 x woodpecker holes at 2-3m and a rot hole at 3m.

Moderate BRP

Climb with ladders and inspect with endoscope.

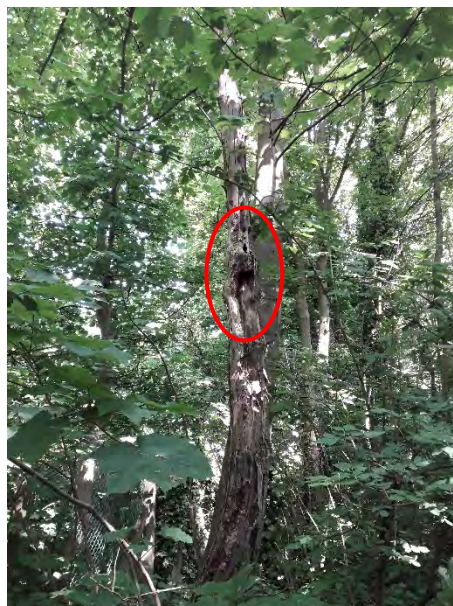
W1.8 – Sycamore

Triple stemmed tree. Eastern stem appears dead. Exposed heart wood and cavity observed behind it at 5m high. Entrance hole 4cm x 2cm. Callus rolls developing either side but no access into cavities observed.

Moderate BRP

Climb with ladders and inspect with endoscope.
