**Prospect House  
21 Huyton Church Road  
Huyton  
L36 5SH**

**Full Arboricultural Assessment  
for  
Development  
(BS 5837:2012)**

**October 2021**

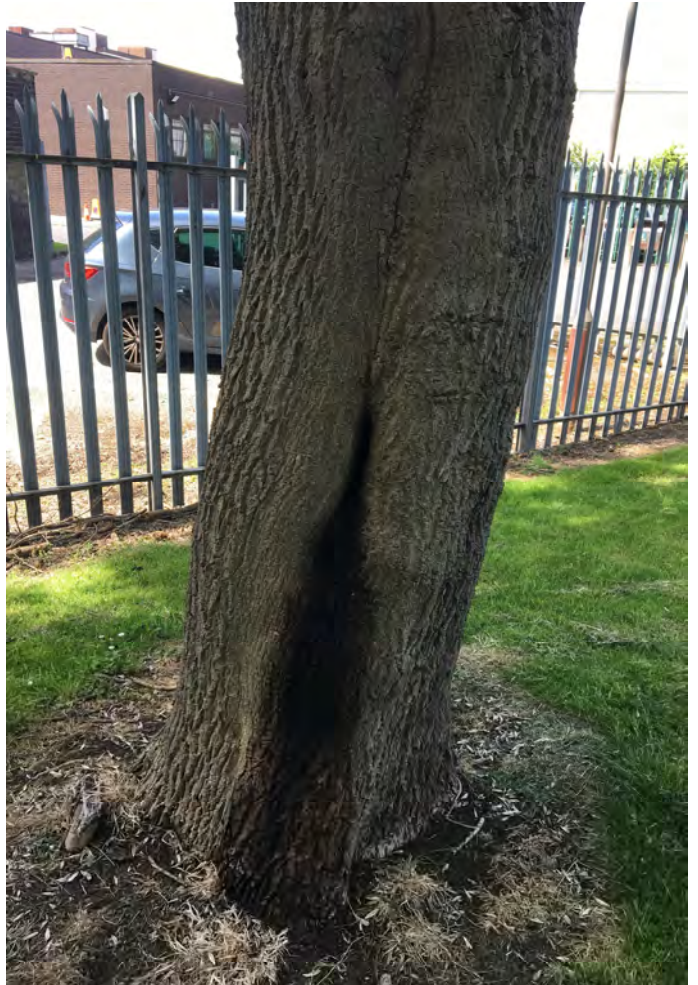
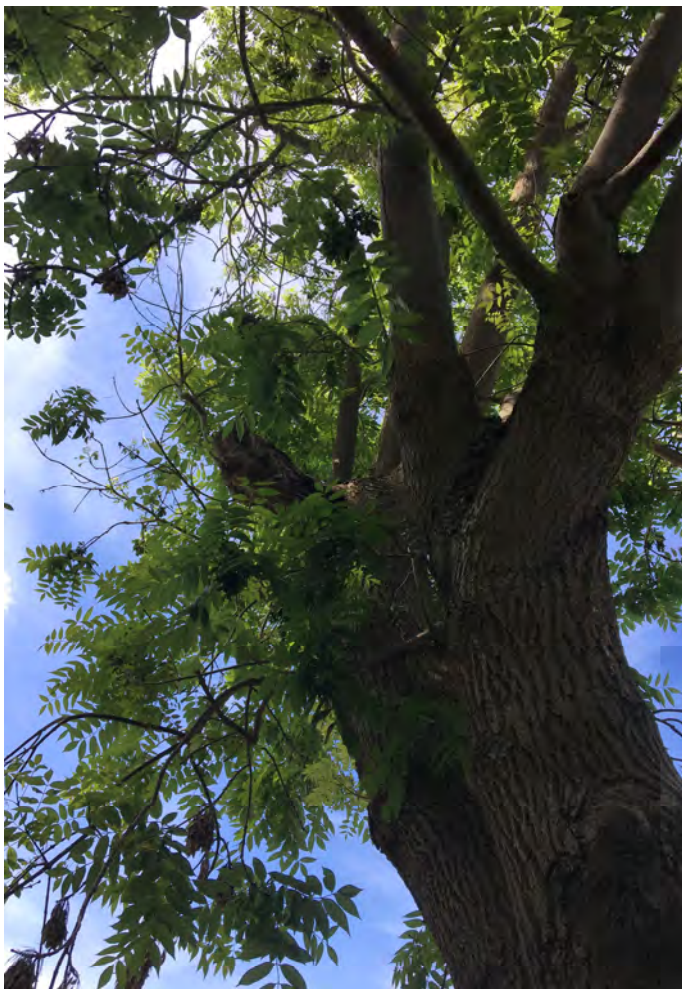
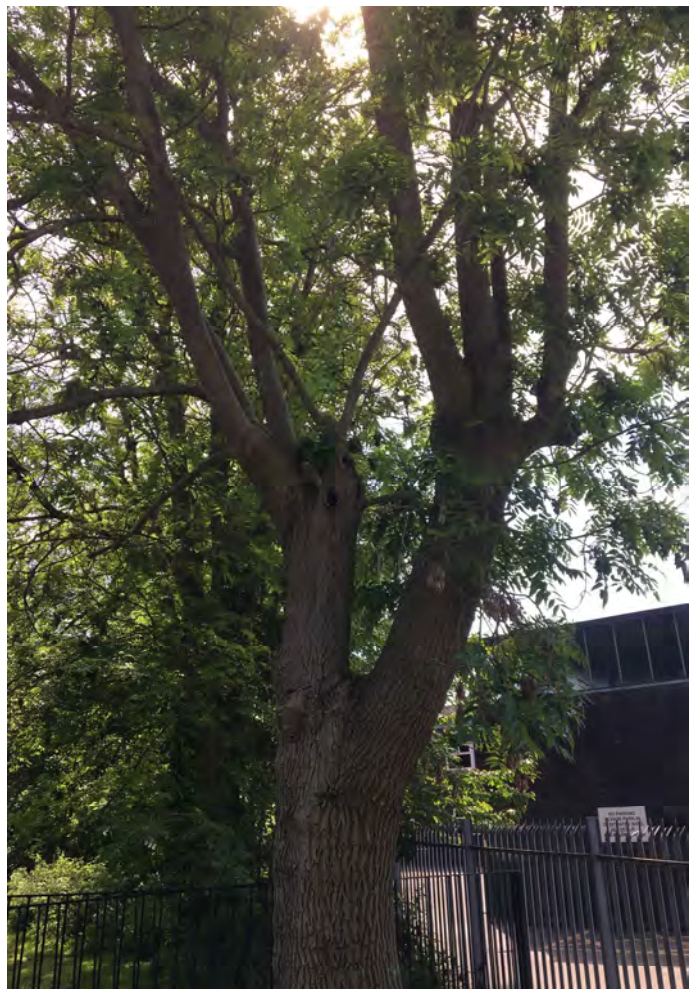
| Arboricultural Data Sheet: Prospect House, 21 Huyton Church Road, Huyton, L36 5SH | | | | | | | | | | | Weather: Dry and bright | Date of Survey: 08/06/21 | | | Surveyor: PM | | |
|---|---|---|---|---|---|---|---|---|---|---|---|---|---|---|---|---|--|
| T7 | Ash | 560 | 16 | M | 5 | 6 | 7 | 4 | 2 | C | A co-dominant specimen located on the rear boundary. Previously cut back from adjacent property. Deadwood present and major stem decay at 4m due to old wounds. Hollowing lower stem and cavity at base. | Remove. | 5-10 | U | 141.87 | 6.72 | |

| Tree No | Species | Root Protection Area (m <sup>2</sup> ) | Circle Radius (m) | Distance to any proposed construction or surfacing (m) | Can the Tree be Successfully Retained |
|---|---|---|---|---|---|
| T7 | Ash | 141.87 | 6.72 | Remove for condition | |

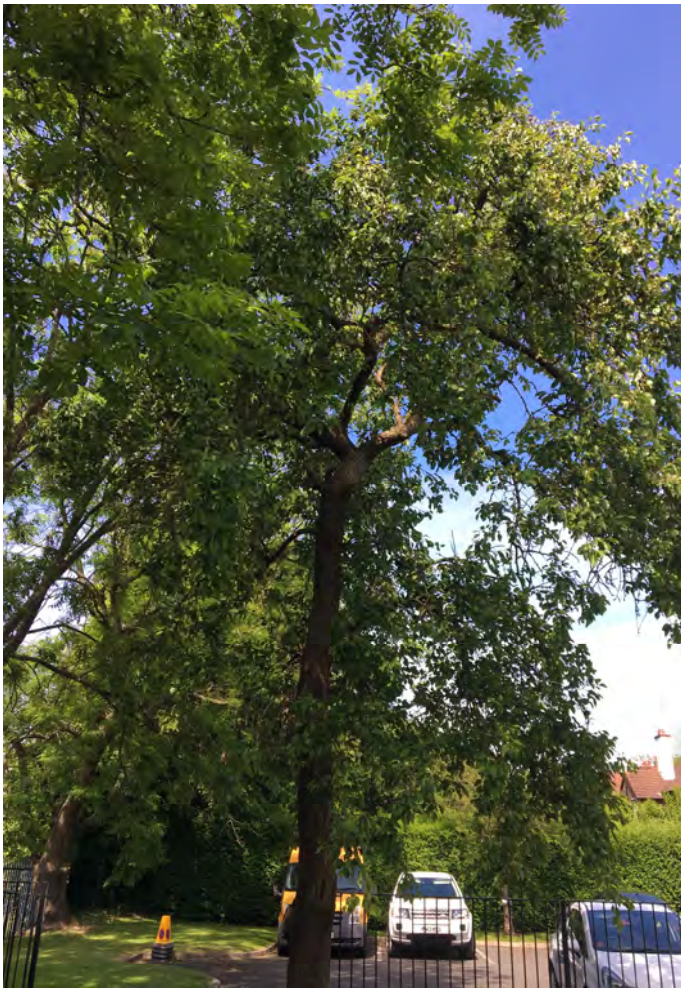
| Arboricultural Data Sheet: Prospect House, 21 Huyton Church Road, Huyton, L36 5SH | | | | | | | | | | | Weather: Dry and bright | Date of Survey: 08/06/21 | | | Surveyor: PM | | |
|---|---|---|---|---|---|---|---|---|---|---|---|---|---|---|---|---|--|
| T9 | Pear | 380 | 6 | M | 2.5 | 2.5 | 4 | 3 | 1.5 | B/C | A mature fruit tree suppressed by the adjacent Ash. Several stem wounds and cavities present plus some rot within several limbs. Typical of species. | n/a | 10+ | C2 | 65.33 | 4.56 | |

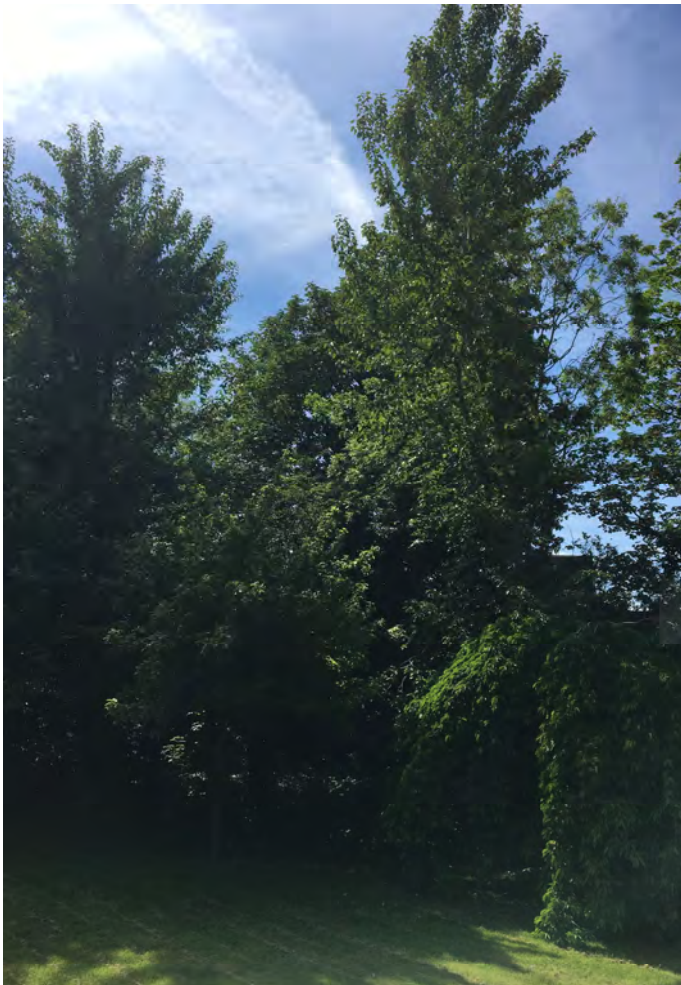
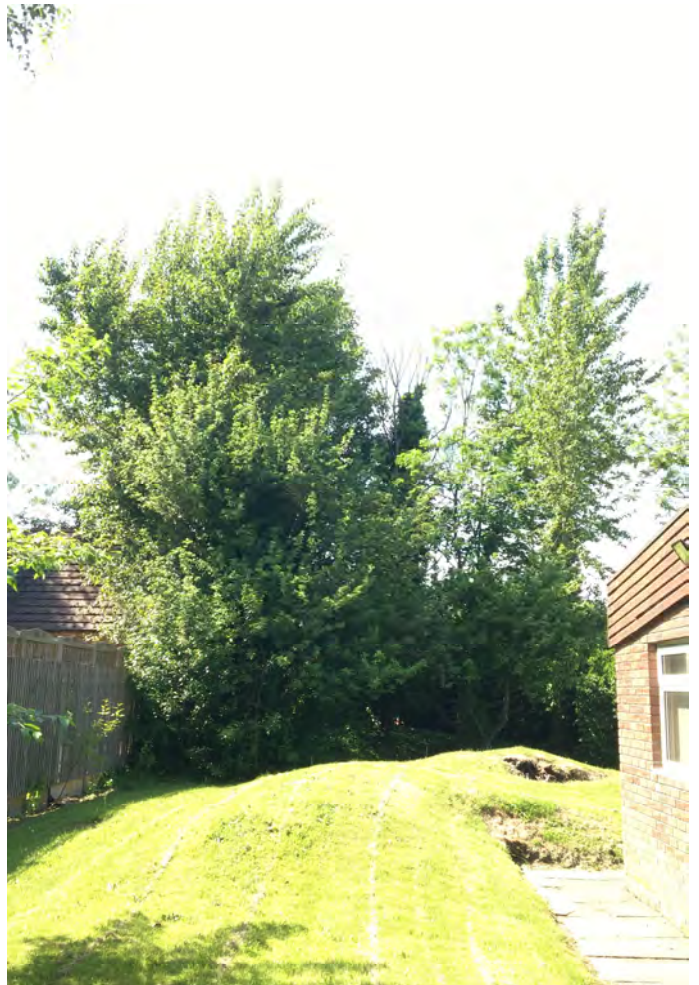
T12 - T21

| Arboricultural Data Sheet: Prospect House, 21 Huyton Church Road, Huyton, L36 5SH | | | | | | | | | | | Weather: Dry and bright | | Date of Survey: 08/06/21 | | | Surveyor: PM | | |
|---|---|---|---|---|---|---|---|---|---|---|---|---|---|---|---|---|--|--|
| T20 | Apple | 280 | 3 | EM | 2.5 | 3 | 3 | 2.5 | 1 | B | Twin-stemmed at base. Minor suppression due to the group and some basal damage present. Reasonable vigour. | n/a | 10+ | C2 | 35.47 | 3.36 | | |
