# LAND AT HALSNEAD PARK WHISTON ARBORICULTURAL IMPACT ASSESSMENT MARCH 2022

| Document Title | Arboricultural Impact Assessment |
| Prepared for | Taylor Wimpey |
| Document Ref | 7137.001 |

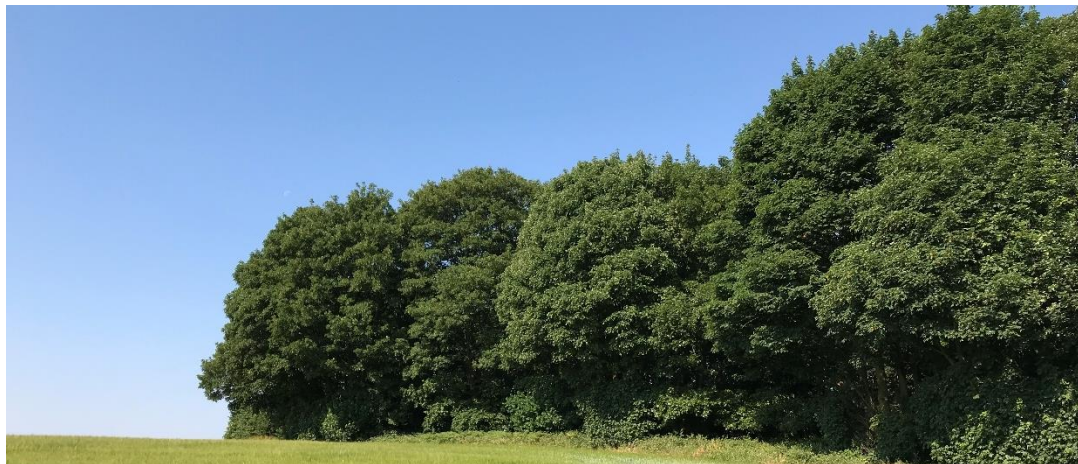
- 4.3 The most prominent trees are those forming Fox's Clump woodland (W1) in the middle of site. This is mixed age woodland, ranging from mature lapsed coppice stools to young saplings. The trees are overall in good condition and the species composition comprises native and naturalised broadleaf species included English oak, sycamore, English elm and sweet chestnut. It is slightly raised above the surrounding field and the topography within the woodland itself varies throughout. The understorey comprises small trees, bracken and bramble amongst other ground flora. The woodland provides landscape value and continuous habitat provision for local wildlife.

*Figure 2 Fox's Clump woodland (W1) situated in the centre of site.*

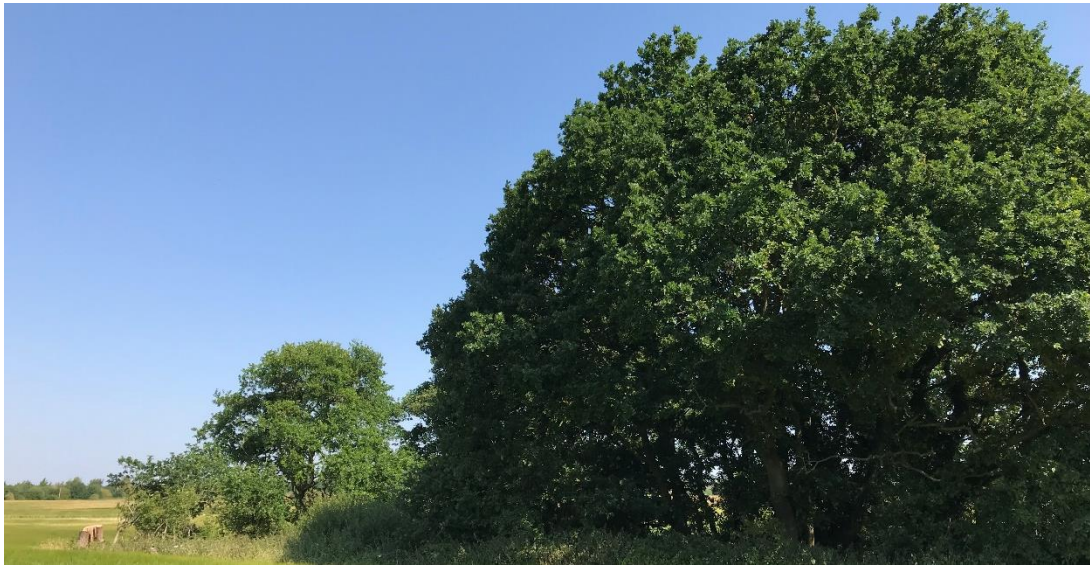
- 4.4 There are several tree groups situated on or adjacent to the site that enclose or are next to ponds, some of which are dry (G2, G5, G6 and G7). These groups comprise middle-aged to mature mixed broadleaf species including English oak, rowan and sycamore, the majority of which are in good condition. Group G2 is located on the western boundary of the site and provides screening to the adjacent Halsnead Park Caravan Park. Groups G5 and G6 groups and provide habitats for local wildlife in the agricultural landscape.

*Figure 3 Group G6 surrounding an arid pond to north-east of site.*

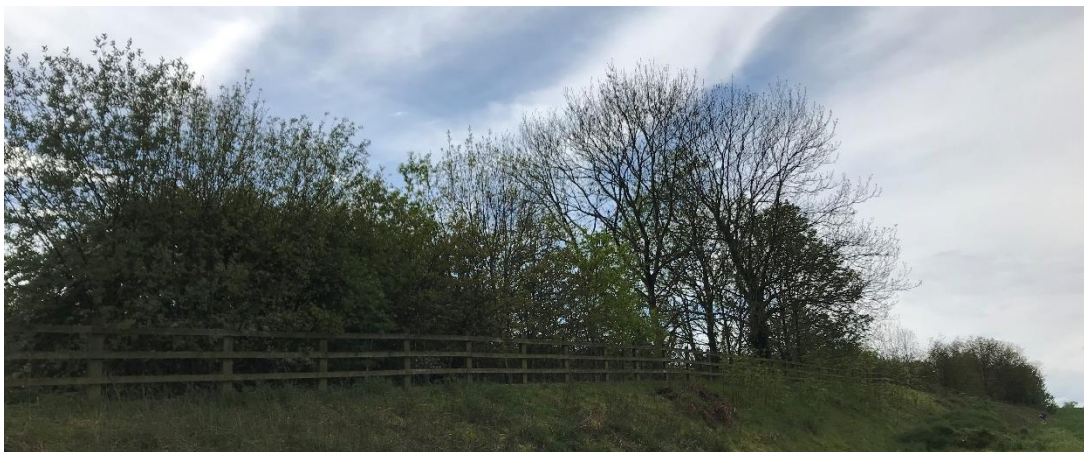
- 4.5 To the south of the site is a large, linear group of trees (G20) on a roadside bund between the site and the M62 which spans the entire southern boundary. This group comprises young to middle-aged trees with the youngest and most dense planting to the west of the group and gradually becoming more mature and less dense to the east. Species composition comprises English oak, sycamore, hawthorn, silver birch and rowan. There are some trees at the eastern end of the group that, due to their size and age likely existed prior to the roadside planting. The primary function of this group is to act as a screen between the site and the M62.

*Figure 4 Eastern end of roadside group G20 between site and M62.*

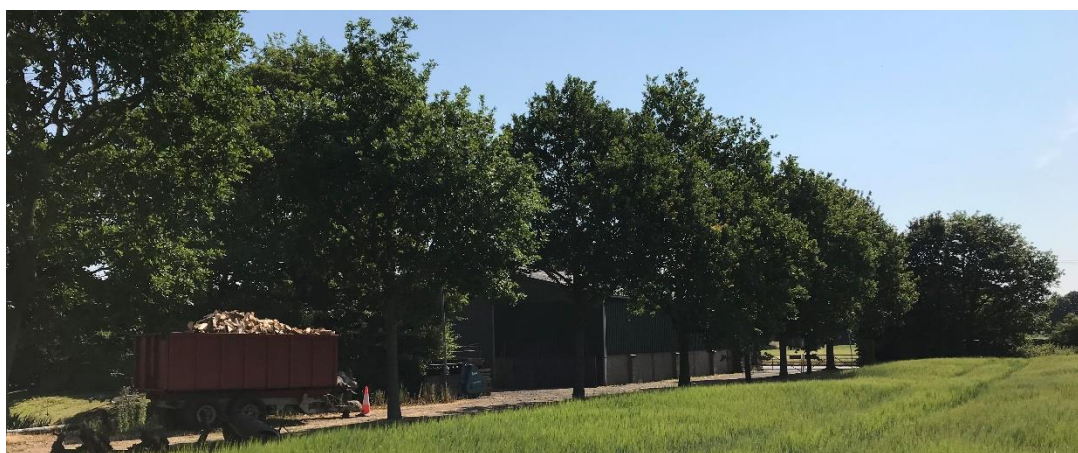
- 4.6 Immediately adjacent to the existing access track is a linear group of trees (G8) comprising 8 middle-aged English oak. All trees have been crown lifted over the access track with pruning wounds evident however, no other management is evident. These trees are in good condition and provide good amenity and landscape value.

*Figure 5 Linear group of English oak (G8) adjacent to existing access track.*

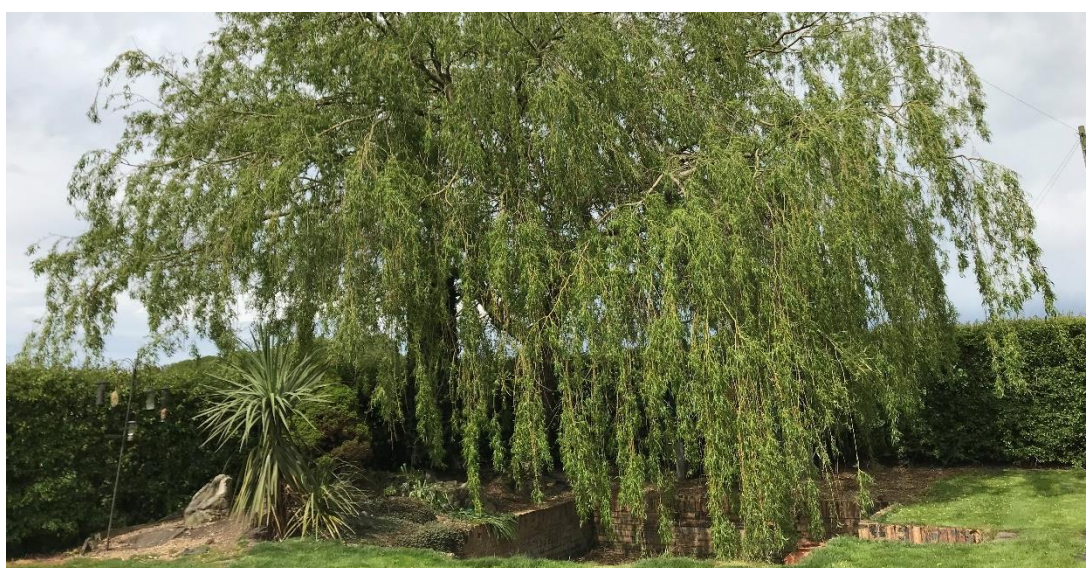
- 4.7 Located to the north-west of the farmhouse garden is a middle-aged weeping willow tree (T27). It is situated in close proximity to a sunken patio area surrounded by retaining walls which will likely have influenced the root growth of the tree. It has good form typical of the species and there is no evidence of previous management.

*Figure 6 Weeping willow (T27) adjacent to sunken patio area with retaining walls.*
