## DESIGN, ACCESS & HERITAGE STATEMENT

Doc Ref: 1415/DOCS/PLANNING/DAS02.  
Client: Ecclestone Properties Ltd.  
Project: Works to 33 Ecclestone Street, Prescott L34 5QA.  
Date: 07/02/22.  
Revision: -

This Design, Access and Heritage Statement has been prepared on behalf of Eccleston Properties Ltd. in support of a planning application for the re-building of a rear gable at 33 Eccleston Street, Prescott L34 5QA.

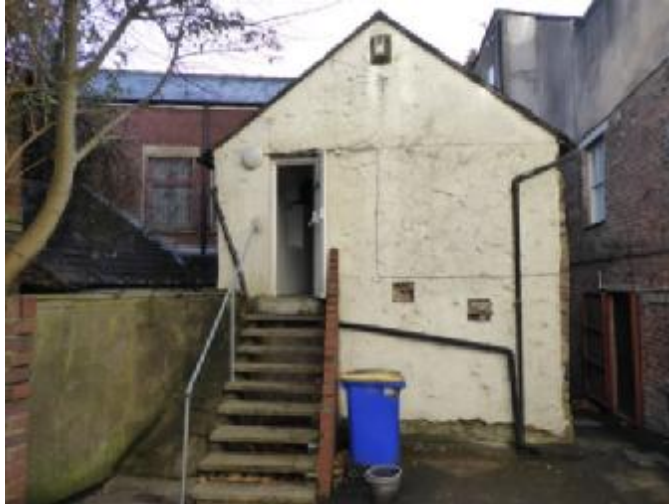
Rear Outrigger Gable with roughcast cement based render. (Image taken prior to the render removed as part of the works relating to planning application ref: 20/00724/FUL).

The existing rear gable wall was significantly bowed at ground and first floor but has a ledge at eaves level and which was plumb above due to the gable having been rebuilt plumb on top of an earlier wall. The gable and the roof have a simple pointed verge.

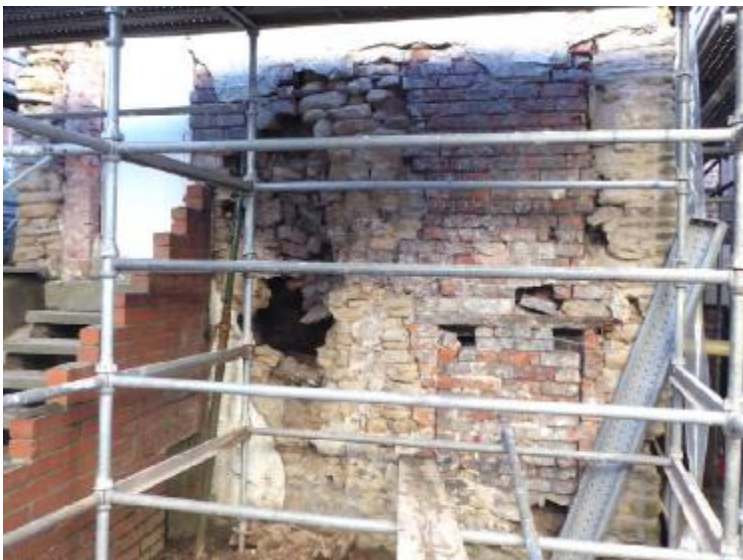
More recently, as part of the works associated with planning application 20/00724/FUL, the rough cast render has since been removed to reveal the existing building fabric beneath. The removal of the render uncovered some significant structural failings in the wall which resulted in partial collapses of the wall. The collapses were due to varying panels of masonry being insufficiently tied and bonded together. It is suspected that the cement based render was likely installed at some point in the past to bond together the varying panels of masonry.

Exposed rear elevation December 2021.

Most of the rear elevation has been rebuilt or altered at some point in the past and these works have substantially weakened the structure. The only parts which are in situ and constructed of the same thin stone blocks as the side elevations are: the N ends of the LH and RH side walls of the cottage; a central pier varying from 300mm-50mm wide and; plinths in the bottom RH and LH corners.

A doorway has been created at first floor level on the LH side and lined with bricks. The outer wall of the former chimney has collapsed for a width of approx 800mm from approx 1000mm above ground level to approx 2500mm above ground level, to the R of the modern external brick staircase. A panel of bricks extends from ground level up to approx 4m above ground level adjacent to the RH (W) side wall.

The Chimney is inadequately tied in to the external stonework and has partially collapsed on the outer face. At some point previously, the chimney was truncated below eaves level, capped off, infilled and partially encased internally by a new lining of bricks.

A structural engineer attended site and confirmed that the gable wall was in a precarious state and was unstable. Emergency temporary propping and support works were set in place by the building contractor to protect the fabric of the building and prevent further deterioration of the gable and surrounding structure.

The proposals, as indicated on the application drawings, are to carefully demolish the existing rear gable masonry structure down to external ground level, setting aside any re-usable masonry and re-building the gable to match the existing. The gable is to be re-built in solid brickwork construction, 9" thick. Handmade reclaimed brickwork on the outer face is to be used along with common brick to the inner leaf brickwork. Masonry to be constructed in a lime based mortar. The new masonry is to be fully tied into the existing fabric and the internal breast is to be tied back into this new gable wall to ensure full stability of the old and new structures. Please refer to the application drawings for brick and mortar specifications.

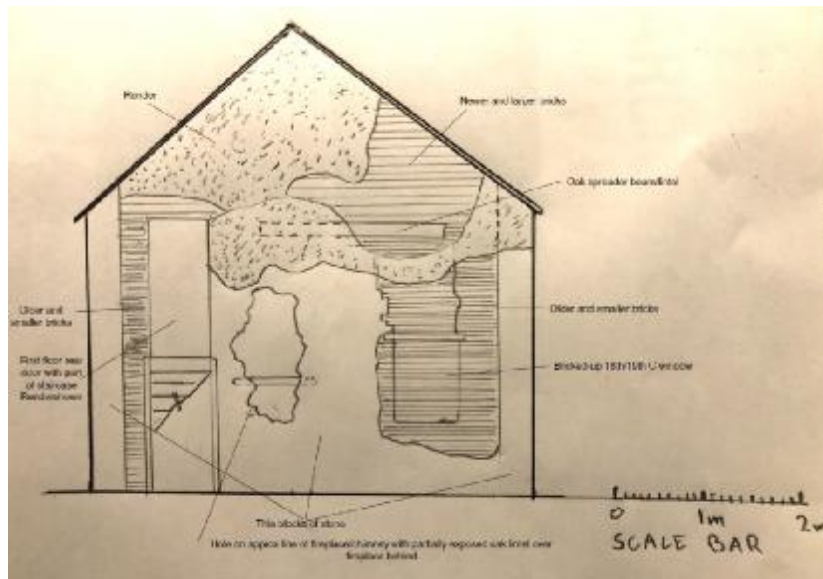
Drawing of rear gable December 2021.

In the centre of this brick panel is a timber lintel and behind the brickwork below the lintel is a blocked up window. Only small parts of the upper corners of the surviving window frame can be seen but it appears to be a vertically sliding sash window with: the weight box set back behind an outer skim of bricks; a rounded and tapered fillet on the RH side and; internal iron security bars. The details of the windows suggest that it was inserted in the 18th or 19th C.

The removal of the render from the top RH part of the gable has exposed the RH end of a timber baulk which appears to be oak and is approx 800mm deep. The wall at the top of the gable, over the baulk, is built in large mid-20th C common bricks. This confirms the top of the gable has been fully rebuilt at some point, without the chimney.
