## Tree Survey Report

BS5837:2012 (Trees in Relation to Design, Demolition and Construction)  
Format

Millbrook Manor, Knowsley Lane, Liverpool L34 0JN

Date: 24/11/2022

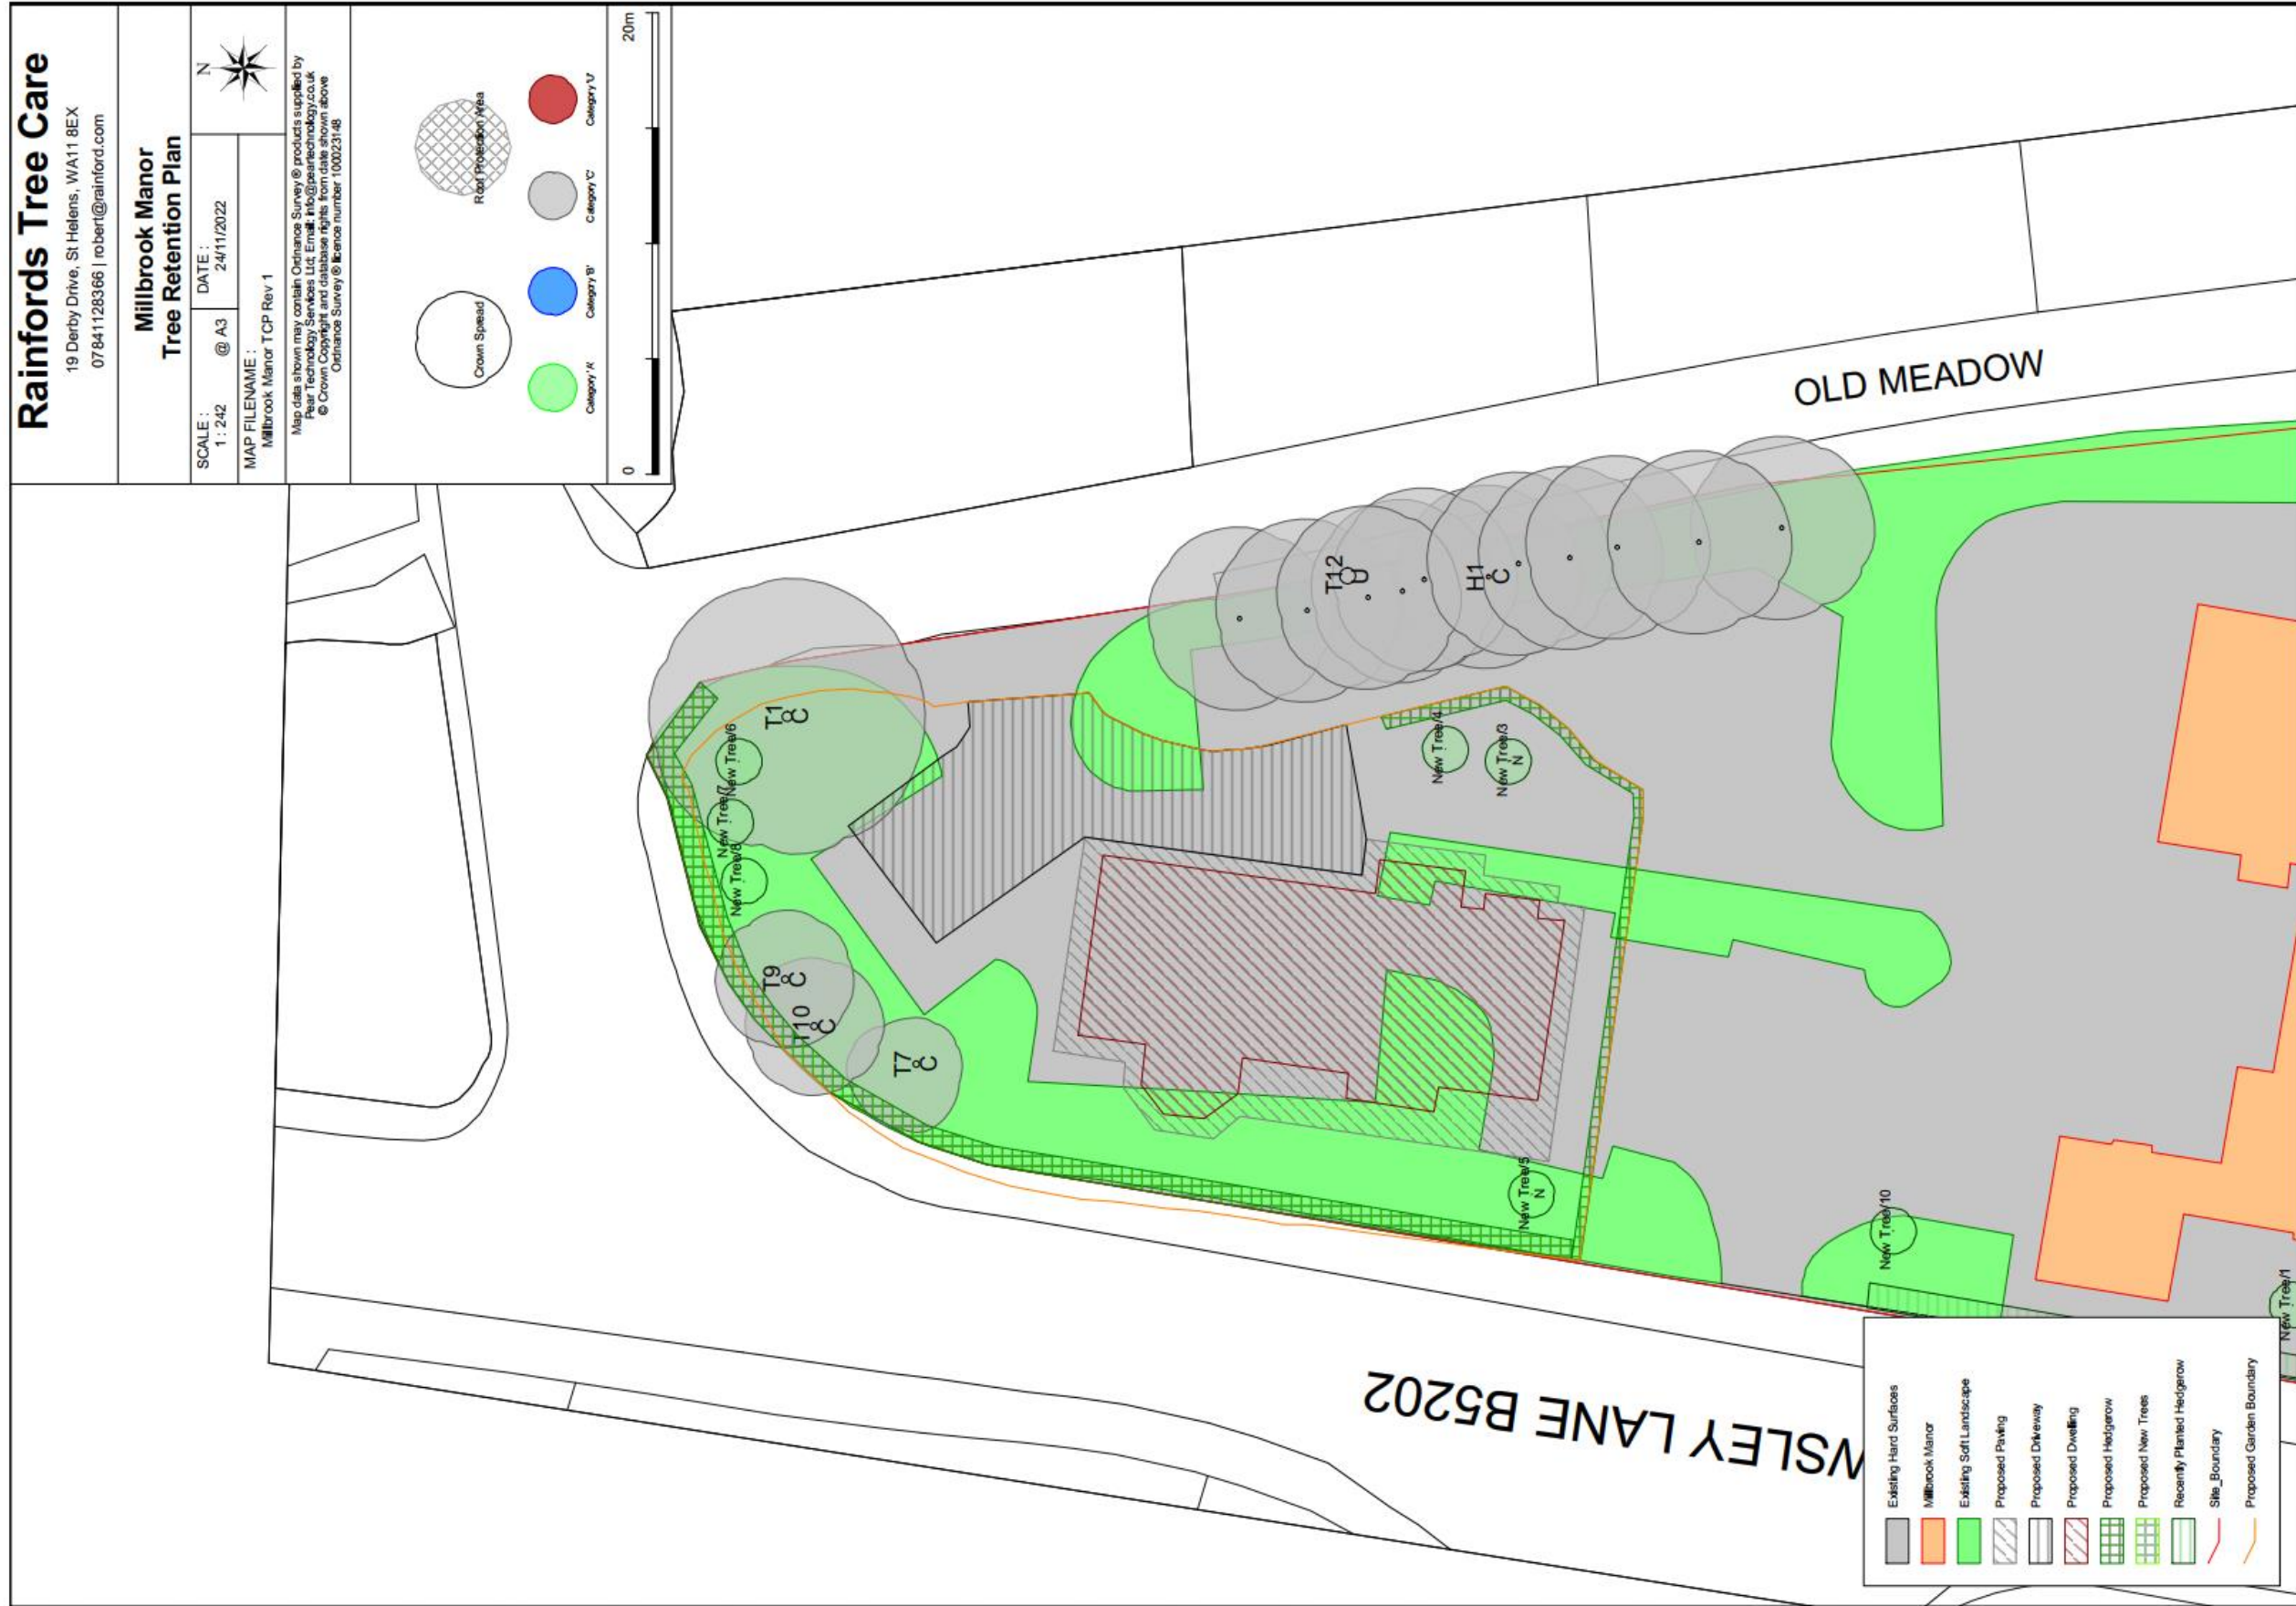
## 9 APPENDIX C - Tree Retention Plan

- 7 Category **U** Trees require work. T2, T3, T4, T5, T6, T8 and T12 are all in poor/deteriorating condition and will require felling before the development work starts.
