# BS 5837:2012

## Arboricultural Impact Assessment

**Report No.** LTM1097.AIA.01  
**Project:** St Agnes Parish Club  
**Authored by:**

St Agnes Parish Club

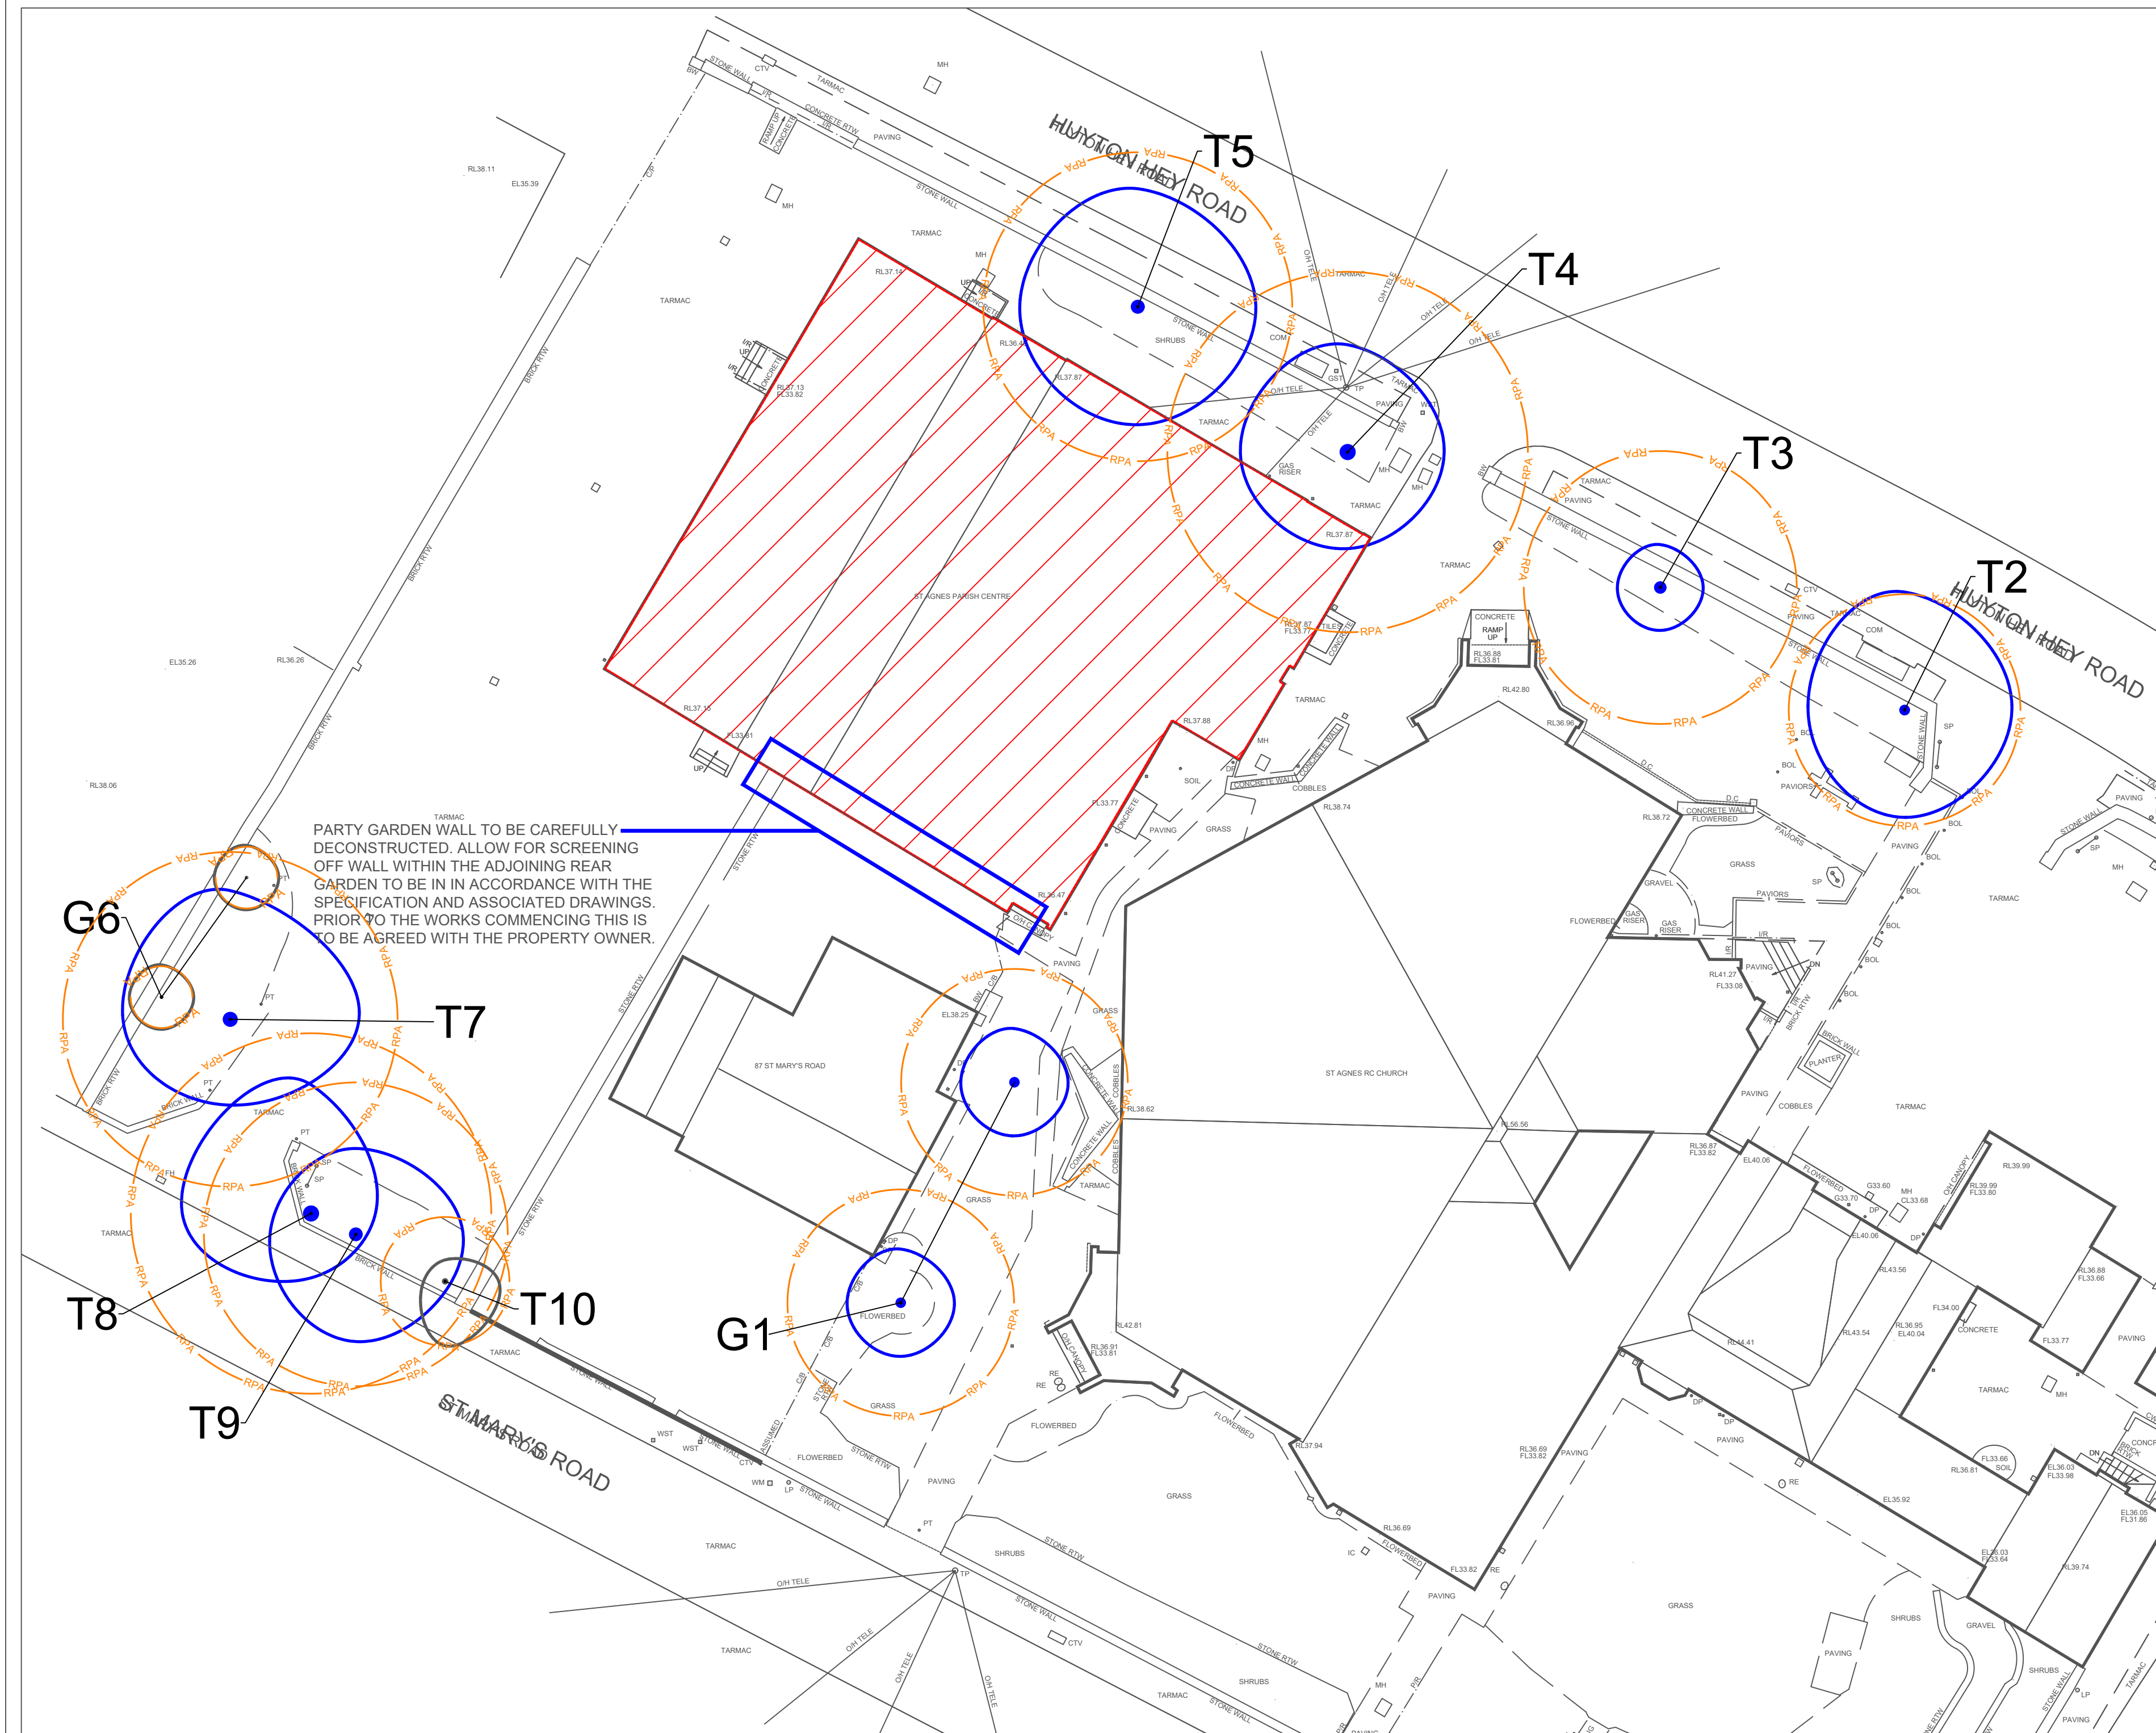
ARBORICULTURAL  
IMPLICATIONS PLAN

- 6.2.1. I have overlayed the proposed site plan provided by Property Surv Building Surveying and Design Ltd onto the existing site plan using computer aided design software and found locations in which there are conflicts with existing trees. I have made this plan available in appendix IV titled Arboricultural Implications plan.

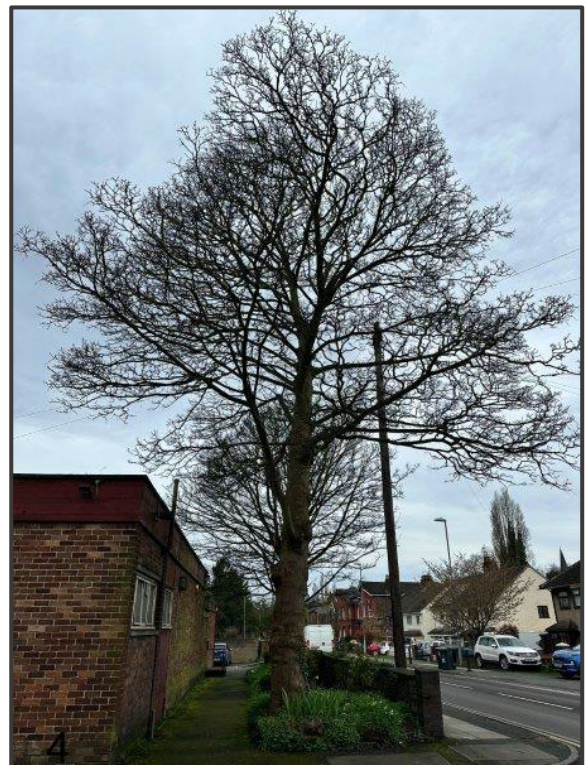
- 7.1.1. I note that the branches of T4 & T5 are in direct contact with the building that is to be demolished. The branches will require pruning to facilitate the demolition. I recommend that the crown of T4 & T5 is raised on the building side of the crown to a height of 4.5m to facilitate the demolition.
- 7.1.2. It is my opinion that if all pruning works are undertaken in line with British Standard 3998:2010 Tree Work – Recommendations then the Safe Useful Life Expectancy of the trees will not be adversely affected.

**Picture 4. T4- Sycamore located at the front of the parish club adjacent to Huyton Hey Road.**

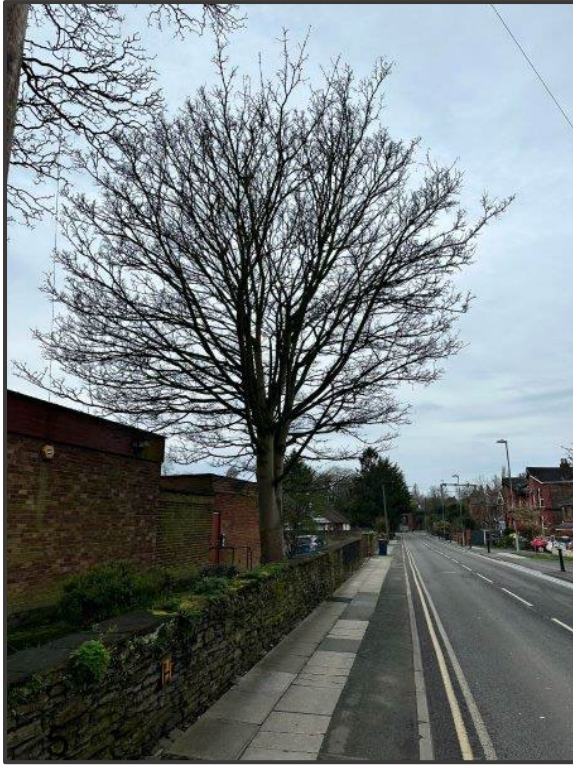
**Picture 5. T5- Sycamore located at the front of the parish club adjacent to Huyton Hey Road.**

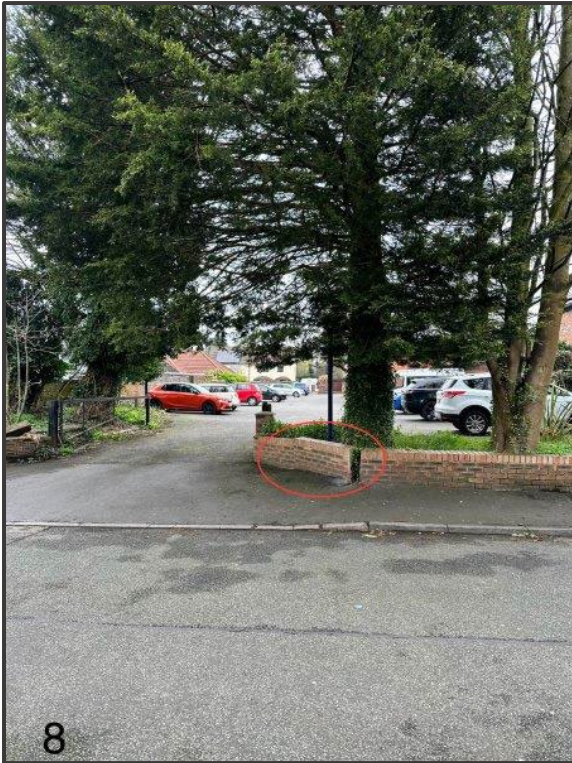
| Tree No. | Species | Stem Dia (mm) | RPA (m <sup>2</sup> ) | RPA Radius (m) | Height (m) | Age Class | Crown Spread (m) | | | | Crown Clearance (m) | Condition | Comments | Recommendations | Remaining Contribution | BS5837 Retention Category |
|---|---|---|---|---|---|---|---|---|---|---|---|---|---|---|---|---|
| T8 | Monterey Cypress | 700 | 222 | 8.4 | 15 | EM | 6 | 3 | 3 | 6 | 2W | A | Asymmetrical crown due to adjacent trees. Low branches over path and car park entrance. Stem growth is damaging wall. | Crown lift to 3m. Monitor wall and repair as required | 40+ | B1 |

**Picture 9. T8-Monterey cypress with low branches over path. Stem growth is damaging wall as shown by red circle.**

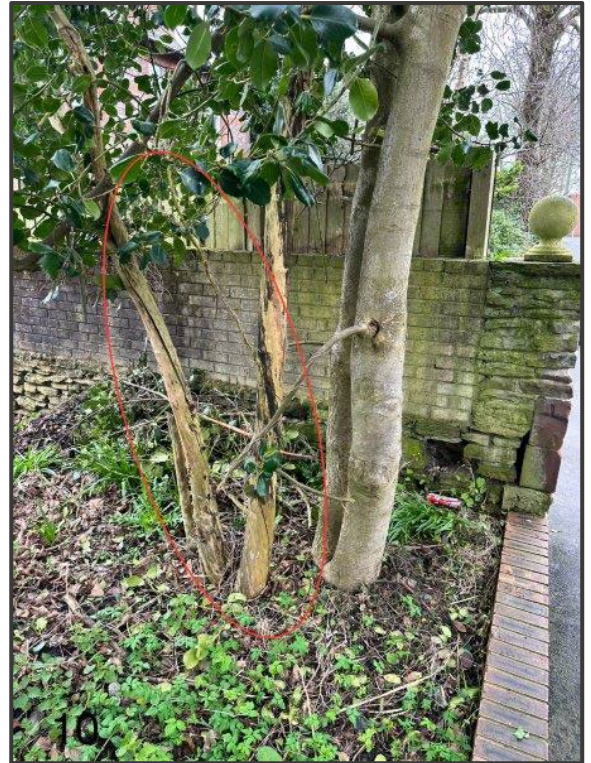
| DATE OF SURVEY: 21/03/2024 | | | JOB REFERENCE: LTM1097.AIA.01 | | | SITE ADDRESS: St Agnes Parish Club, Huyton Hey Rd, Huyton, L36 5SQ | | | | | | | | | | |
|---|---|---|---|---|---|---|---|---|---|---|---|---|---|---|---|---|
| T10 | Holly | 250 | 28 | 3 | 7 | EM | 1 | 2.5 | 3 | 1 | 3S | A | Asymmetrical crown. Double stemmed with acute basal union. Vitality appears normal. Tree appears to be stable. Dead elderberry bush close to this tree should be removed. | Remove dead elderberry bush next to this tree | 40+ | C1 |

**Picture 10. T10-Double stemmed holly with acute basal union. Dead elderberry bush next to holly indicated by red circle.**
